# National Transportation Safety Board

ERA23LA013

Factual Report 23-065

Location: Woodstock, Virginia  
Date: October 8, 2022  
Vehicle: Schempp-Hirth Discus CS, N520RJ  
Investigator: Robert Gretz (AS-ERA)

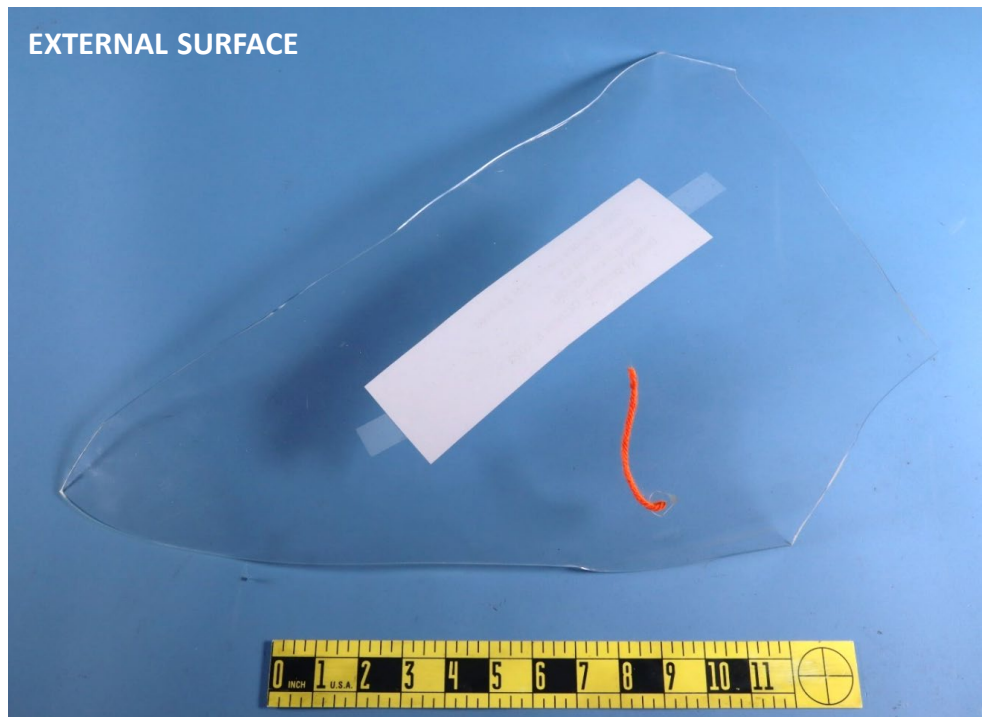
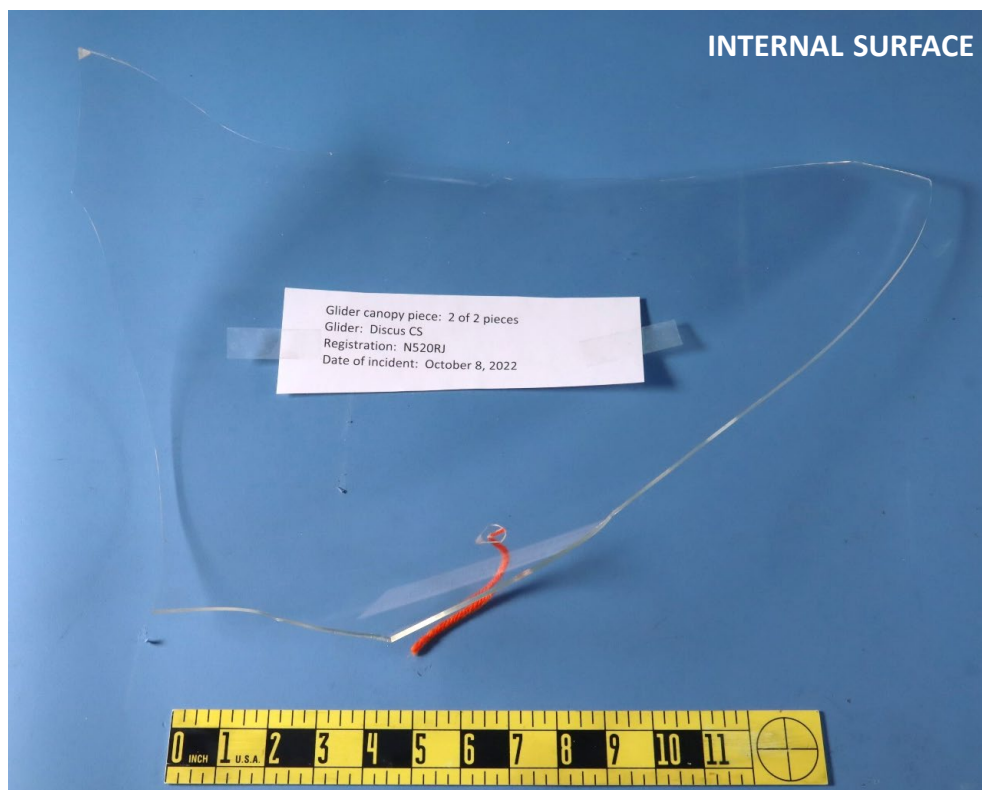
The overall shape and clear edges without any adherent paint on the smaller piece (Figure 1) was consistent with it originating somewhere in the center of the canopy. The fracture surfaces were examined under a 5x to 50x zoom stereo microscope. All the fracture surfaces had features consistent with overstress.

**Figure 1.** Macro photos showing the smaller canopy remnant piece.

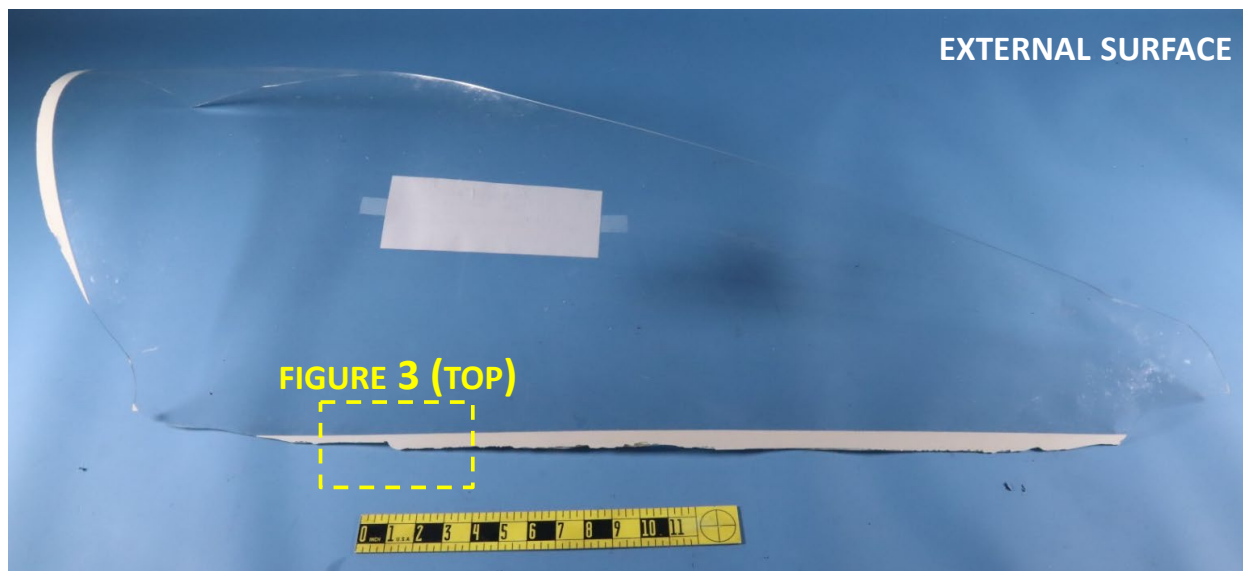
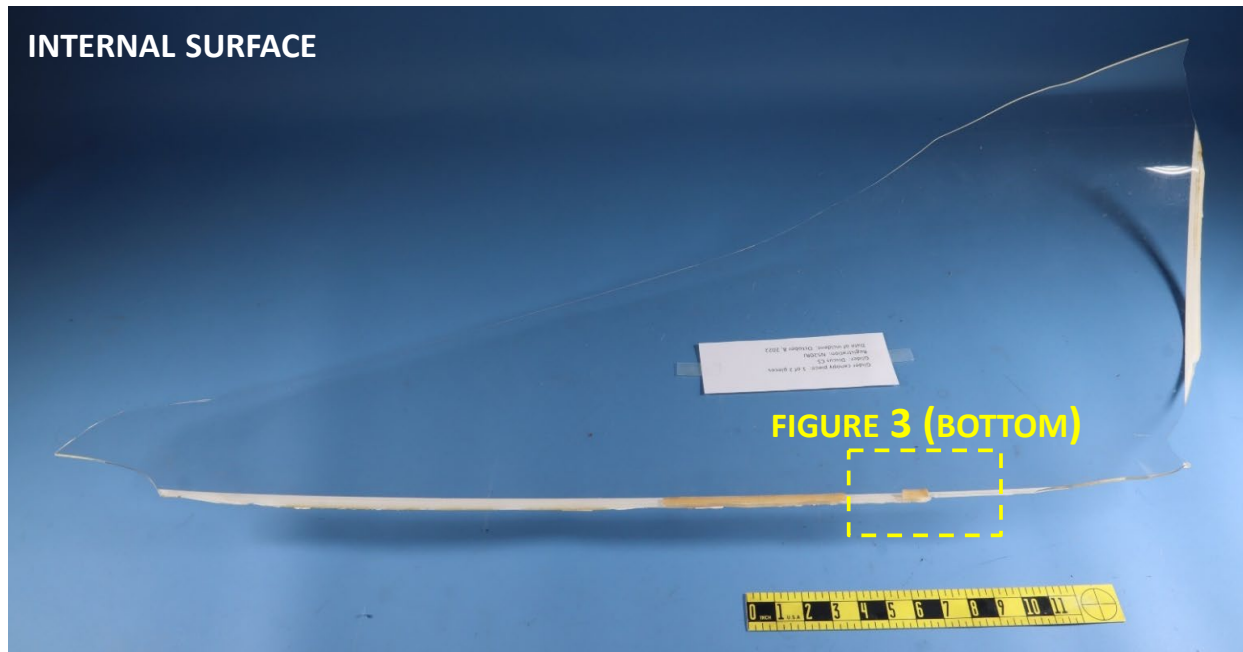
The larger piece of canopy had two edges with adherent paint - a parabola-shaped edge along the short side and a straight edge along the long side, as shown in Figure 2. The shape of the piece and location of the adherent paint was consistent with the piece originating from the aft left side edge of the canopy.

**Figure 2.** Macro photos showing the larger canopy remnant piece.

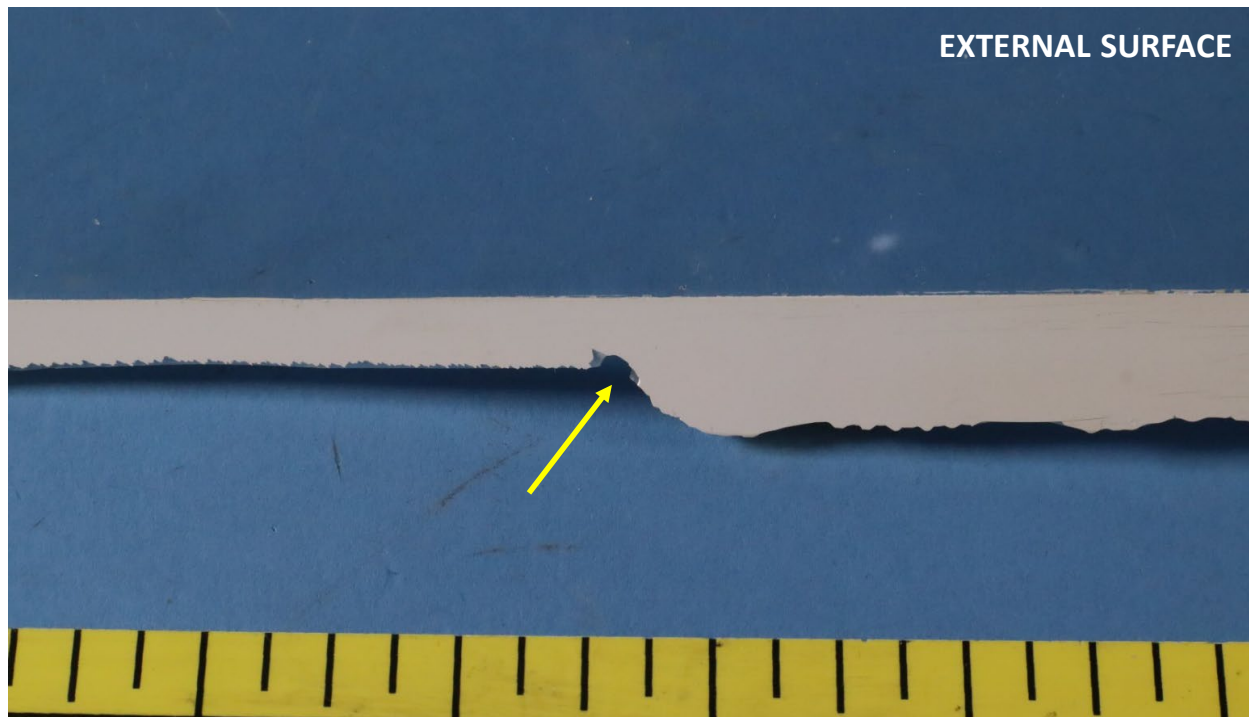
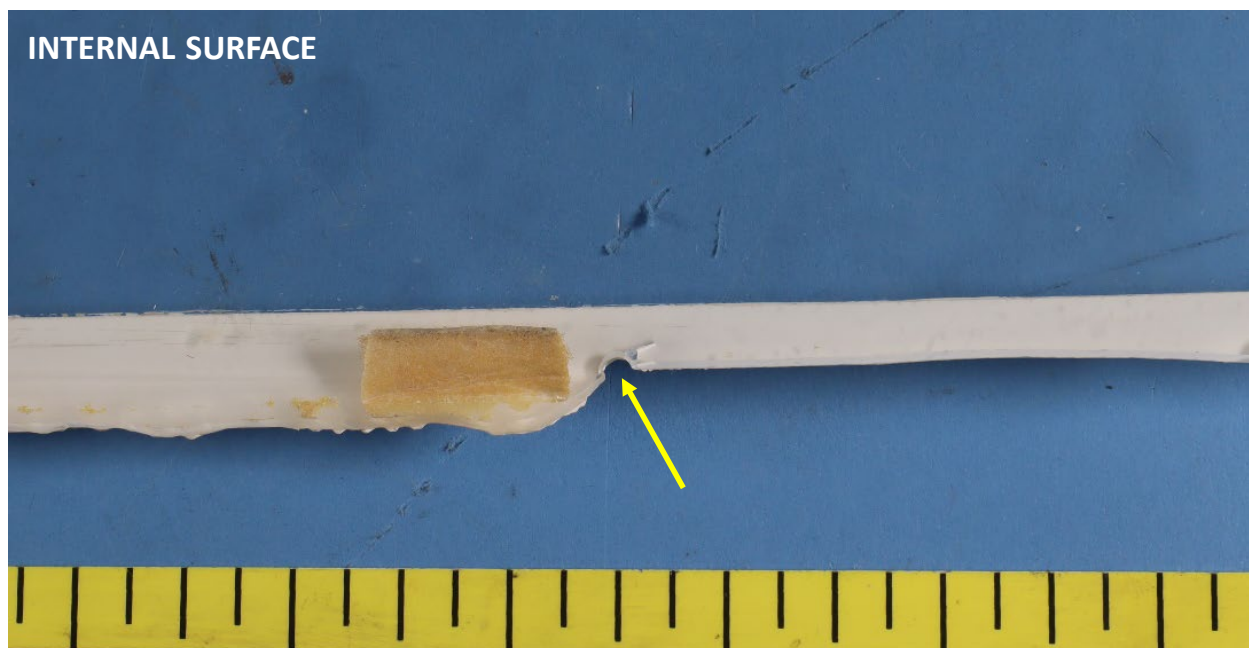
A straight fracture surface extended from near the aft edge of the piece forward, terminating in a drilled hole. Yellow arrows in Figure 3 point to the hole. The profile of the straight portion from the canopy piece fracture surface and the drilled hole is traced in the top of Figure 4 and compared to a photo of the glider frame from the on-scene investigation shown in the bottom of Figure 4. The on-scene photo shows that the flat fracture surface resulted from a crack that extended forward above one edge of the latch (red bracket). The crack was previously observed, and the hole was drilled as an attempt to halt crack propagation.

**Figure 3.** Close-up photos showing the hole (yellow arrows) drilled in the larger canopy remnant piece.

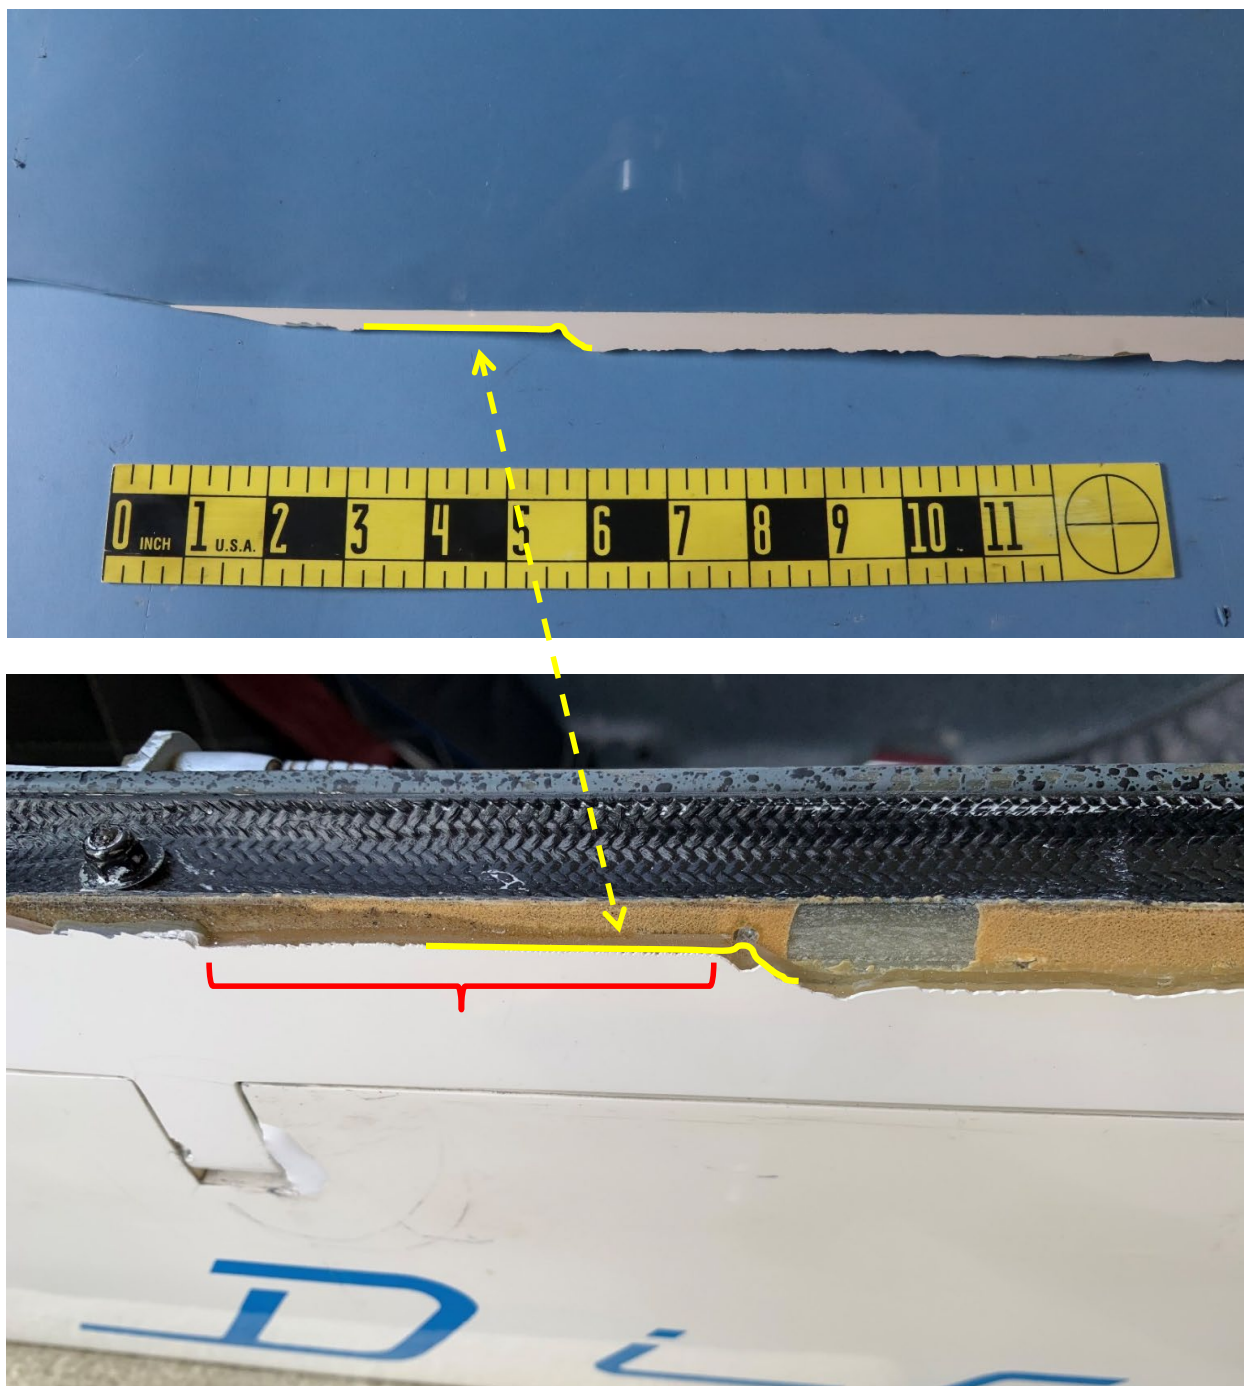
**Figure 4.** The top image is a close-up photo (top) of the larger canopy remnant piece. The bottom image is a photo from on-scene of the glider body. The yellow lines compare profiles of the two canopy fracture surfaces. The red bracket indicates the length of the original canopy crack.

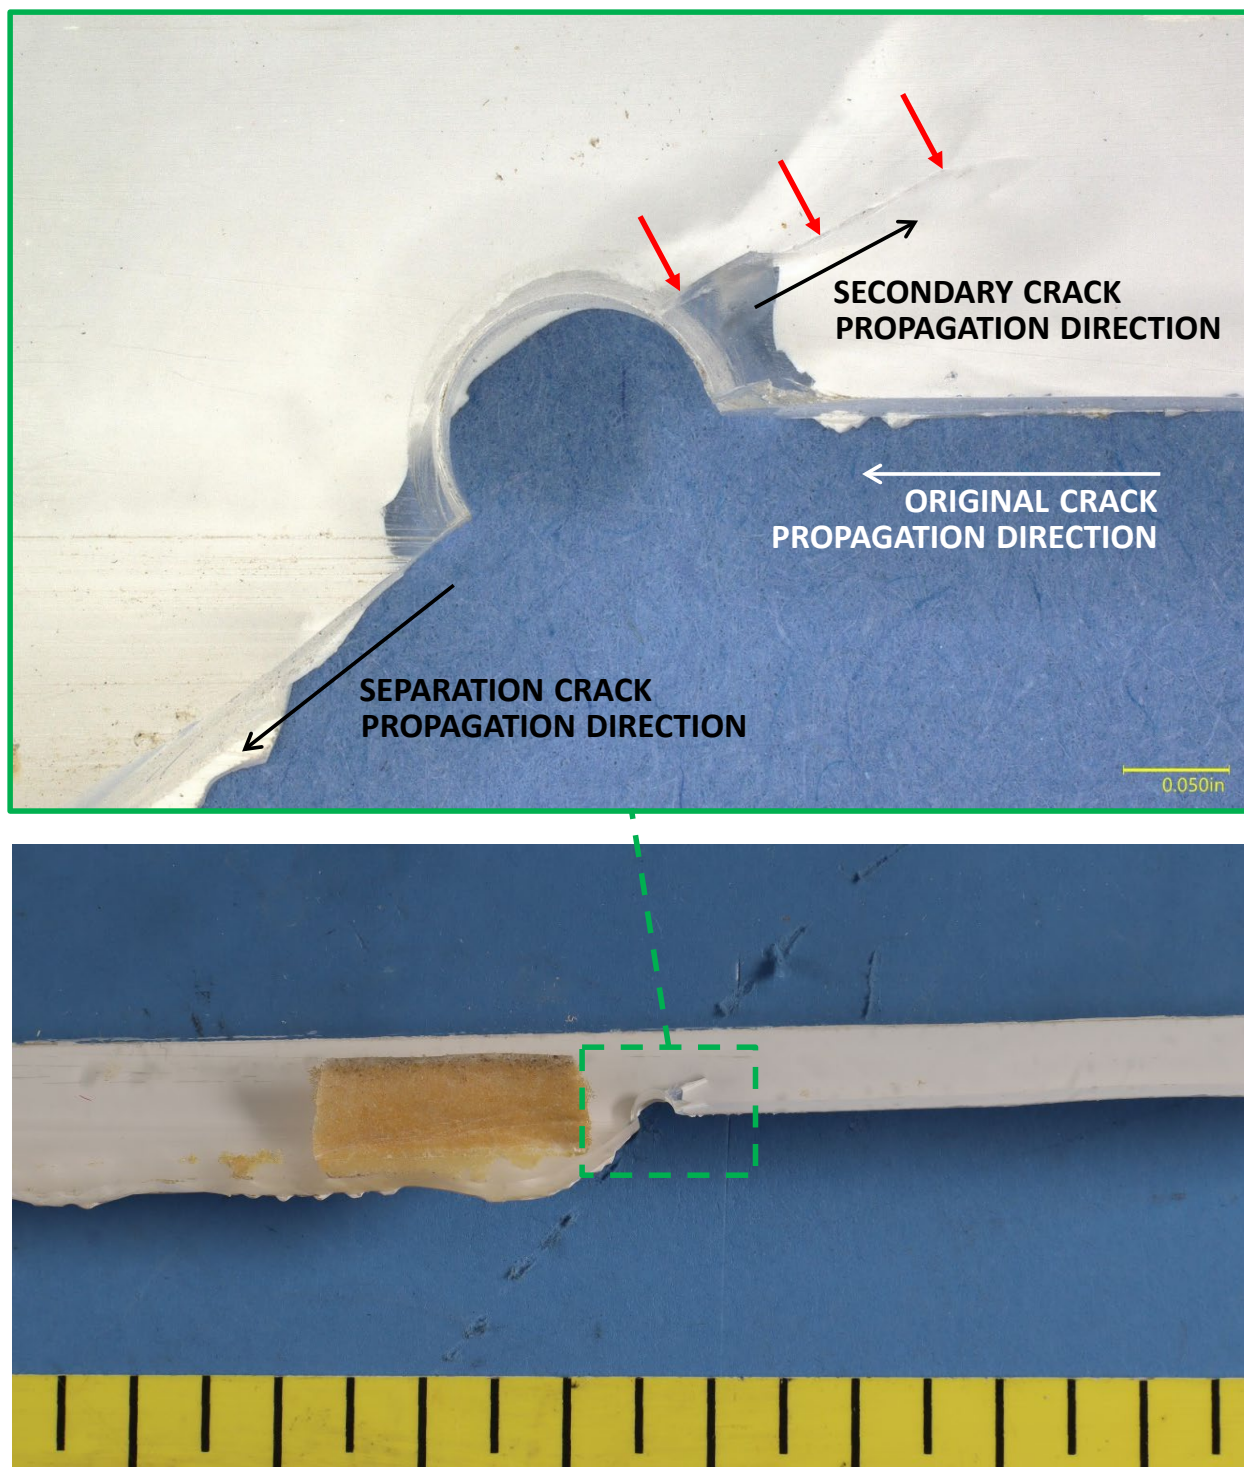
Close-up views of the hole in the canopy piece are shown in Figure 5. The straight fracture surface from the original crack extended into the hole from the right

side of the images. The fracture surface from the canopy piece separation extends out of the hole towards the bottom left corner of the hole. A secondary crack (red arrows) extends out of the hole diametrically opposite the separation fracture surface.

**Figure 5.** Close-up photo (bottom) and digital microscope image (top) of the larger canopy remnant piece. The red arrows point to a secondary crack and the direction of crack propagation for each crack is indicated.

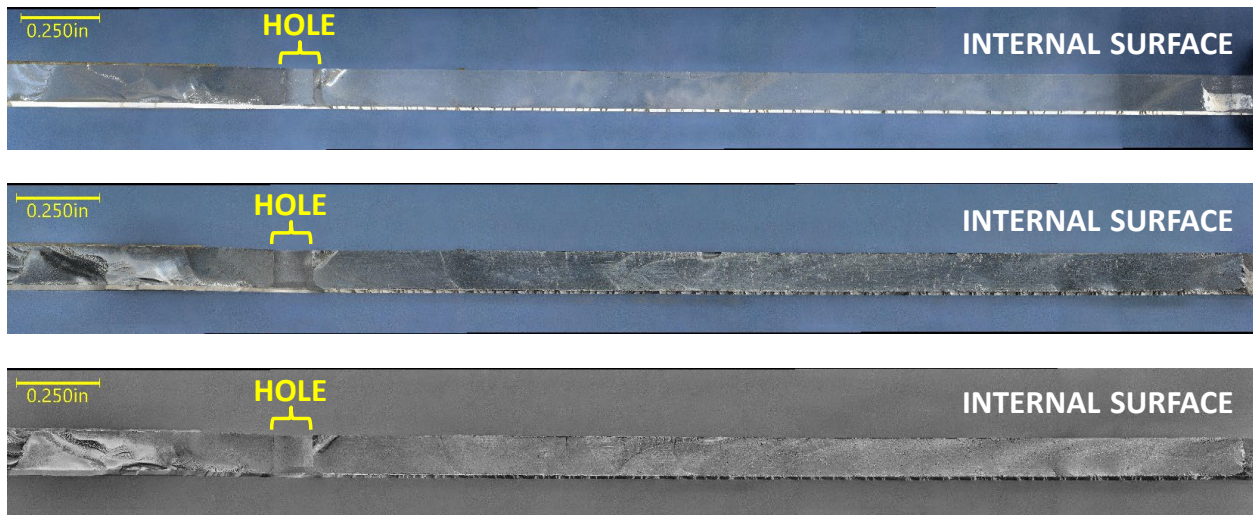
A portion containing the fracture surfaces surrounding the hole was sectioned from the canopy piece. The fracture surface is documented in the as-received condition in the top image of Figure 6. The fracture surface was sputter coated with a thin layer of gold-platinum alloy to improve opacity of the transparent canopy material and highlight the fracture surface features. The fracture surface with the sputter coating is shown in color in the center image of Figure 6 and in black and white in the bottom image of Figure 6.

**Figure 6.** Digital microscope composite images of the fracture surface in the (top) as-received condition, (center) with a sputter coating applied and viewed in color, and with a sputter coating applied and viewed in black and white.

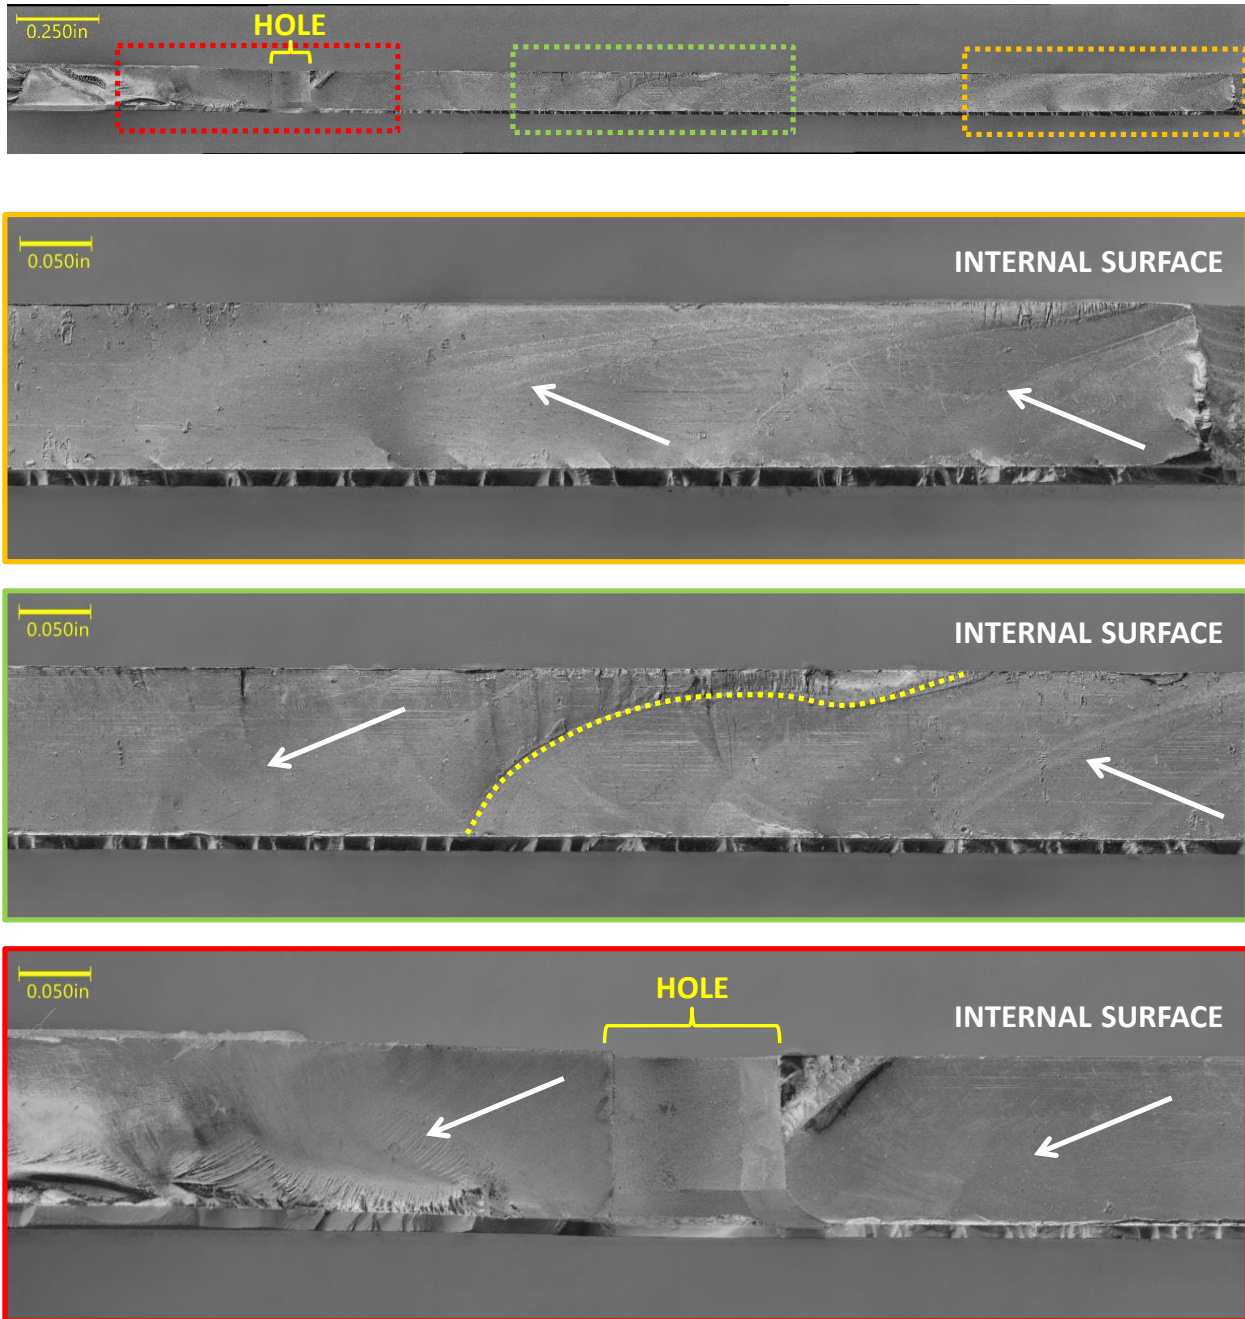
The fracture surface is shown at higher magnification in Figure 7. White arrows indicate the crack propagation direction on the fracture surface. Rib markings indicated the original crack initiated and propagated from the external surface, as shown in the orange highlighted rectangle. Approximately halfway along the straight fracture surface, rib markings begin emanating from the internal surface, indicating a transition in the stress state driving crack propagation. The transition from external surface to internal surface crack propagation is traced by the yellow dotted line in the green highlighted rectangle. The original crack continued to propagate from the internal surface up to the drilled hole, as shown in the red highlighted rectangle. The separation fracture surface also propagated from the internal surface, initiating at a corner of the drilled hole profile.

**Figure 7.** Digital microscope images of the fracture surface with a sputter coating applied and viewed in black and white. Each dotted rectangle outlines the area shown in the image bordered in the corresponding color at higher magnification. The white arrows indicate the direction of crack propagation. The yellow dotted line traces the transition from external surface to internal surface crack propagation.

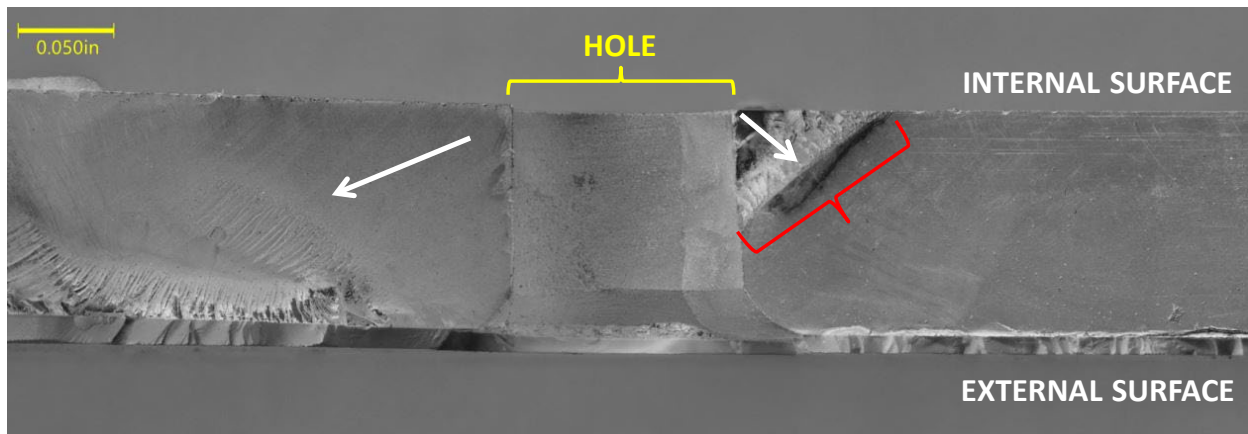
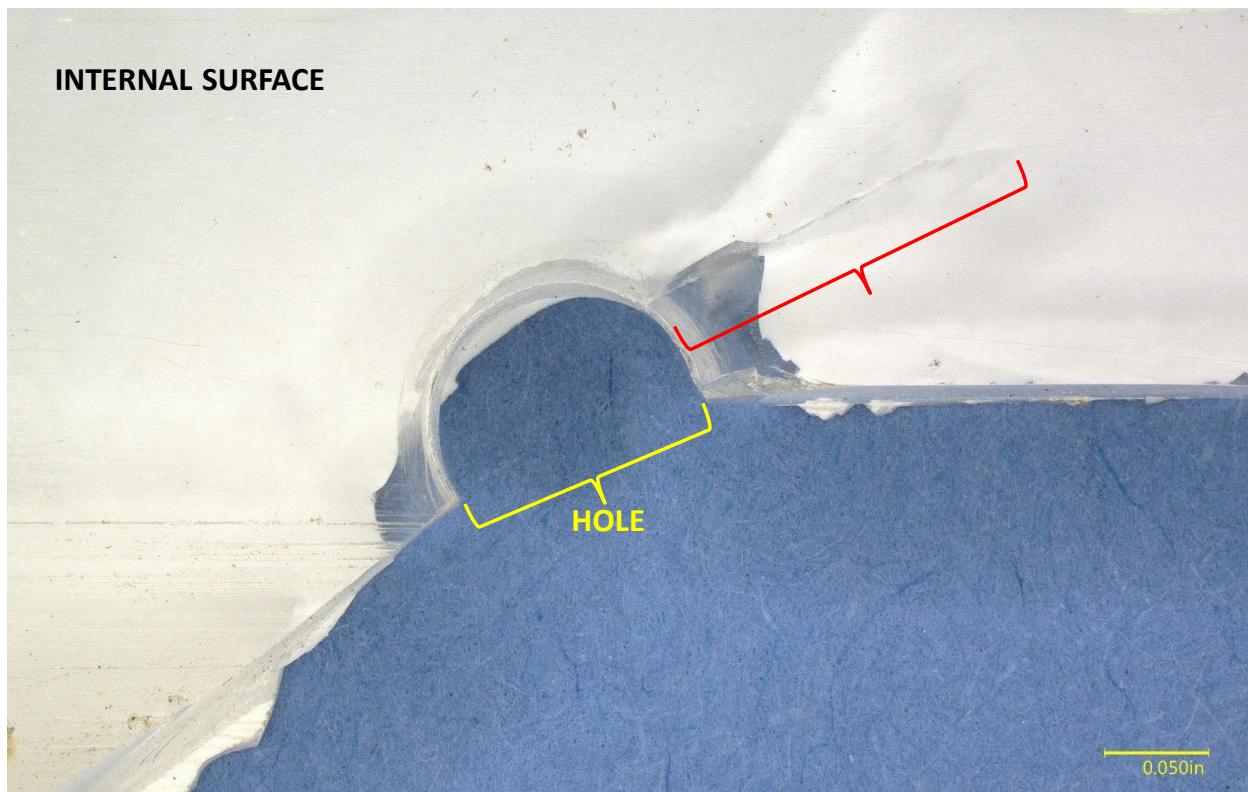
The length of the secondary crack observed on the internal surface is compared to the crack depth visible beneath the fracture surface in Figure 8. Because of the transparent nature of the canopy material, the secondary crack can be seen beneath the fracture surface, as indicated by the red bracket in the top image of Figure 8. The secondary crack also initiated at a corner of the drilled hole profile and propagated from the internal surface.

**Figure 8.** (Top) Digital microscope image with a sputter coating applied and viewed in black and white. The white arrows indicate the direction of crack propagation. (Bottom) Digital microscope image of the internal surface of the larger canopy remnant piece. The red brackets indicate the secondary crack branching from the drilled hole.
