## Memorandum For Record

**Date: December 19, 2022**  
**NTSB Accident Number: ERA23LA020**

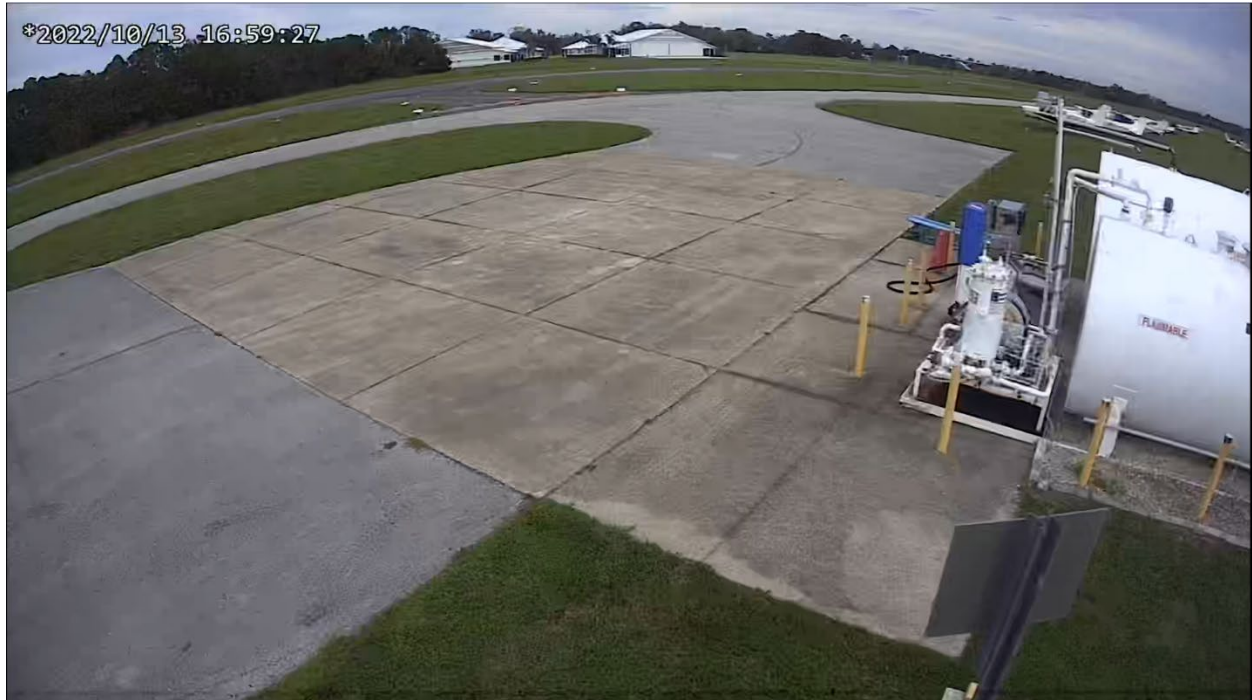
Figure 1: Screen Shot from Channel 9. Depicts the airplane Above the Runway in a Nose-High Attitude.

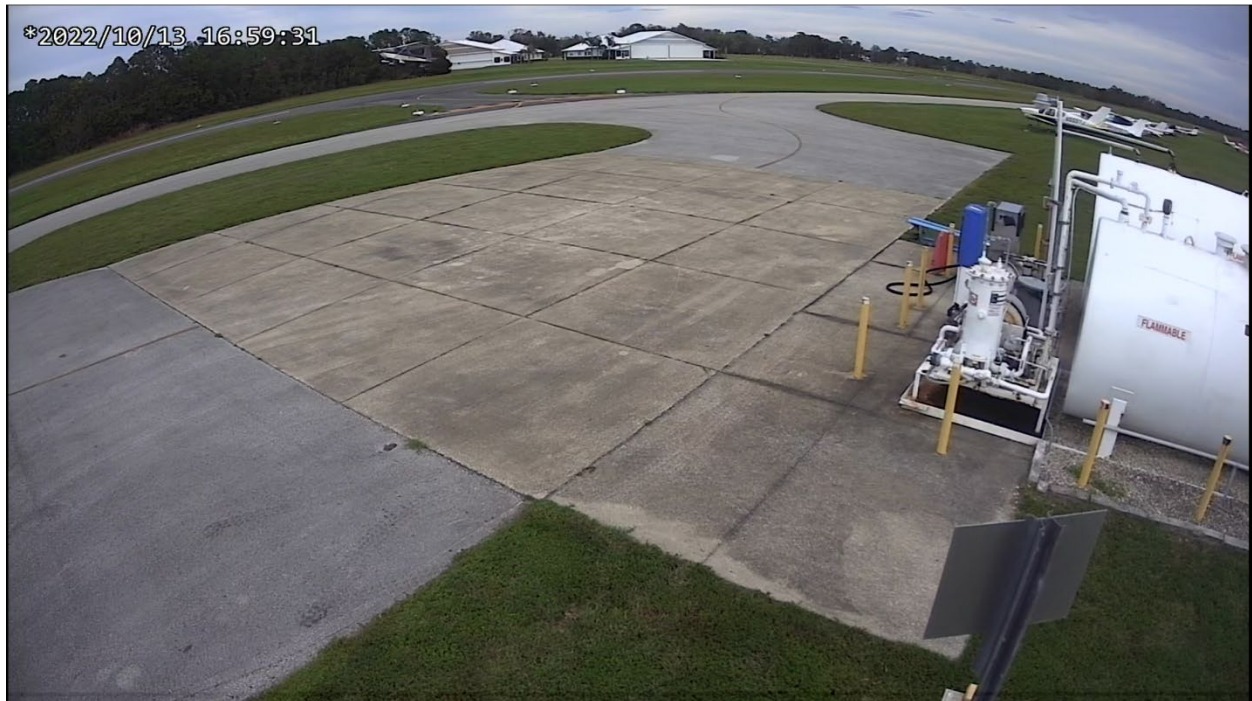
Figure 2: Screen Shot from Channel 9. Depicts the airplane Above the Runway in a Nose-High Attitude.

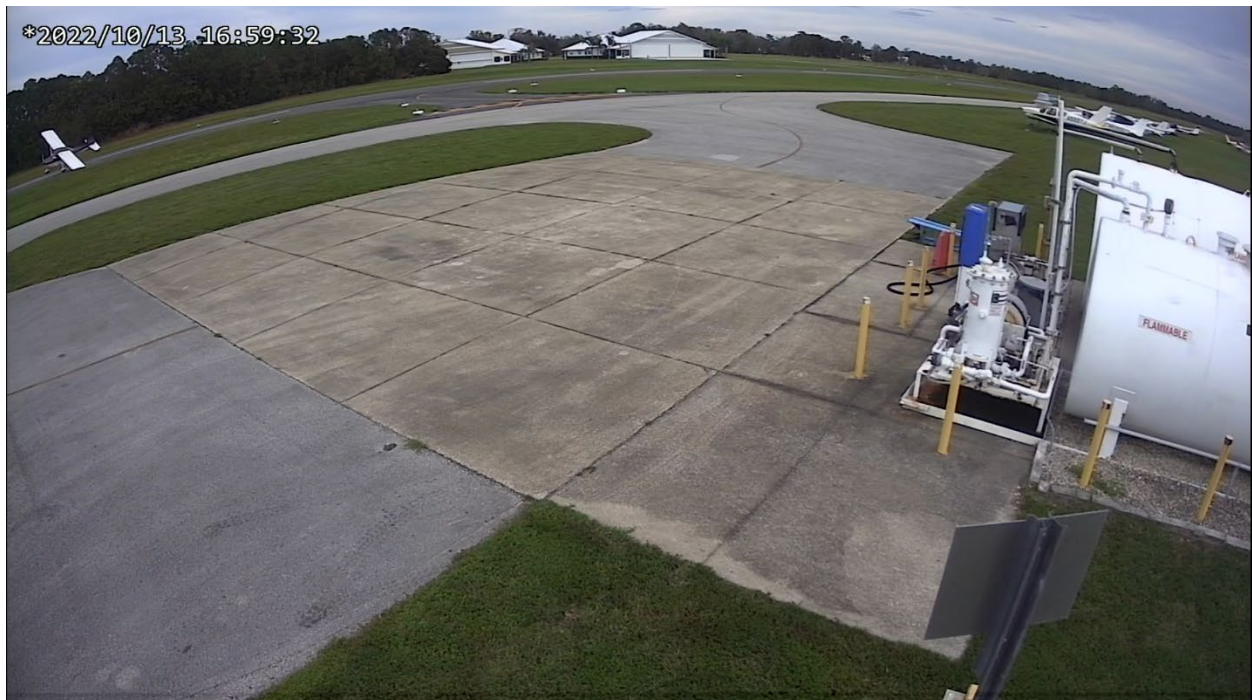
One video taken from Channel 09 was a 59-seconds long video clip taken that depicted a portion of the takeoff and entire accident sequence. The video depicted a view of the northeast and a portion of runway 18/36. At 16 seconds elapsed time, the airplane came into view while on the runway. The airplane continued on the runway and was noted to become airborne at about 17 seconds elapsed time. The flight continued over the runway at an estimated height of about 10 ft above ground level (agl) and at 26 seconds elapsed time was noted to be in a nose-high attitude (Figure 1). The flight continued in the same nose-high attitude and same approximate altitude and at 30 seconds elapsed time when near a taxiway about 2,800 ft from the approach end of the runway, the airplane was in a nose-high attitude estimated to be about 10 ft agl (Figure 2). After passing the taxiway the left wing dropped and the airplane began descending. At about 32 seconds elapsed time the airplane was in a left wing low attitude and the left wingtip was about ground level (Figure 3). The airplane continued out of camera view at 33 seconds elapsed time.

Figure 3: Screen Shot from Channel 9. Depicts the airplane At or Just Before Left Wing Contact with the Ground.

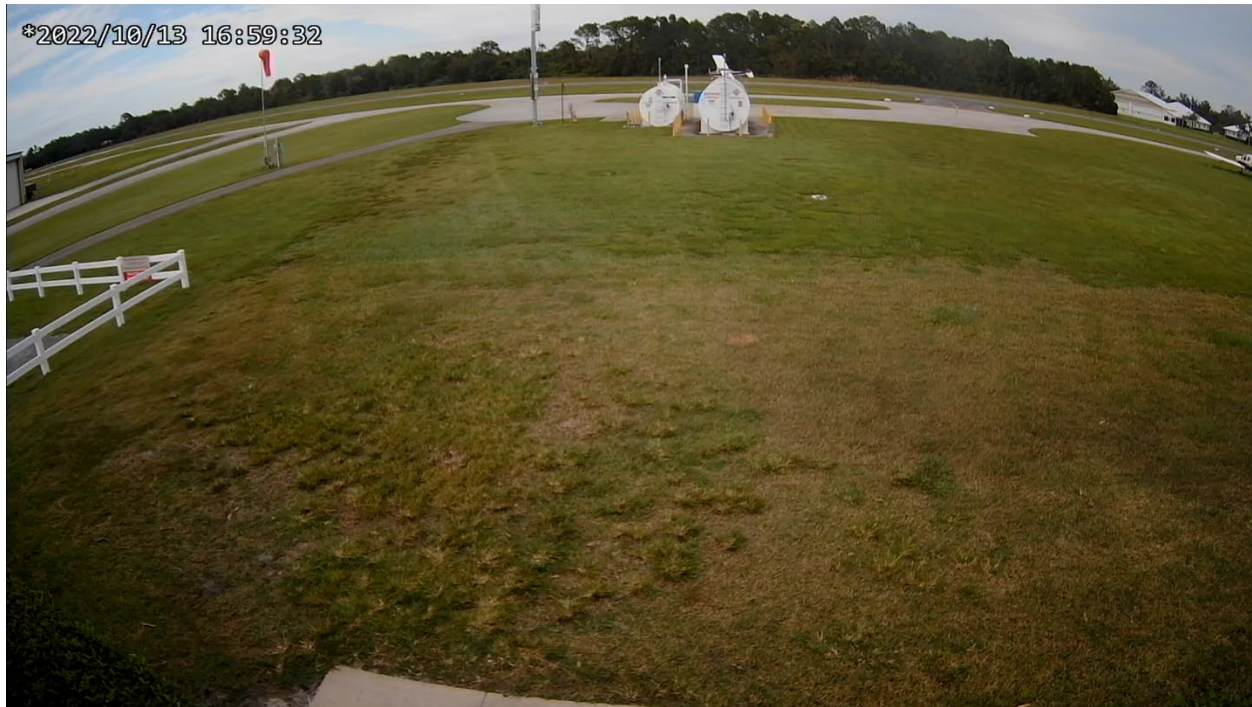
Figure 4: Screen Shot from Channel 3. Depicts the airplane At or Just Before Left Wing Contact with the Ground.

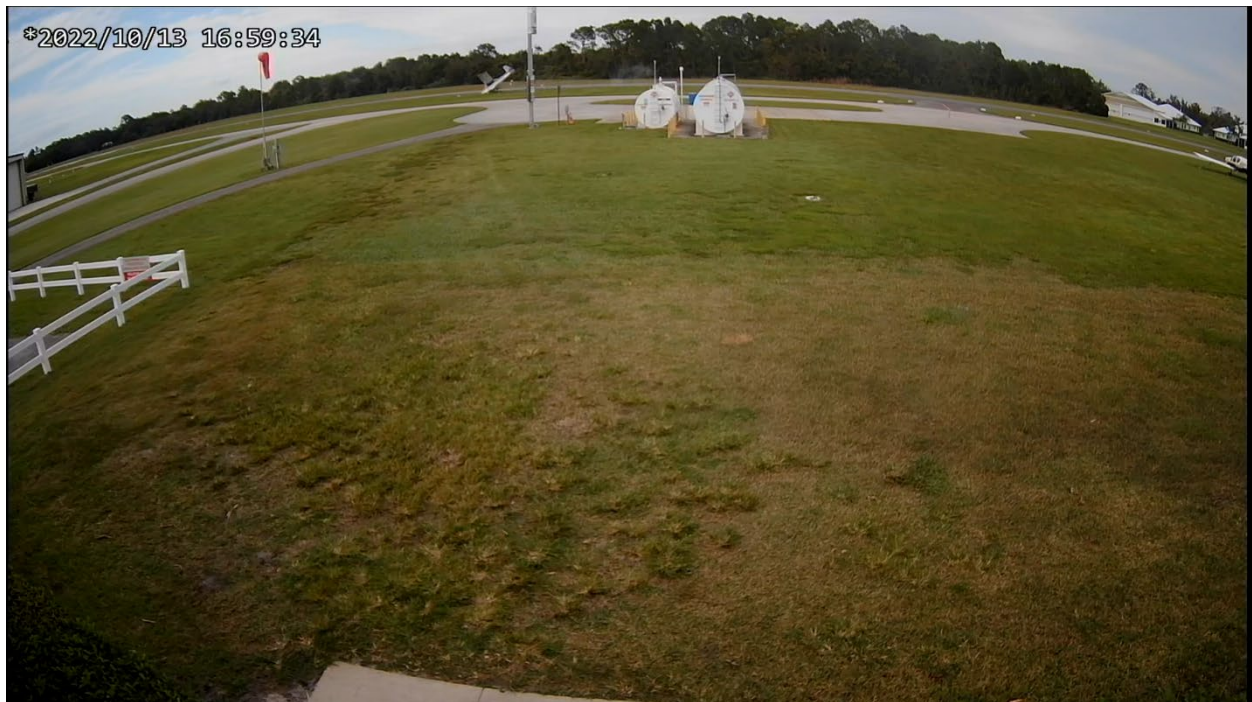
Figure 5: Screen Shot from Channel 3. Depicts the airplane Near the Final Forward Skid.

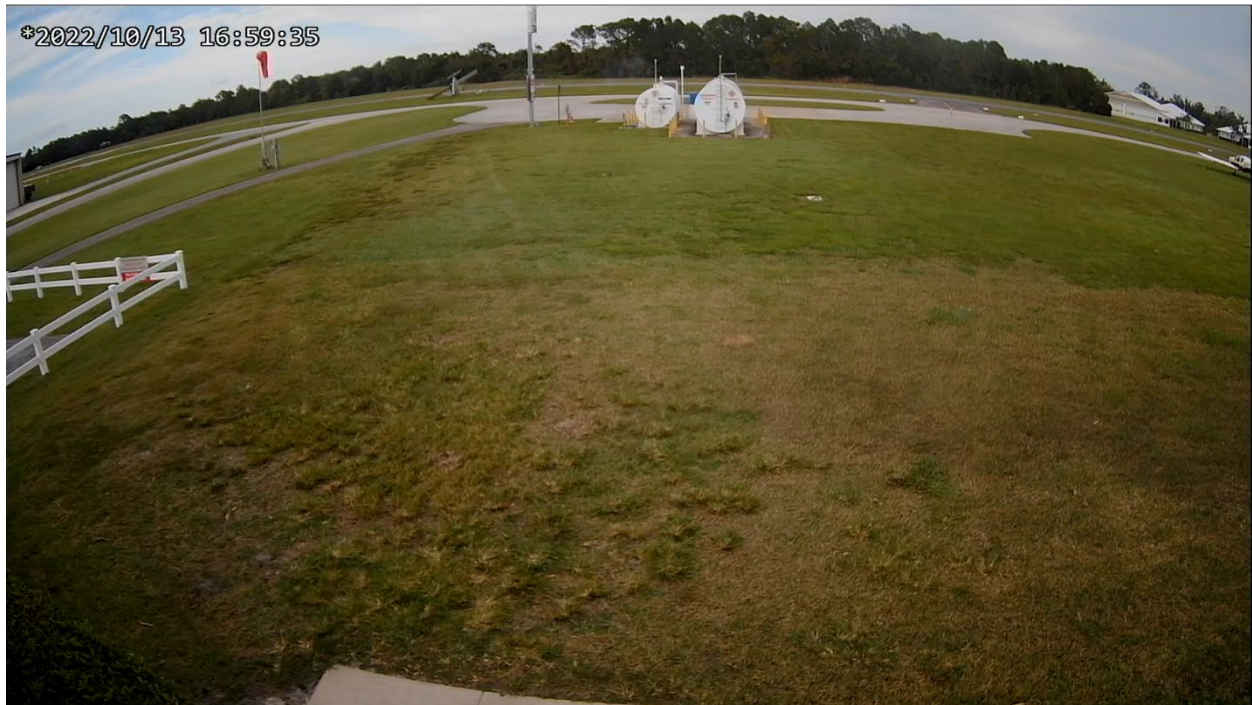
Figure 6: Screen Shot from Channel 3. Depicts the airplane Left Wing Contact Again Just Before Coming to Rest.

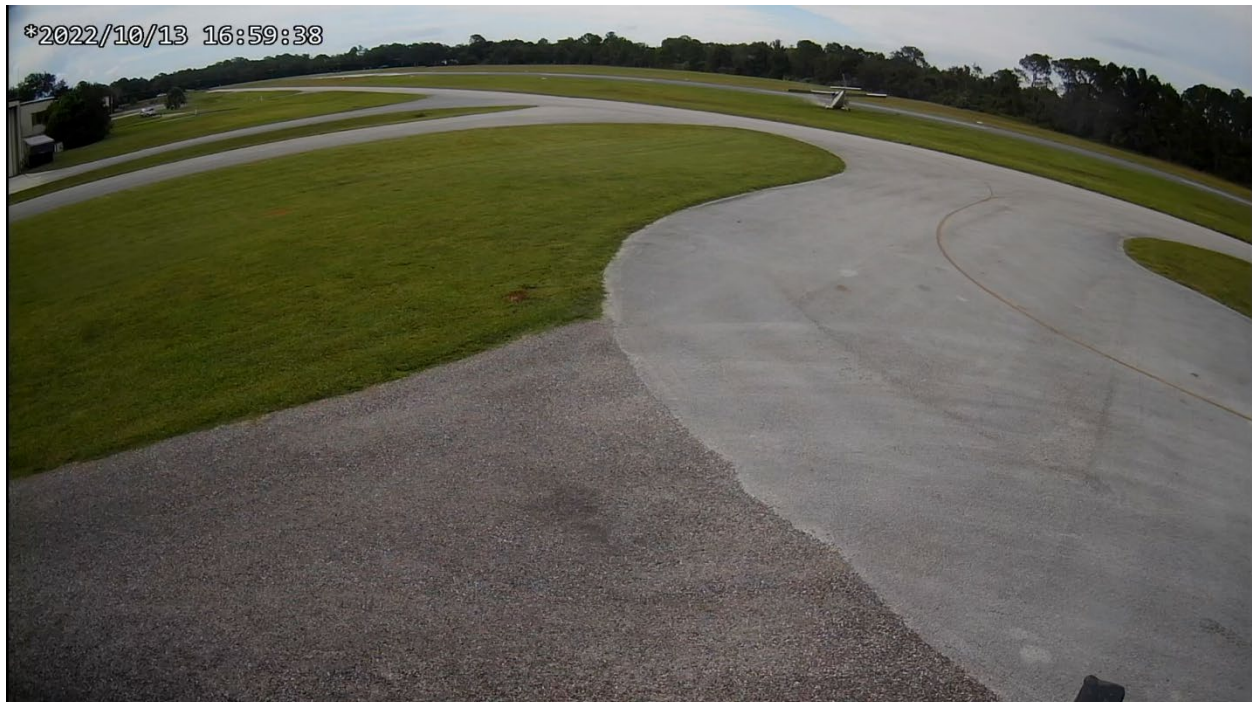
Another video taken from Channel 8 was a 29-seconds long video clip from a camera that was also located near the fuel farm looking east which captured the end portion of the accident flight. At about 1 second elapsed time the airplane started to come into view on the right side of the screen and at 2 seconds elapsed time, the airplane was in a left wing low attitude partially over the runway. The remainder of the video was the same as captured by Channel 3. The airplane came to rest upright (Figure 7)

Figure 7: Screen Shot from Channel 8. Depicts the Airplane as It Came to Rest.
