## **NATIONAL TRANSPORTATION SAFETY BOARD**

**Photo Array**

**ERA23LA030**

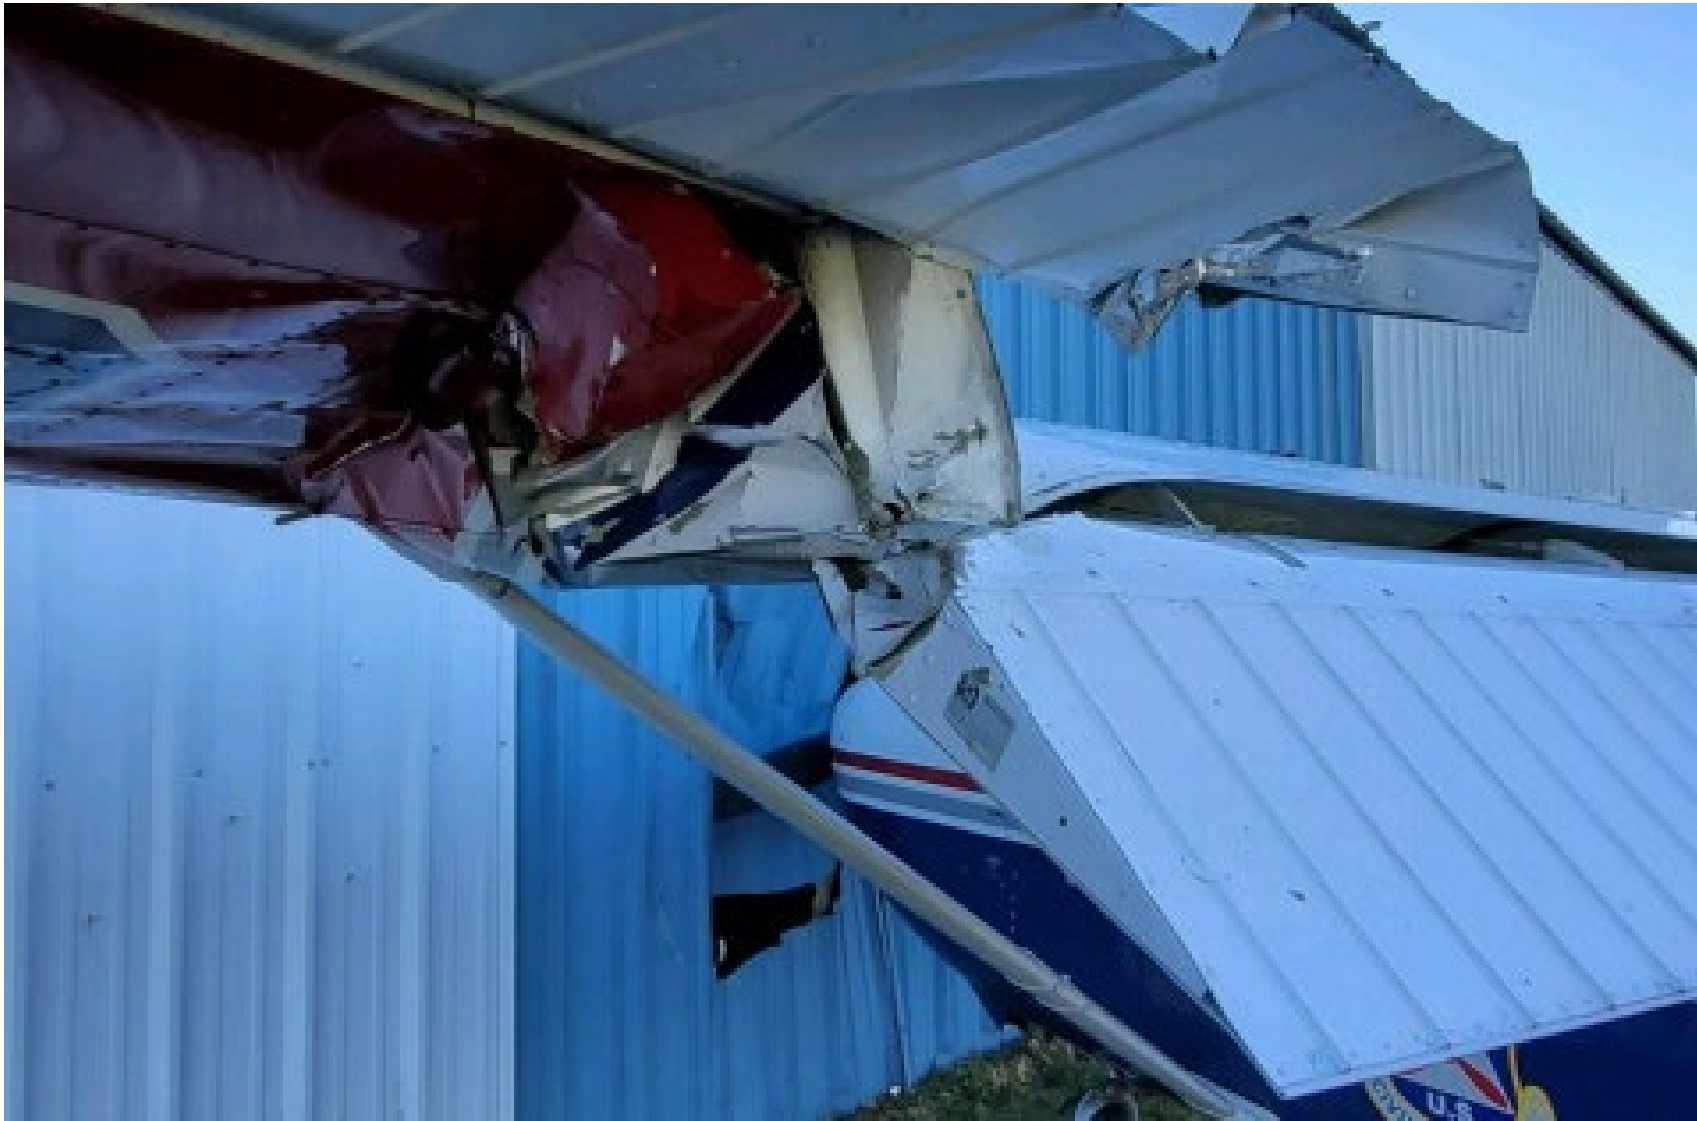
**Photo 1 – View of Left Wing Damage (Photo Courtesy of PJ Mills)**

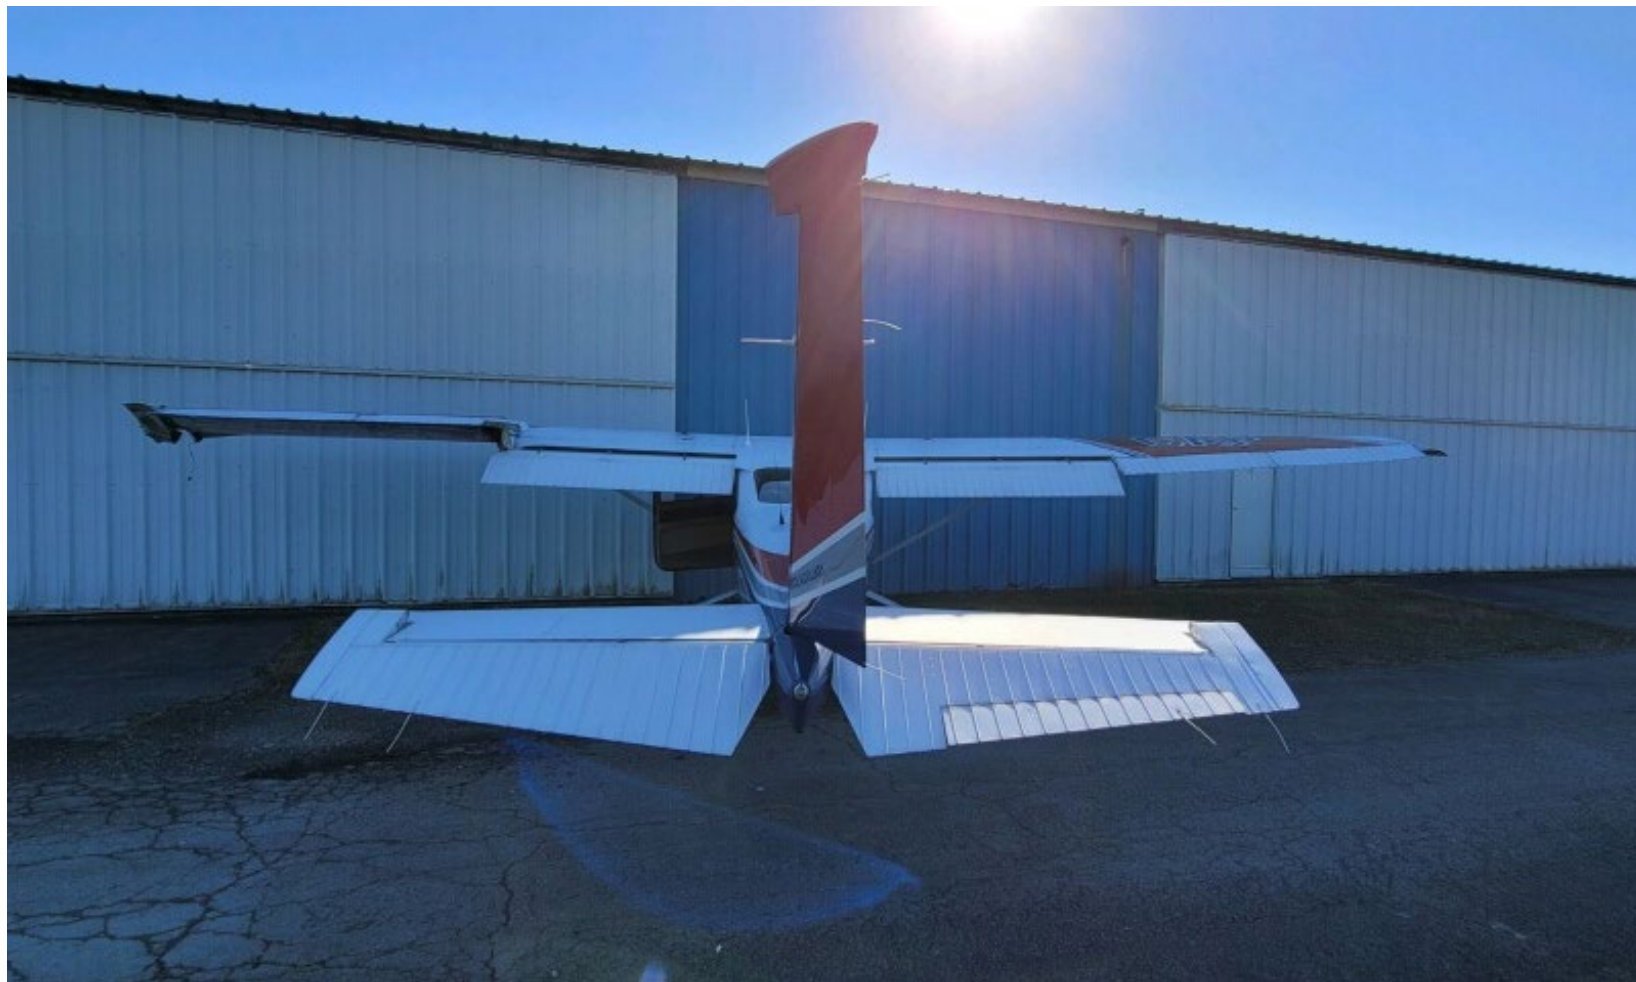
**Photo 2 – View of Airplane from Rear (Photo Courtesy of PJ Mills)**

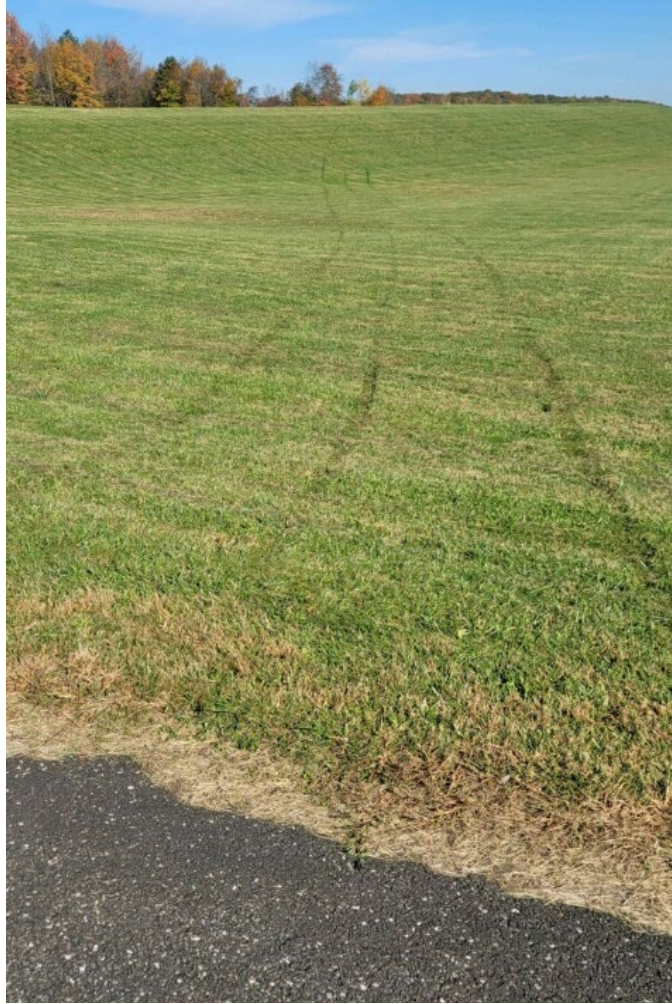
**Photo 3 – View of Ground Scars (Photo Courtesy of PJ Mills)**
