ERA23LA035

## INVESTIGATION PHOTOGRAPHS

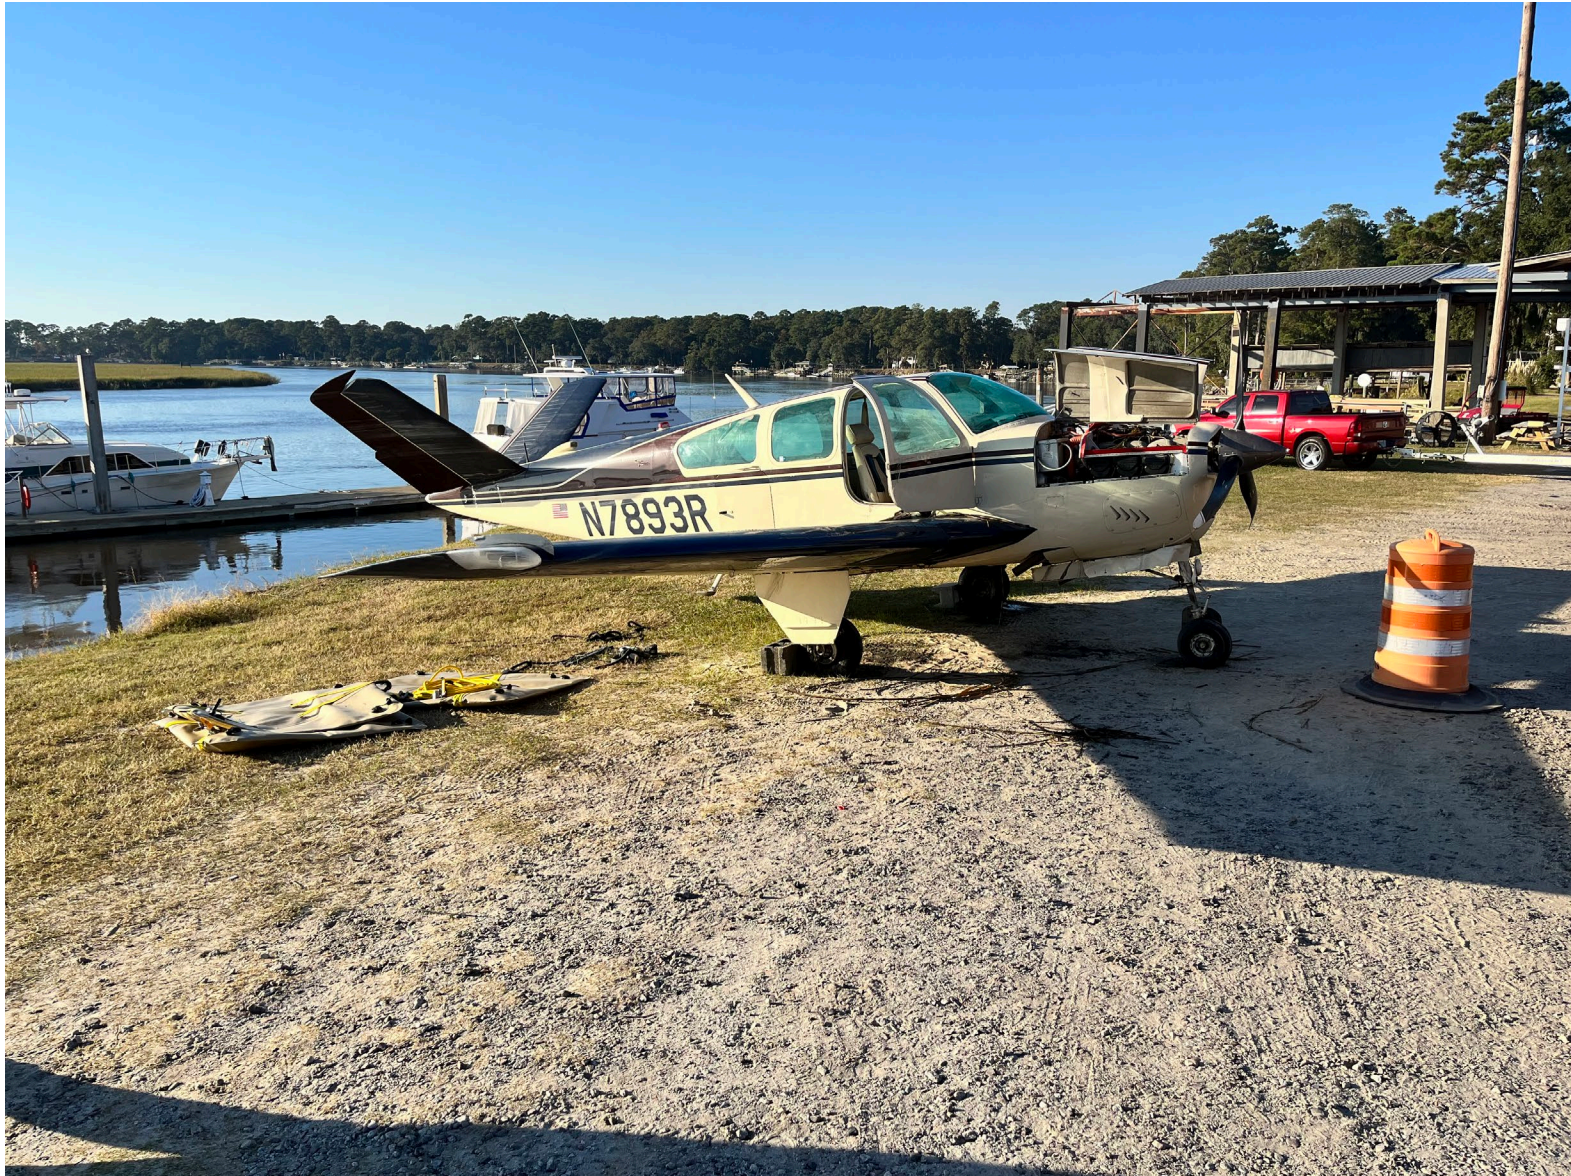
**Photograph 1 - Airplane after recovery from water (Courtesy of FAA)**

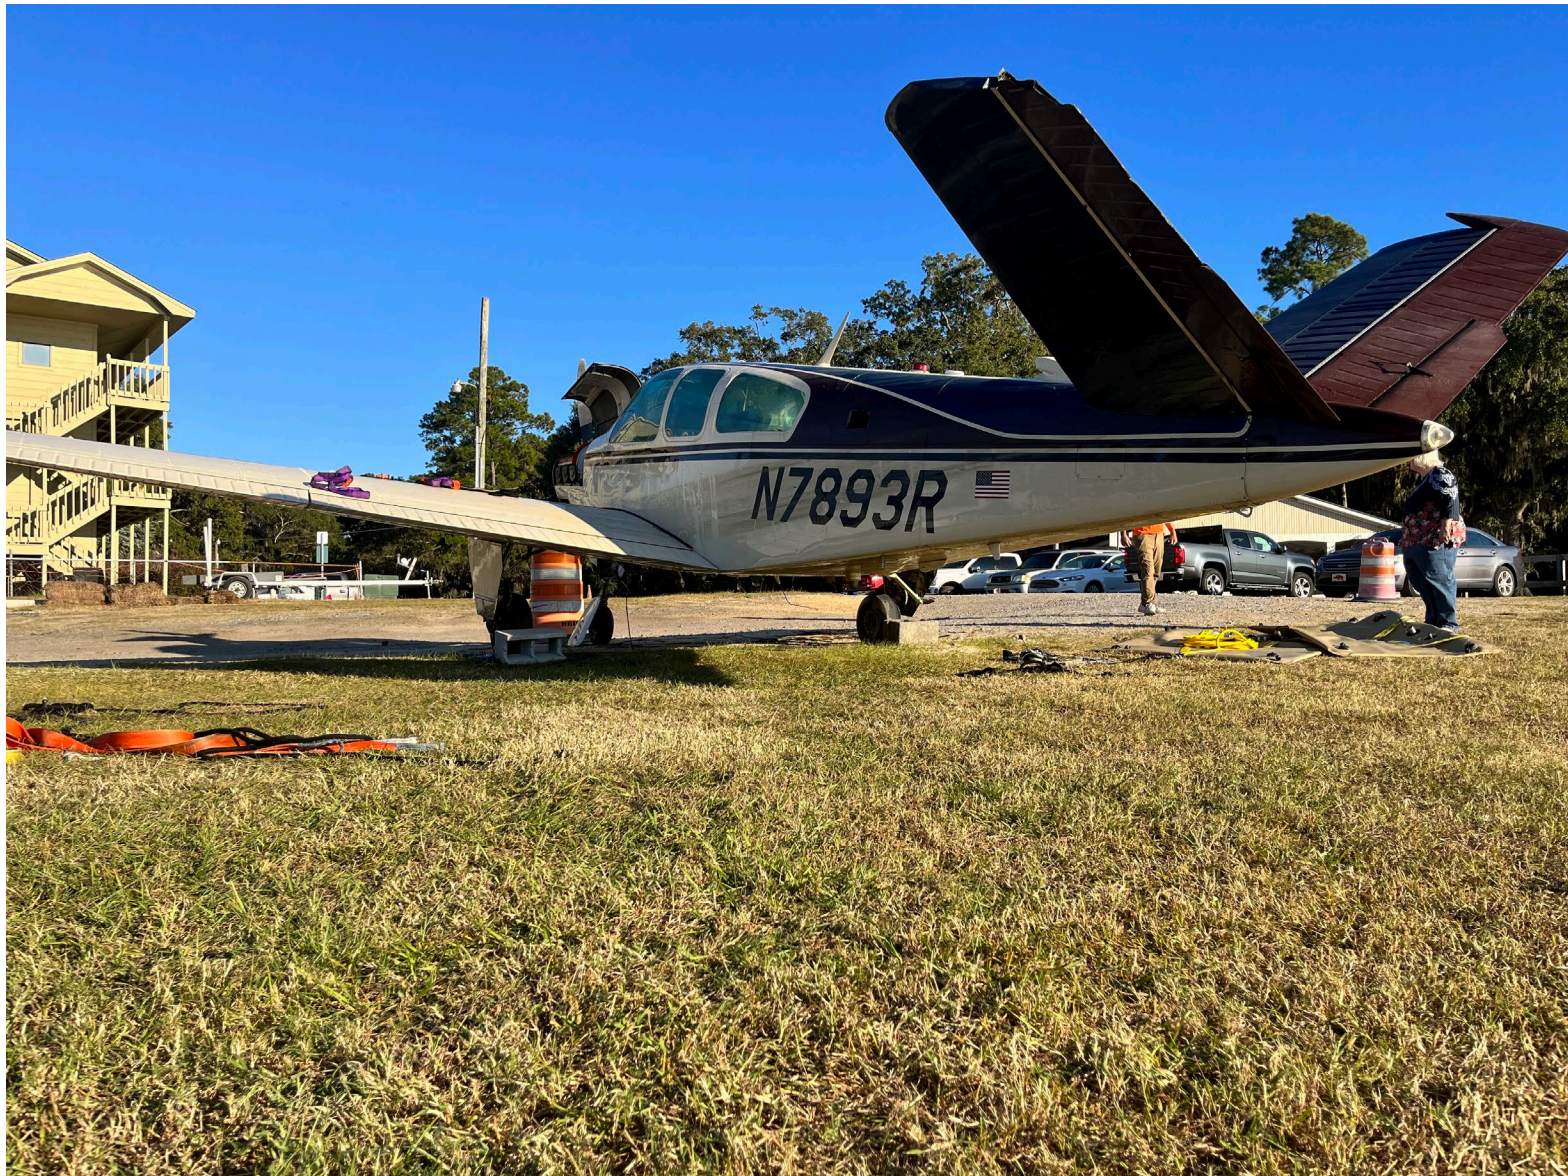
**Photograph 2 - Airplane from aft left, note damage to ruddervator (Courtesy of FAA)**

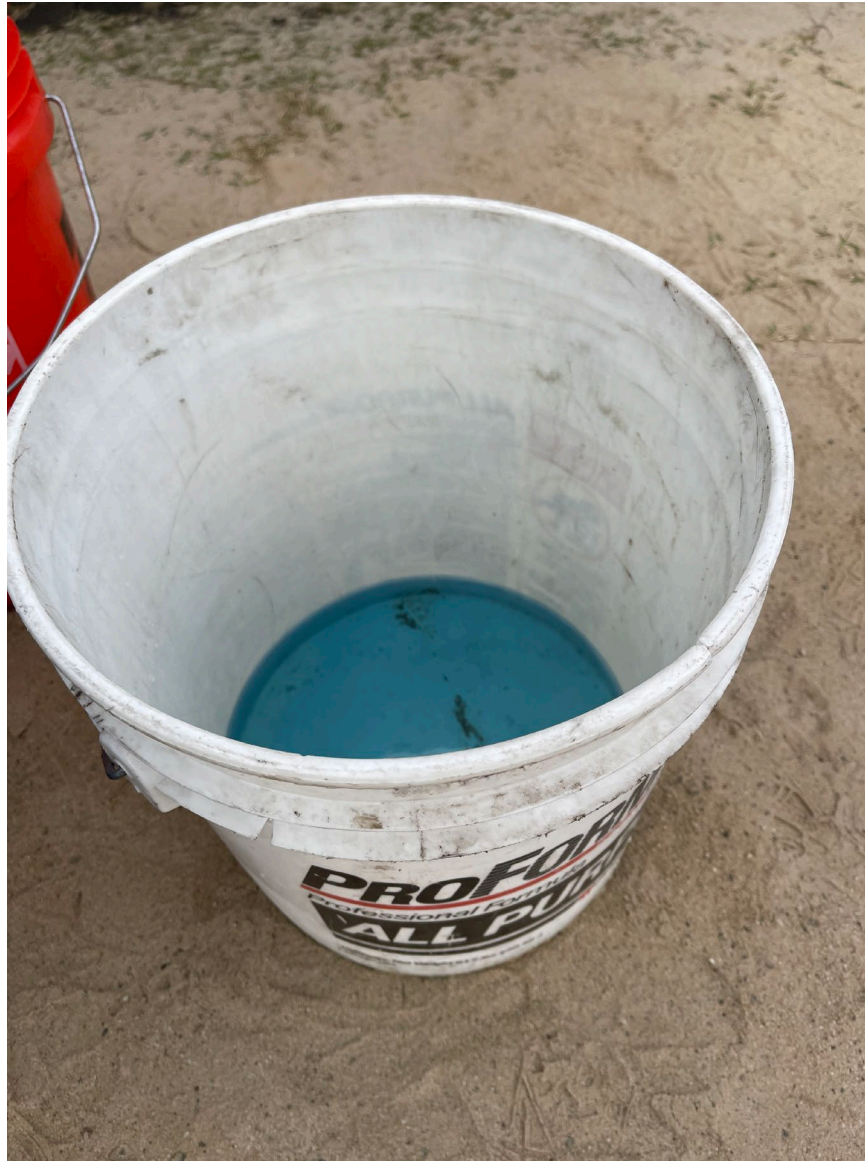
**Photograph 3 - Fuel recovered from both wings (Courtesy of Atlanta Air Recovery)**

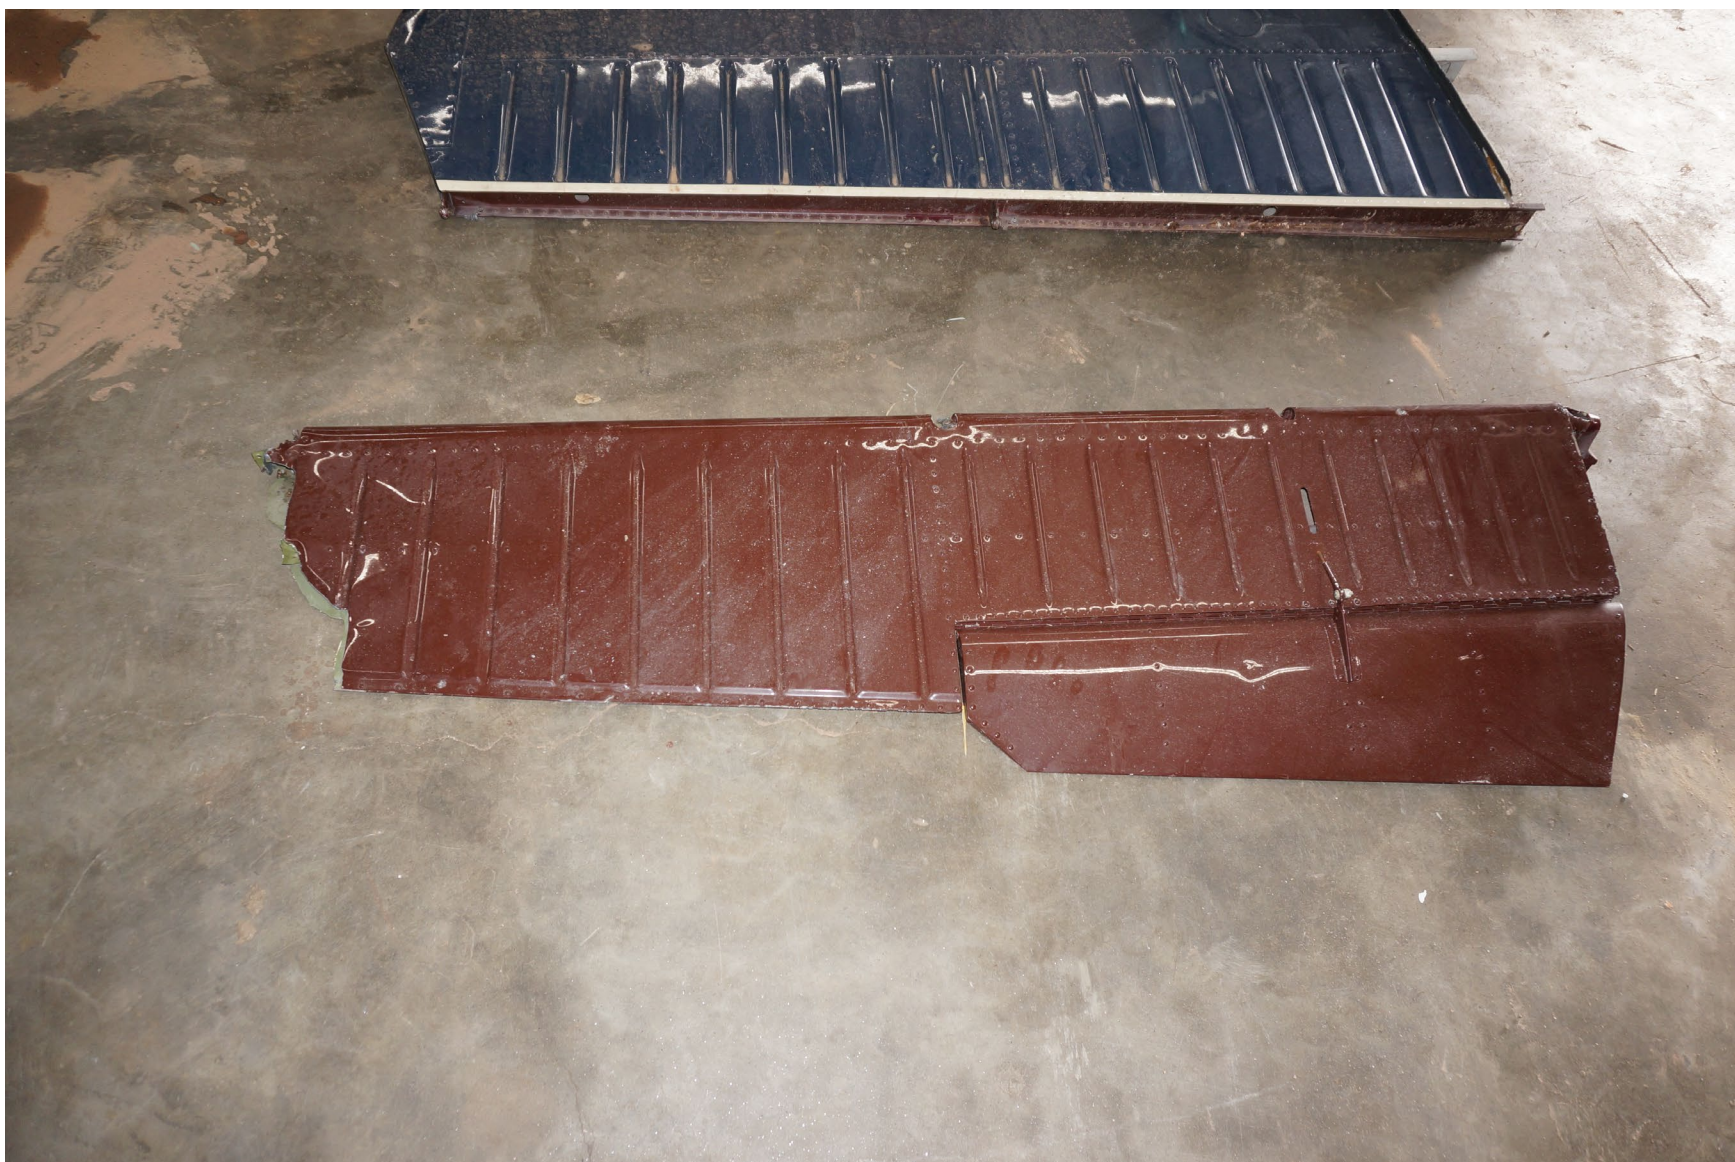
**Photograph 4 - Damaged ruddervator (NTSB)**
