ERA23LA037

## INVESTIGATION PHOTOGRAPHS

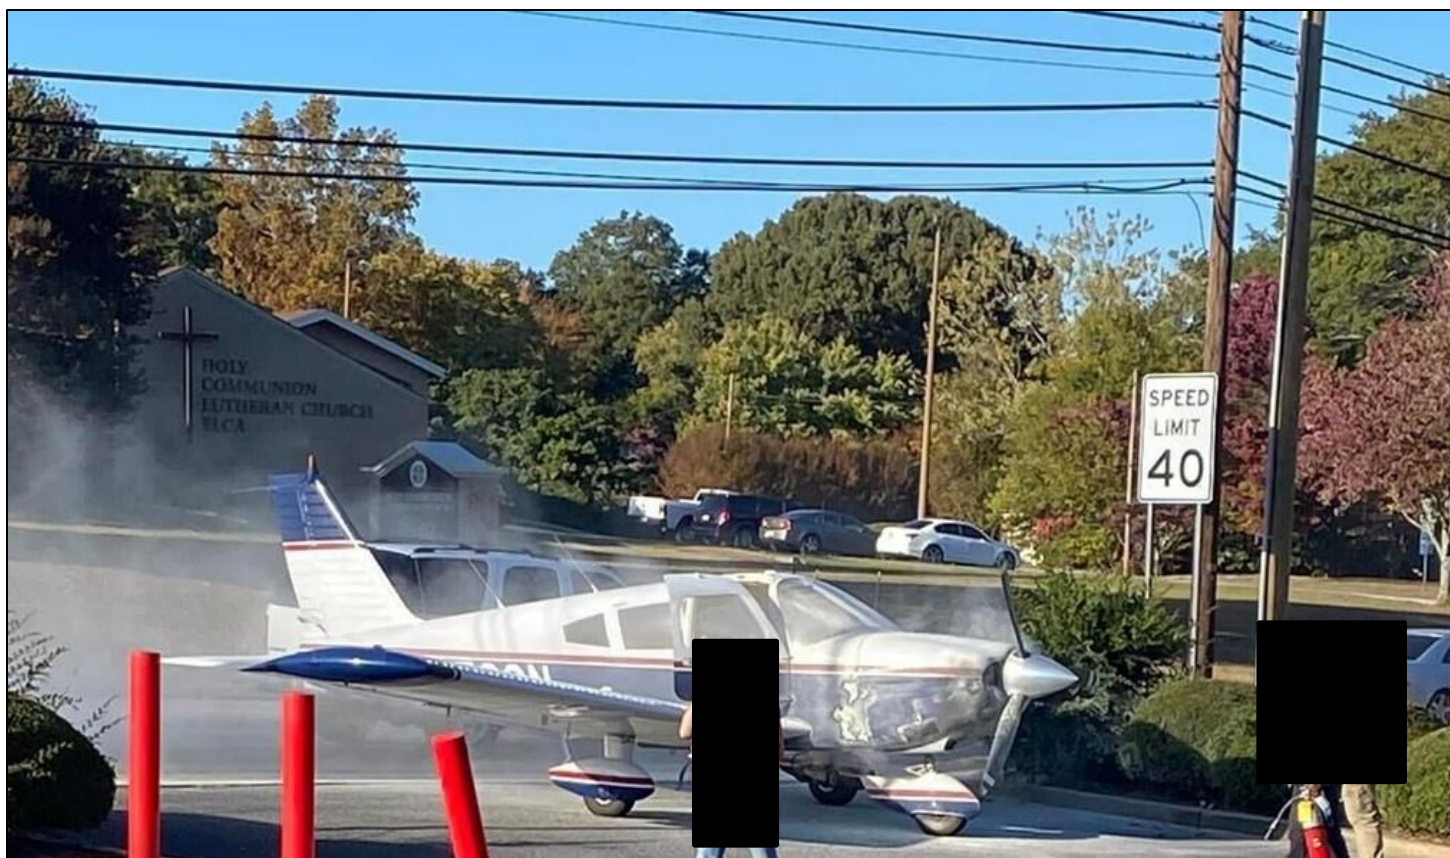
**Photograph 1 - Image of the airplane at the accident site (Courtesy of FAA)**

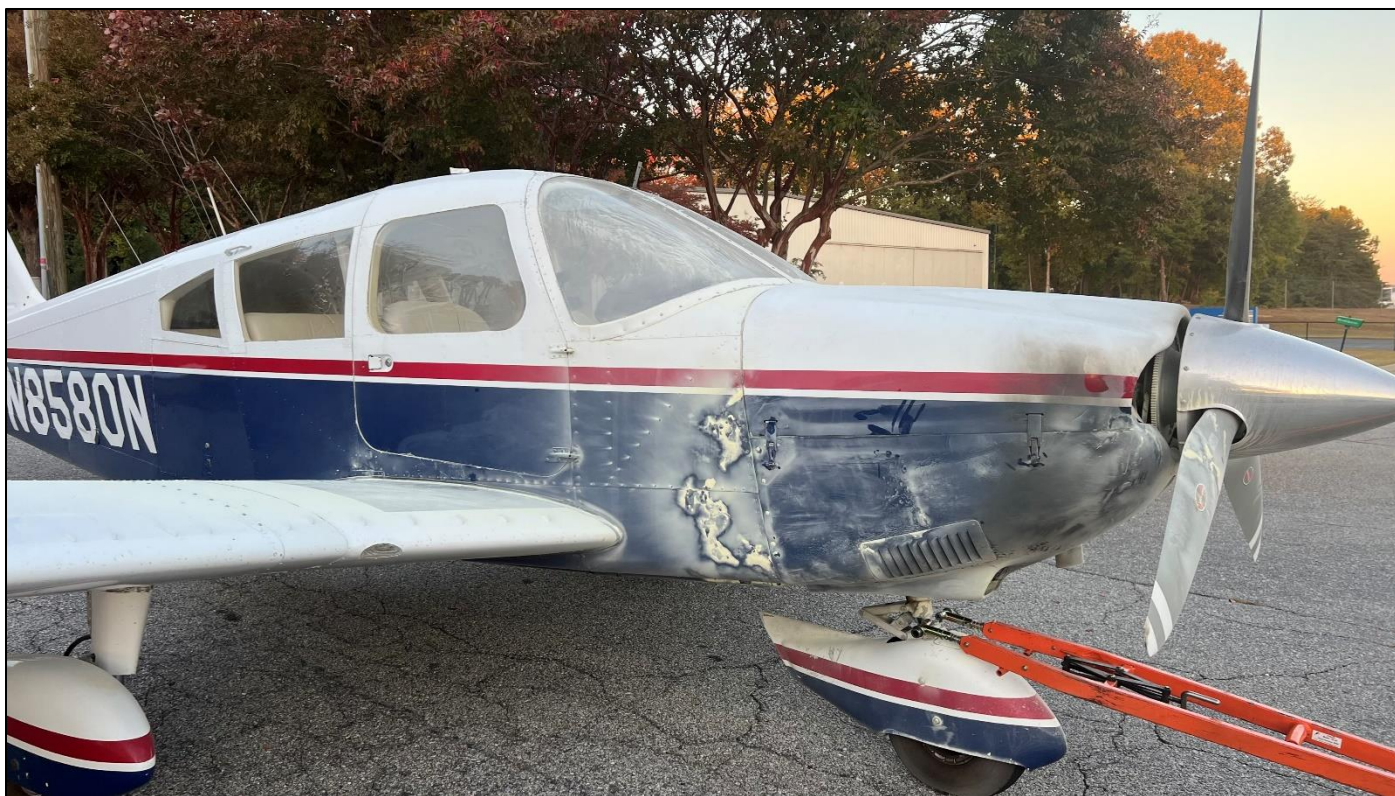
**Photograph 2 - Image of the thermally damaged cowling (Courtesy of FAA)**

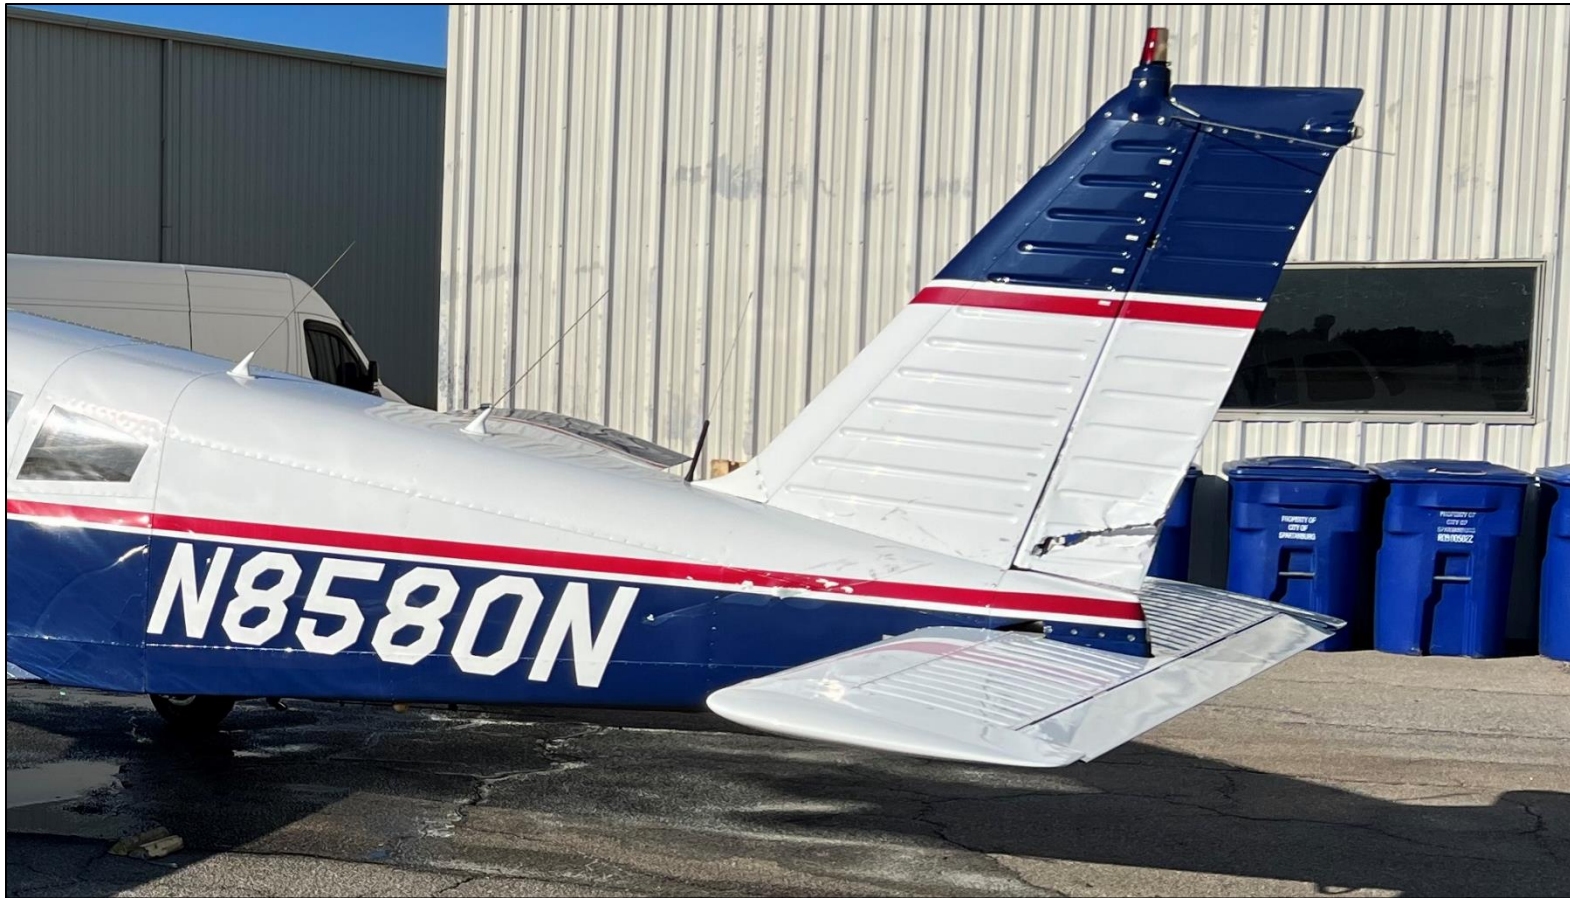
**Photograph 3 - Image of substantially damaged rudder (Courtesy of FAA)**
