# National Transportation Safety Board

ERA23LA037

## **MATERIALS LABORATORY**

Factual Report 23-070

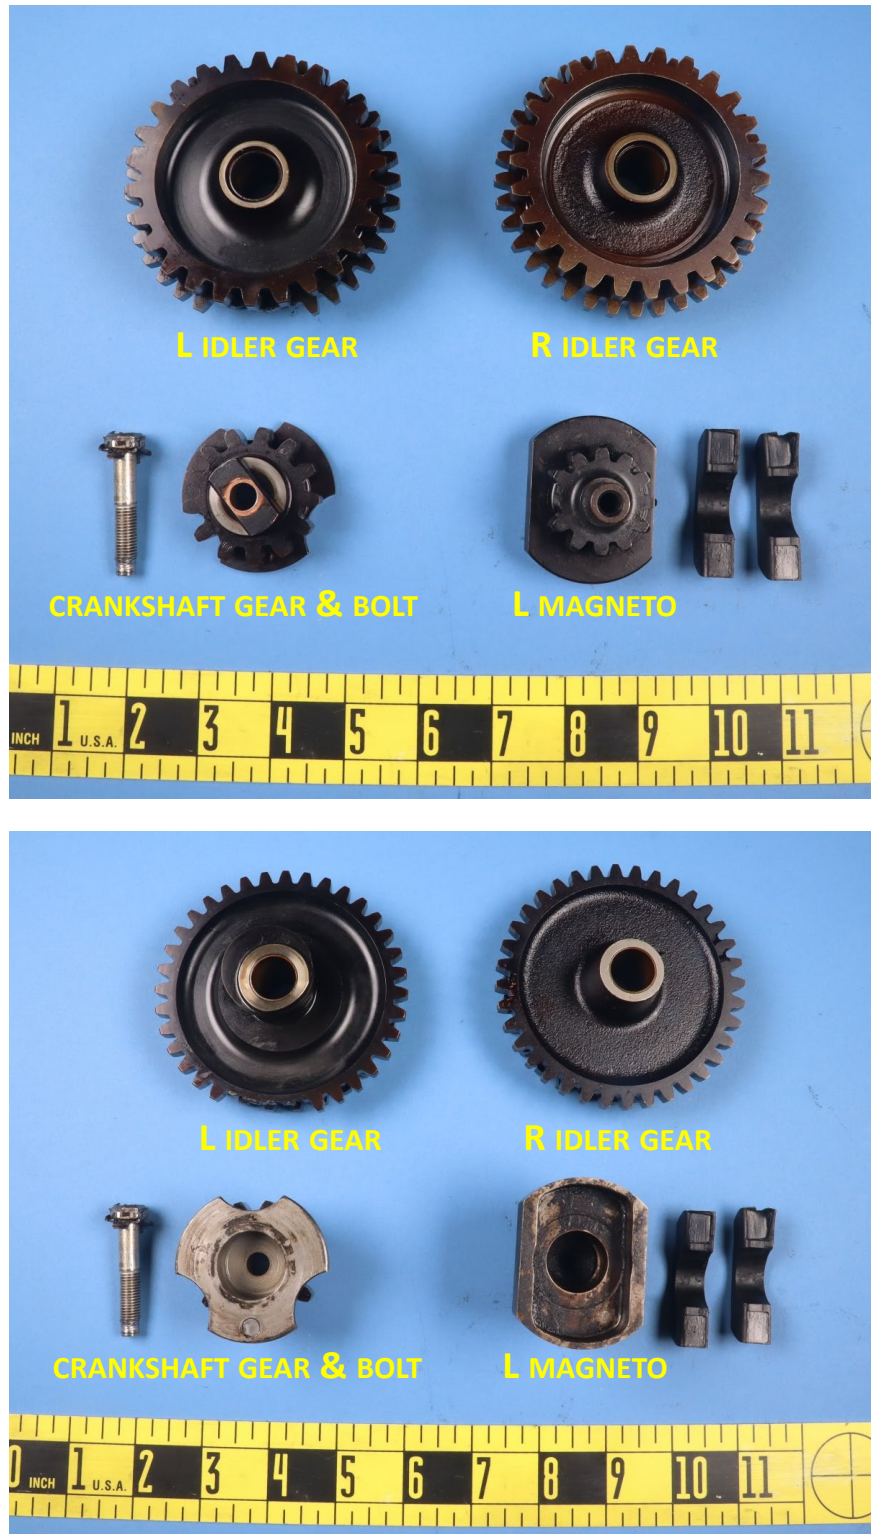
Figure 1 shows the left magneto gear, left and right idler gears, the crankshaft drive gear with separated dowel pin, and the crankshaft drive gear bolt submitted for examination. The left magneto gear was missing one gear tooth and the left idler gear was missing four adjacent gear teeth. All the teeth on the right idler gear were intact. The crankshaft drive gear teeth were also intact, but the dowel pin had separated and was still assembled to the gear. The shaft of the crankshaft drive gear bolt was bent near the start of the threads and the last threads were flattened, and the end face of the bolt was smeared. The red bracket and red arrows in Figure 2 indicate the separations on the various components.

**Figure 1.** Macro photos of the gears and bolt submitted for examination.

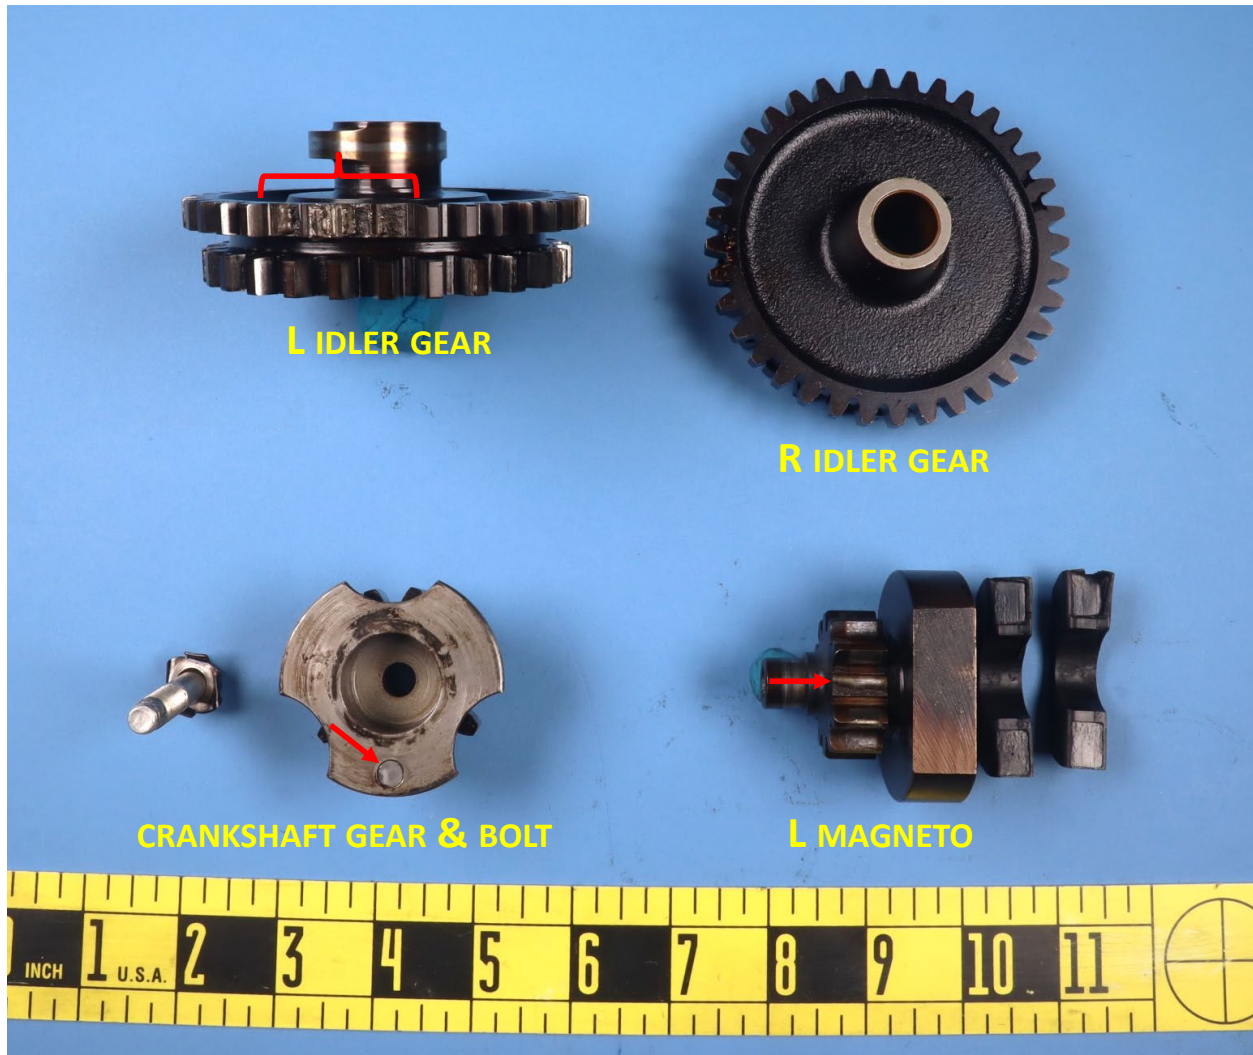
**Figure 2.** Macro photo showing the separated tooth on the left magneto gear (red arrow on right), the four separated teeth on the left idler gear (red bracket), and the separated crankshaft drive gear dowel pin (left red arrow).

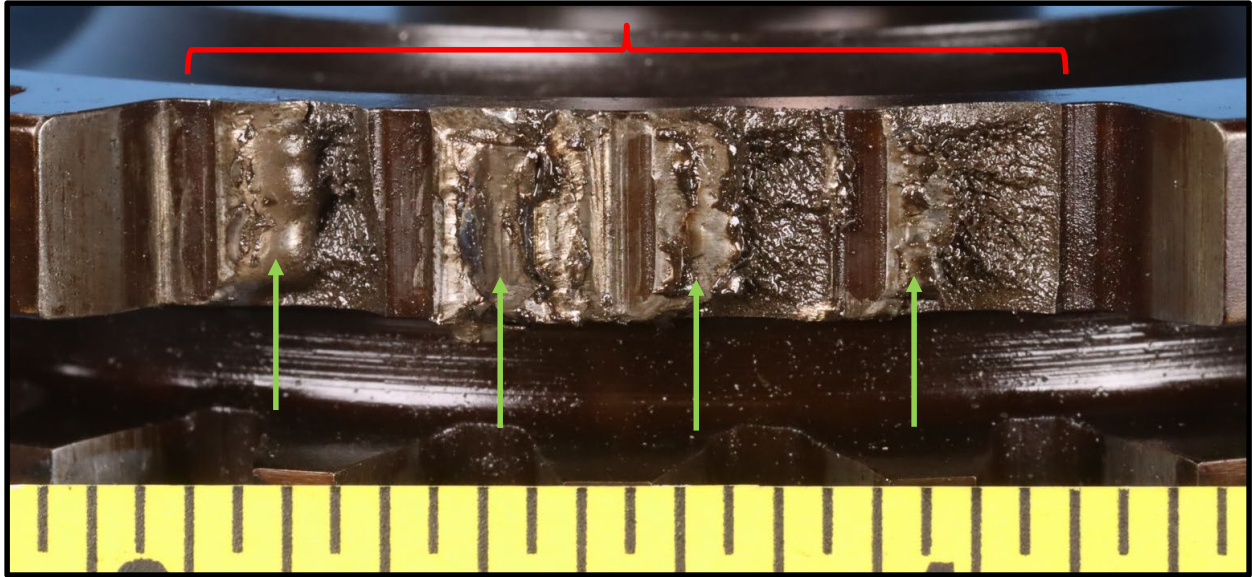
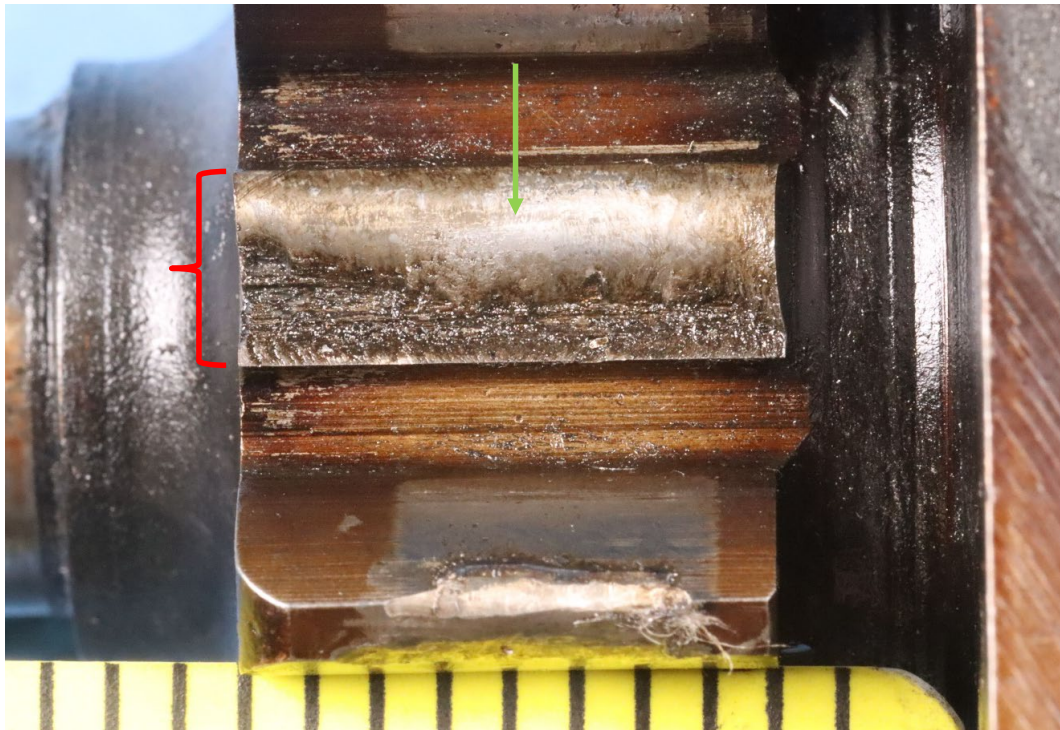
The fracture surface of the separated left magneto gear tooth is shown in the bottom image of Figure 3. The fracture surfaces of the left idler gear are shown in the top image of Figure 3. Secondary smearing damage (green arrows) obscured portions of all the fracture surfaces. The visible fracture surfaces had features consistent with overstress separation.

**Figure 3.** Close-up photos showing the fracture surfaces of the separated tooth on the left magneto gear (red bracket, bottom image) and the four separated teeth on the left idler gear (red bracket, top image). The green arrows point to secondary smearing damage obscuring the fracture surfaces.

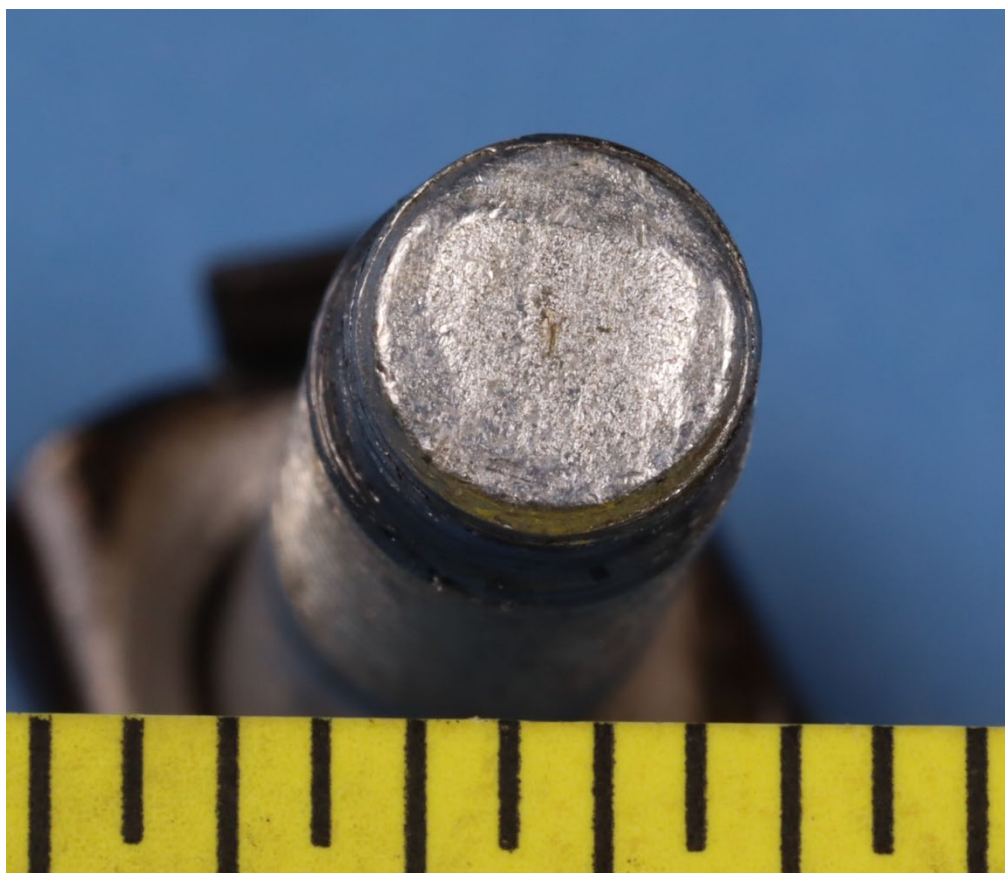
The end face of the crankshaft drive gear bolt is shown in Figure 4. The end face was completely obscured by secondary smearing damage and no discernible features were noted to determine if any of the bolt had separated and was missing. As shown in Figure 5, the fracture surface of the crankshaft drive gear dowel pin was in-line with the outer flat of the flange and was mostly unobscured, with only a small area of secondary smearing damage. The visible fracture surface features on the dowel pin were consistent with shear overstress separation.

**Figure 4.** Close-up photo showing the end face of the crankshaft drive gear bolt.

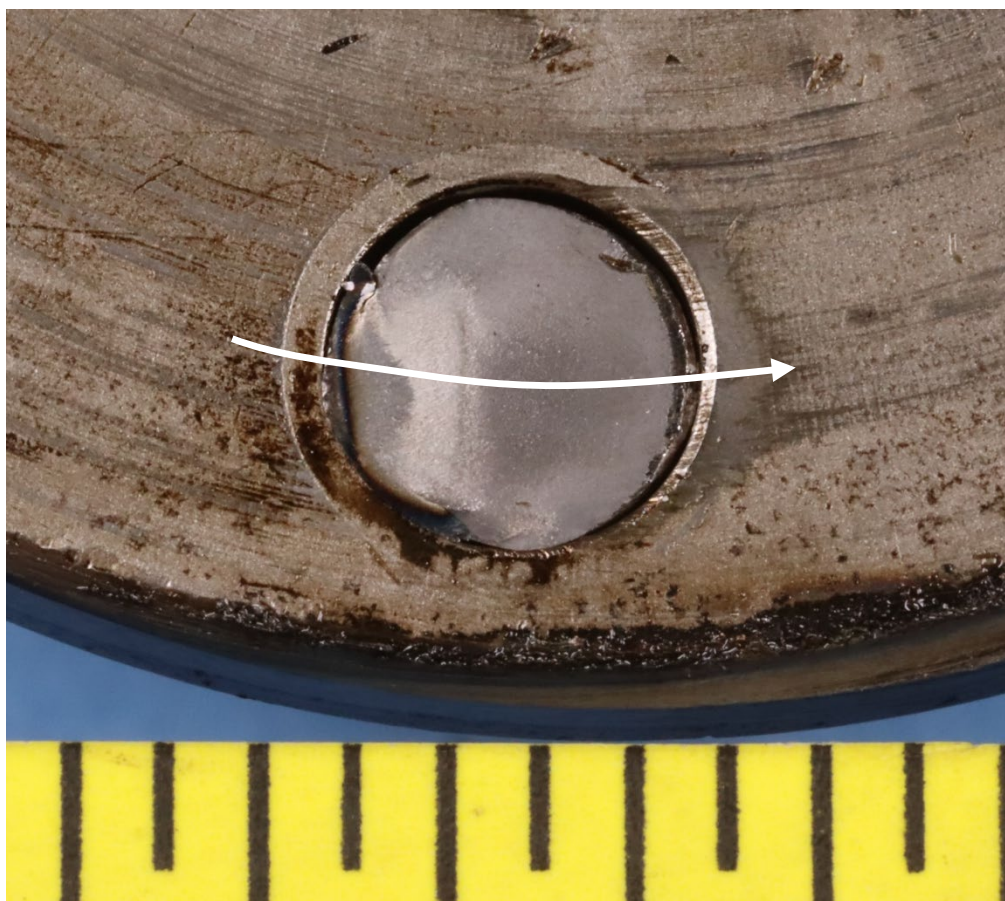
**Figure 5:** Close-up photo showing the fracture surface on the crankshaft drive gear dowel pin. The fracture surface had features consistent with shear overstress separation in the direction indicated by the white arrow.

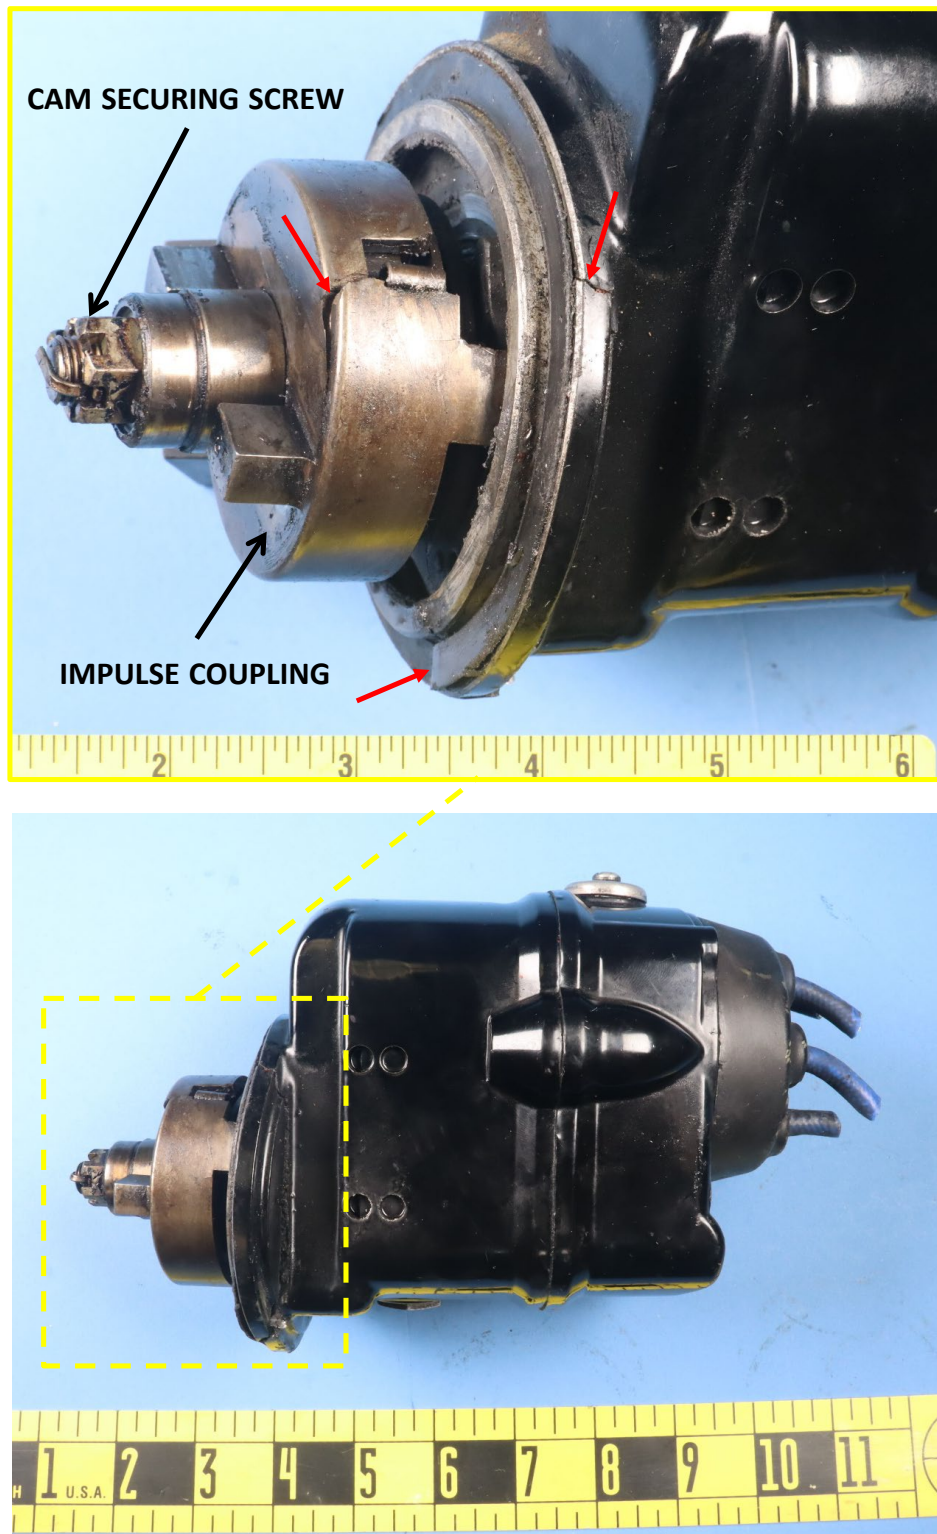
The magneto was also submitted for evaluation and is shown in Figure 6. The cables that attached to the sparkplugs had been cut to facilitate removal. The internal

components of the magneto were frozen, and the camshaft would not rotate. The impulse coupling housing and the adjacent magneto housing flange were both cracked and pushed away from the main magneto housing body, as indicated by the red arrows in Figure 6. The cam securing screw was present with the lock tab still intact.

**Figure 6.** Macro (bottom) and close-up (top) images of the magneto submitted for examination. The red arrows point to cracks visible in the magneto housing flange and the impulse coupling housing.

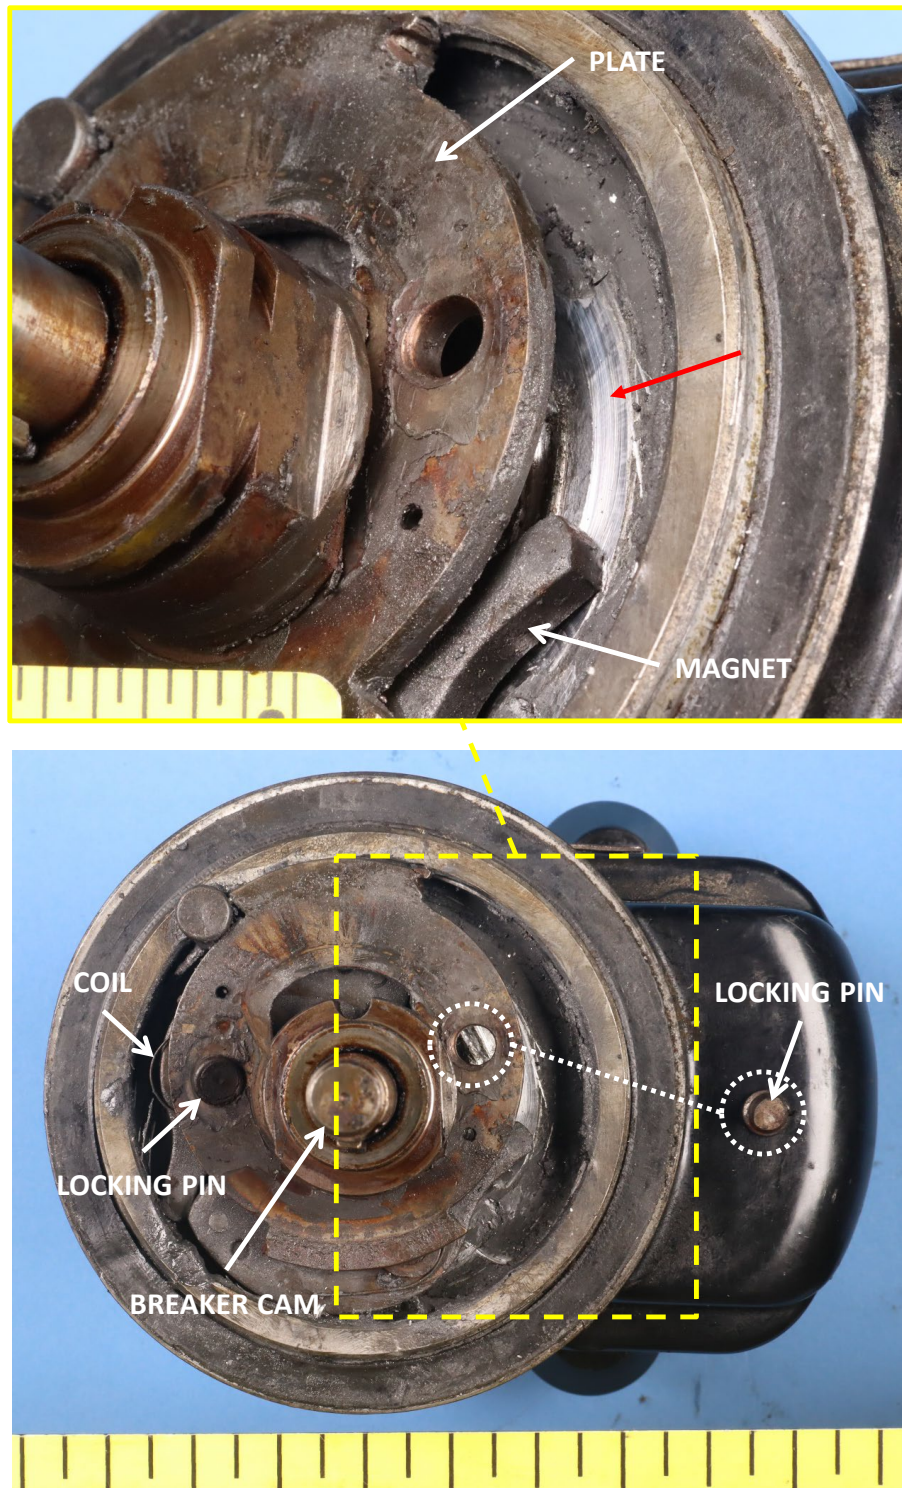
The magneto was disassembled. With the impulse coupling removed (shown in Figure 7) the breaker cam could be very slightly rotated, one of the locking pins was observed in place but separated (white dotted circles) and the underlying plate could be moved laterally. In addition, a portion of the coil was visibly out of alignment and gouges (red arrow) were observed on the housing surface underneath the plate. The gouges were in-line with the mating magnet.

**Figure 7.** Close-up photos of the magneto with the impulse coupling disassembled. One of the locking pins was found in place but separated (white dotted circles; removed from position for photo). Underneath the plate, the side of the coil was visible, and gouges (red arrow) were observed on the housing surface in-line with the magnet.

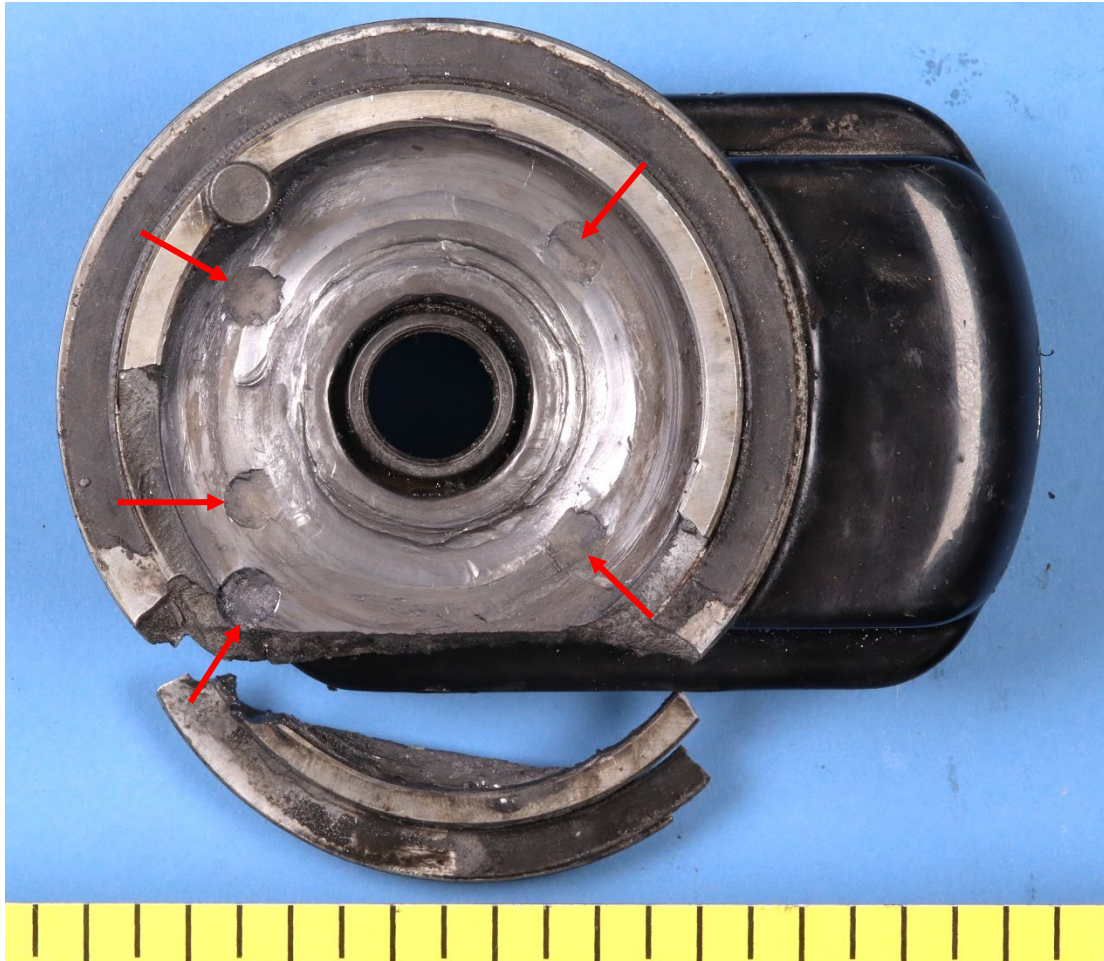
The camshaft, plate, and magnet were subsequently disassembled. Once exposed, the crack in the magneto housing flange was observed to progress through a full chord of the flange and a portion of the flange separated, as shown in Figure 8. Extensive damage was observed on the housing surface underneath the magnet. Multiple rotational gouges were visible in-line with the mating magnet. Several circular imprints (red arrows) were observed on the surface, likely contact marks from the plate locking pins. All the damage was consistent with secondary damage from multiple impacts to the magneto.

**Figure 8.** Macro photo showing the magneto housing surface with the camshaft, plate, and magnet disassembled. A portion of the magneto housing flange separated. Multiple rotational gouges and several circular imprints (red arrows) were observed on the magneto housing surface.
