# MANDATORY SERVICE BULLETIN

**DATE:** January 30, 2003**Service Bulletin No. 475C**  
(Supersedes Service Bulletin No. 475B)  
Engineering Aspects are  
FAA Approved**SUBJECT:** Crankshaft Gear Modification and Assembly Procedures**MODELS AFFECTED:** All Lycoming direct drive piston aircraft engines (including VO-360 and IVO-360; excepting O-320-H, O-360-E, LO-360-E, TO-360-E, LTO-360-E, and TIO-541 series engines).**TIME OF COMPLIANCE:** During overhaul, after a propeller strike, or whenever crankshaft gear removal is required.

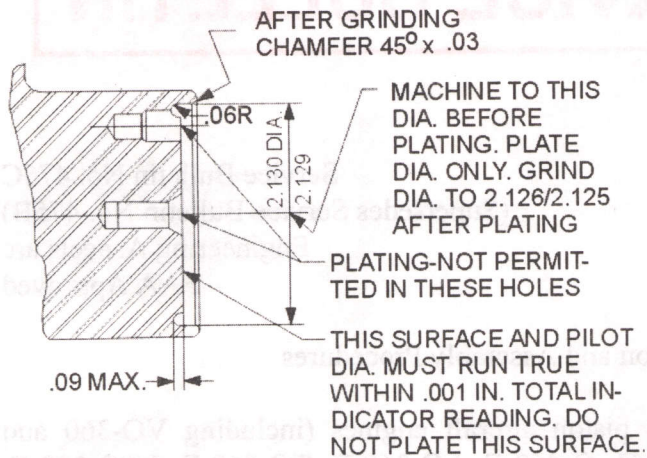
Figure 1. Details for Repairing Pilot Diameter of Crankshaft

3. Check the pilot diameter of the counterbore on the end of the crankshaft for size and evidence of damage. This diameter should not exceed 2.1262 inches when measured at any location. If found to be oversize, the crankshaft may be repaired as described in the following steps. Do not attempt to reuse a crankshaft with an oversize pilot diameter.

- a. After removing the dowel, machine the pilot diameter in the end of the crankshaft to 2.129/2.130 inch as shown in the illustration. See Figure 1. Also, cut the .09 deep x .06R undercut as shown.

- b. Chrome or nickel plate the surface of the pilot diameter with a firmly bonded deposit that is free of pin holes, blisters and any other imperfections that could impair the function of the parts.

- c. After plating, stress relieve the shaft by baking at 390° to 410°F for 3 to 5 hours.
  - d. Grind the plated pilot diameter surface to 2.125/2.126 inch. Note that the diameter must run true with rear main journal within .001 inch total indicator reading.

- e. Chamfer edge of pilot diameter 45° x .03 as shown in Figure 1.
4. If the dowel has been removed, check the condition of the dowel hole in the crankshaft. If out of round or oversize, ream as required for installation of an oversize dowel. Available oversize dowels and the corresponding size for reamed holes are shown in Table 1.
5. Install a new dowel in the crankshaft as shown in Figures 2 and 3. Insure that the correct dowel is installed.

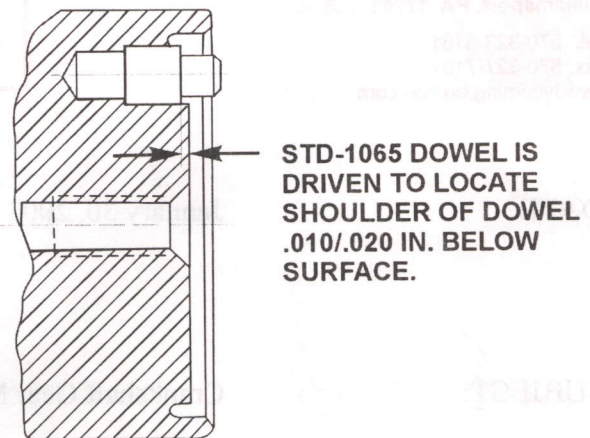
Figure 2. Section Thru End of Crankshaft Showing Driven Height of STD-1065 Dowel

2. Check the condition of the dowel in the end of the crankshaft. It should be perfectly smooth with no indication of nicks or deformation. If it is out of round, it should be removed and replaced with a new one. Replacement instructions are in paragraph 4. If dowel condition is acceptable, insure that it is installed as shown in Figure 2 or 3.

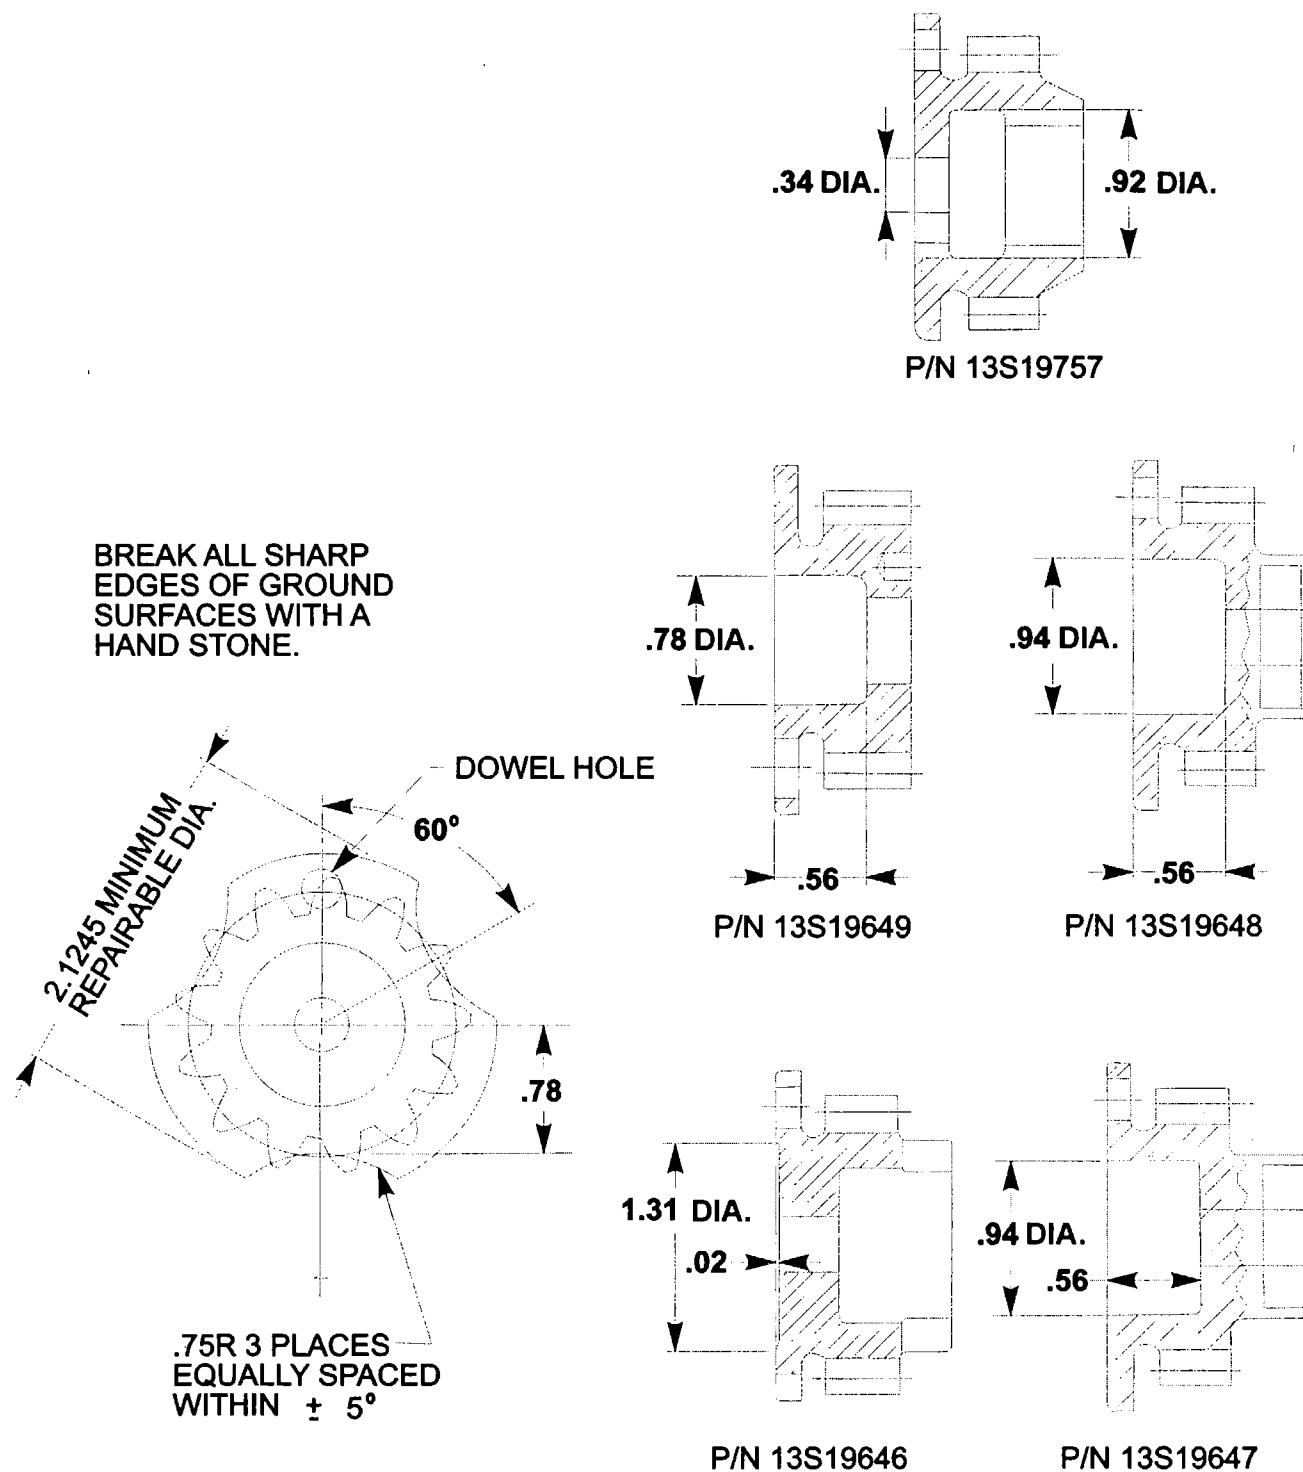
Figure 5. Details for Rework of Crankshaft Gears to Current Configuration

CRANKSHAFT GEARS FOR APPLICABLE ENGINES ARE NOW MANUFACTURED WITH THREE 3/4 INCH RADIUS SCALLOPS CUT INTO THE O.D. OF THE PILOT FLANGE AND A COUNTERBORE ON THE BACK SIDE OF THE GEAR. THESE ENLARGED SCALLOPS HAVE BEEN ADDED TO ALLOW INSPECTION OF THE GEAR AND CRANKSHAFT ASSEMBLY. SERVICEABLE GEARS MUST BE MODIFIED AS SHOWN IN FIGURE 5. PRIOR TO BEING REASSEMBLED ON THE CRANKSHAFT, OR A NEW GEAR THAT HAS BEEN MANUFACTURED TO THIS CONFIGURATION MUST BE INSTALLED. BEFORE MODIFYING THE GEAR, MEASURE THE DIAMETER OF THE PILOT FLANGE. IF IT IS LESS THAN 2.1245 INCH, IT SHOULD NOT BE RESUED. THE ORIGINAL 2.1250/2.1255 DIMENSION OF THE CRANKSHAFT GEAR MUST BE RESTORED WITH A FLASH COPPER PLATE OF UP TO .0005 INCH MAX.

SOME OLD CRANKSHAFT GEARS ARE CARBORIZED ALL OVER. IF CARBORIZED, THEY WILL NOT NICK WHEN A FILE IS USED ON SCALLOP. IF CARBORIZED ALL OVER, GEAR SHOULD NOT BE REWORKED.

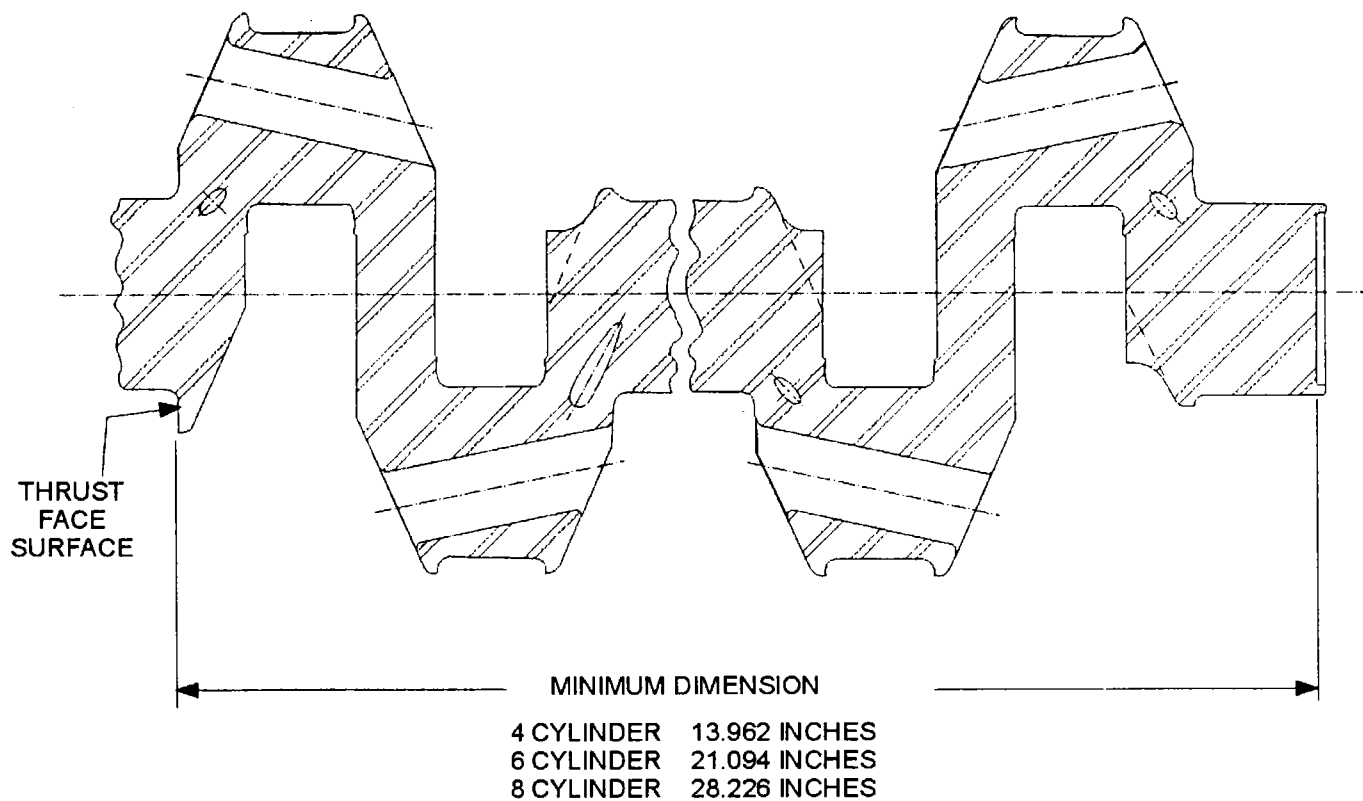
Figure 7. Minimum Dimension of Crankshaft

THE CRANKSHAFT COUNTERBORED GEAR MOUNTING FACE SHOULD BE CHECKED FOR DAMAGE. IF THE SURFACE REQUIRES REPAIR OTHER THAN SPECIFIED IN "CAUTION" ON PAGE 1, THE CRANKSHAFT SHOULD FIRST BE MEASURED AS SHOWN IN FIGURE 7. IF THE CRANKSHAFT MEASURES MORE THAN THE MINIMUM DIMENSION SHOWN IN FIGURE 7, THE SURFACE MAY BE REWORKED DOWN TO THE DIMENSIONS SHOWN. (DO NOT PLATE THIS SURFACE.) THE SURFACE MUST BE TRUE WITHIN .001 IN. TOTAL INDICATOR READING TO REAR MAIN BEARING AND THE SURFACE FINISH MUST BE HELD TO 45 TO 90 MICROINCHES.

INSURE MINIMUM DIMENSION IS MEASURED BETWEEN THRUST FACE SURFACE AND PILOT.
