# National Transportation Safety Board

ERA23LA037

## **AIRWORTHINESS FACTUAL REPORT**

Location: Spartanburg, South Carolina  
Date: October 23, 2022  
Time: 1700 Local  
2100 UTC  
Airplane: Piper PA28-235, N8580N

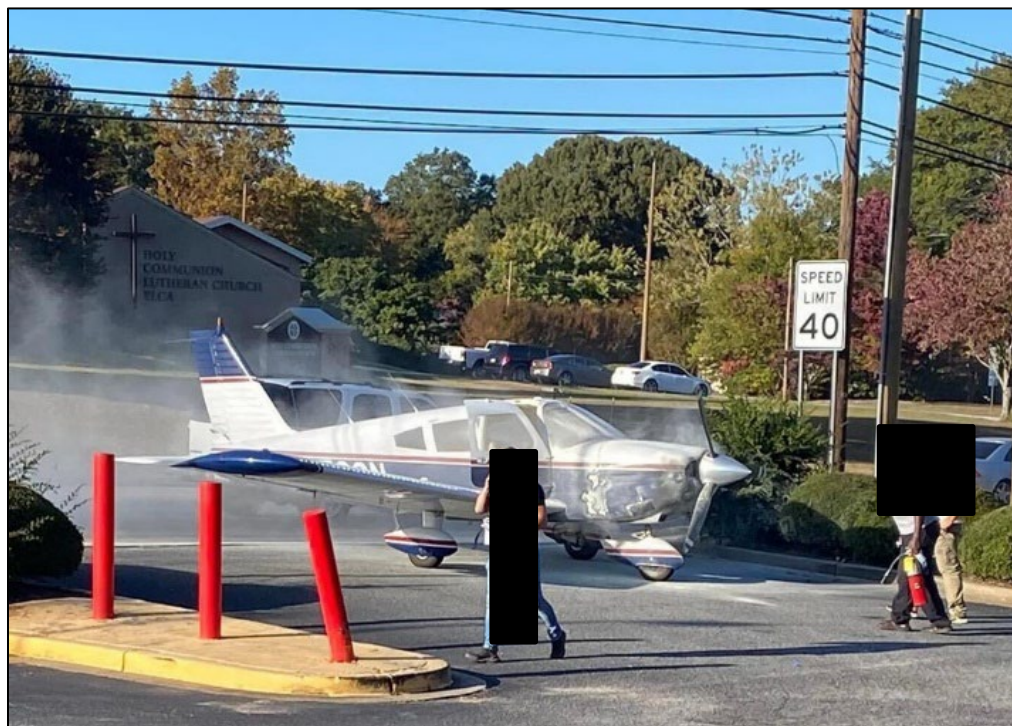
The engine displayed sooting and thermal damage. There was thermal damage to the engine cowling, with heavier thermal damage noted to the lower right side. Oil staining was found inside the lower area of the engine cowling, on the front area of the heater muff and in the area of the air filter and carburetor air box assembly. The air filter was partially melted. The alternator was thermally discolored.

**Figure 1: View of airplane shortly after landing showing the thermal damage (Photo Courtesy of FAA).**

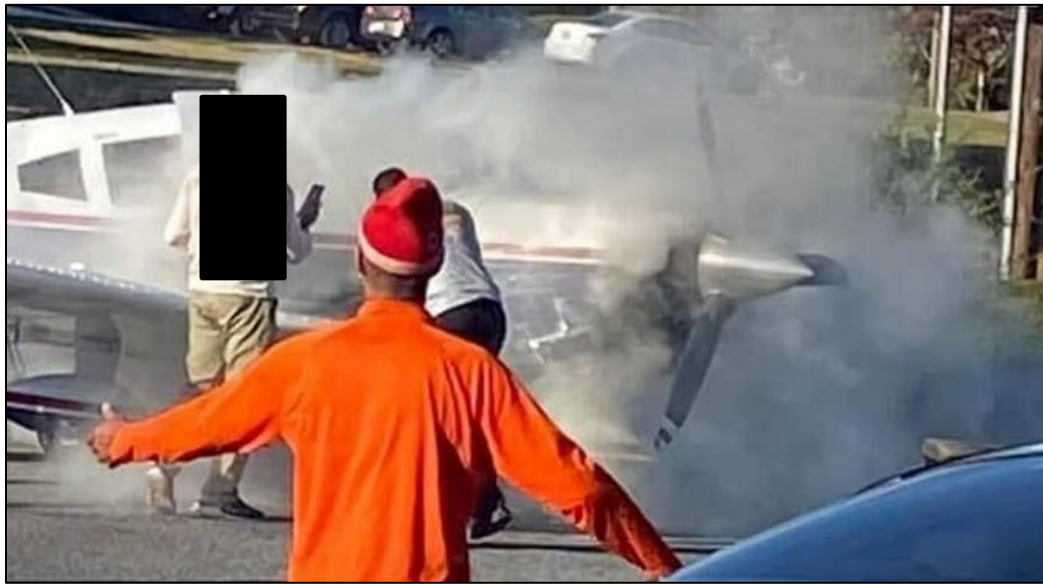
On-scene photos noted oil inside the bottom area of the engine cowling. Oil staining was observed on the front area of the heater muff and residual oil was noted in the area of the air filter and carburetor air box assembly. Fire extinguishers were used to put out a fire in the cowling area.

**Figure 2: View of the smoke emitted from the engine compartment shortly after the landing.**

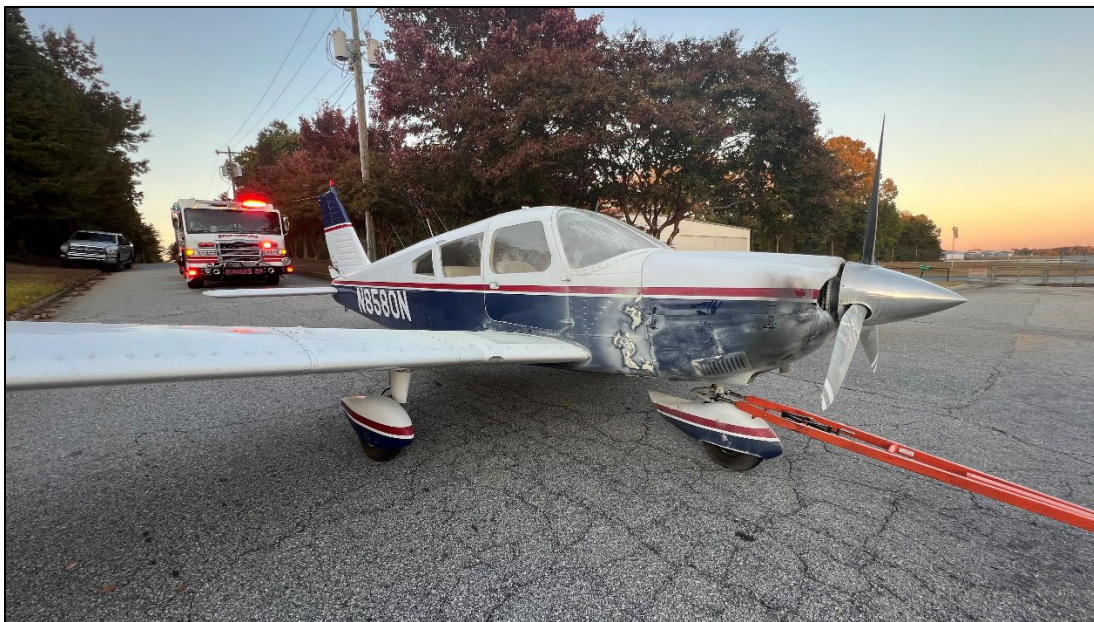
**Figure 3: View of the thermally damaged engine compartment and cowling area (Photo Courtesy of FAA).**

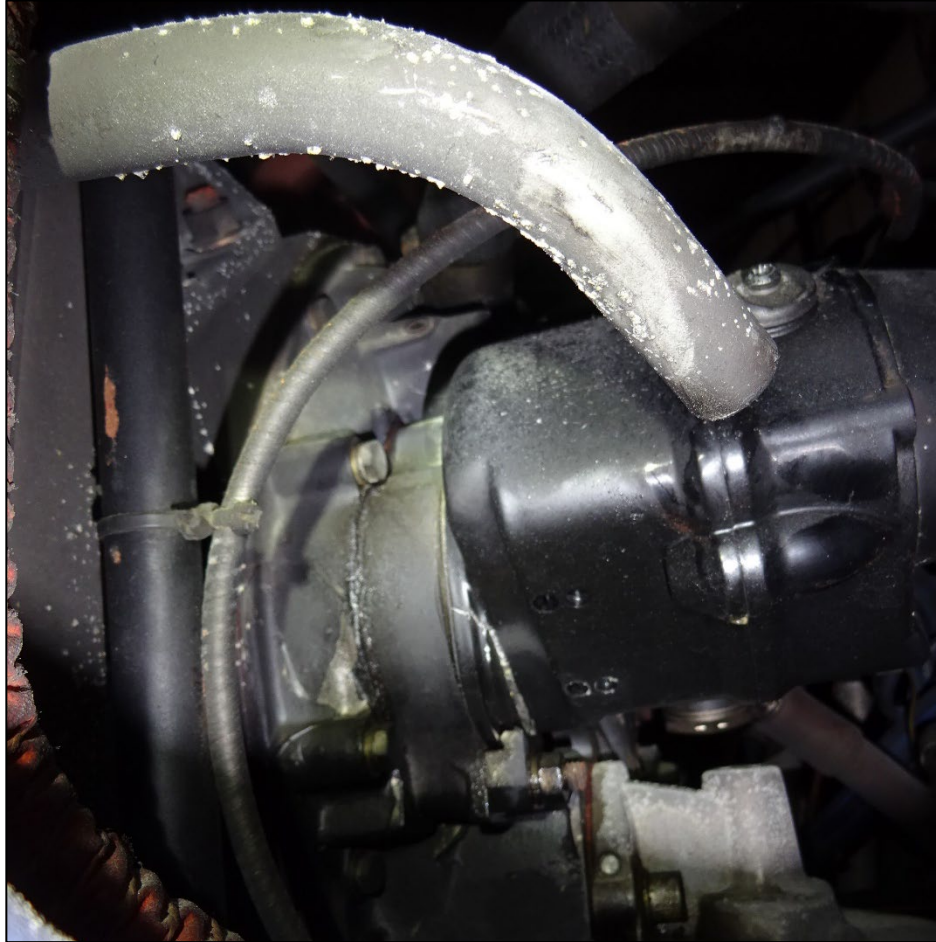
The engine displayed no visible impact related damage. The right magneto was found attached to the accessory section. It was rotated, and spark was noted on all cut leads. The left magneto's exterior casing was found fractured and partially rotated from its normal attachment points. It had a bent drive shaft and could not be rotated.

**Figure 4: View the left magneto displaced from its attachment area.**

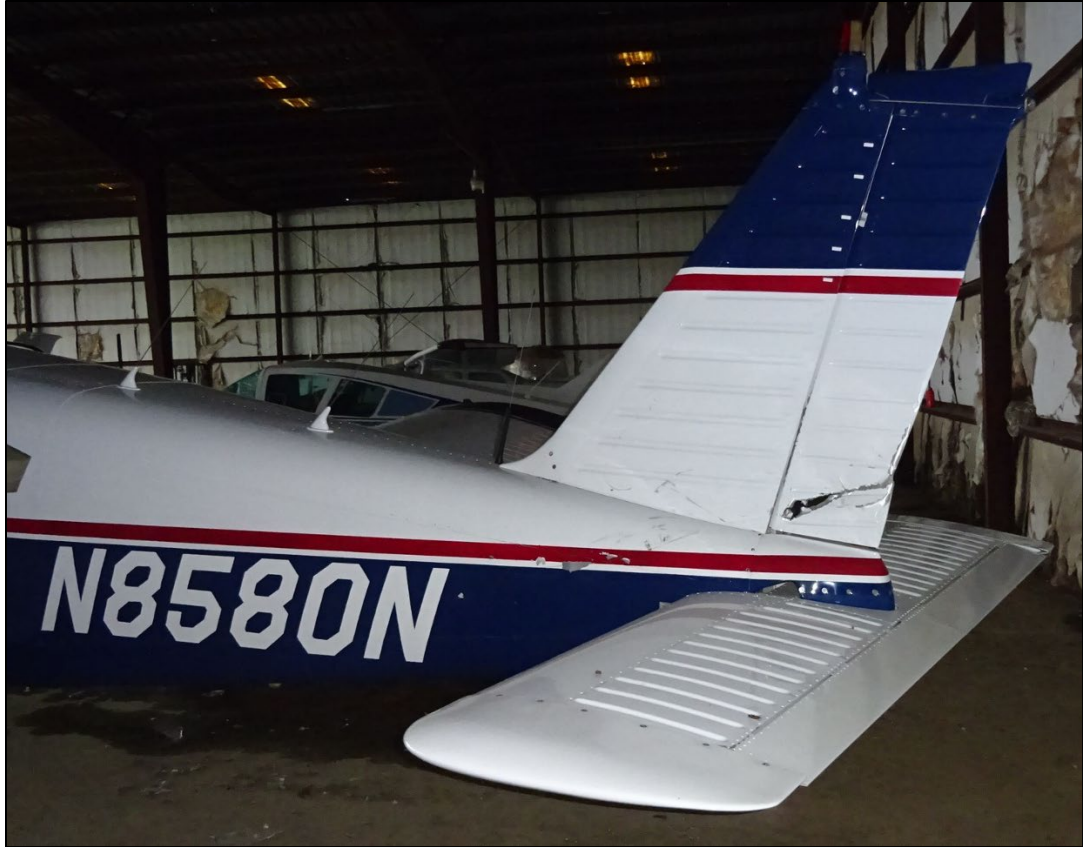
The lower section of the rudder was cut, and in the same general area, the right lower aft section of the vertical fin and right aft section of the fuselage noted a diagonal black transfer marks consistent with a wire strike.

**Figure 6: View of the substantially damaged rudder.**

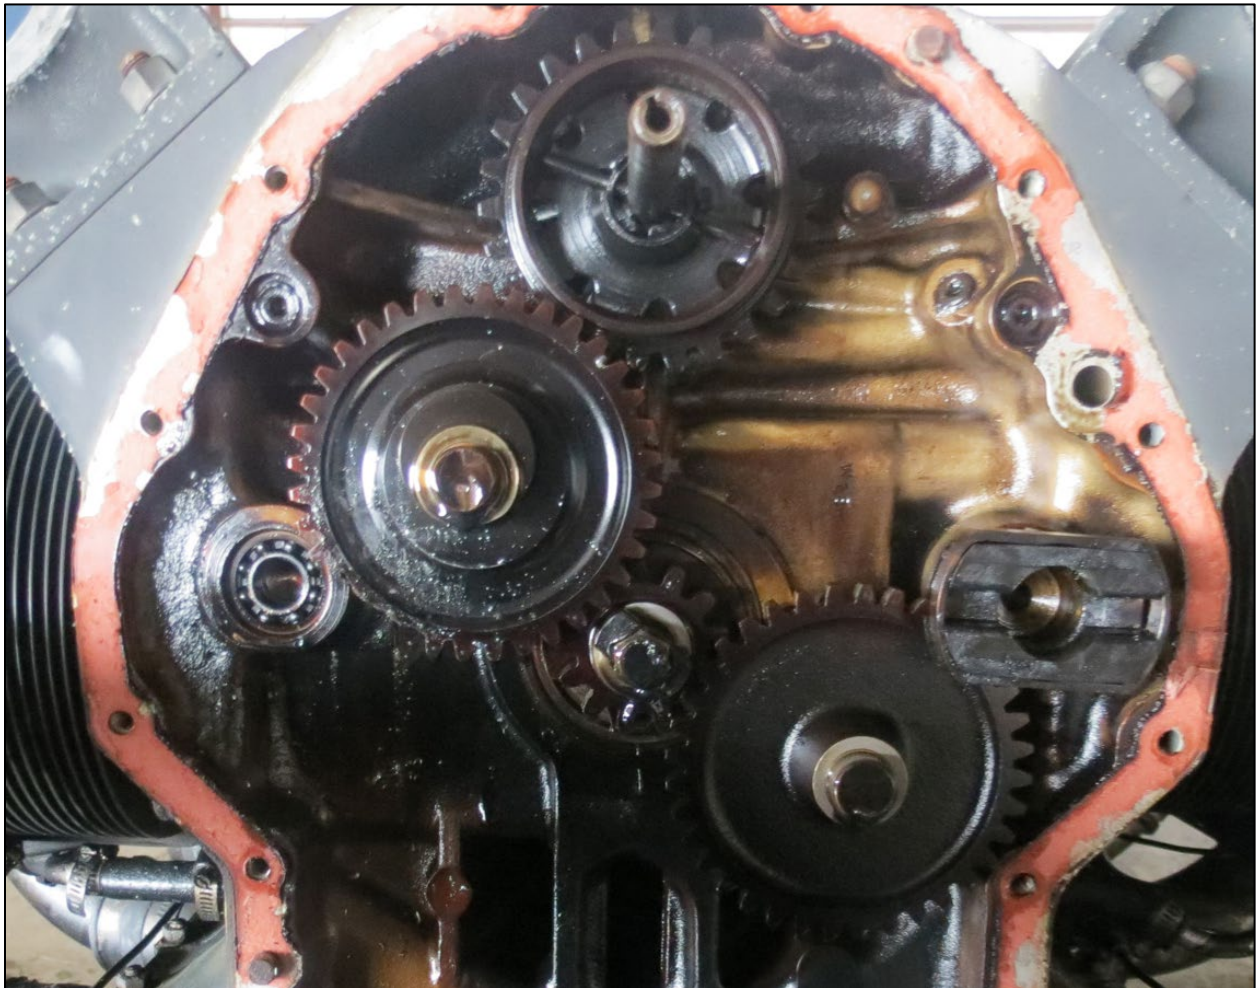
The accessory section of the engine was removed. The left idler gear was damaged and missing three gear teeth, and the left magneto drive gear was damaged and missing one gear tooth. The crankshaft gear was partially separated from the crankshaft. The crankshaft gear bolt was partially backed out from its normal position and its bottom few threads were stripped. The safety clip remained attached. The crankshaft rotated however the crankshaft gear did not. The crankshaft gear dowel had sheared.

**Figure 7: View of the exposed accessory section and engine gear area of the engine.**

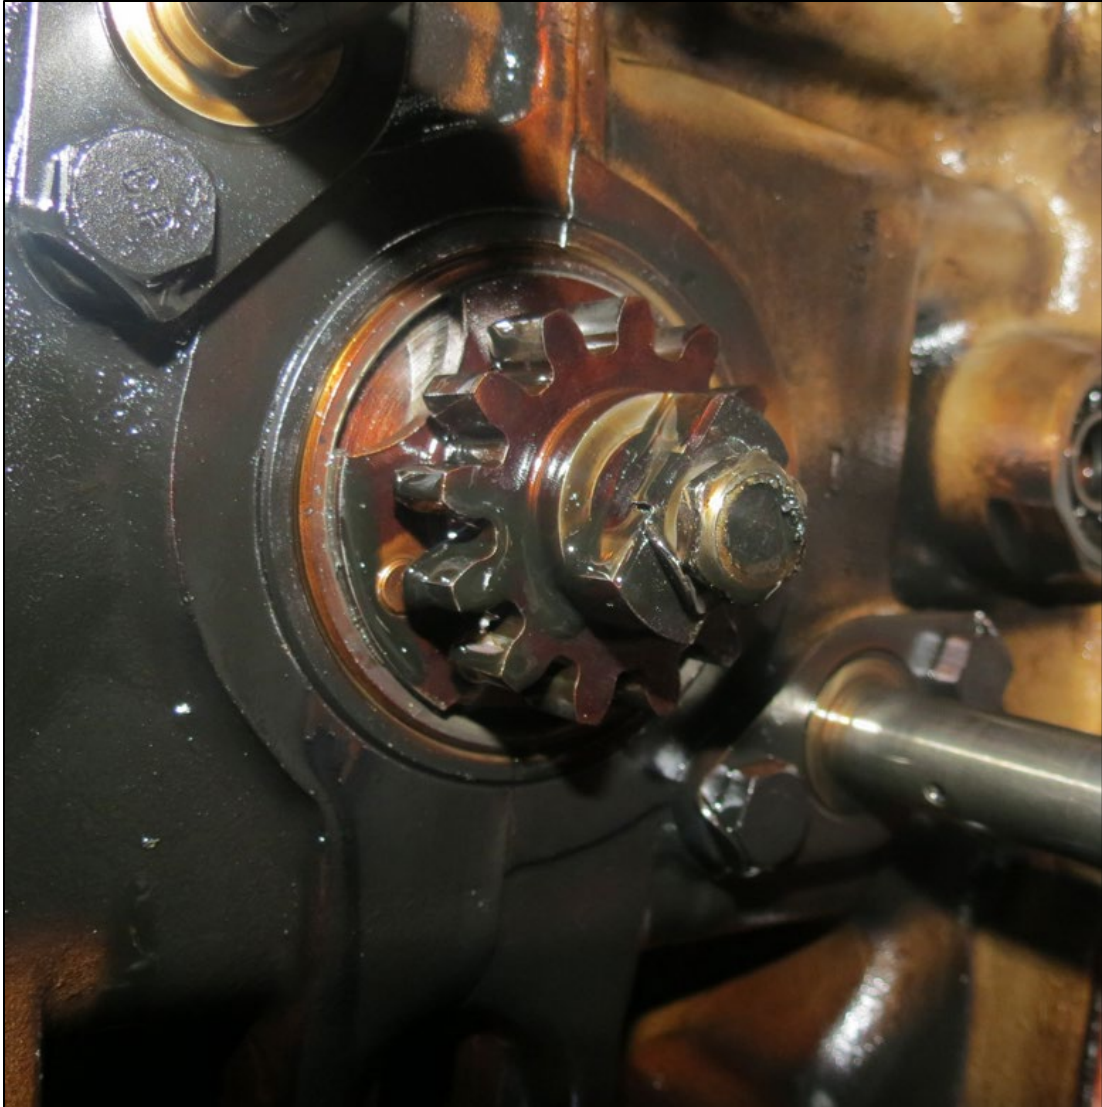
**Figure 8: Crankshaft drive gear and bolt.**

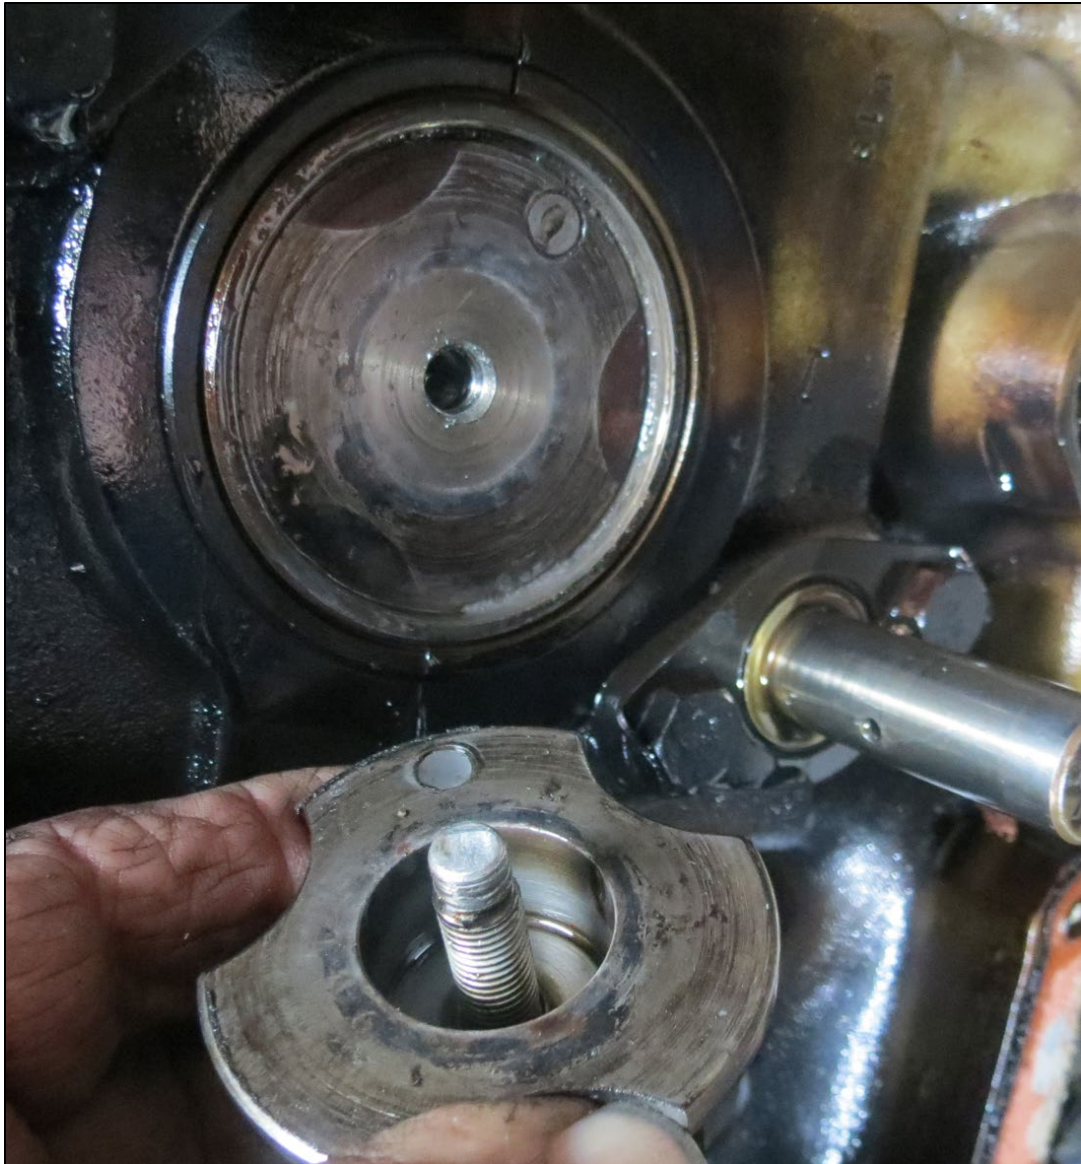
**Figure 9: Crankshaft drive gear bolt removed. Note the dowel pin had sheared.**

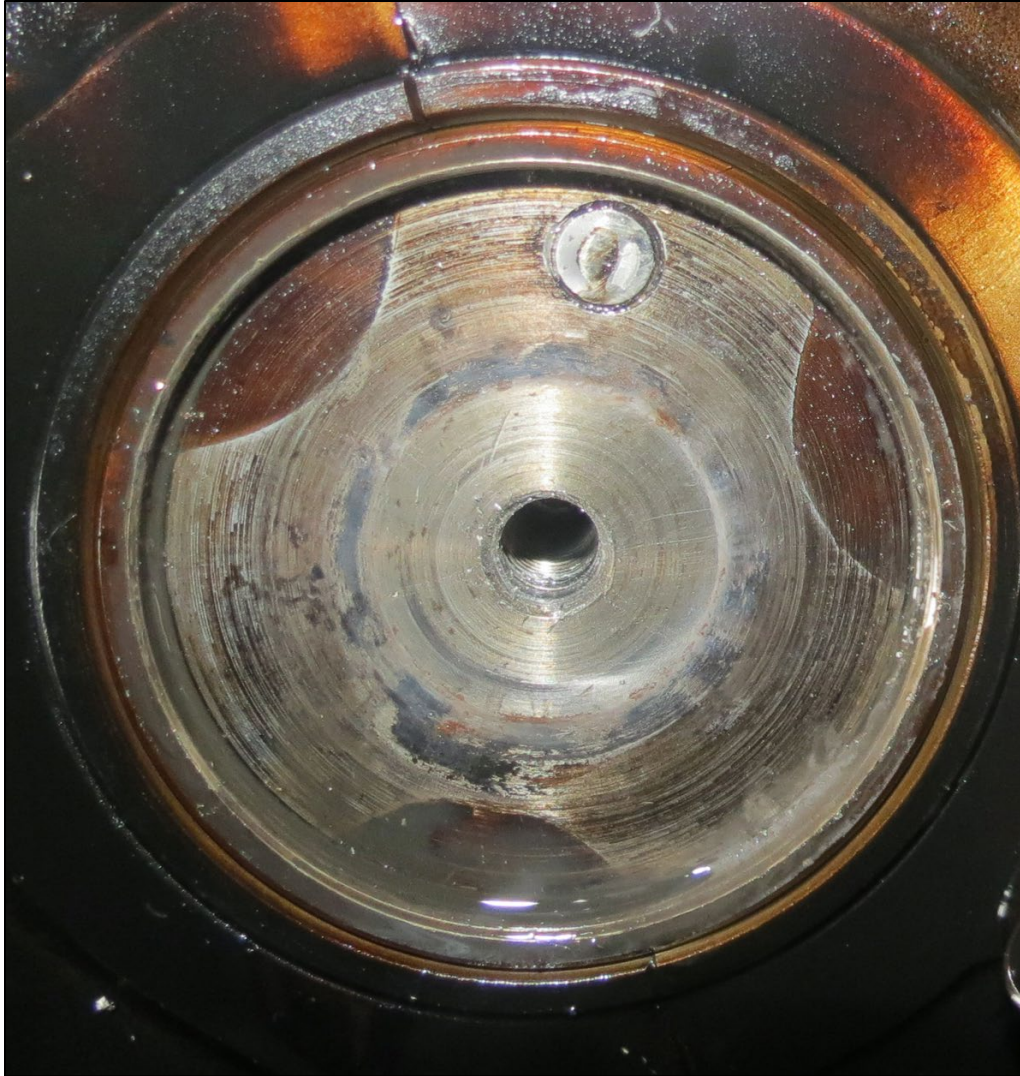
**Figure 10: View of the dowel pin and crankshaft drive gear attachment area.**

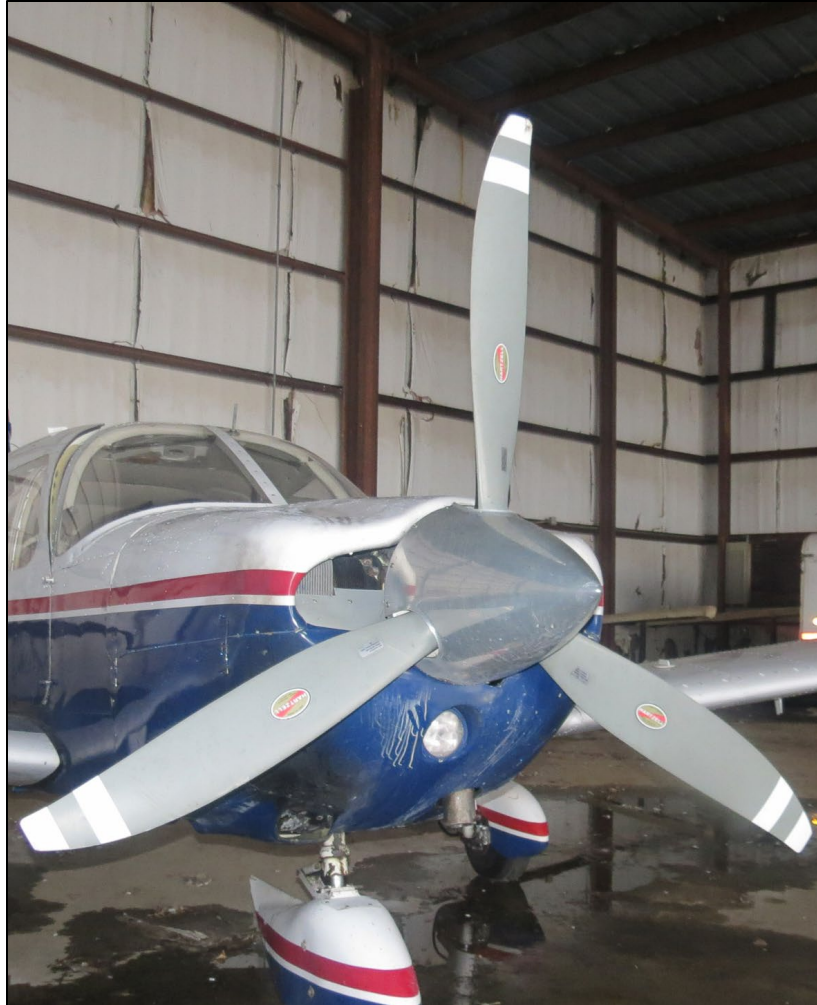
One propeller blade tip noted black marks on the front side and a small section of the tip damage was consistent with arc damage<sup>2</sup>. One other blade outboard leading edge was abraded, and the last blade had no visible damage.

**Figure 11: Thermal damage noted to the propeller oriented upward.**
