# National Transportation Safety Board

ERA23LA040

## EXAMINATION NOTES

Location: Palm Beach County Airpark (LNA)  
Date: October 23, 2022  
Time: 1610 pm local EDT  
2010 (UTC)  
Airplane: Piper PA-32-RT-300T Serial # 32R-7887127; N39628

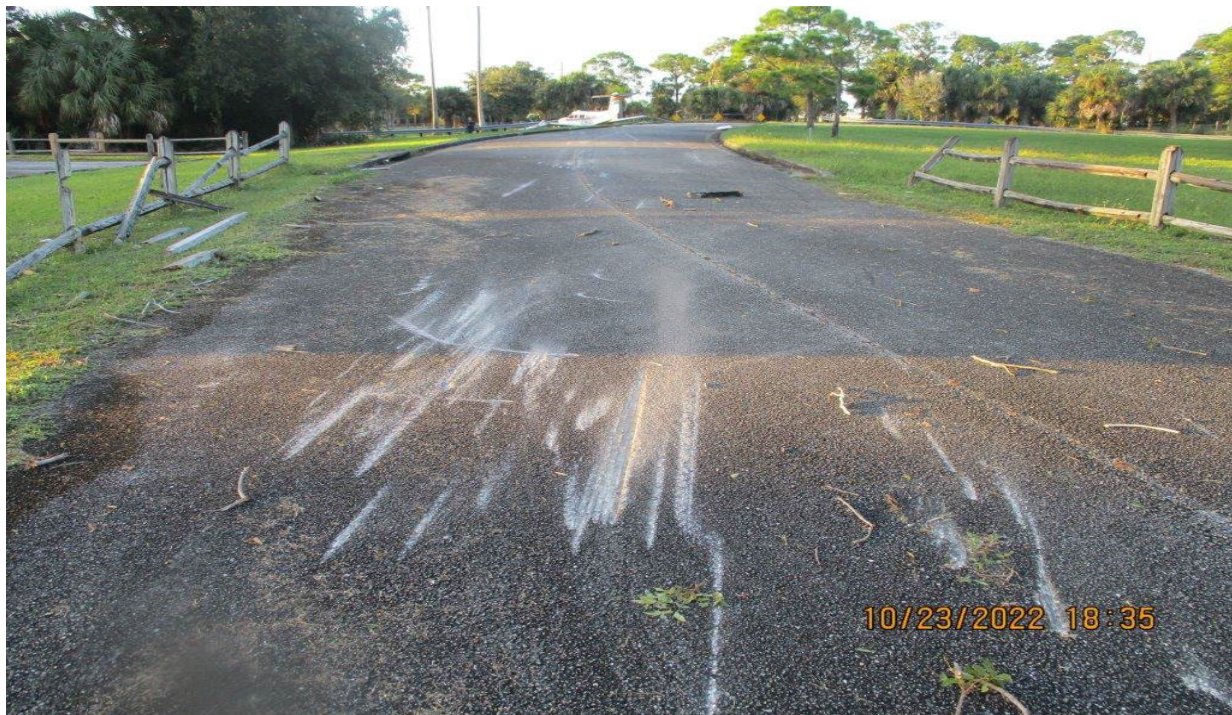
Accident site was about 500 feet long. The wreckage path consisting of the ground scars and between four and eight propeller strike marks/gouges in the asphalt pavement leading up to the main wreckage. All components, flight control surfaces, wings, elevator & stabilizers were located in the immediate vicinity of the wreckage.

**Figure 1: Accident site showing ground scars and wreckage.**

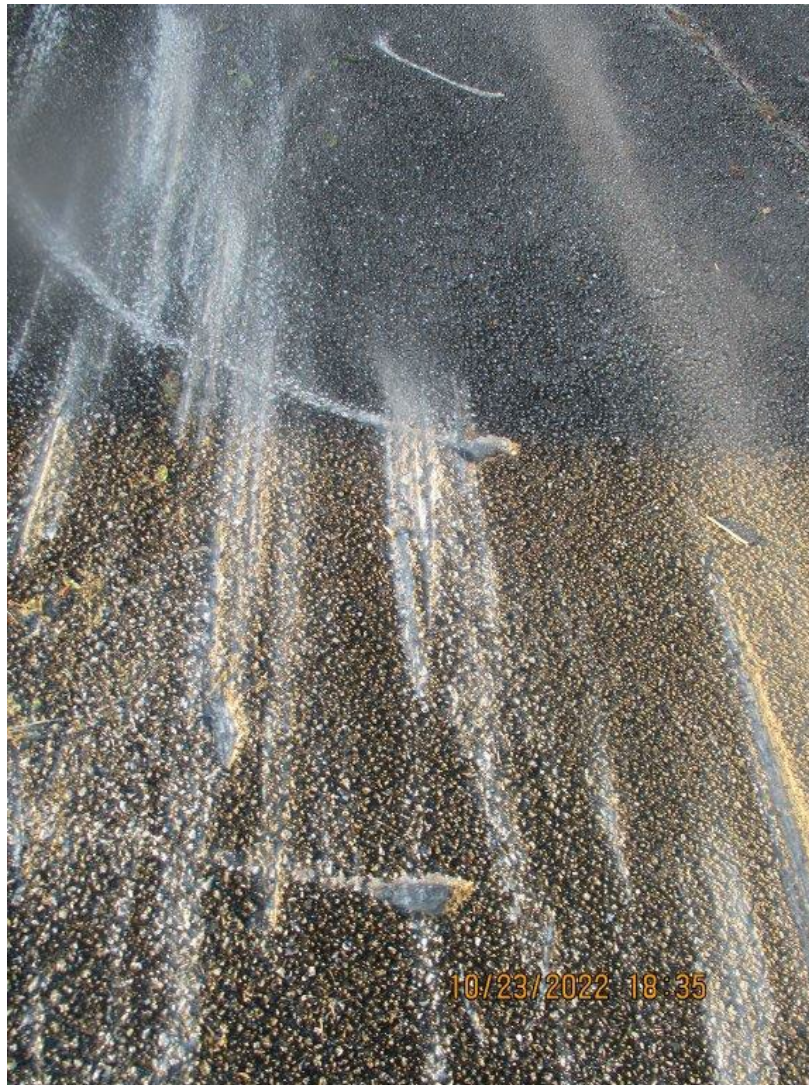
**Figure 2: Sequential propeller impact gouges in the asphalt.**

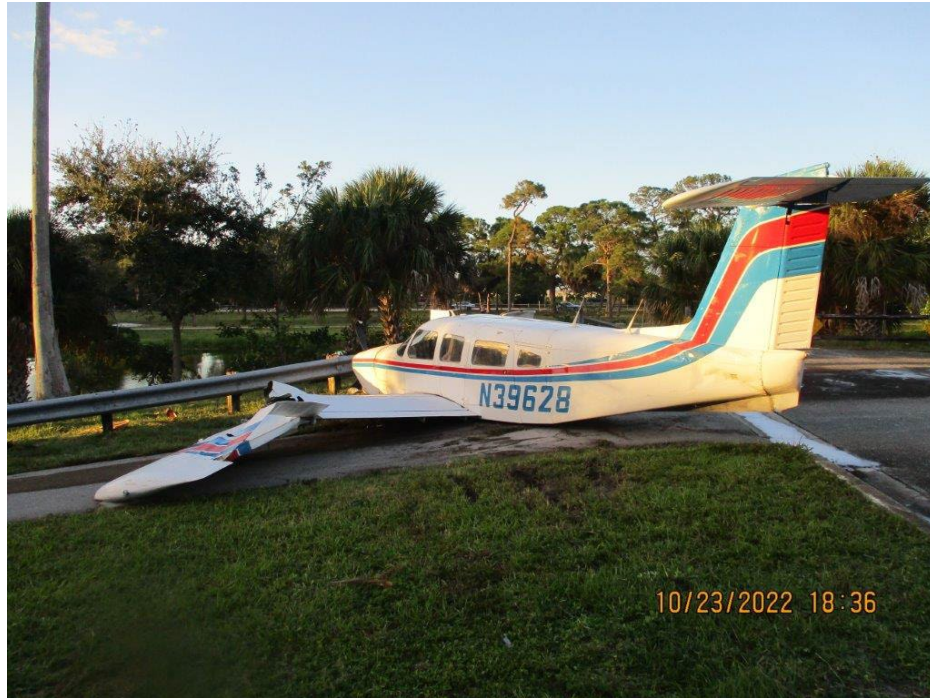
Fuselage buckled and crumpled in several areas but mostly intact from behind the engine compartment and firewall. The most severe damage was to the wings and bottom of the fuselage.

**Figure 3: Main wreckage.**

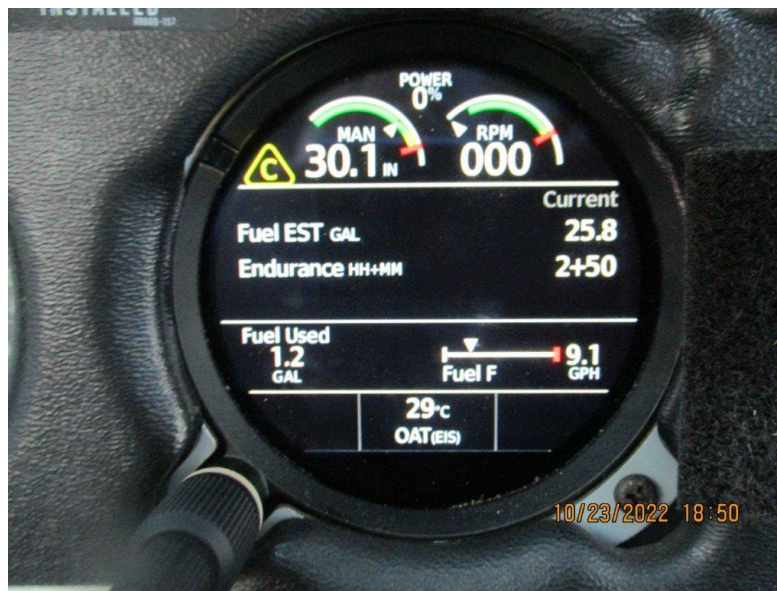
Leftover fuel samples from fuel tanks found no contamination. The pilot purchased 10 gallons of fuel from Stellar Aviation of South Palm Beach at the Lantana Airport. Fuel farm sample taken after accident found no fuel contamination and 42 aircraft were fueled from the fuel farm prior to this accident flight with no other issues reported. Fuel recovered from ruptured fuel tanks was about 1 1/2 gallons. Wing left and right fuel gauges indicate zero fuel, cockpit right fuel gauge indicate zero, left fuel gauge indicate about three gallons and electronic flight instrument indicator indicated 26 gallons.

**Figure 4: Engine/performance monitor showing fuel.**

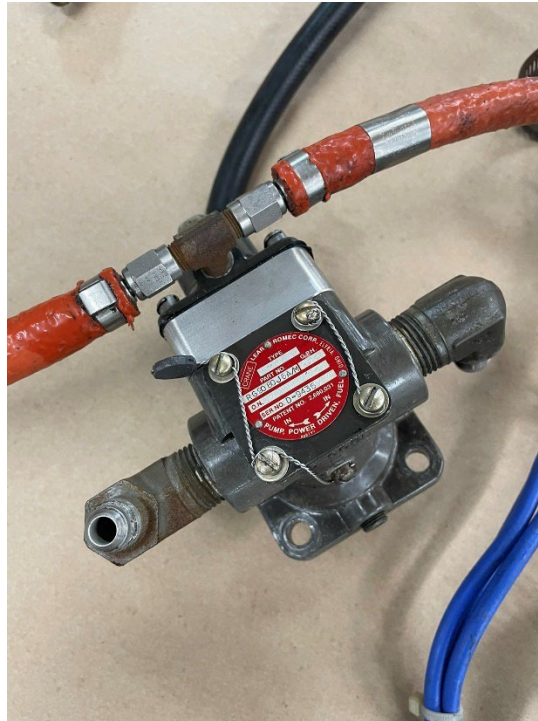
The engine driven fuel pump was intact and operational. It was manually rotated with a drill and sucked/expelled fuel at low through high rpm settings.

**Figure 5: Fuel pump prior to functional testing.**

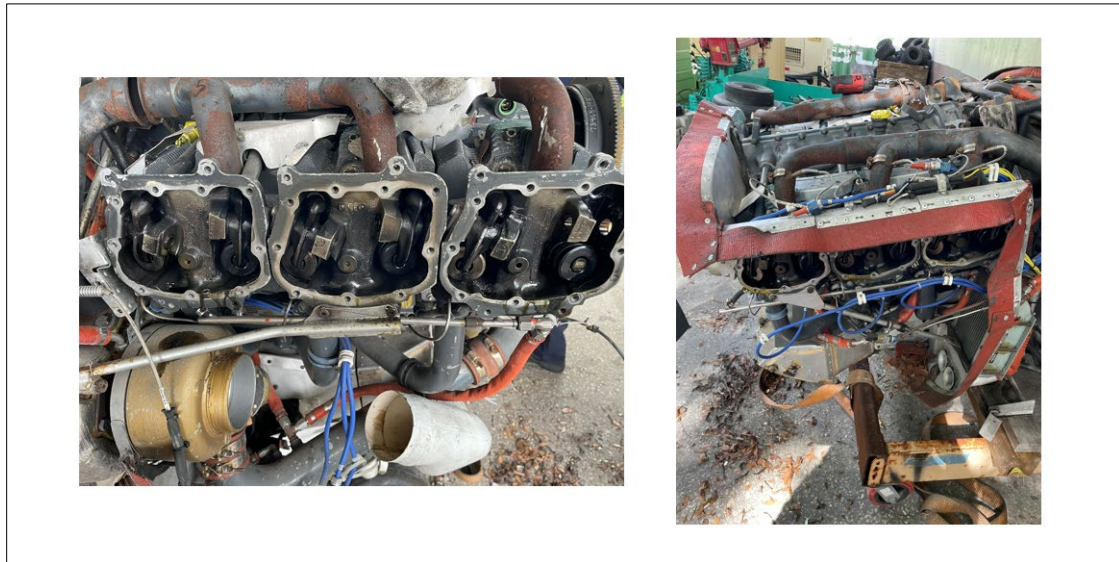
The engine was intact with no external impact damage to the power section. But there was engine mount damage and fractures. The propeller hub and prop assembly were canted slightly and all 3 blades exhibited rotational impact damage.

**Figure 7: Engine right and left sides with valve covers removed.**

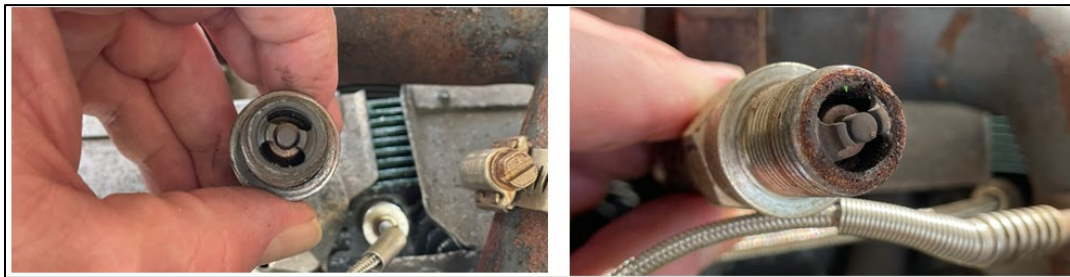
All 12 the spark plugs displayed normal coloration and normal electrodes as compared to the Champion Aerospace AV-27 Check-A-Plug chart. Two lower spark plugs (Nos 1, 3) were had some corrosion around the threads that appeared to be from weather exposure (heat/humidity) The electrodes were intact.

**Figure 8: Spark plugs.**

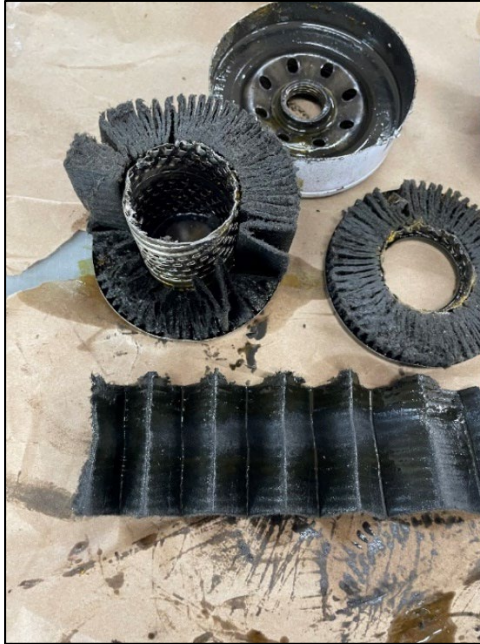
The oil filter was opened, and the pleats contained no trace amounts of ferrous material. The oil appeared mahogany brown in color and all lubricated components appeared to be well lubricated.

**Figure 9: Opened oil filter and pleats.**

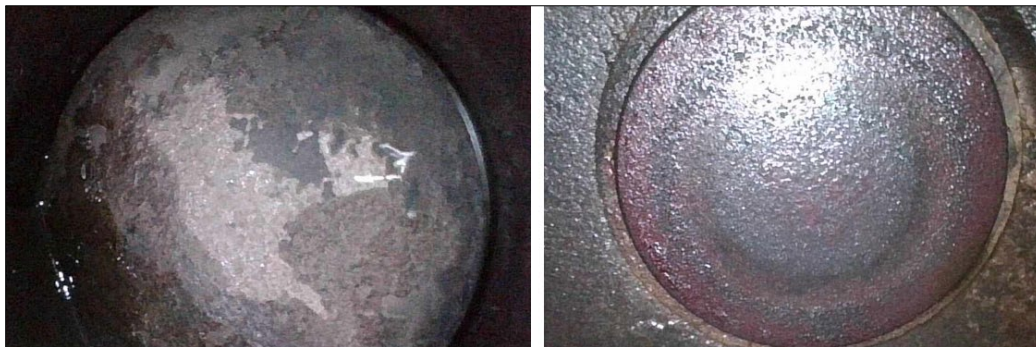
The engine crankcase could not be manually rotated 360 degrees. It would bind after about 45 degrees of travel in both directions. Likely caused by impact and typical of a cam lobe interference caused by impact. There was binding internally that limited movement; noting that the pilot stated the propeller continued to rotate and there was rotational damage to the propeller and pavement during impact. A subsequent borescope of all six cylinders, pistons and valves revealed no anomalies noted on the piston faces, valve faces and interior of the cylinders. The fuel injectors were open and free of any obstructions. The fuel injectors were clear, and all six injectors appeared normal on the interior face of the injector. The engine oil suction screen was removed and examined. It was free of contaminants.

**Figure 10: Borescope photographs examples of overall condition of all six piston/cylinder assemblies.**

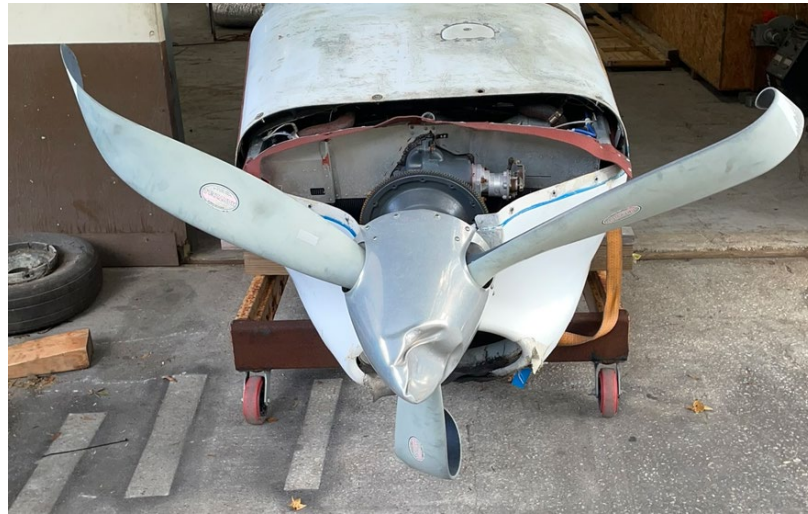
The propeller (Hartzell) hub remained attached to the flange and crankshaft and was slightly canted. The blades were designated as A, B and C for identification. The A blade had significant leading edge gouges on the outer 12 inches and was curled aft. The B blade had camber scrapes and gouges on the leading edge and was curled aft tightly indicating this was likely the first blade to make contact with the pavement. The C blade had scrapes and gouges of less severity and had a slight curve aft. The spinner was crushed inwards on one side and showed some rotational damage. The propeller governor and control linkage were functional and remained connected.

**Figure 11: Propeller damage.**

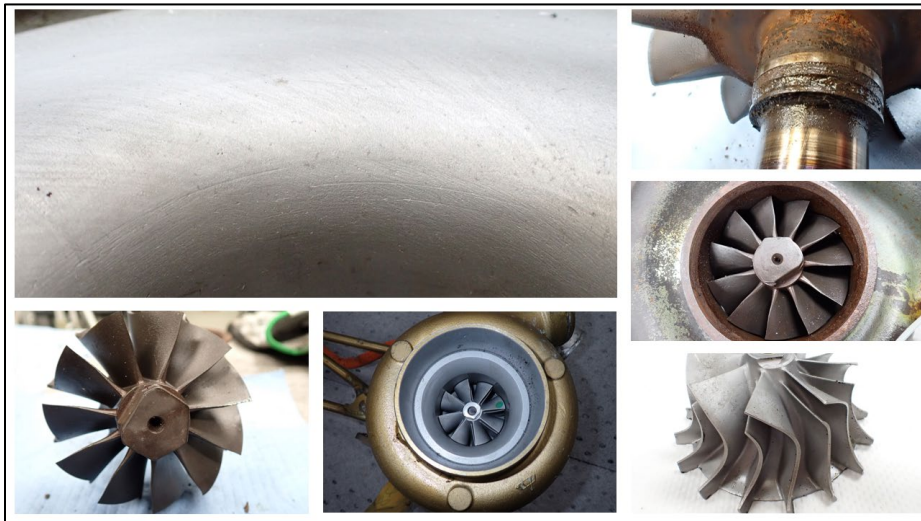
The turbo charger compressor section was frozen in place and could not be rotated. Visually there was no damage to the compressor blades. They were clean and exhibited no damage prior to closer examination. A member of the salvage/recovery team inadvertently twisted off the wheel nut/shaft while trying to disassemble the unit during the examination causing damage to the nut and a few blades. Once the entire unit was removed, an attempt was made to rotate the unit but was unsuccessful. The unit had superficial damage to the shroud but was otherwise intact and no cause could be determined why the unit would not rotate. The unit was sent to the manufacturer (Hartzell) for an observed examination, teardown and functionality testing.

Subsequent testing at Hartzell revealed corrosion/rust between the shaft and housing which prevented rotation. Note, the airplane had been sitting outside in the elements (Florida) for a year. Using an arbor press, the shaft dropped out fine. The bearings and journals looked normal. Nothing was seen that would prevent normal

operation. There was rotational scoring on the intake housing. The unit was well lubricated and exhibited signs that during the accident, it was rotating.

**Figure 12: Turbo examination photographs. Note rotational scoring in top left.**
