**Date:** December 20, 2022  
**Subject:** ERA23LA053, Record of Conversation/Interview  
**Contact:** Fernando Alvarado-Rivero, Pilot and Co-Owner of N30RK

**Date:** December 21, 2022  
**Subject:** ERA23LA053, Record of Conversation/Interview  
**Contact:** Swaid Rahn, Previous Owner of N30RK

**Subject:** ERA23LA053, Record of Conversation/Interview

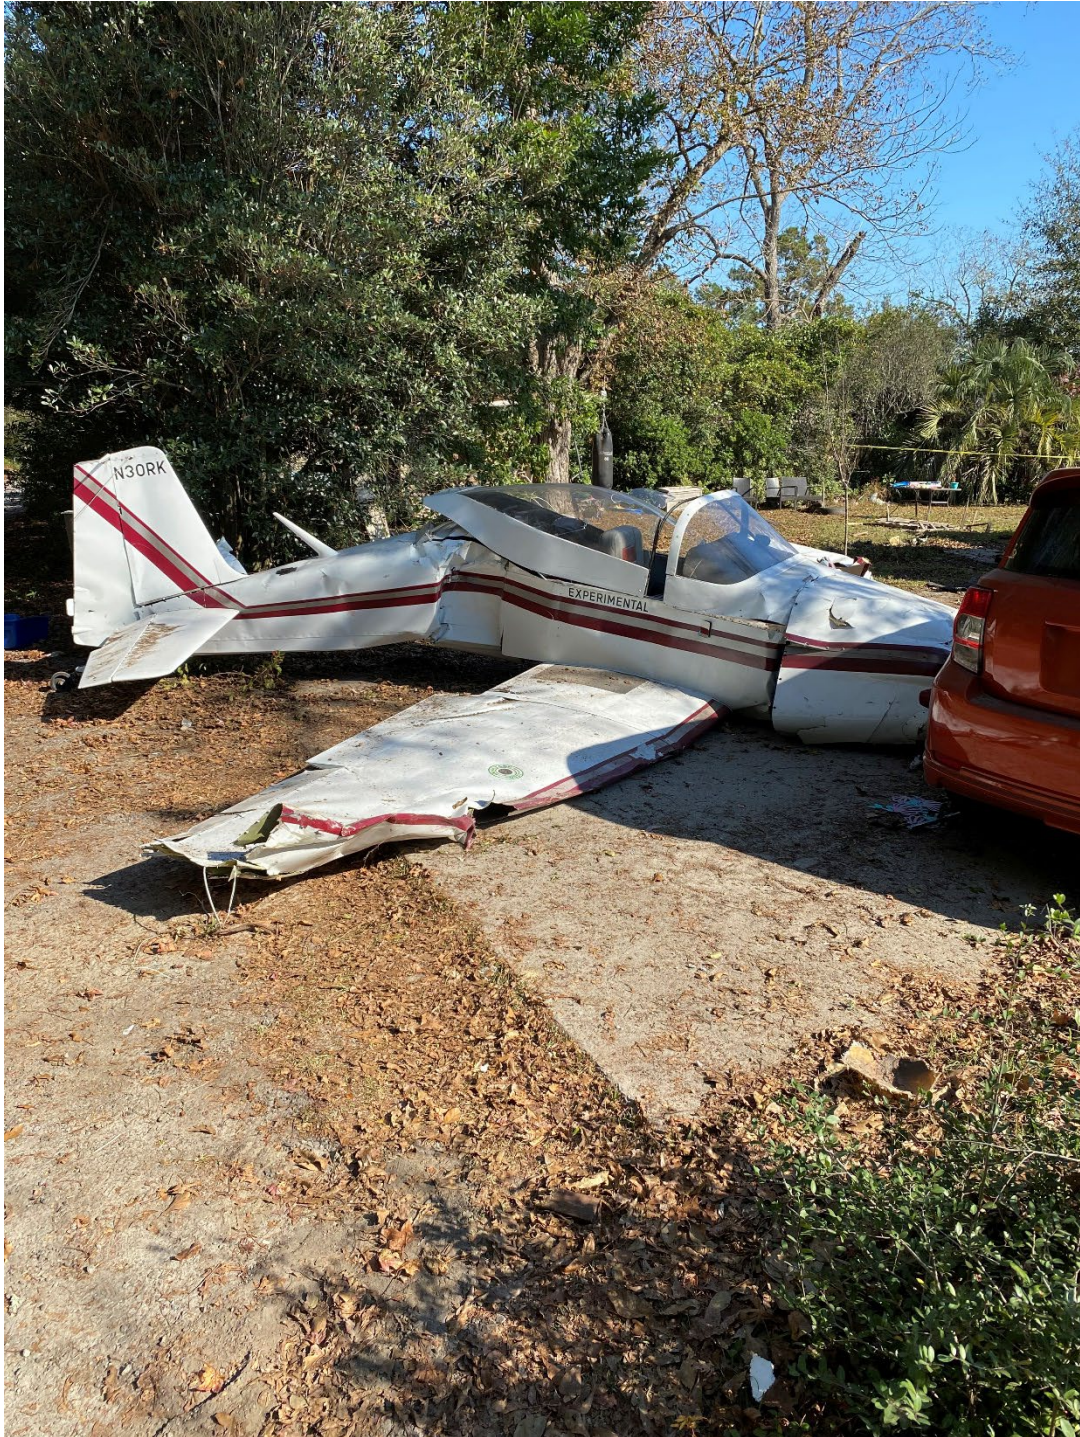
rest adjacent to a house/car (Figure 1). The airplane came to rest about 20 ft from the initial ground impact point.

Yes. From what we (he and FAA inspector Bean) could tell, it was totally out of fuel. The carburetor broke in 2 at impact. There was no indication of a major fuel leak.

Figure 1: FAA Digital Photograph. Right Forward Quartering View of the Airplane At the Accident Site.

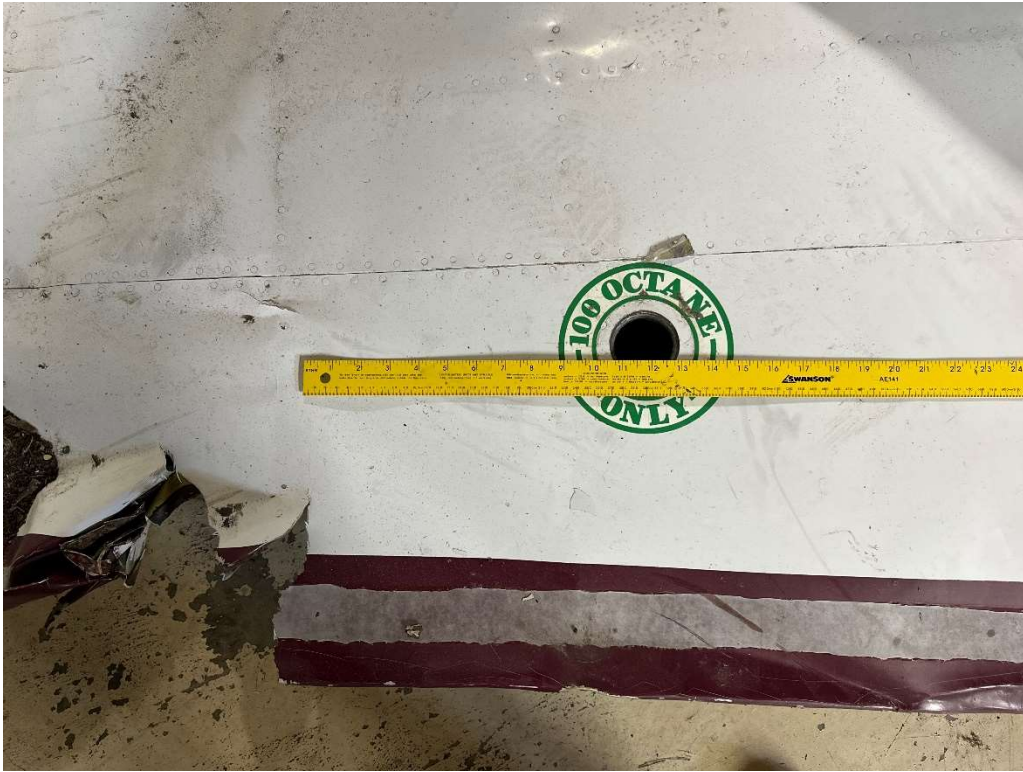
With respect to the airplane, it was still in their hangar. He went to the airplane and noted the fuel tank in the right wing went from the wing root outboard 5 ribs. The leading edge of the right wing was damaged about 12 inches outboard from the center of the fuel filler cap opening (Figure 1). That location coincided with the outboard location of the fuel tank that was in the wing leading edge.

Figure 1: Digital Photograph from Jeremy Hill. Frontal View of a Portion of the Leading Edge of the Right Wing. Note the measurement from the fuel Filler Opening to the Outer Most Rib of the Wing Fuel Tank.

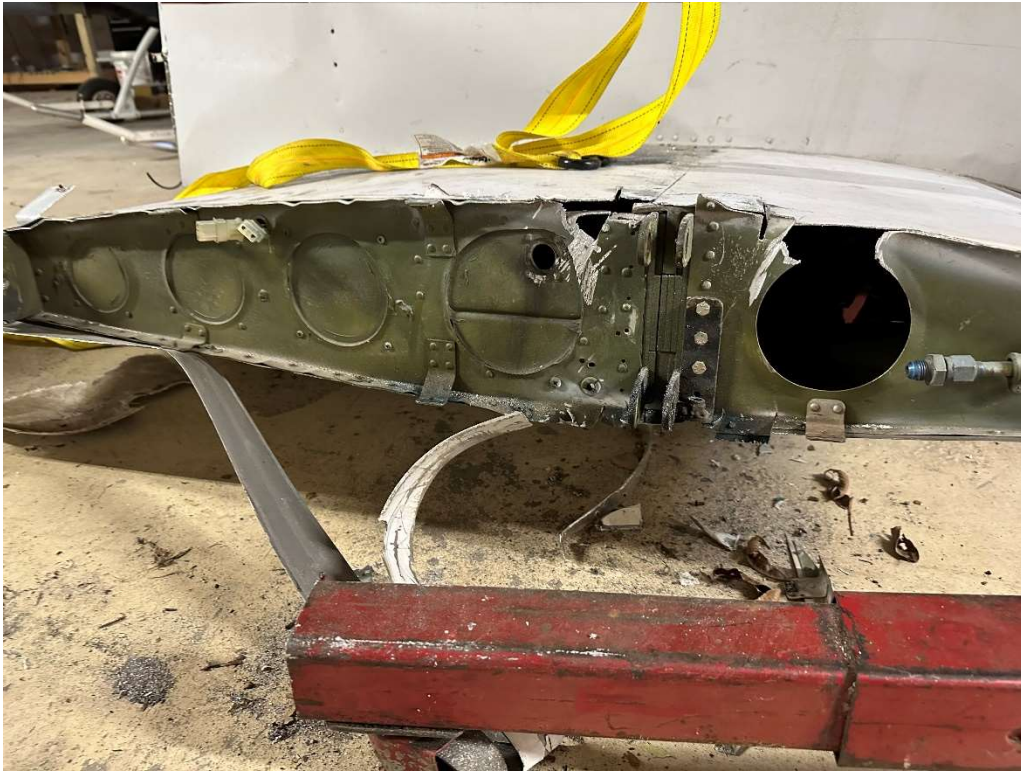
He indicated that there was no header fuel tank in the cockpit, no fuel tank behind the seats, and there was no evidence of a fuel tank in the wing center section between the spars for either wing. He took a photo of the wing root of the right wing (Figure 2).

Figure 2: Digital Photograph from Jeremy Hill. View of Right Side of the Wing Center Section. Note the absence of any fuel tank between the main and aft spars.

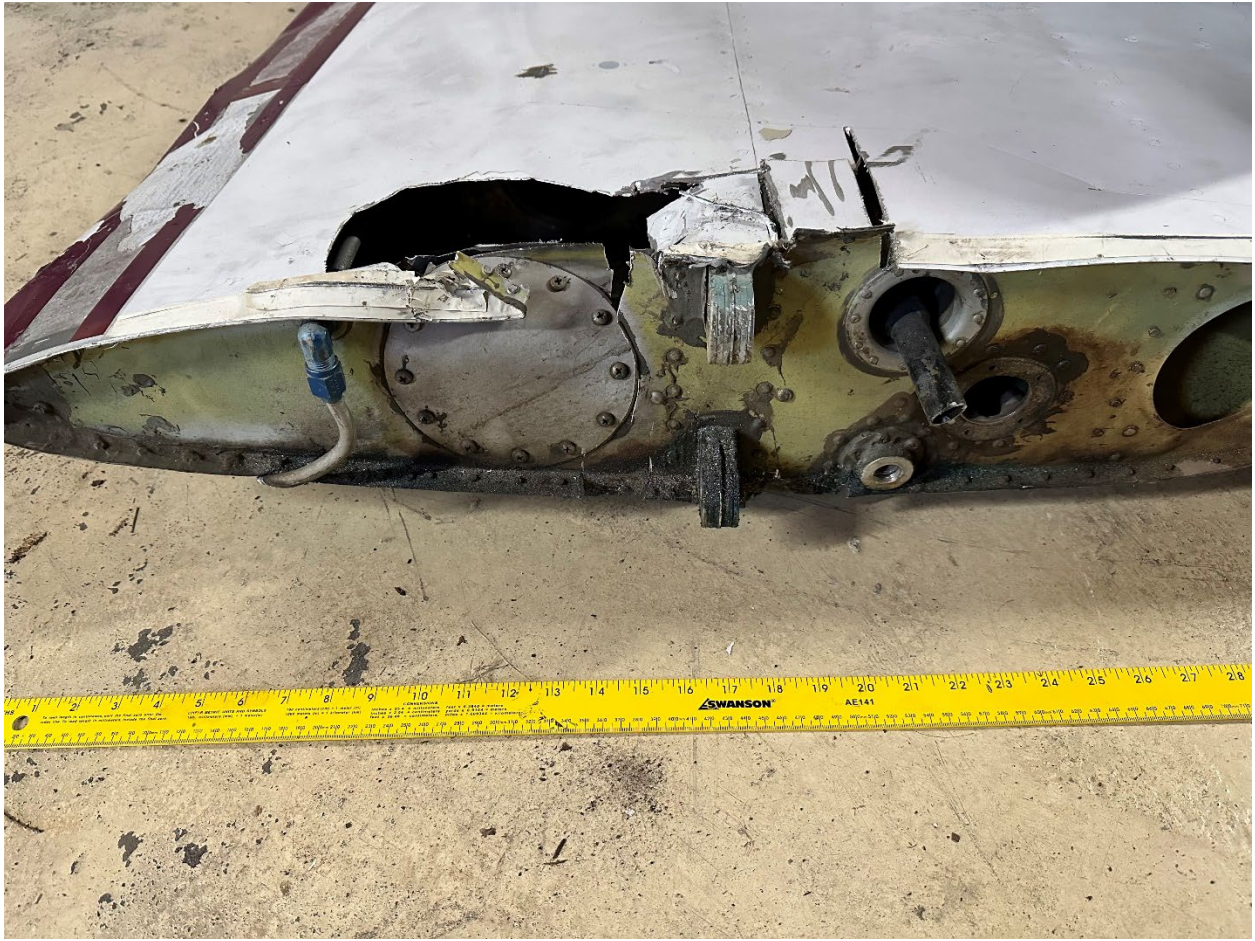
He indicated that in reviewing picture IMG\_9299 (Figure 1), the area behind the main spar is normally open, but with the sealed openings aft of the main spar, and the sealed fuel fitting boss aft of the main spar, that airplane had a fuel tank aft of the main spar and could be consistent with the reported 44 gallon total capacity.

Figure 1: Digital Photograph from SE Avionics. Photograph IMG\_9299. View Depicting the Wing Root of the Right Wing. Note the Sealed fuel fitting Boss and other sealed openings in the Inboard Rib aft of the Main Spar. This is consistent with a fuel tank aft of the Main Spar.
