ERA23LA058

## INVESTIGATION PHOTOGRAPHS

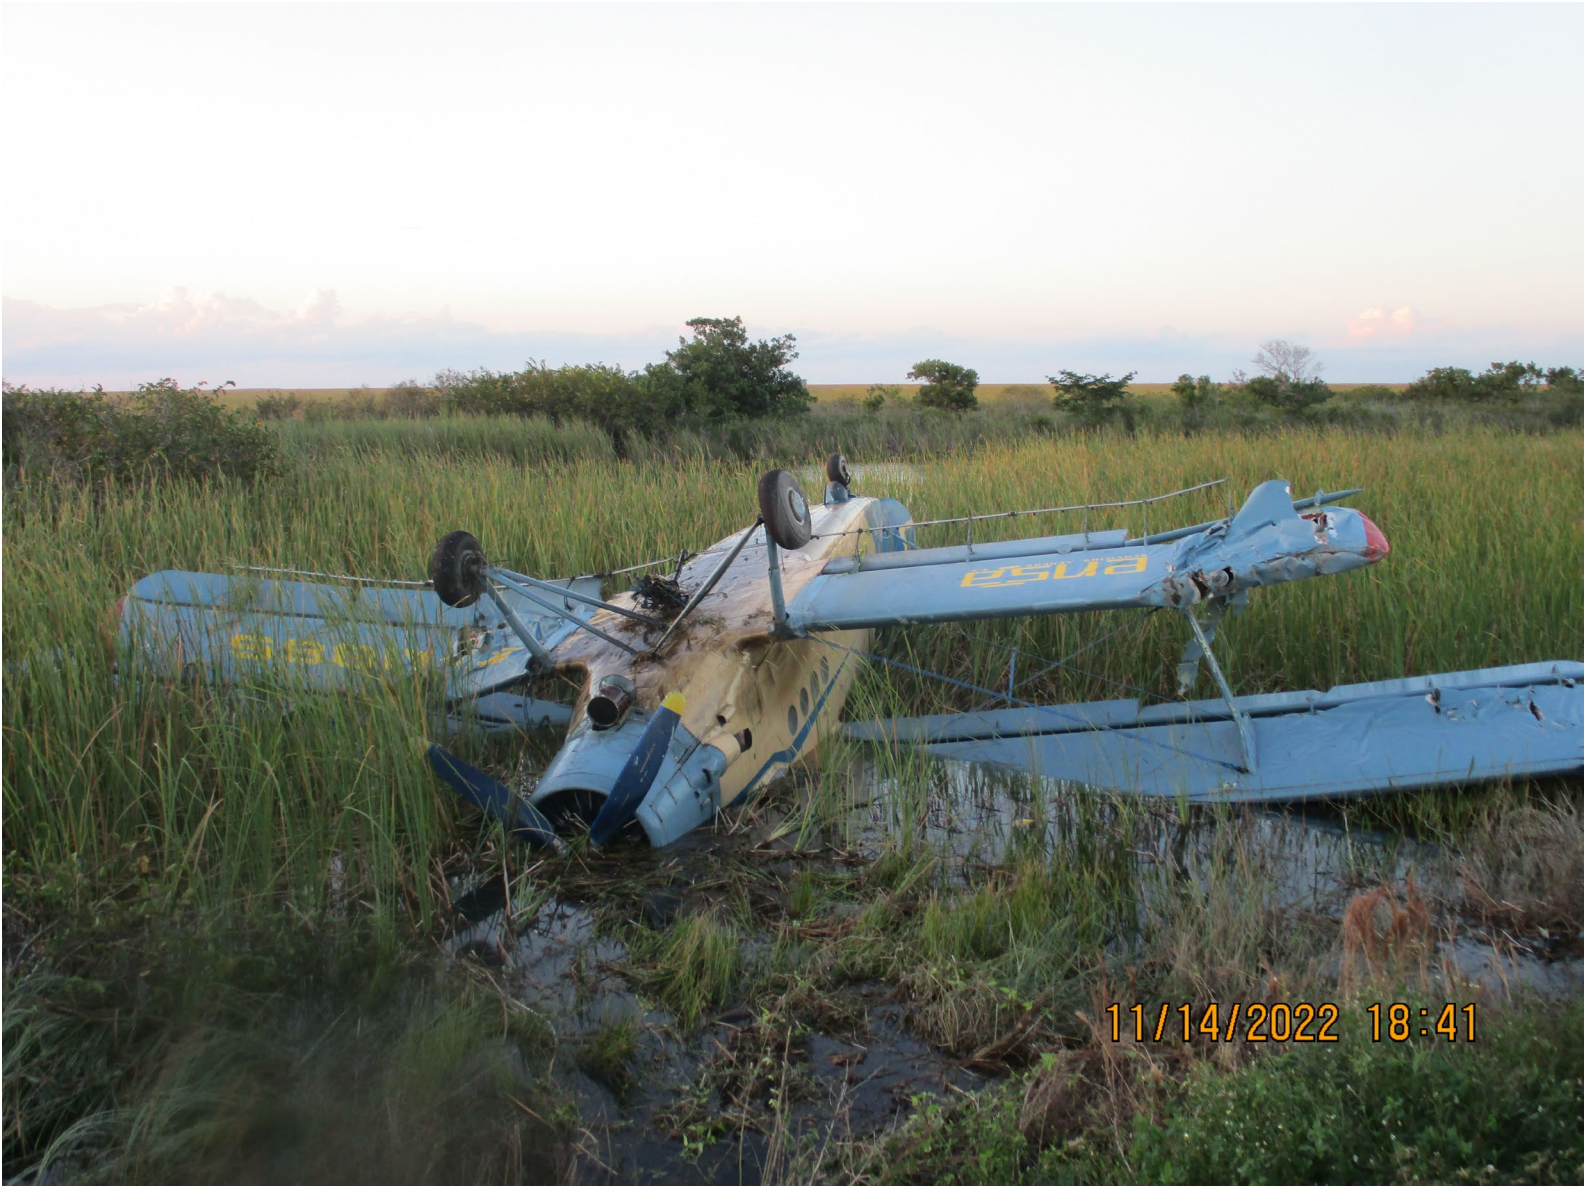
**Photograph 1 - Main Wreckage (Courtesy of FAA)**

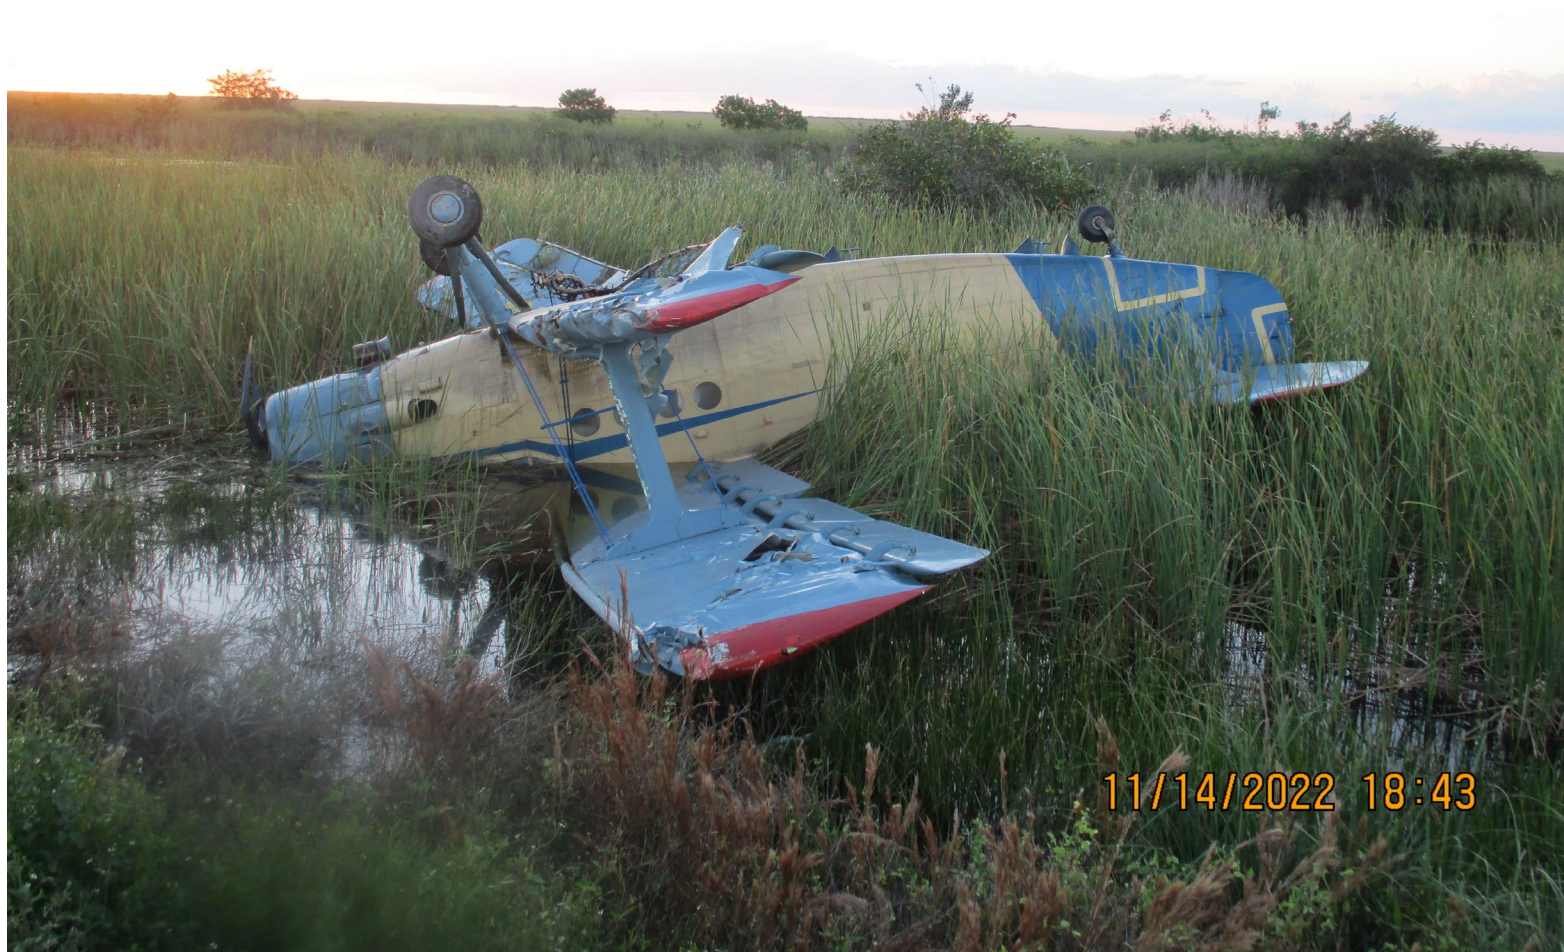
**Photograph 2 - Side View of Main Wreckage (Courtesy of FAA)**

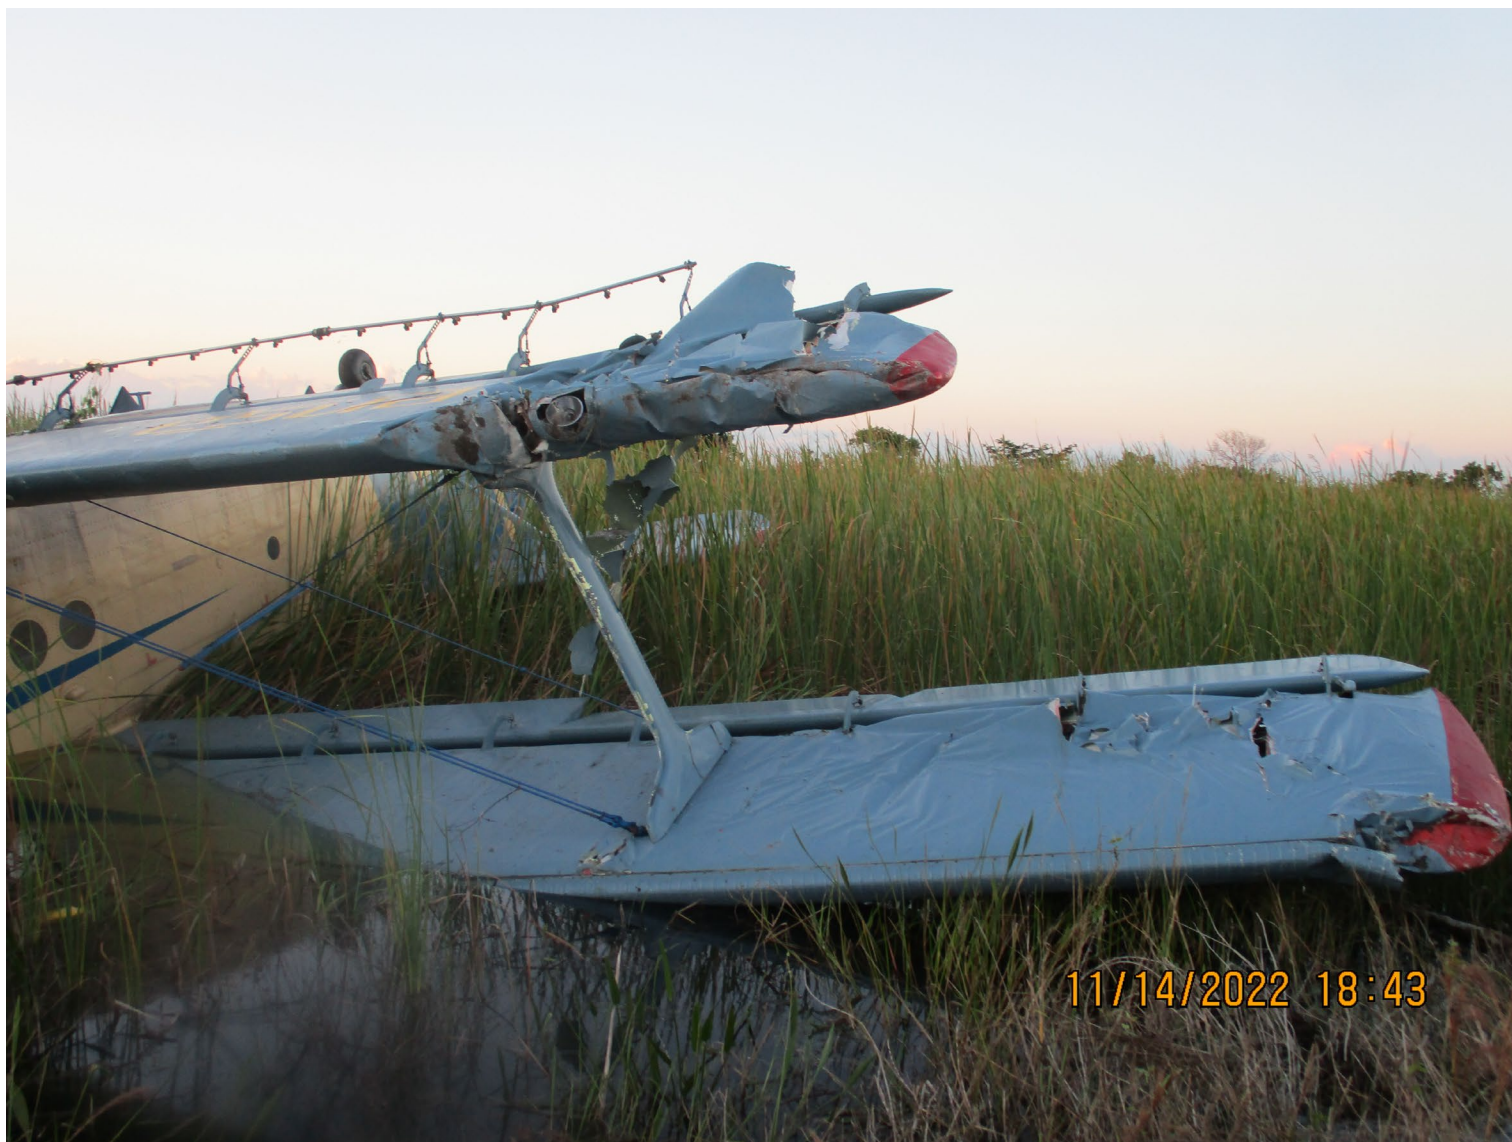
**Photograph 3 - Close Up of Outboard Sections of Lower and Upper Outboard Right Wing Sections (Courtesy of FAA)**

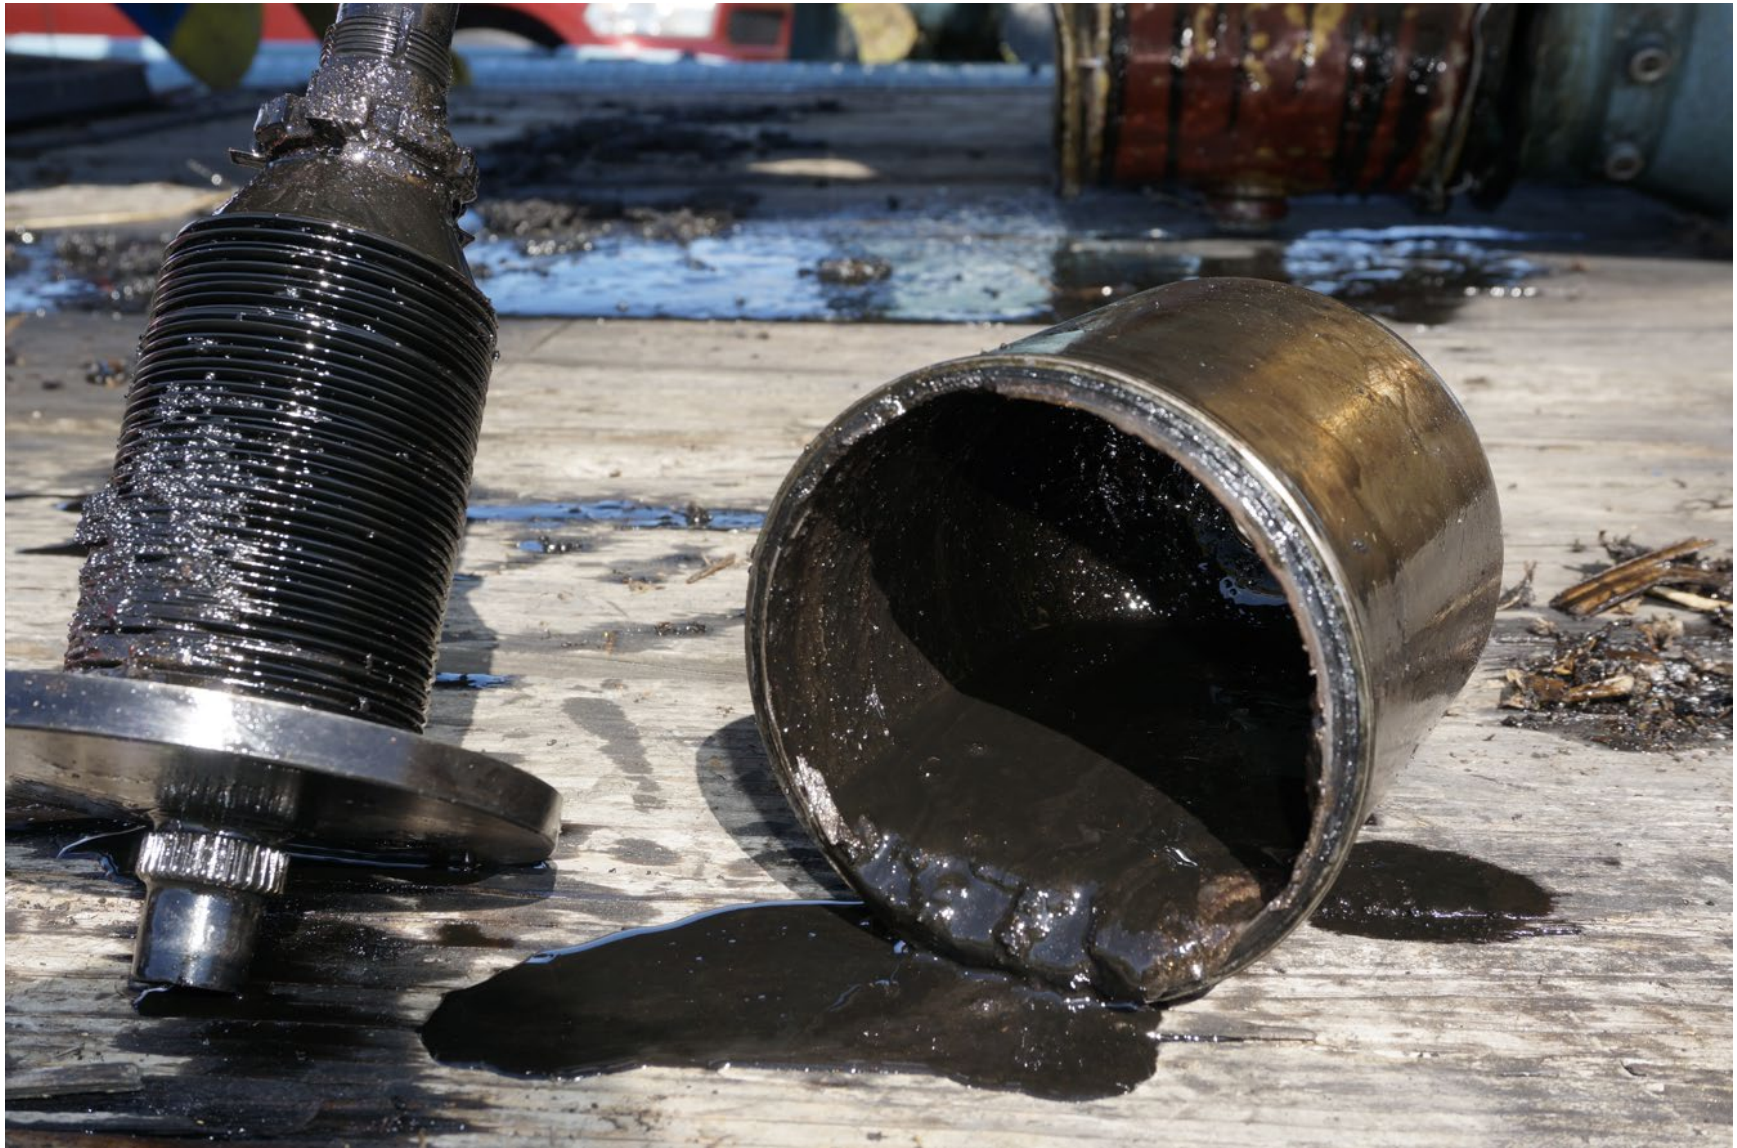
**Photograph 9 - Metallic Particles**

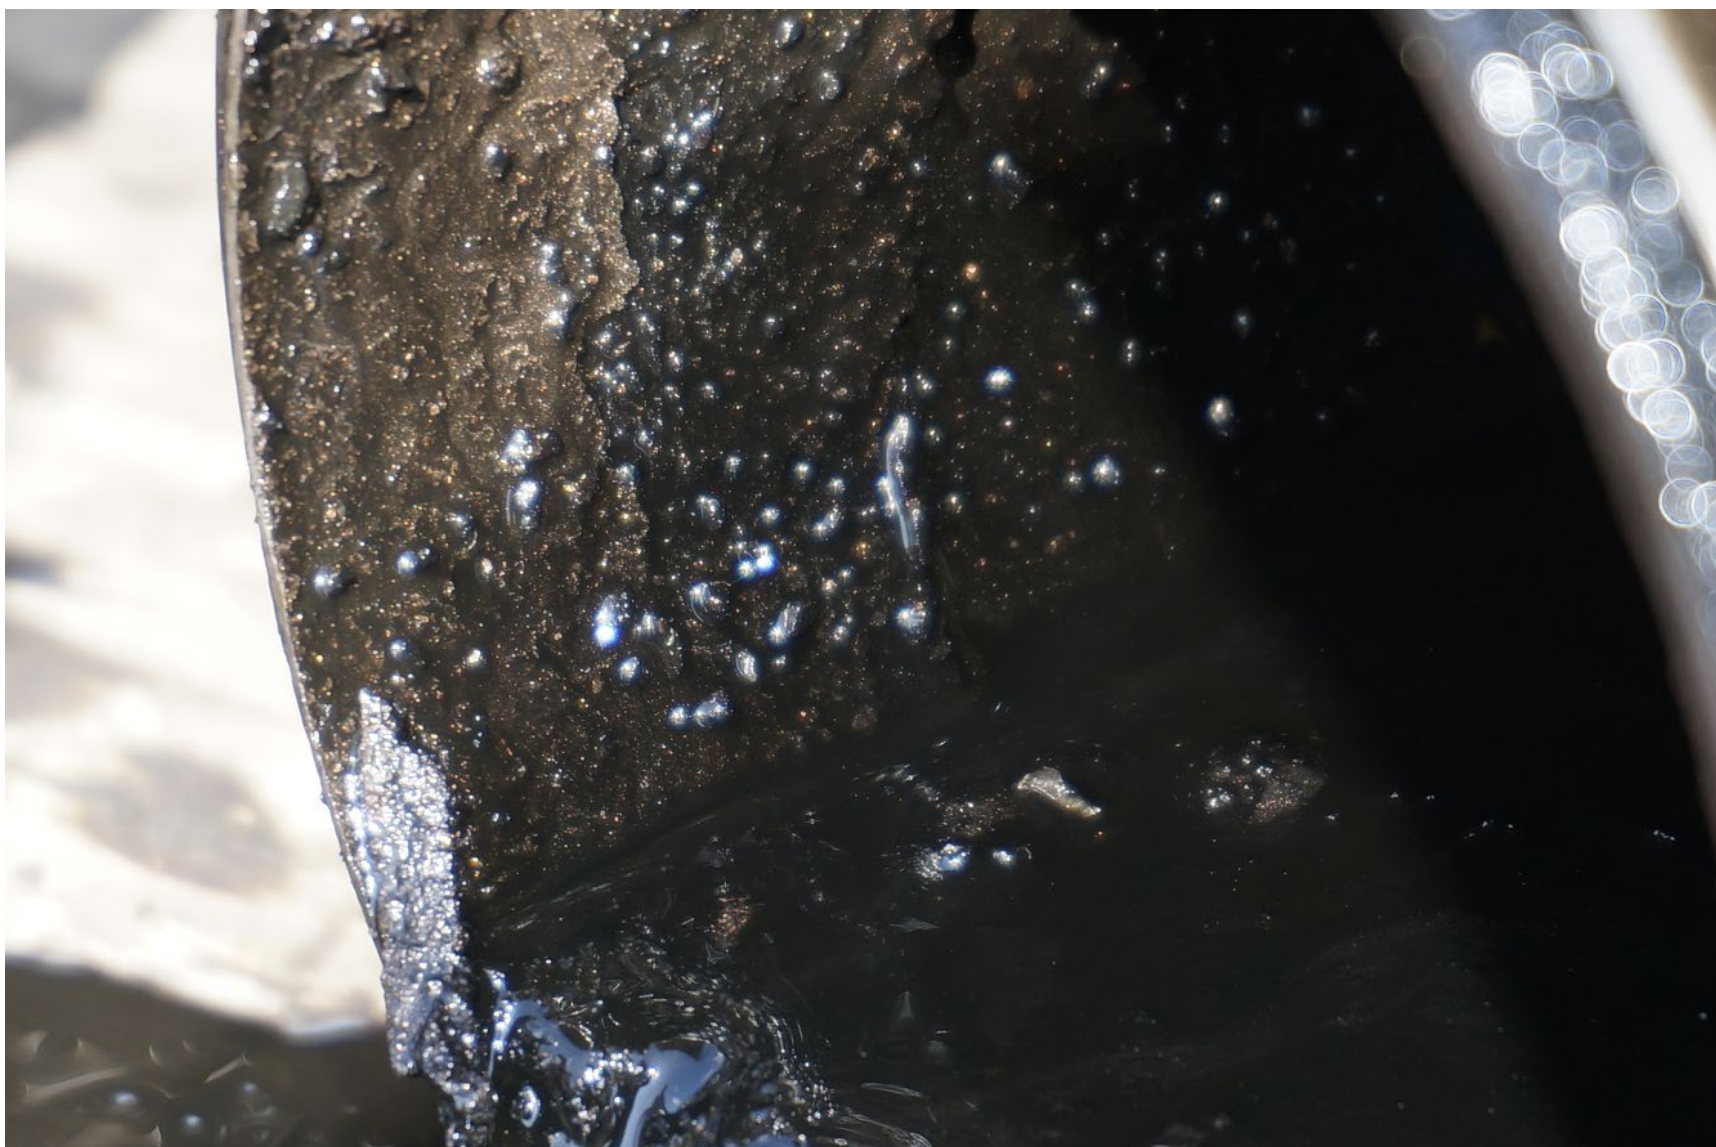
**Photograph 10 - Close Up of Metallic Particles**
