**Robert Gretz**  
**Senior Air Safety Investigator**  
**Eastern Region Aviation**

**Subject:** ERA23LA061

**Contact:** Jason Cobb, FAA CMH FSDO

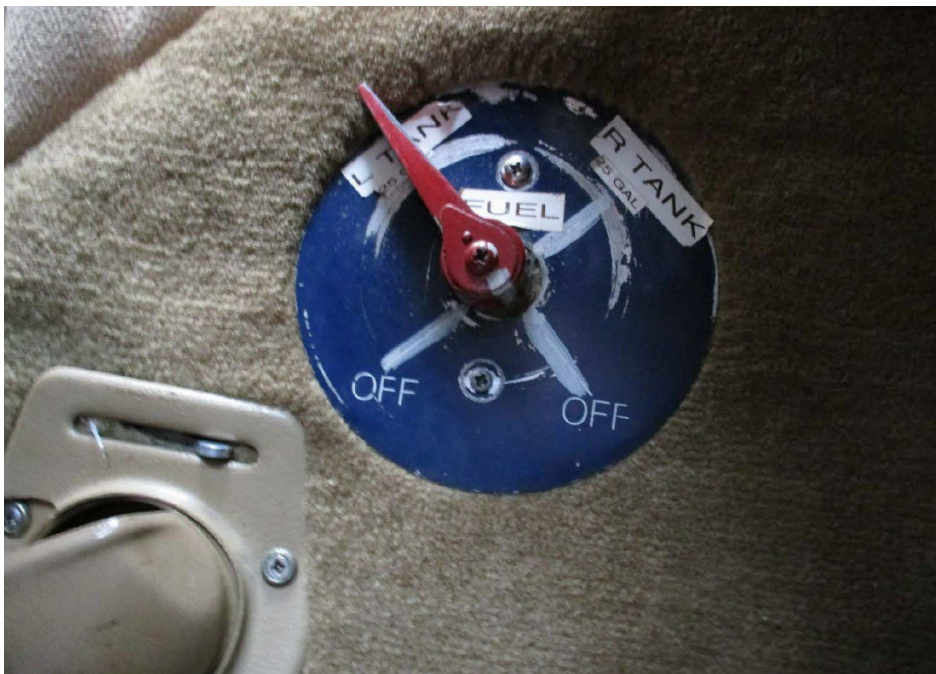
Mr. Cobb was interviewed via telephone. He stated that the fuel selector was a first generation fuel selector that can be rotated 360°. On one side of the knob is a handle and on the other side is a small triangle to point to the selected tank. As the small triangle is difficult to see, the operator painted a gray stripe on the triangle and fuel tank positions to assist pilots in correctly selecting the desired position.

Mr. Cobb added that the flight instructor had accrued about 10 hours in the airplane, misunderstanding the fuel selector position the entire time (positioning the handle to desired tank instead of triangle), but had not experienced a loss of engine power prior to the accident takeoff. He had planned to further examine the selector with Inspector Peterson, but the NTSB had never followed up on it. He believes that the operator has since donated an airplane to a fire department.

Mr. Rooney was interviewed via telephone. He stated that the wreckage has since been scrapped in a junkyard. He further stated that the flight instructor knew the correct positioning of the fuel selector in that airplane as he had taught in it many times; however, the selector is on the left side of the cockpit and obstructed by the student pilot's left leg.

The student pilot was on their third lesson and completed a before start checklist, which includes selecting fuel to the fullest tank. Mr. Rooney believes that the flight instructor had the right fuel tank selected correctly (as he had just returned from a previous lesson in that airplane) and that the student pilot attempted to select the left fuel tank, but in actuality moved the selector to an off position.

Mr. Conte was interviewed via telephone. He stated that that he was confused with the after-market white paint stripes on the fuel selector; however, his prior student stated he never moved the fuel selector and he told the accident student not to touch the selector because she was knew. Additionally, Mr. Conte conducted 15 to 20 minutes of the accident lesson on the ground, with the engine running, explaining things to the new student. He believes that there was something wrong with the selector that the engine could operate so long with the selector in the incorrect position. He added that he had heard of prior power losses in that airplane due to the same confusion as to fuel selector position.
