ERA23LA064

## INVESTIGATION PHOTOGRAPHS

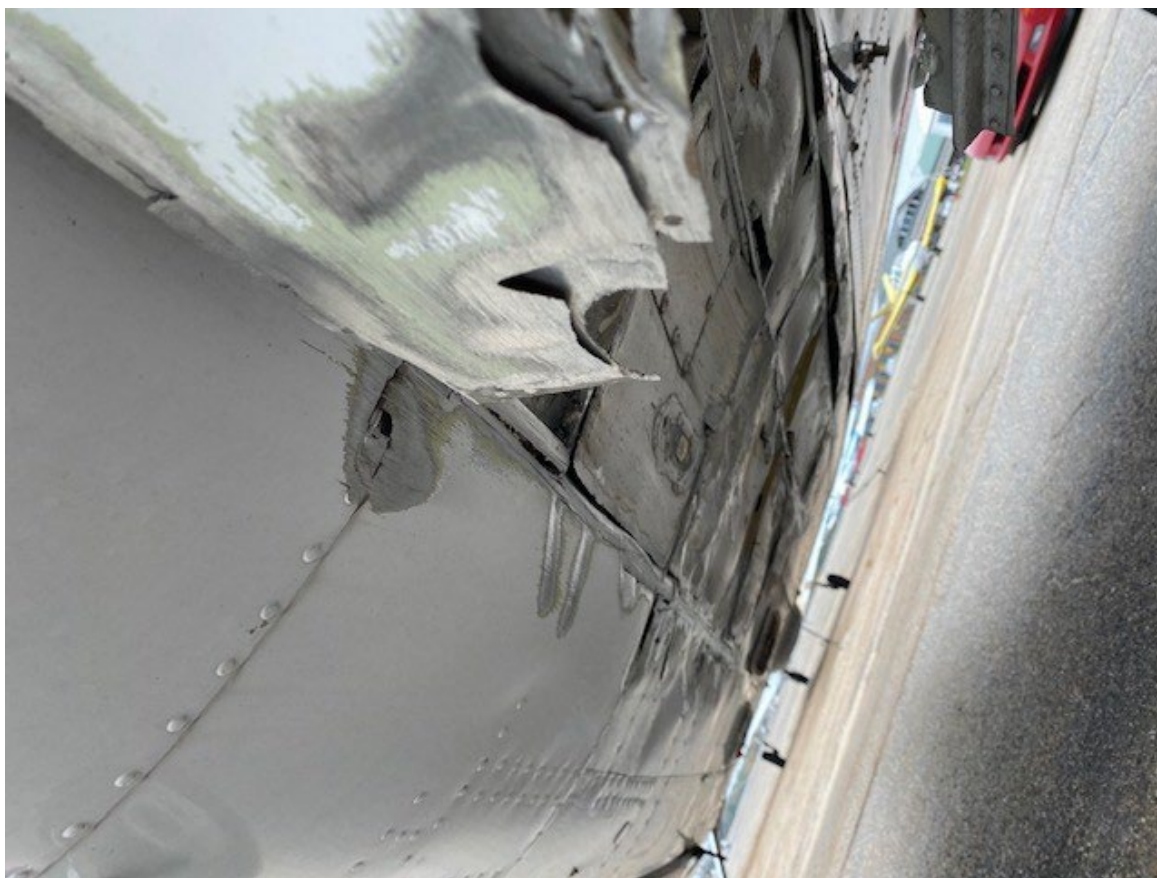
**Photograph 1 - Lower Fuselage Skin and Structure Damage (Courtesy of FAA)**

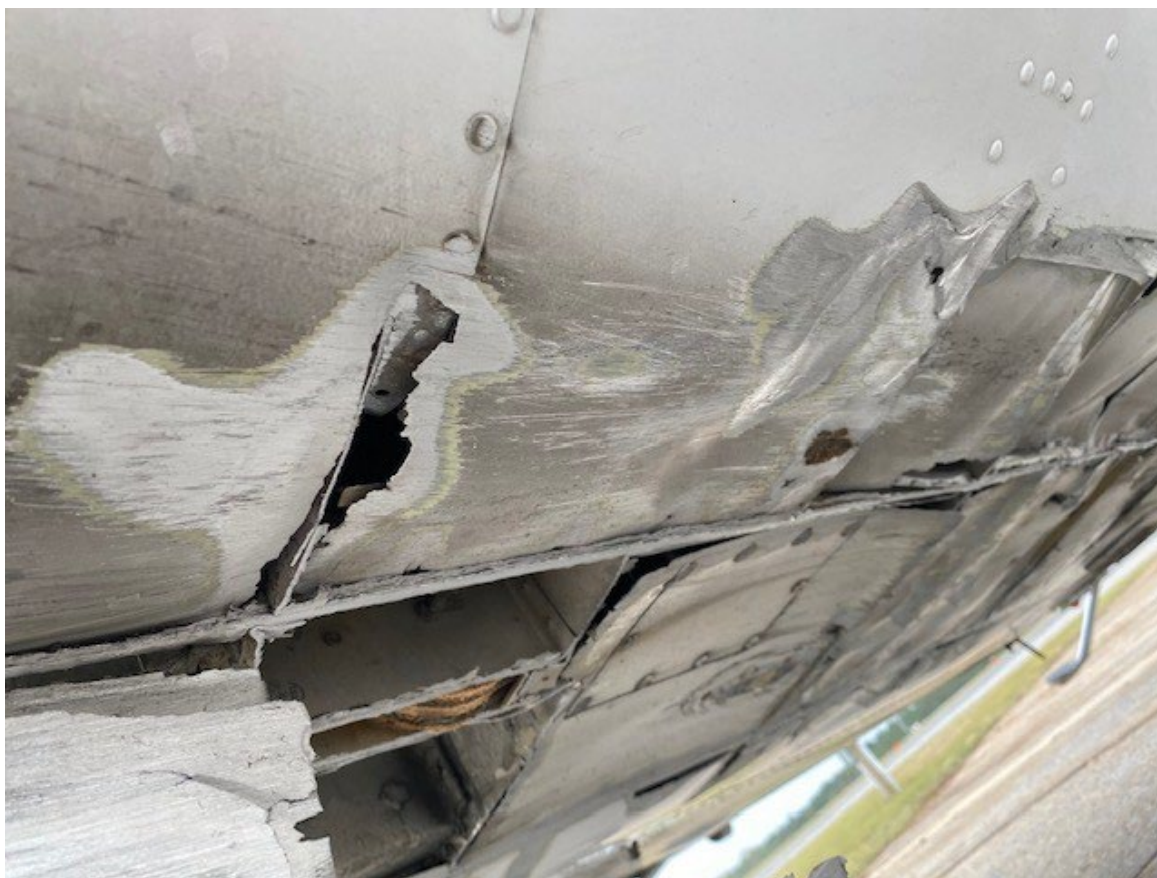
**Photograph 2 - Lower Fuselage Skin and Structure Damage (Courtesy of FAA)**

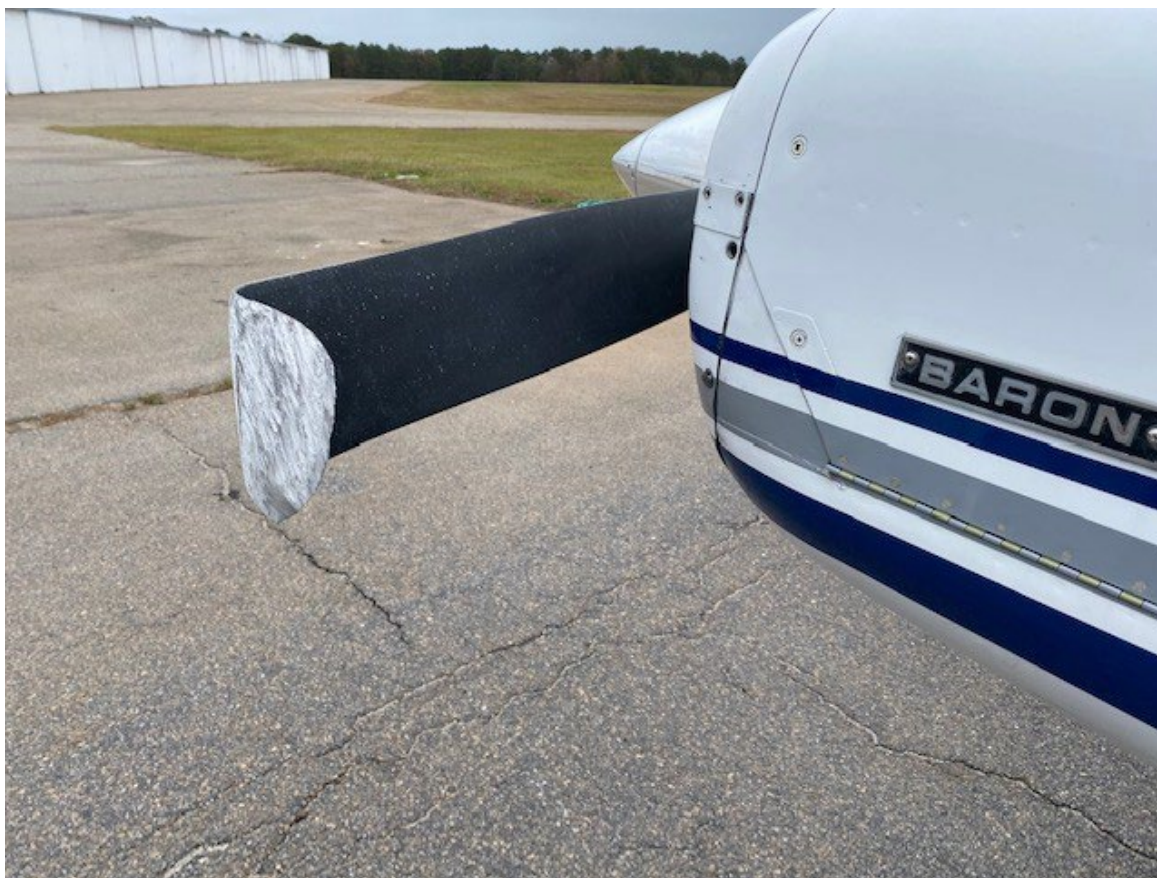
**Photograph 3 - Propeller Damage (Courtesy of FAA)**
