# National Transportation Safety Board

ERA23LA064

## **ENGINE AND ELECTRICAL SYSTEM EXAMINATION**

Location: Athens, Georgia  
Date: 11/3/2022  
Time: 1855 EST  
2355 UTC  
Airplane: N101DC, Beech 95-B55

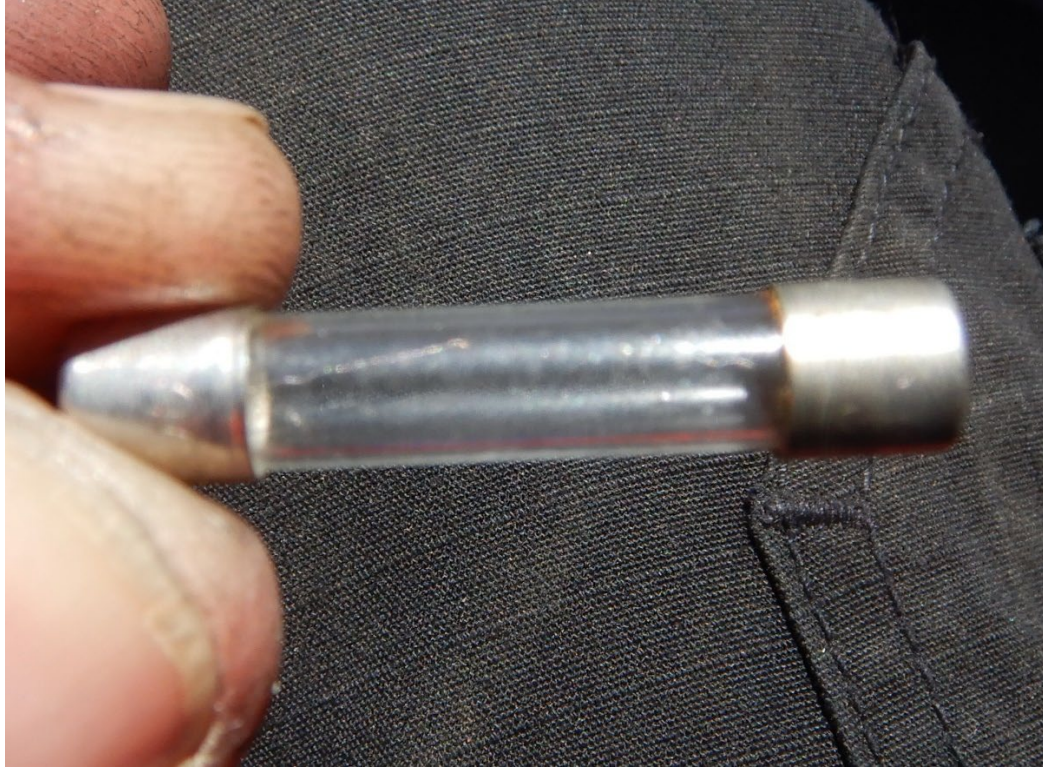
The right engine was shut down to access to the battery. The portable battery charger was removed, and a voltmeter was connected to the battery post to verify if the left engine alternator was operating and supplying voltage to charge the battery. It was noted that the left engine alternator was not supplying voltage to the battery. The left engine was shut down and the applicable aircraft alternator electrical wiring diagram was reviewed. After troubleshooting, a 2-amph fuse for the left engine alternator system was found open (blown). A replacement 2-amph fuse was installed. The portable battery charger was reinstalled on the battery, the left engine primed, and the engine started. The portable battery charger was disconnected from the battery post. The left engine alternator switch was turned on and 28 to 29 volts were read on the voltmeter at the battery posts. The left engine alternator switch was turned off and voltage at the battery post read 6 to 13 volts. The left engine alternator was turned back on and voltage at the battery post read 28 to 29 volts. The left engine was shut down and secured.

Photo 1 - Open 2-amp Fuse (Courtesy Textron Aviation)

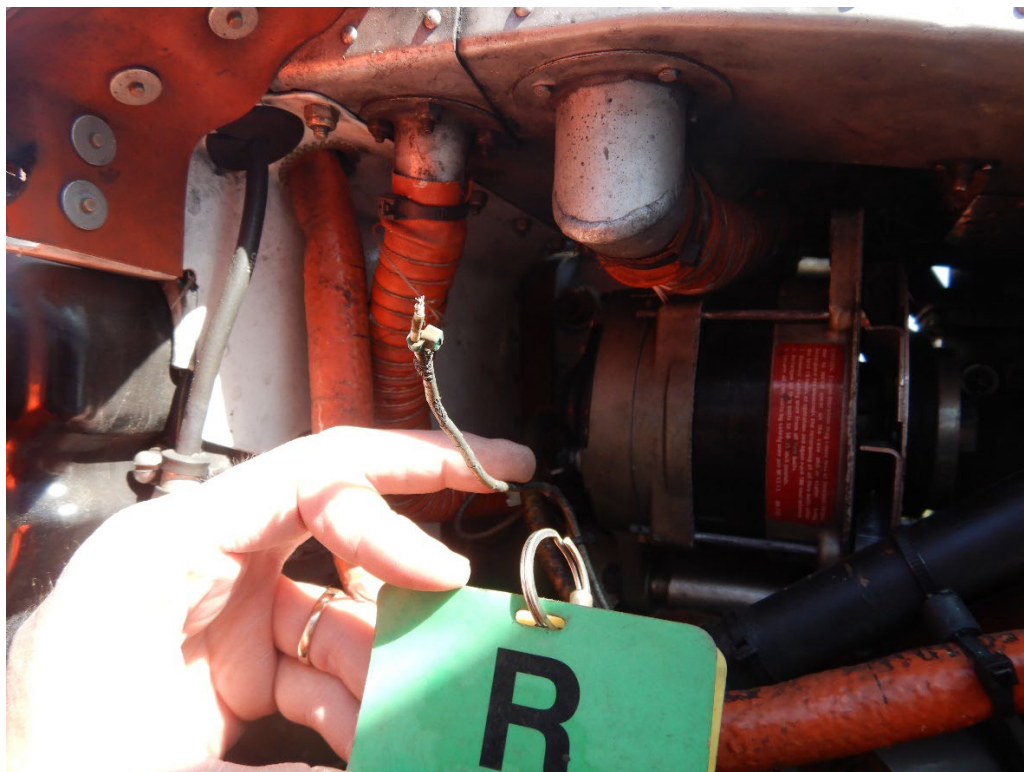
Battery extension cables were installed on the battery post and routed outside and underneath the nose to the left side of the aircraft. The battery/nose compartment door was closed. The portable battery charger was connected to the battery extension cables and the right engine was primed and started. After the aircraft was started, the portable battery charger was disconnected from the battery extension cable and the voltmeter was connected to it. The right engine alternator switch was turned on but only 6 to 13 volts was read on the voltmeter. The right engine alternator switch was turned off and the right engine was shut down and secured. After troubleshooting and reviewing the applicable aircraft alternator electrical wiring diagram, the right alternator field wire was found separated from the alternator connection. The field wire was reconnected to the alternator and the right engine was primed and started. The right alternator switch was turned on and 28 to 29 volts was read on the voltmeter. The alternator switch was again turned off and 6 to 13 volts was read on the voltmeter. The right alternator switch was turn back on and 28 to 29 volts were read on the voltmeter. The right alternator switch was turned off and the right engine was shut down and secured.

Photo 2 - Separated Alternator Field Wire (Courtesy Textron Aviation)
