# N8129M

Total Loss Aircraft Fire

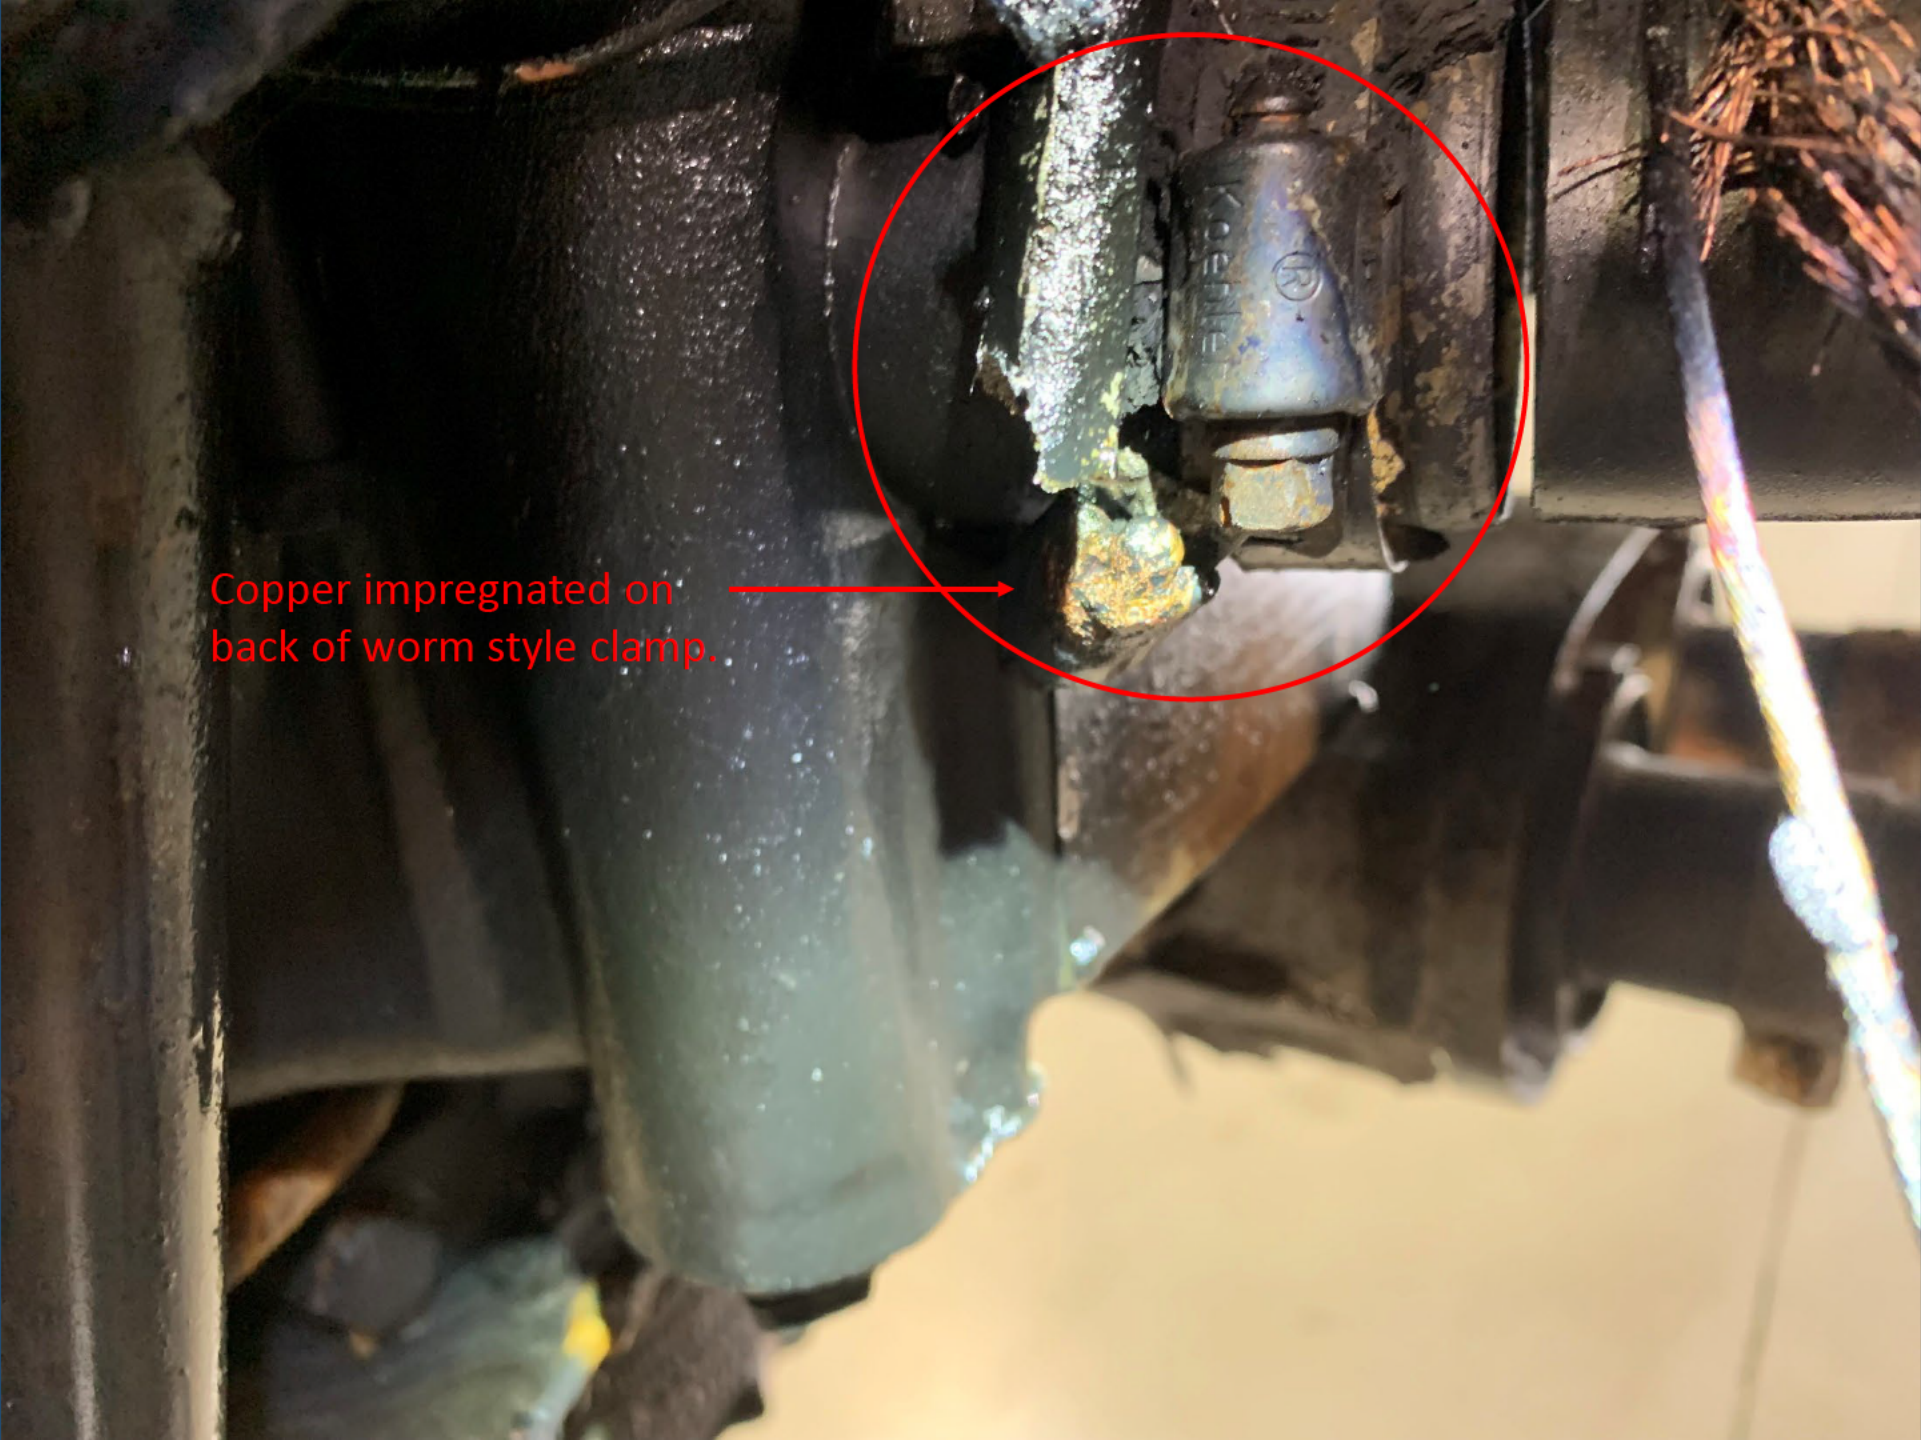
Copper impregnated on  
back of worm style clamp.

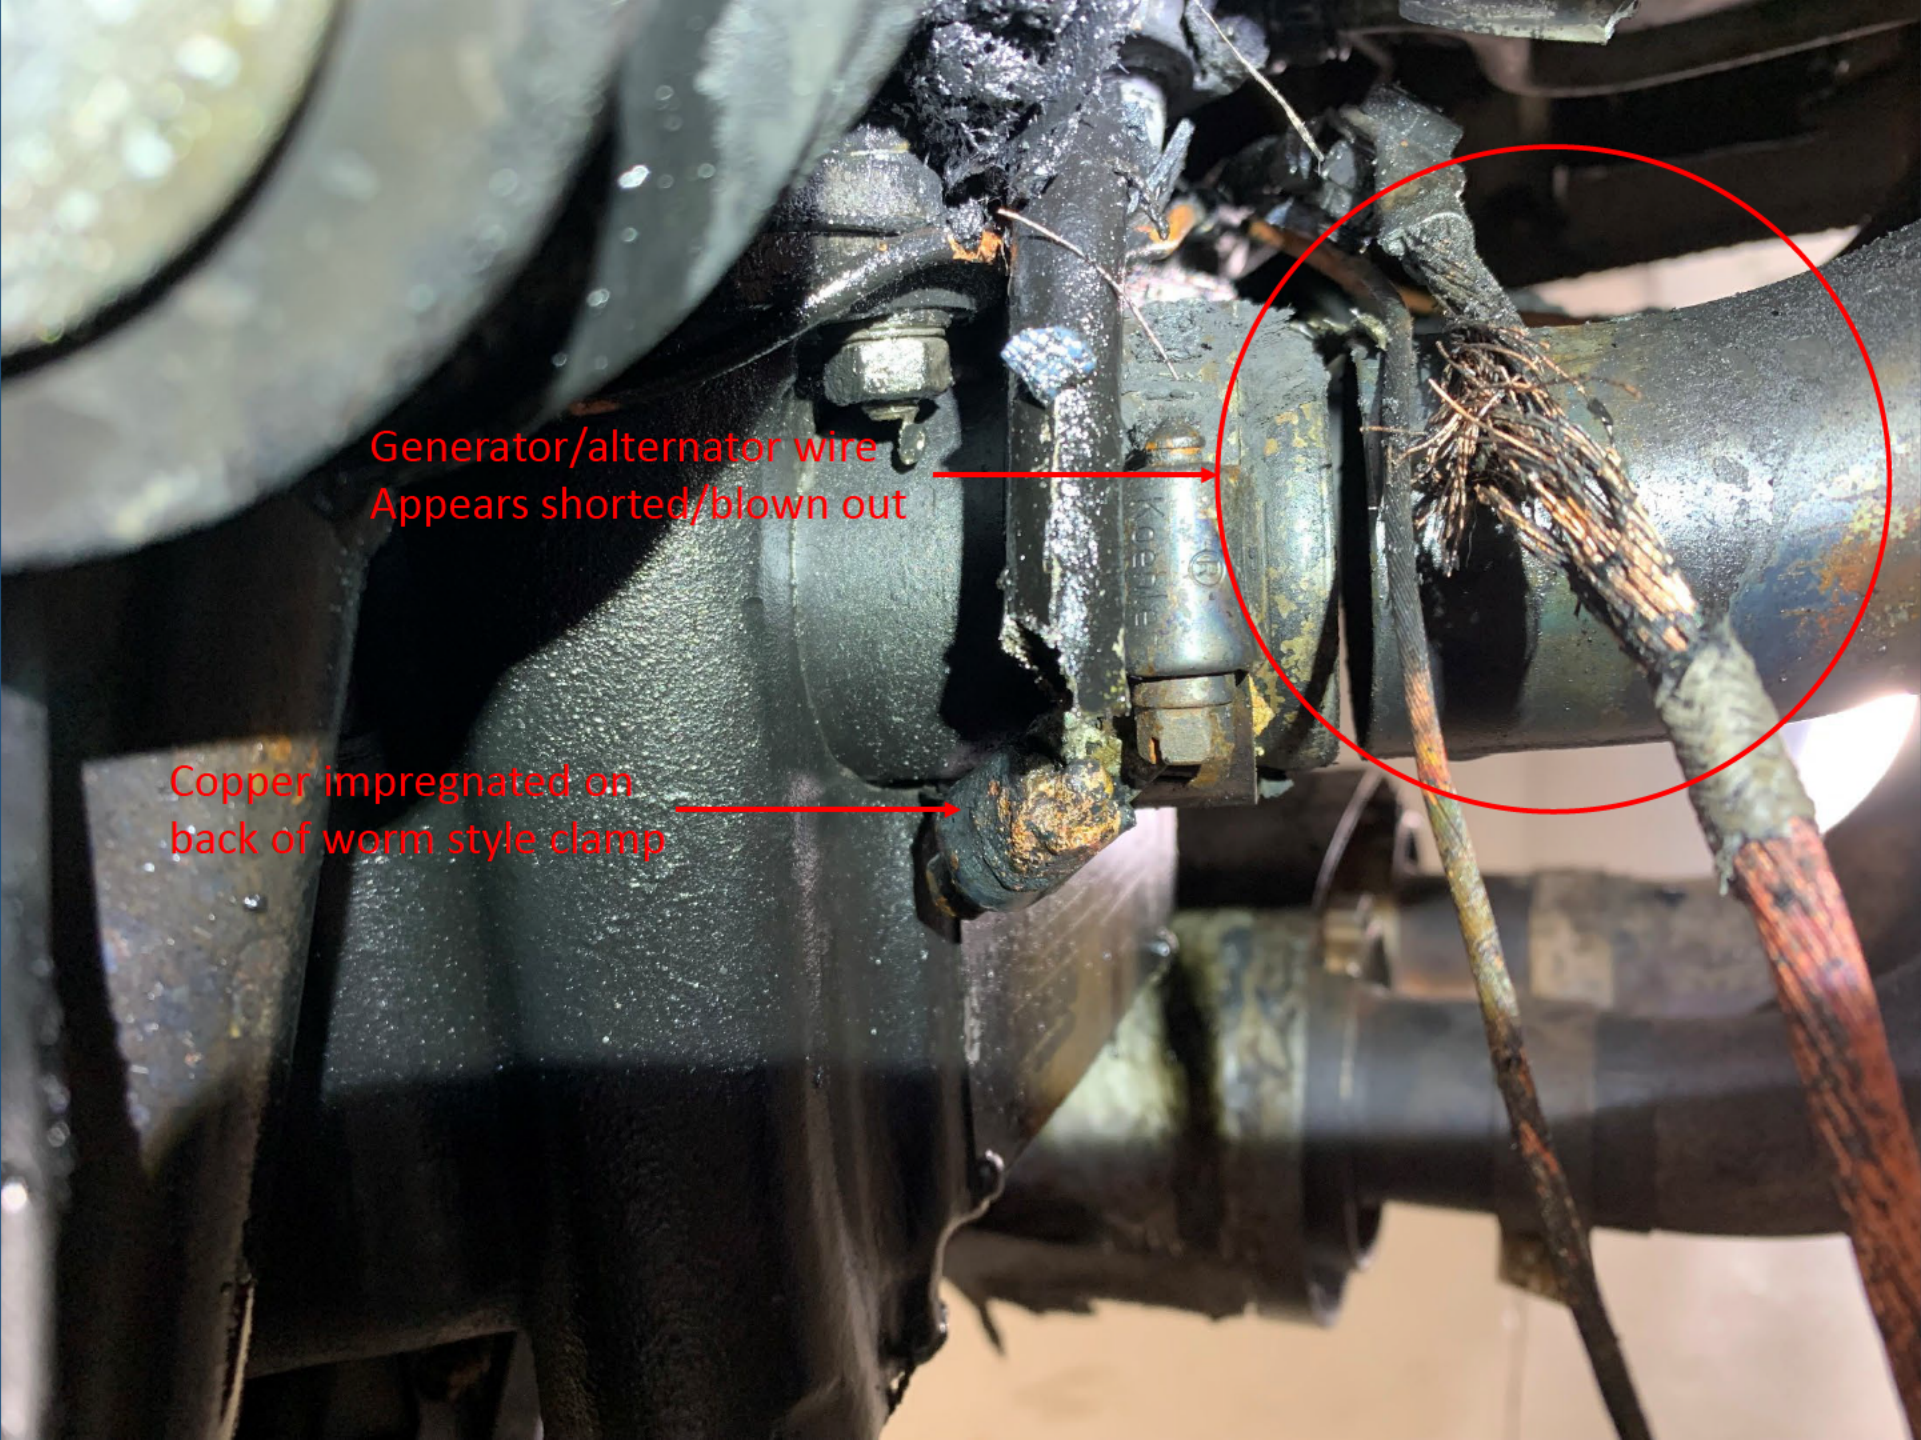
Generator/alternator wire  
Appears shorted/blown out

Copper impregnated on  
back of worm style clamp

Removed for inspection

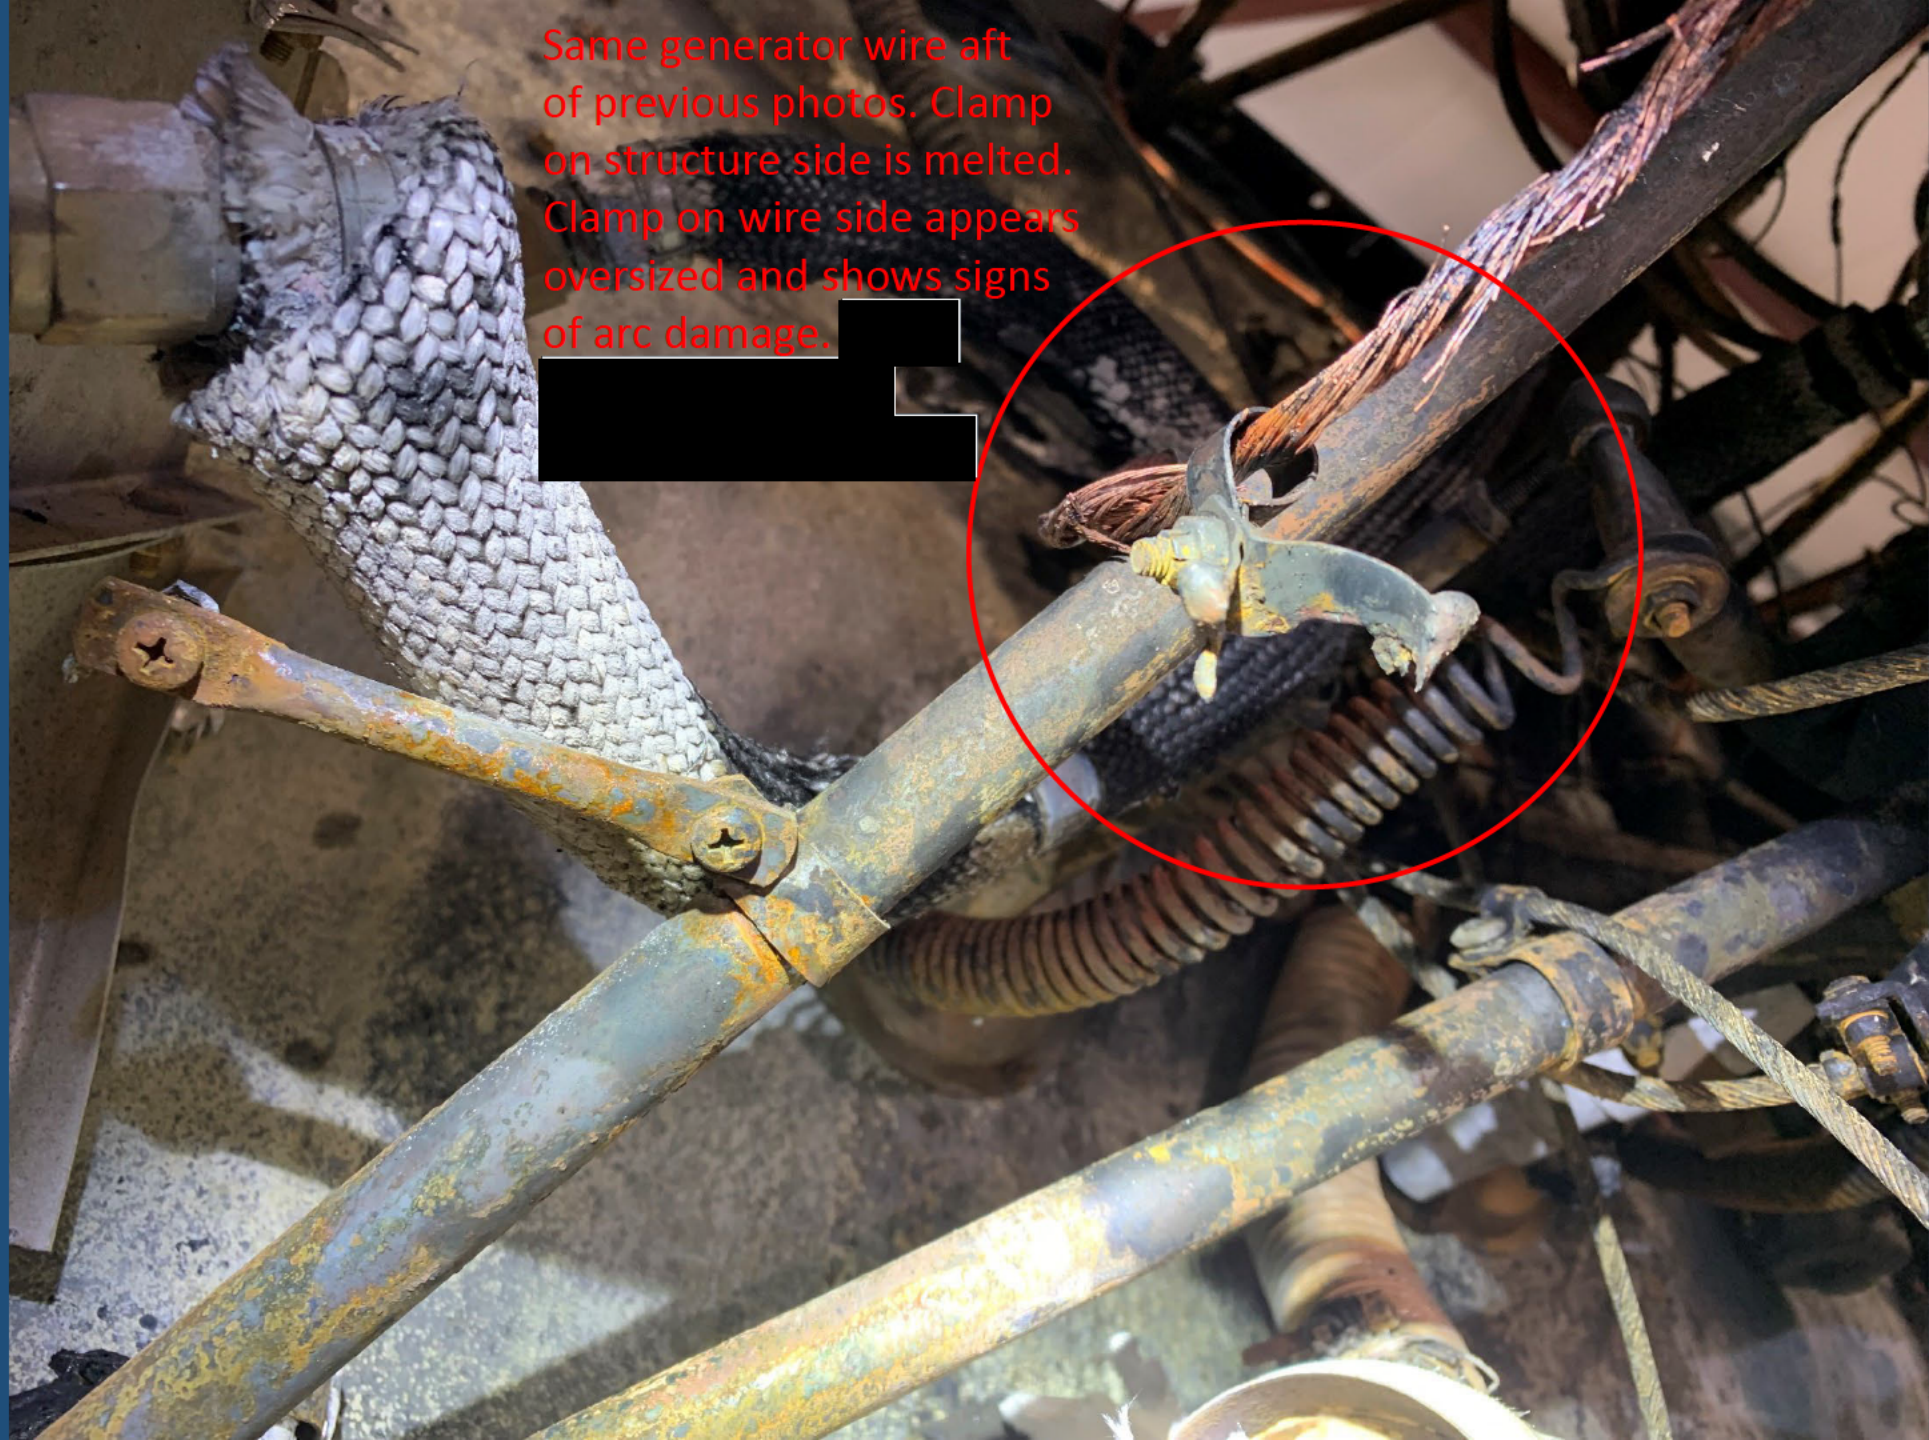
Same clamp as previous. Arc damage is present on wire side of the clamp. Melted sections of structure side of clamp can be seen below.

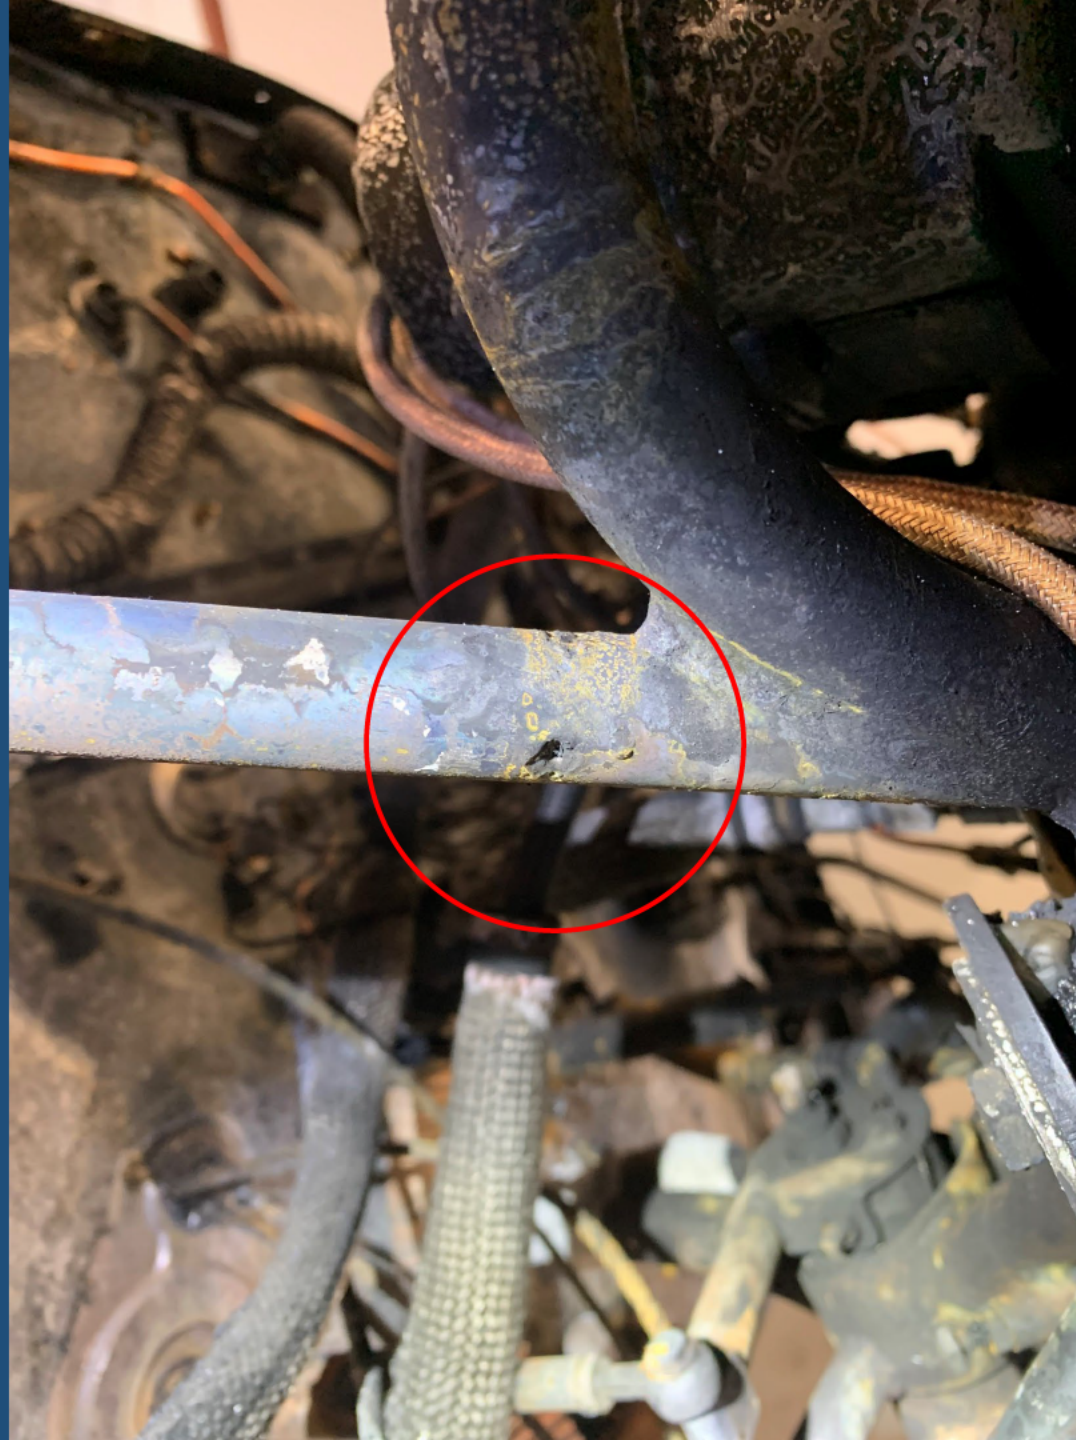
Same clamp attach point/damage
