ERA23LA065

## INVESTIGATION PHOTOGRAPHS

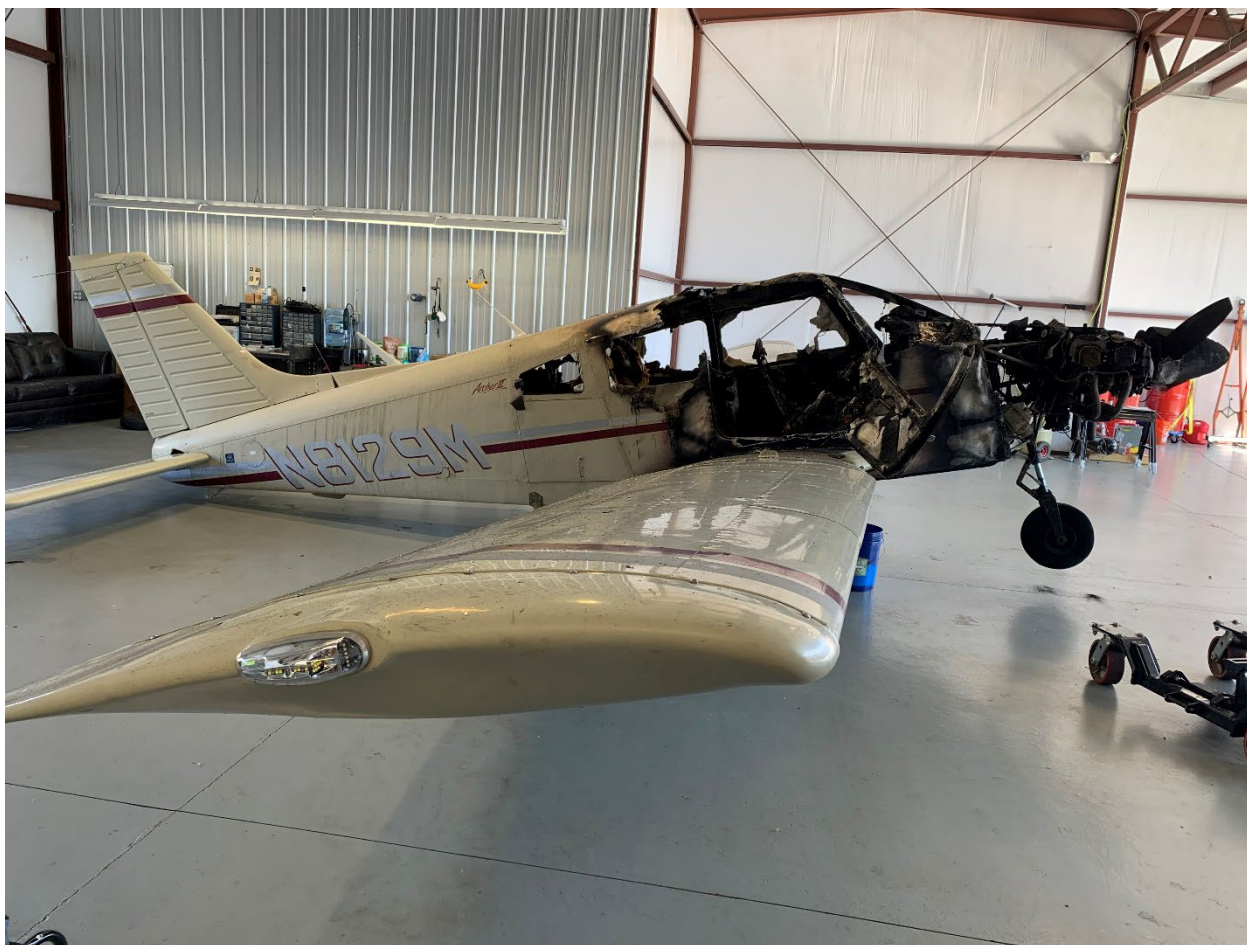
**Photograph 1 - Overall view of fire damaged airplane. (Courtesy of FAA)**

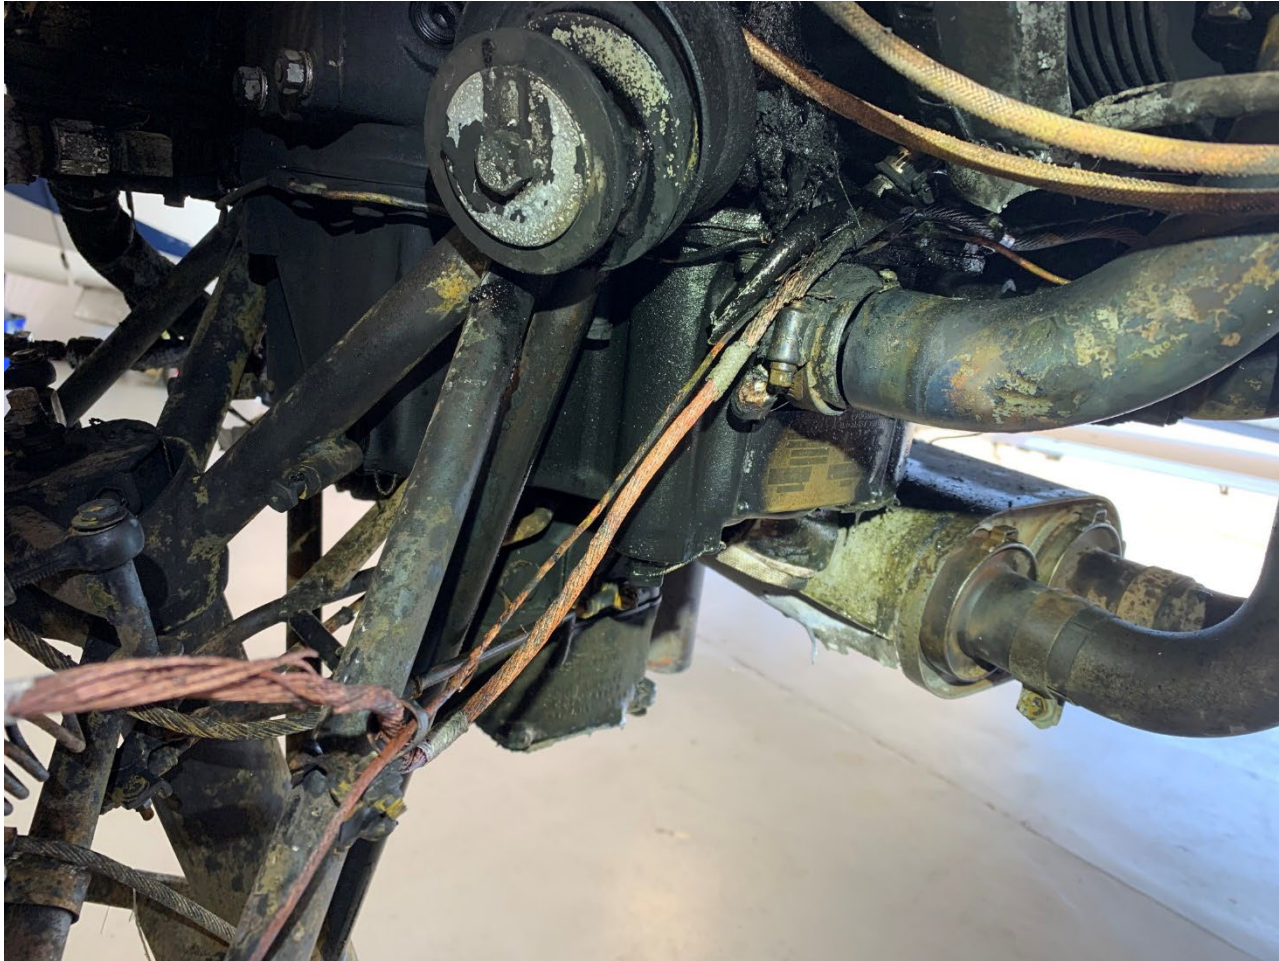
**Photograph 2 - View of engine compartment alternator wire. (Courtesy of FAA)**

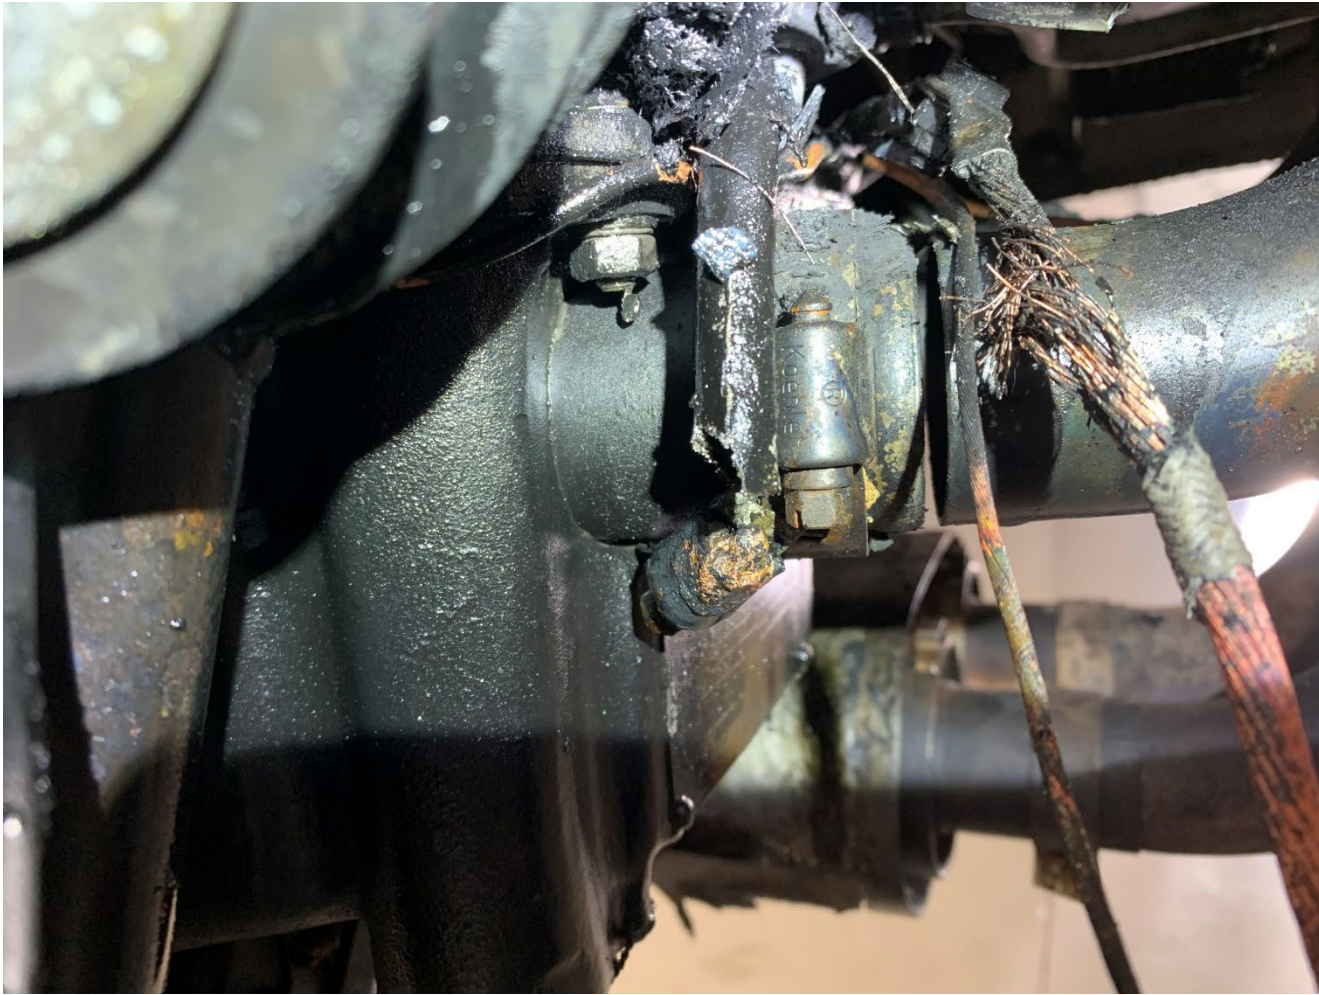
**Photograph 3 - View of alternator wire damage. (Courtesy of FAA)**

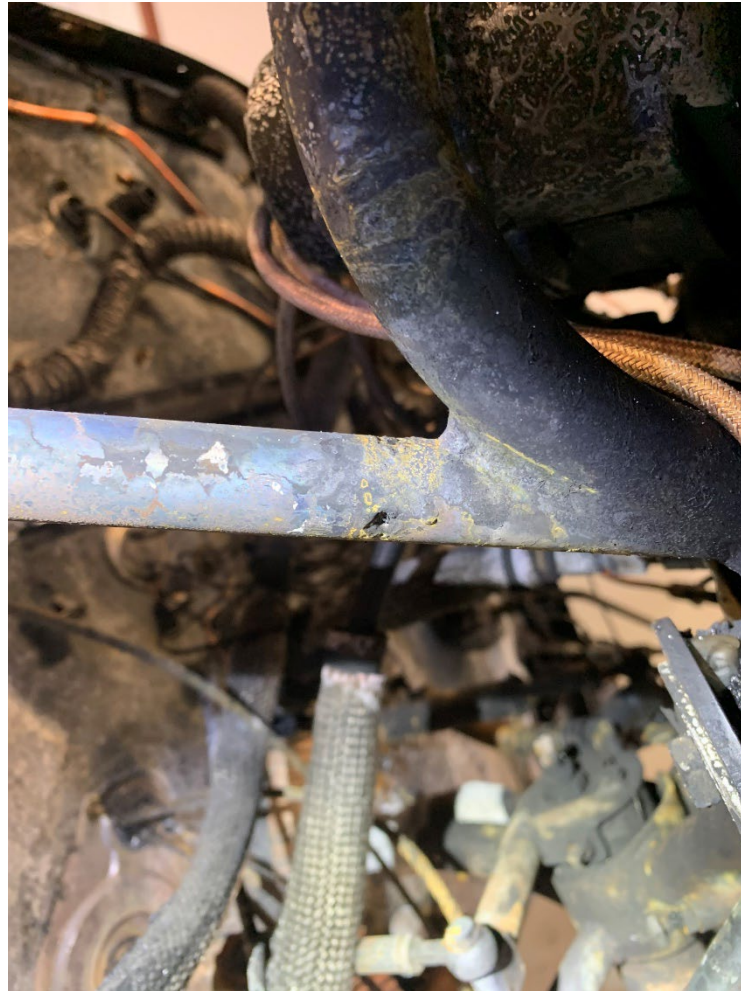
**Photograph 4 - View of engine mount electrical arc damage. (Courtesy of FAA)**
