## **NATIONAL TRANSPORTATION SAFETY BOARD**

Office of Aviation Safety  
Eastern Region

**Photo Array**

**ERA23LA076**

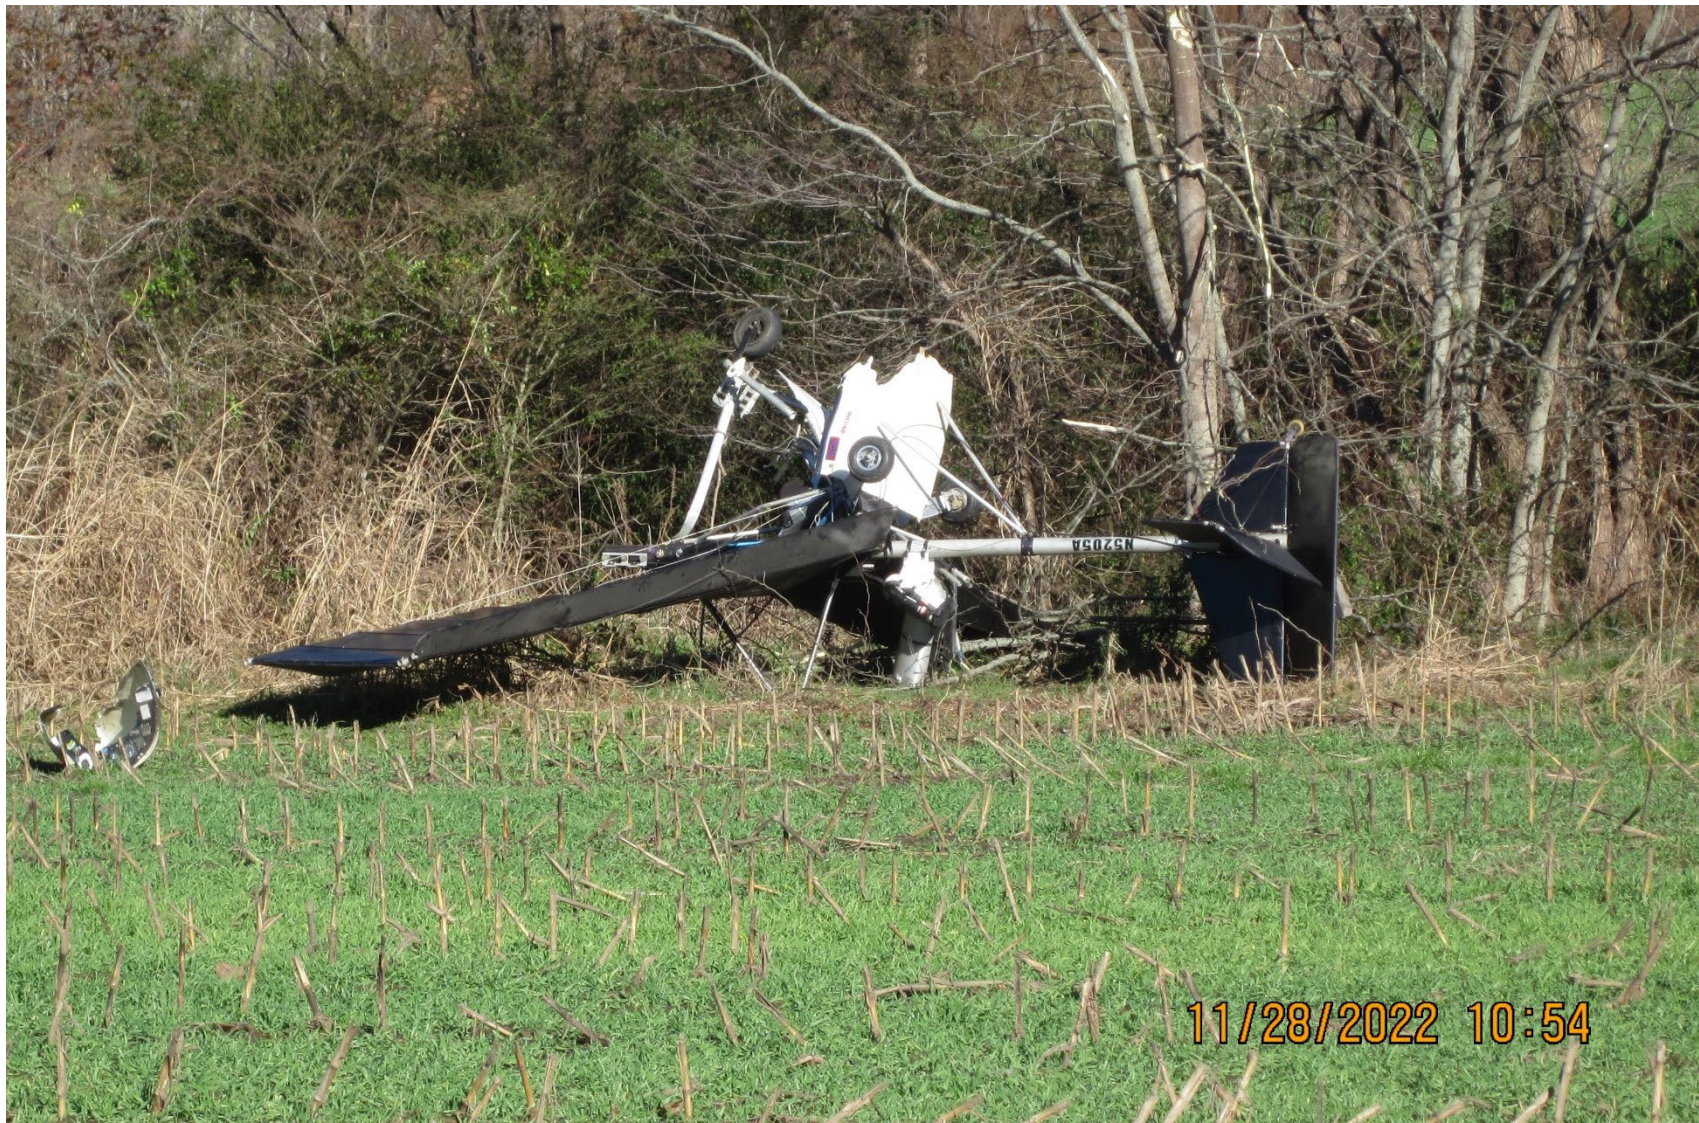
**Photo 1 – View of Ultralight at Accident Site – Note N-Number and Wreckage is Inverted (Courtesy of FAA)**

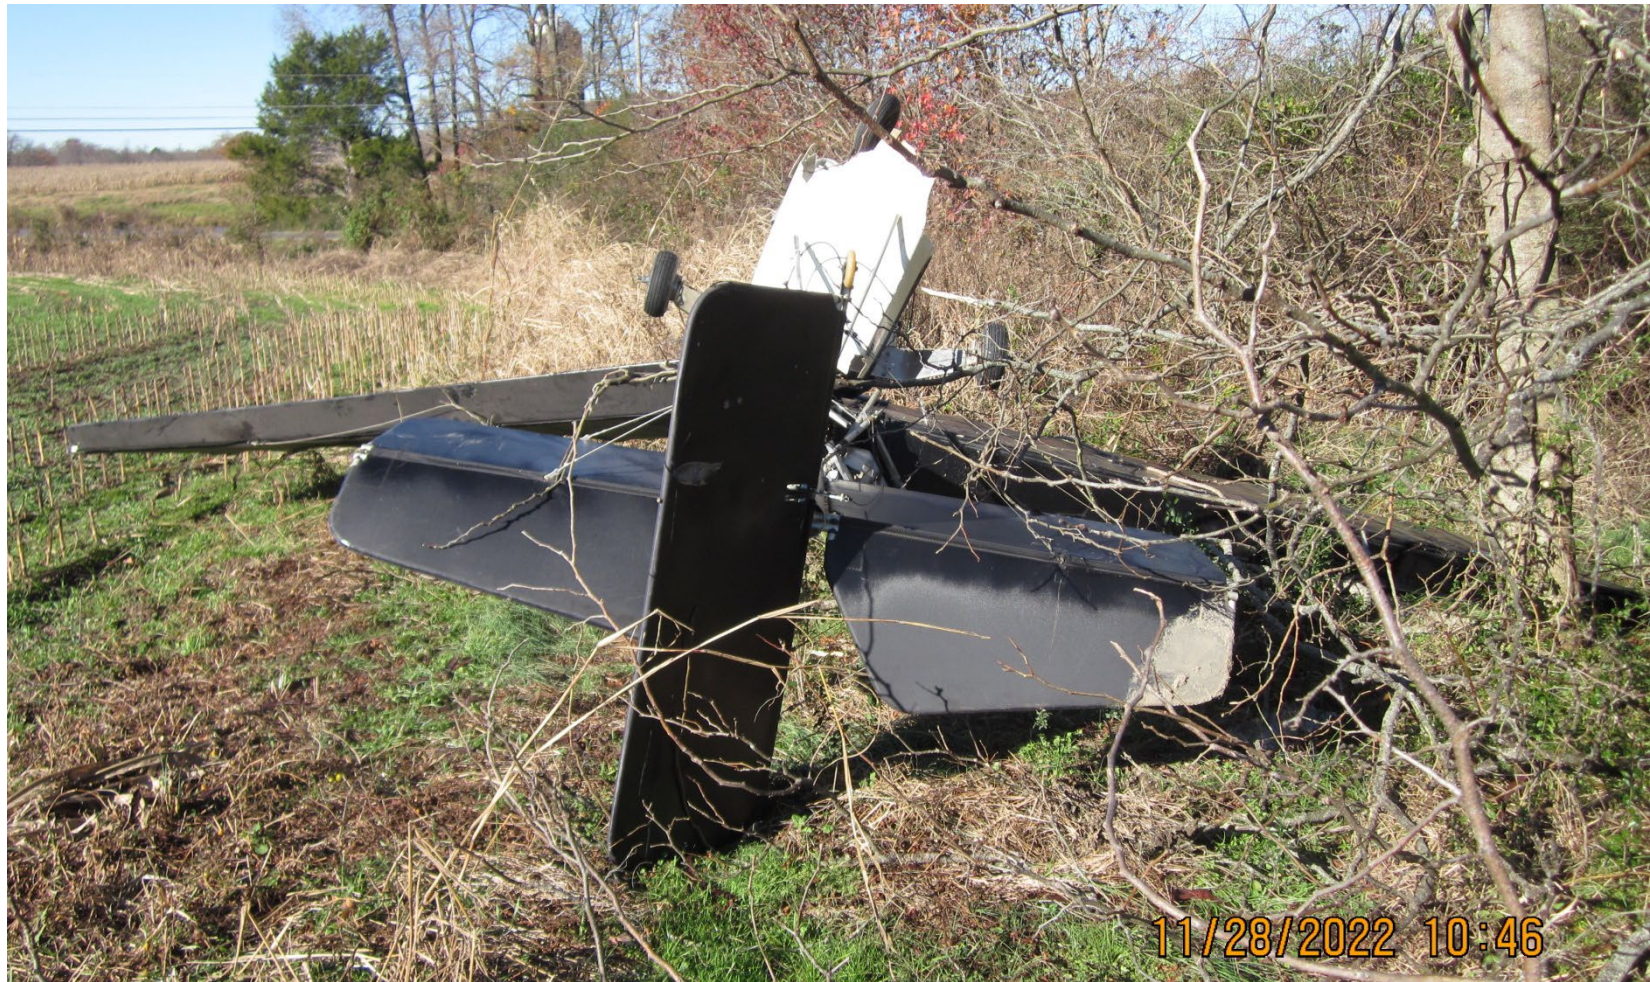
**Photo 2 – View of Ultralight from Rear (Courtesy of FAA)**

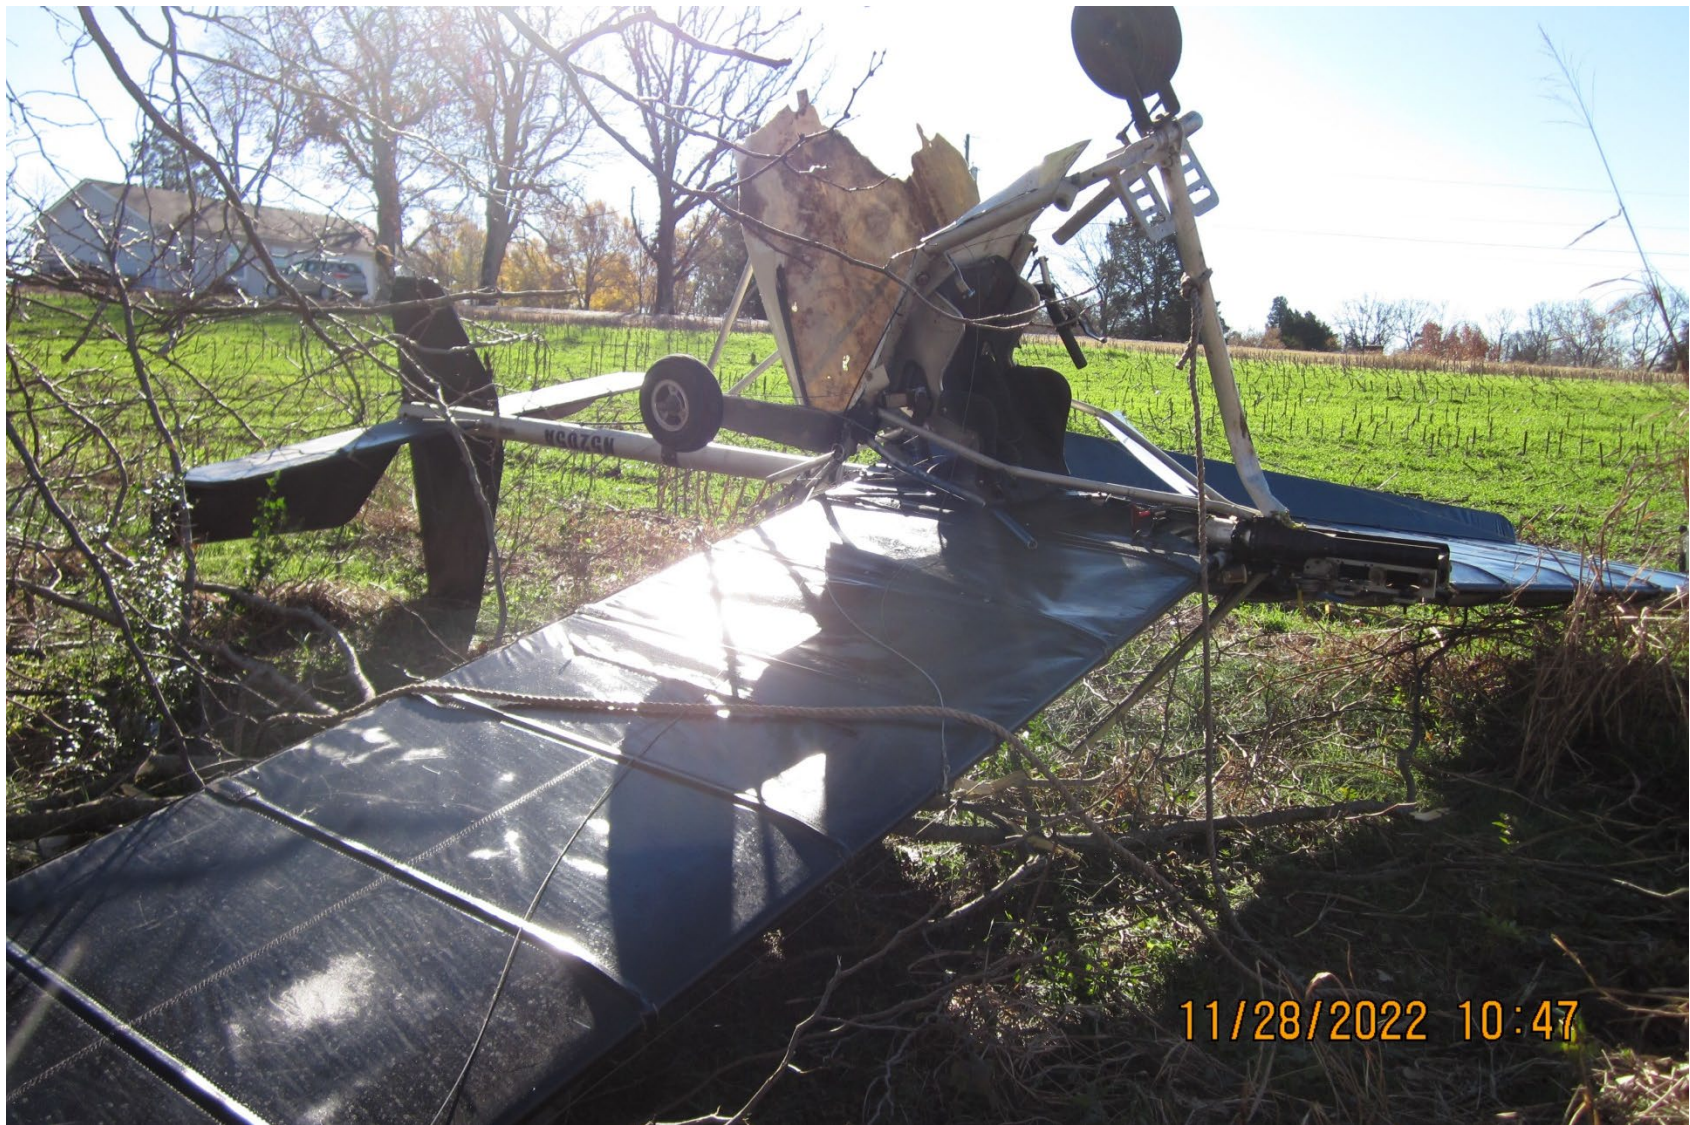
**Photo 3 – View of Ultralight’s Front Left Side – Note Ultralight is Inverted (Courtesy of FAA)**
