PIC description of incident involving 783SF at initial start-up in shade hanger (last space; third row). Preflight of aircraft was performed according to check list. No "abnormalities" other than passenger door was inoperative. The parking brake was checked and in the full set position. It was tested by rocking the aircraft gently during the external preflight. Before engine start check list was performed according to the check list; mixture full out & throttle in  $\sim 1/4 - 1/2$  inch. Prop area was cleared, Master switch & beacon light turned on. Feet were placed on the brake pedals – the parking brake was NOT released. The ignition switch was turned and as the engine "caught" the mixture was moved to full rich. It was at this time the airplane jumped forward and pivoted to the left with the left wing striking the vertical support (over – refers to back of page)

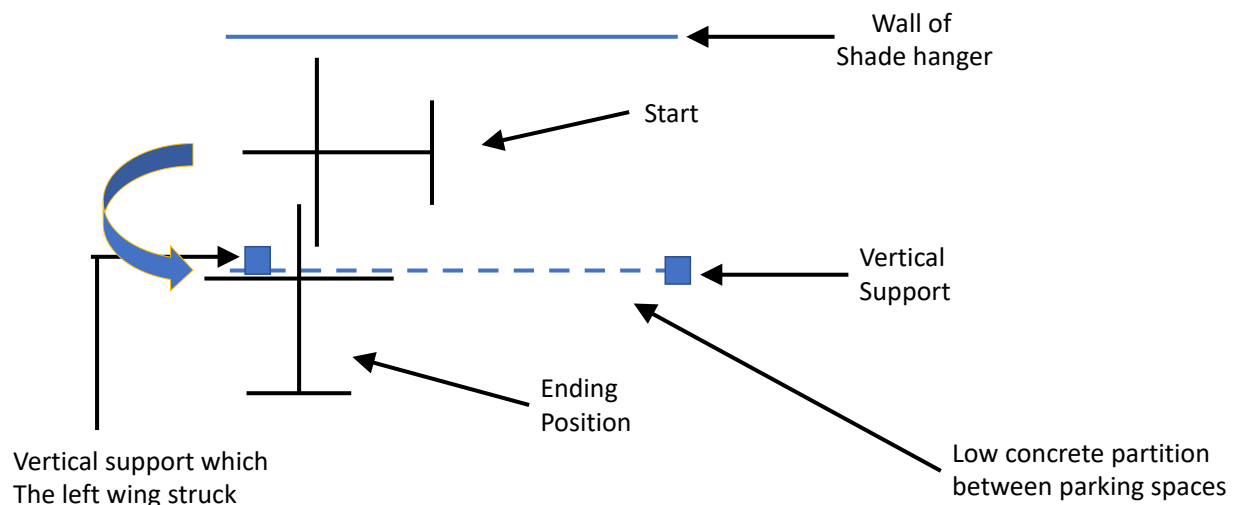
of the shade hanger. [the word Before is crossed out] Before I could react fully the airplane continued to turn/pivot to the left around the support into the adjoining parking slot. (See diagram).

As the plane pivoted I applied manual brake pressure "equally" on both pedals. The airplane was stopped by pulling the 1) throttle to idle 2) mixture to full lean. The entire incident occurred over a 3-4 second period. The parking brake was never released. Individuals from the FBO came over and contacted "o the" [other?] parties. The airplane was not removed or moved while I was present.
