## **NATIONAL TRANSPORTATION SAFETY BOARD**

# **EXAMINATION SUMMARY**

**ERA23LA097**

Location: Athens, Georgia  
Date: December 29, 2022  
Time: 1327 EST  
Airplane: Piper PA-24-260, N9026P

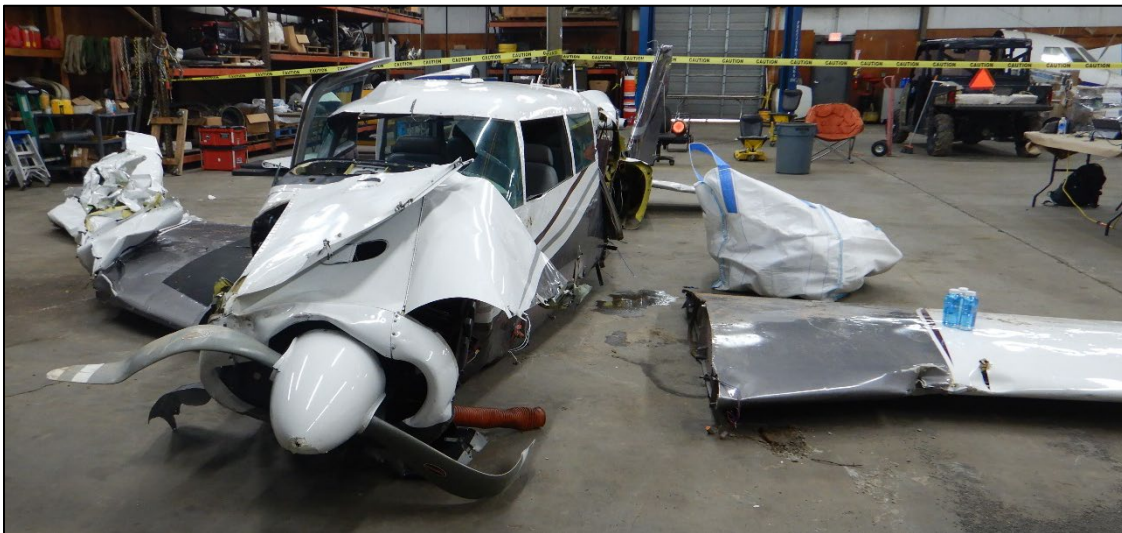
*Photo 1- View of airplane from front before examination*

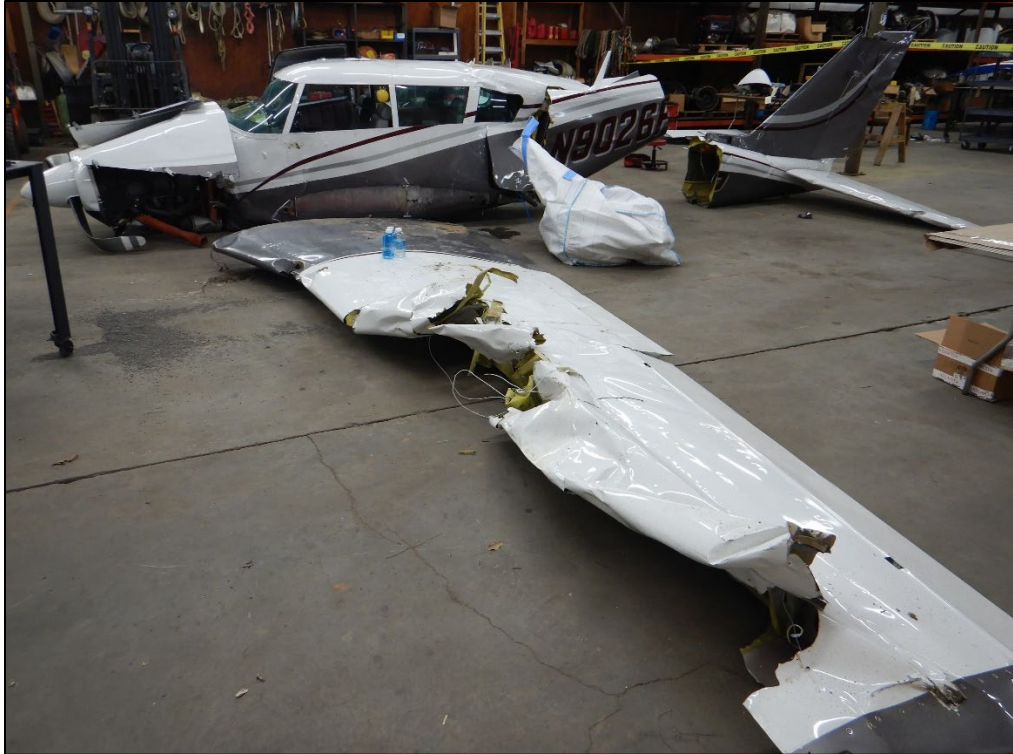
*Photo 2 - View of airplane from left wing before examination*

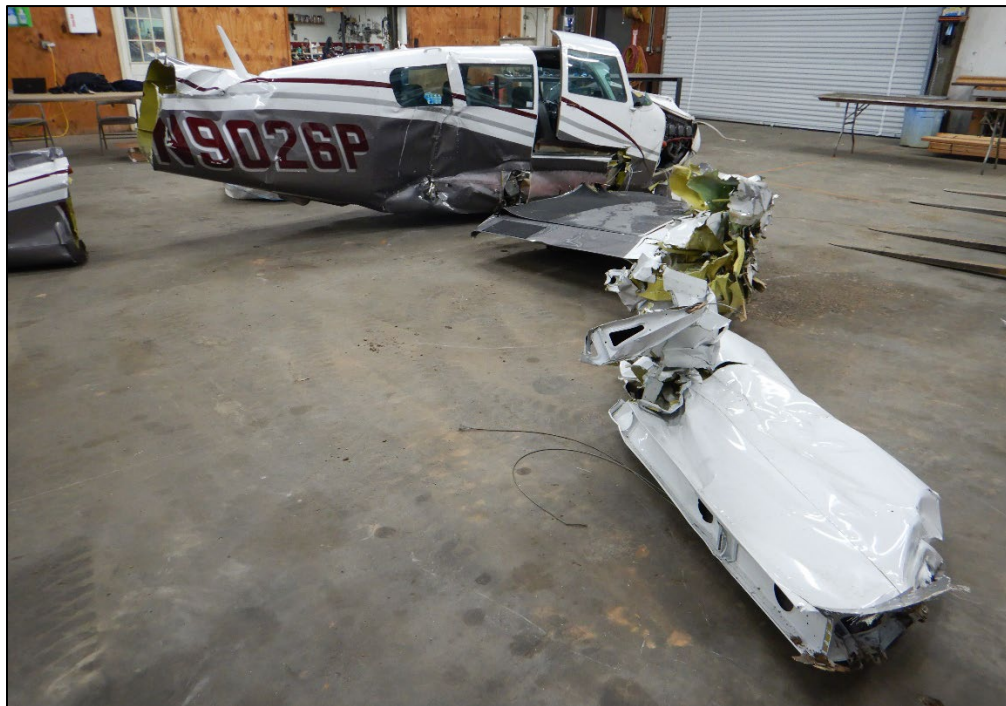
*Photo 3 - View of airplane from right wing before examination*

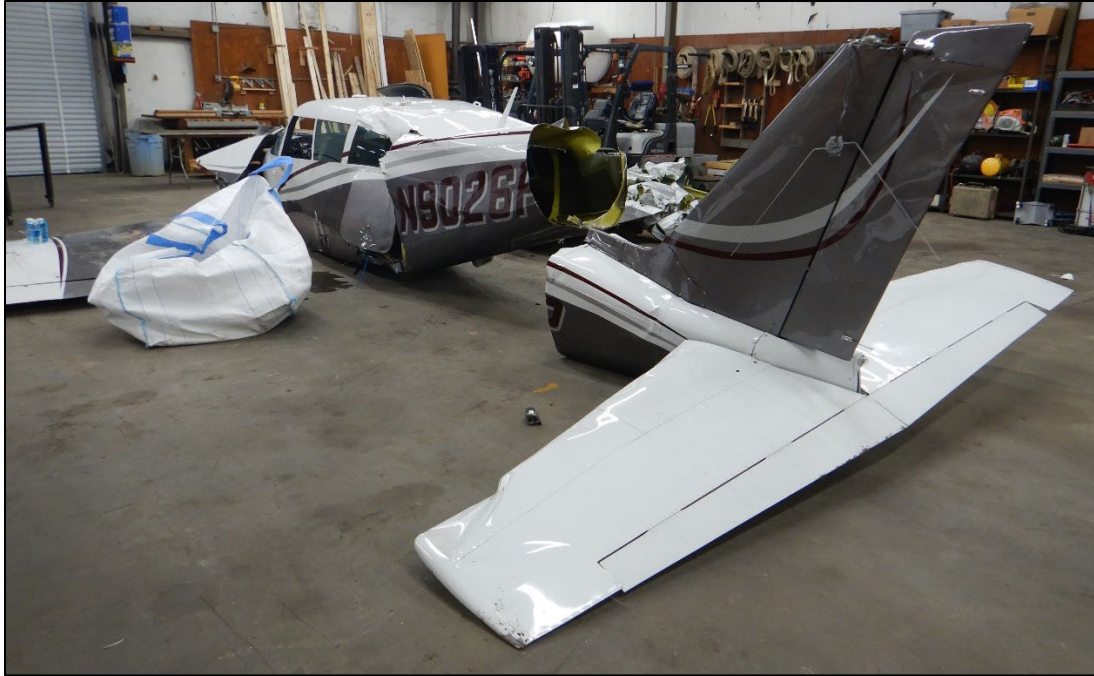
*Photo 4 - View of airplane from left rear before examination*

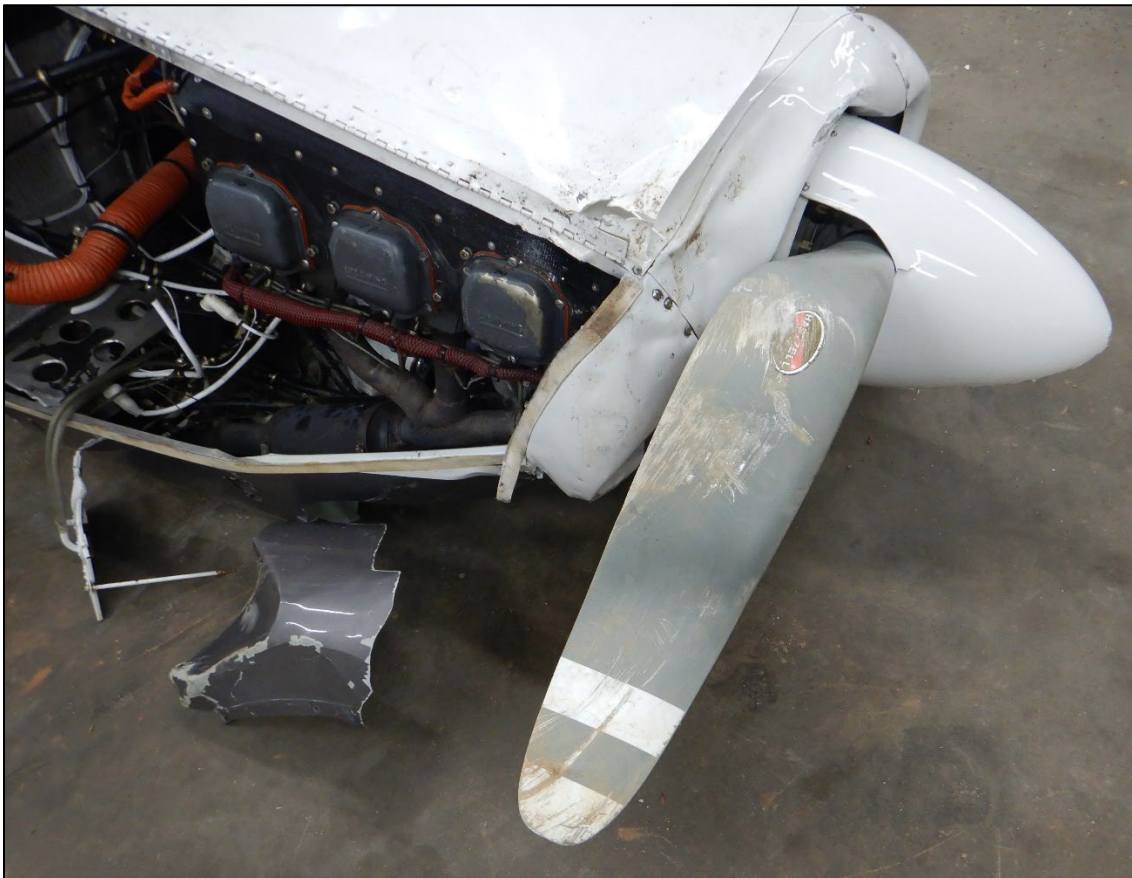
*Photo 5 - View of engine and propeller before examination*

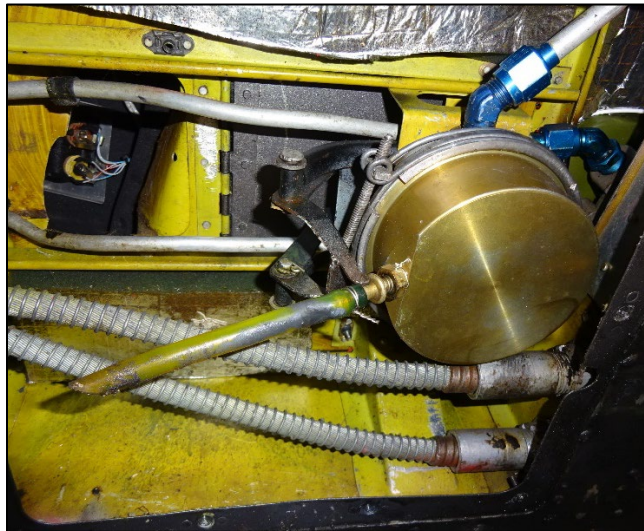
operational in all positions. Fuel and water were observed in the fuel gascolator bowl. Debris was observed in the fuel gascolator filter. Low pressure air was used to check all fuel lines from the fire wall to the 4 bladder fuel tanks, no obstructions were noted.

*Photo 6 - View of gascolator in airplane belly below flight selector*

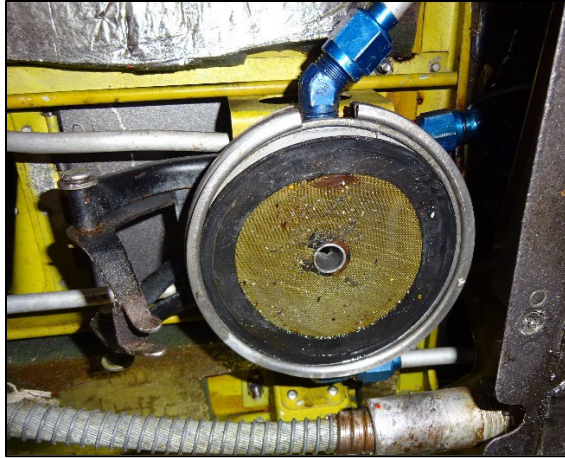
*Photo 7 - View of gascolator filter with debris*

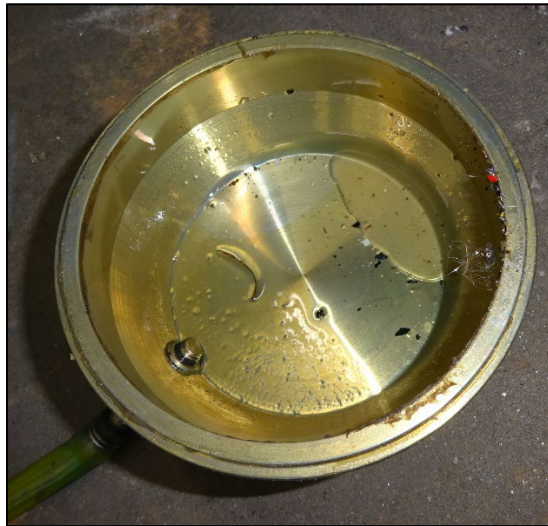
*Photo 8 - View of gascolator bowl before testing*

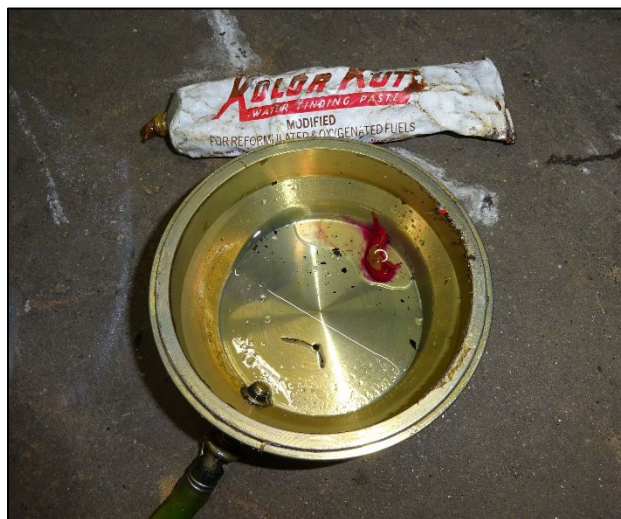
*Photo 9 - View of gascolator bowl with red water-finding paste*

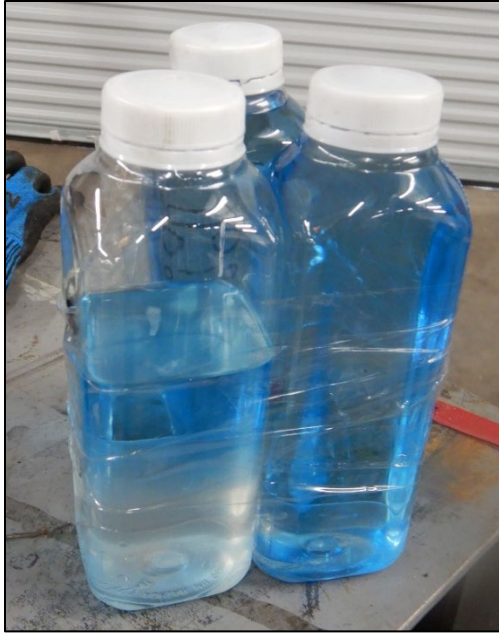
*Photo 10 - View of recovered fuel with water present*

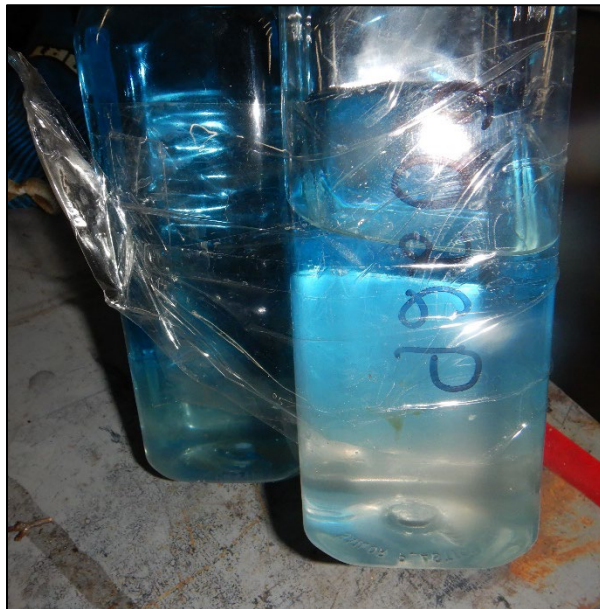
*Photo 11 - Close-up view of water in fuel*

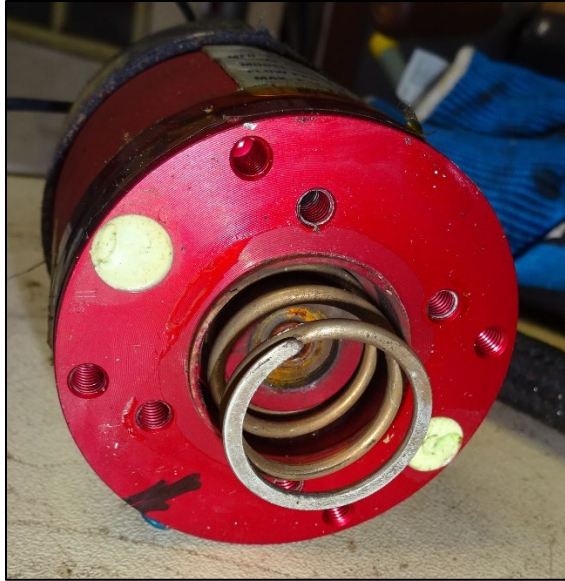
The electrical fuel pump was field tested with DC power source and would not operate. Rust was noted on the shaft bearing. The fuel pump was stuck and could not be rotated by hand.

*Photo 12 - Electric fuel pump with corrosion evident*

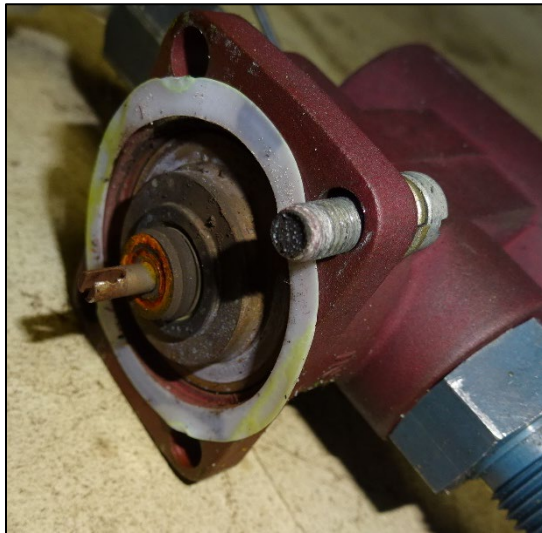
*Photo 13 - Electric fuel pump attachment fitting with corrosion*

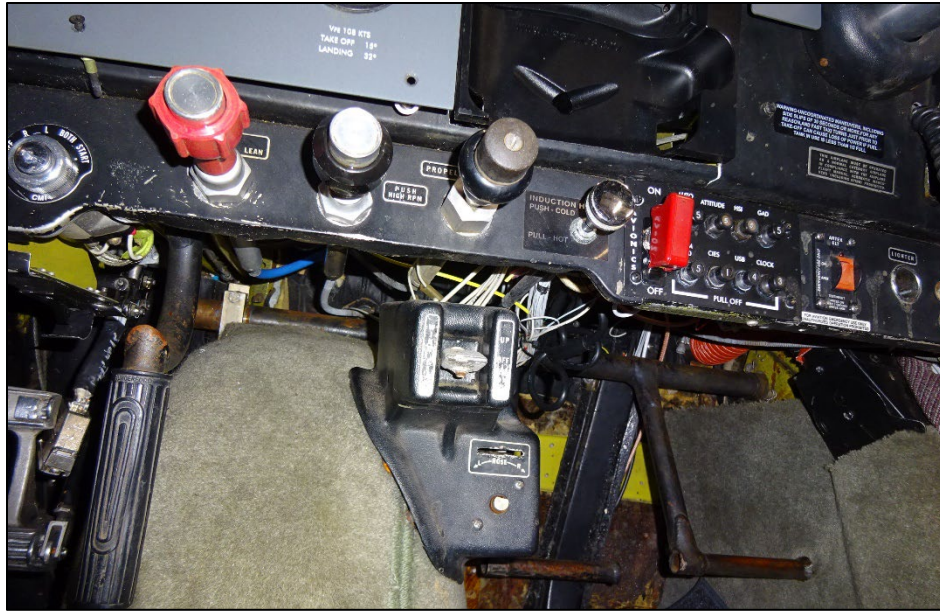
The flight control levers indicated: Throttle, full forward; propeller, full forward; mixture, full forward.

*Photo 14 - View of flight controls*

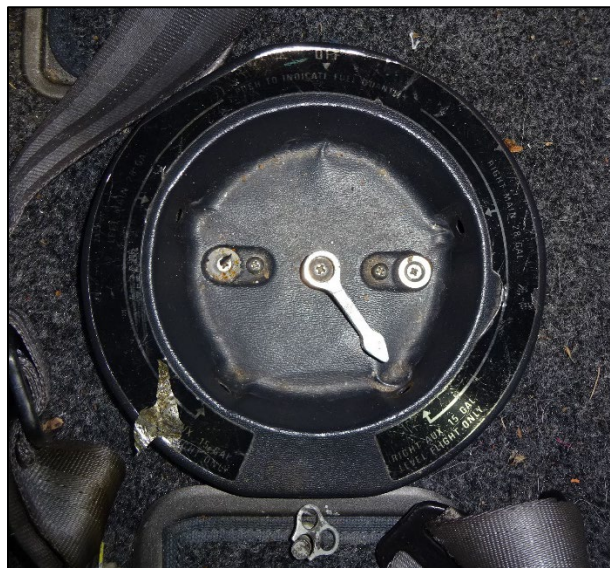
The fuel selector handle was found in the right aux position. The fuel selector valve was in the right aux fuel tank position. Fuel selector valve was field tested with low pressure air and was

*Photo 15 - View of fuel selector selected to right aux tank*

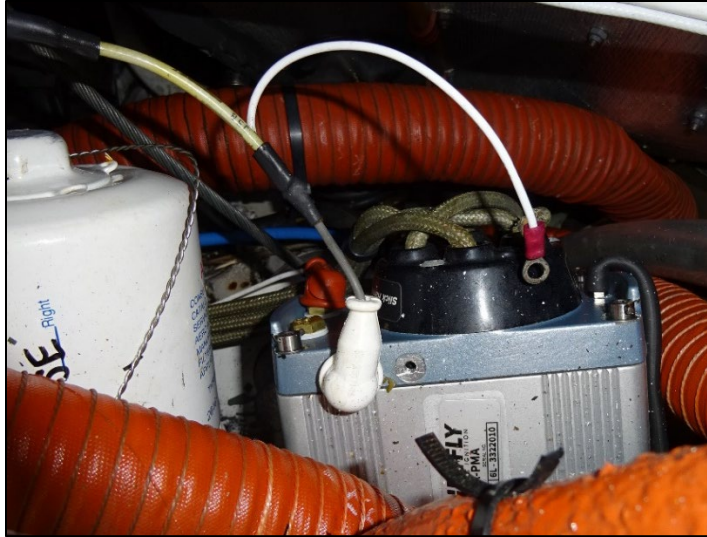
*Photo 16 - View of left magneto ground strap disconnected from the magneto*

Both magnetos remained attached to the engine and no external damage was noted. The left magneto “P” lead shield ground was observed not attached to the magneto. When the left magneto was removed and connected to a 12-volt power supply, sparks were observed from all ignition towers when rotated using an electric drill. The right magneto was removed and produced spark from all ignition towers when rotated using an electric drill. The spark plugs exhibited gray coloration and worn normal condition. The ignition harness was impact damaged.

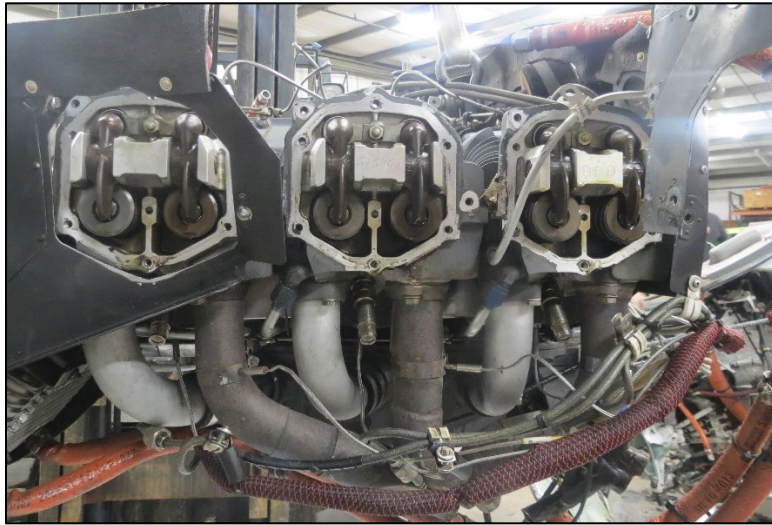
*Photo 17 - Cylinder Nos 2, 4, and 6 with rocker covers removed*

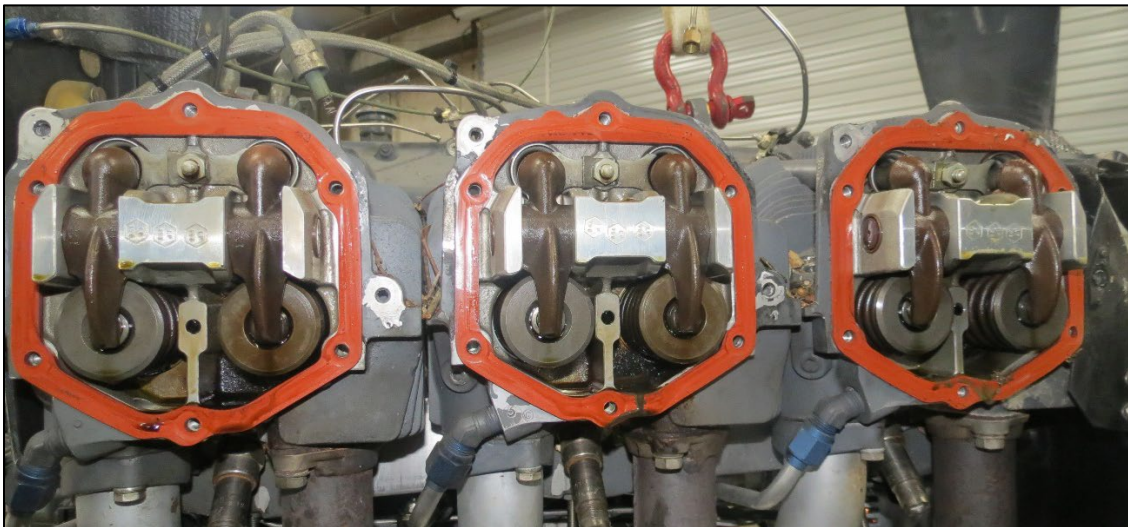
*Photo 18 - Cylinder Nos 1, 3, and 5 with rocker covers removed*

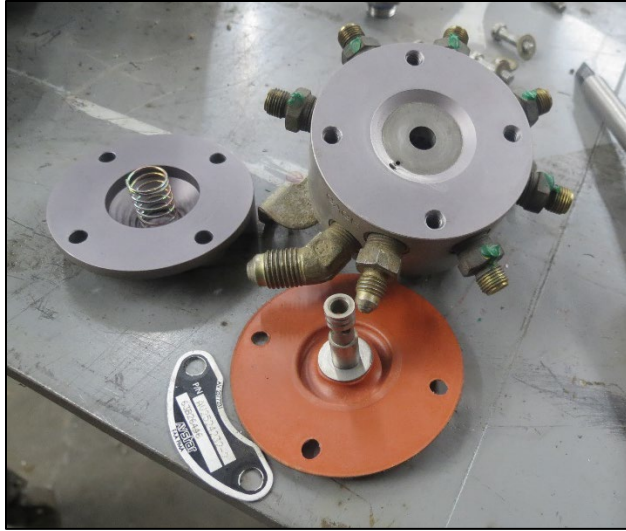
The fuel flow divider remained attached to the engine and no damage was noted. The steel injector lines were secure. The flow divider was partially disassembled and no damage to the rubber diaphragm or other internal components was noted. The fuel injector nozzles were unobstructed.

*Photo 19 - Fuel flow divider after examination*

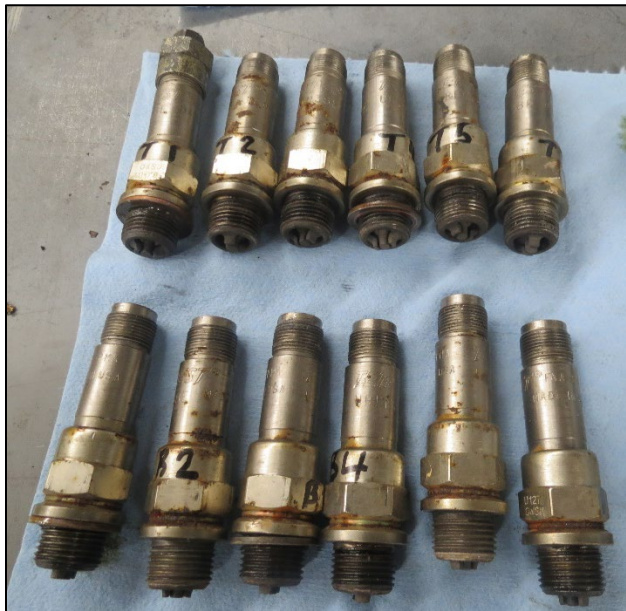
*Photo 20 - Spark plugs*

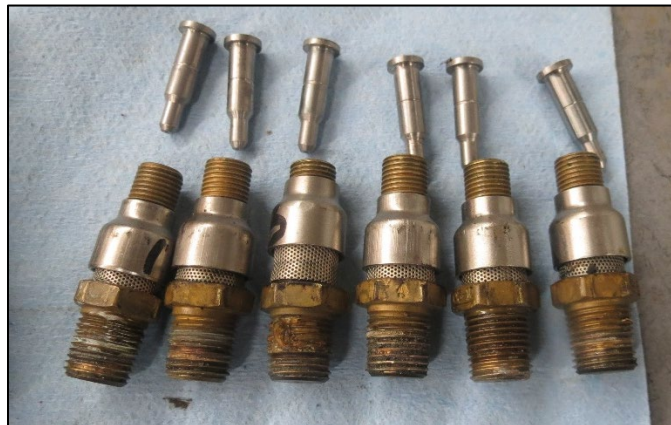
*Photo 21 - Fuel injectors*

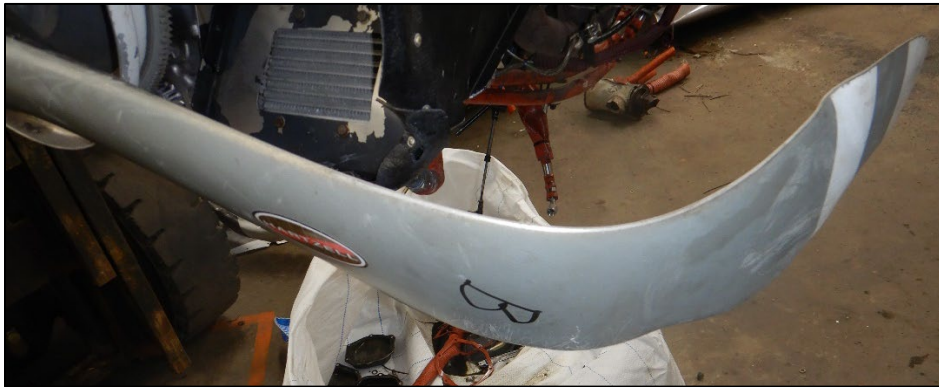
*Photo 22 - View of propeller blade "B"*

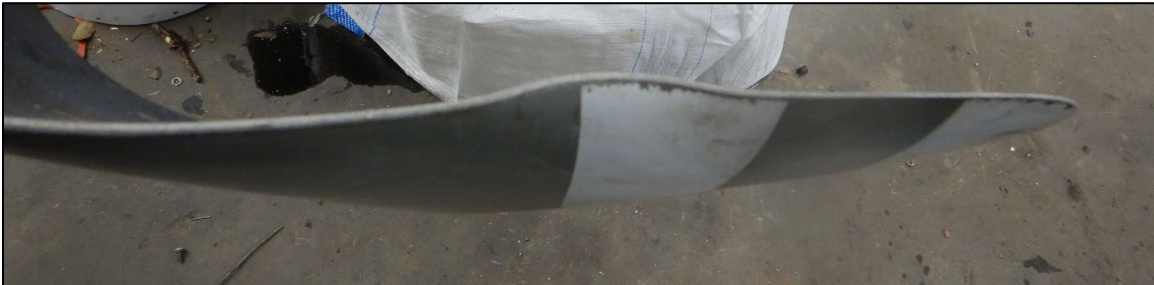
*Photo 23- View of deformation of the outermost portion of propeller blade "B"*

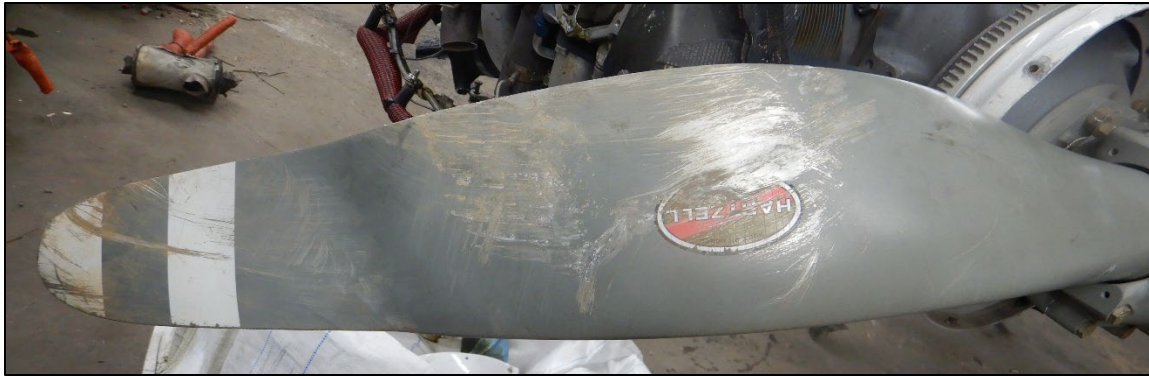
The propeller remained attached to the engine crankshaft flange. The propeller spinner remained attached to the propeller. The spinner tip was impact damaged. The propeller blade marked "A" was free to rotate in the hub. That blade was bent aft about 60 degrees at about 16 inches out board of the hub and bent forward about 30 degrees at about 8 inches inboard of the tip. The blade marked "A" was bent aft about 90 degrees at about  $\frac{3}{4}$  span. The propeller governor remained attached to the engine and no damage was noted. The propeller control cable remained attached to the governor control arm and the arm was positioned at the full increase RPM stop. The cockpit throttle control was positioned fully forward. The governor was removed and the governor oil screen observed absent of debris. The governor drive spline was rotated freely by hand.

*Photo 24 - View of propeller blade "A"*

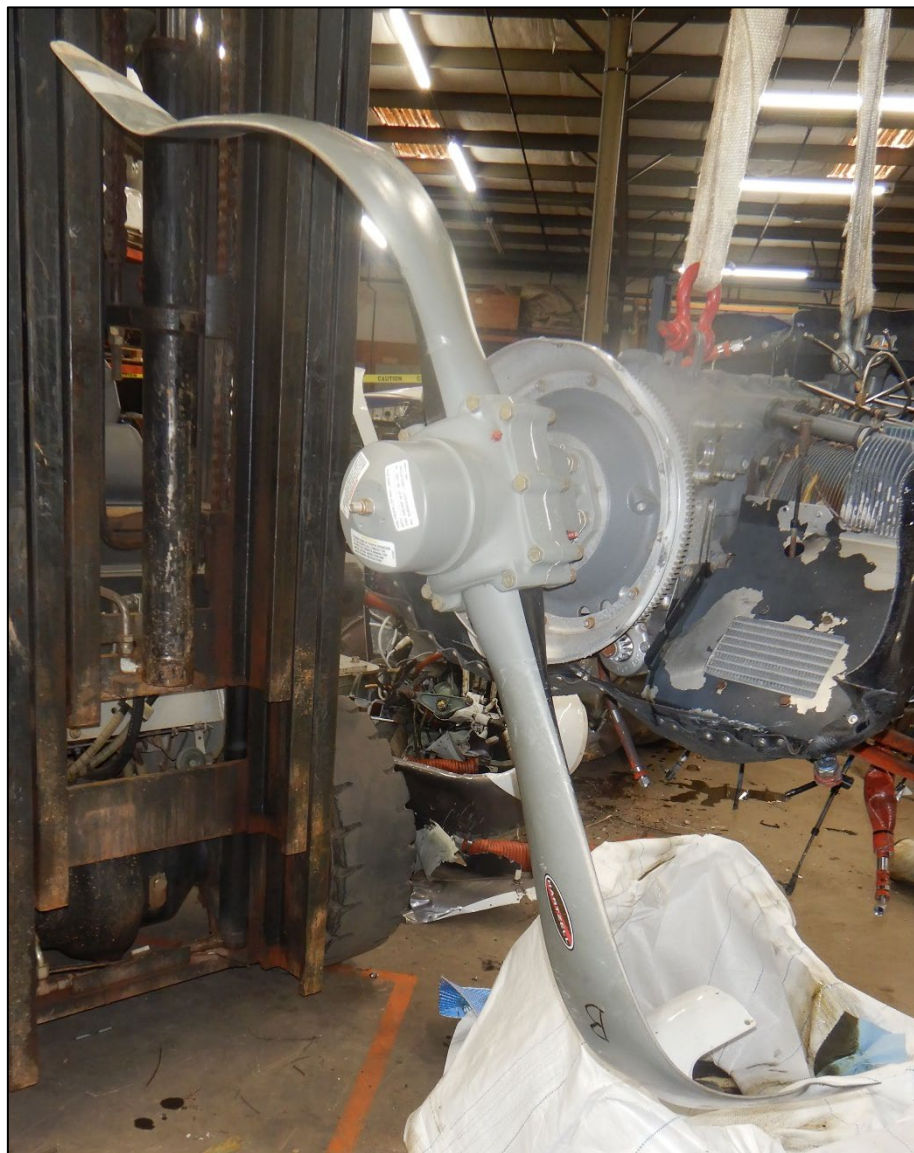
*Photo 25 - Photo of propeller with blades attached*
