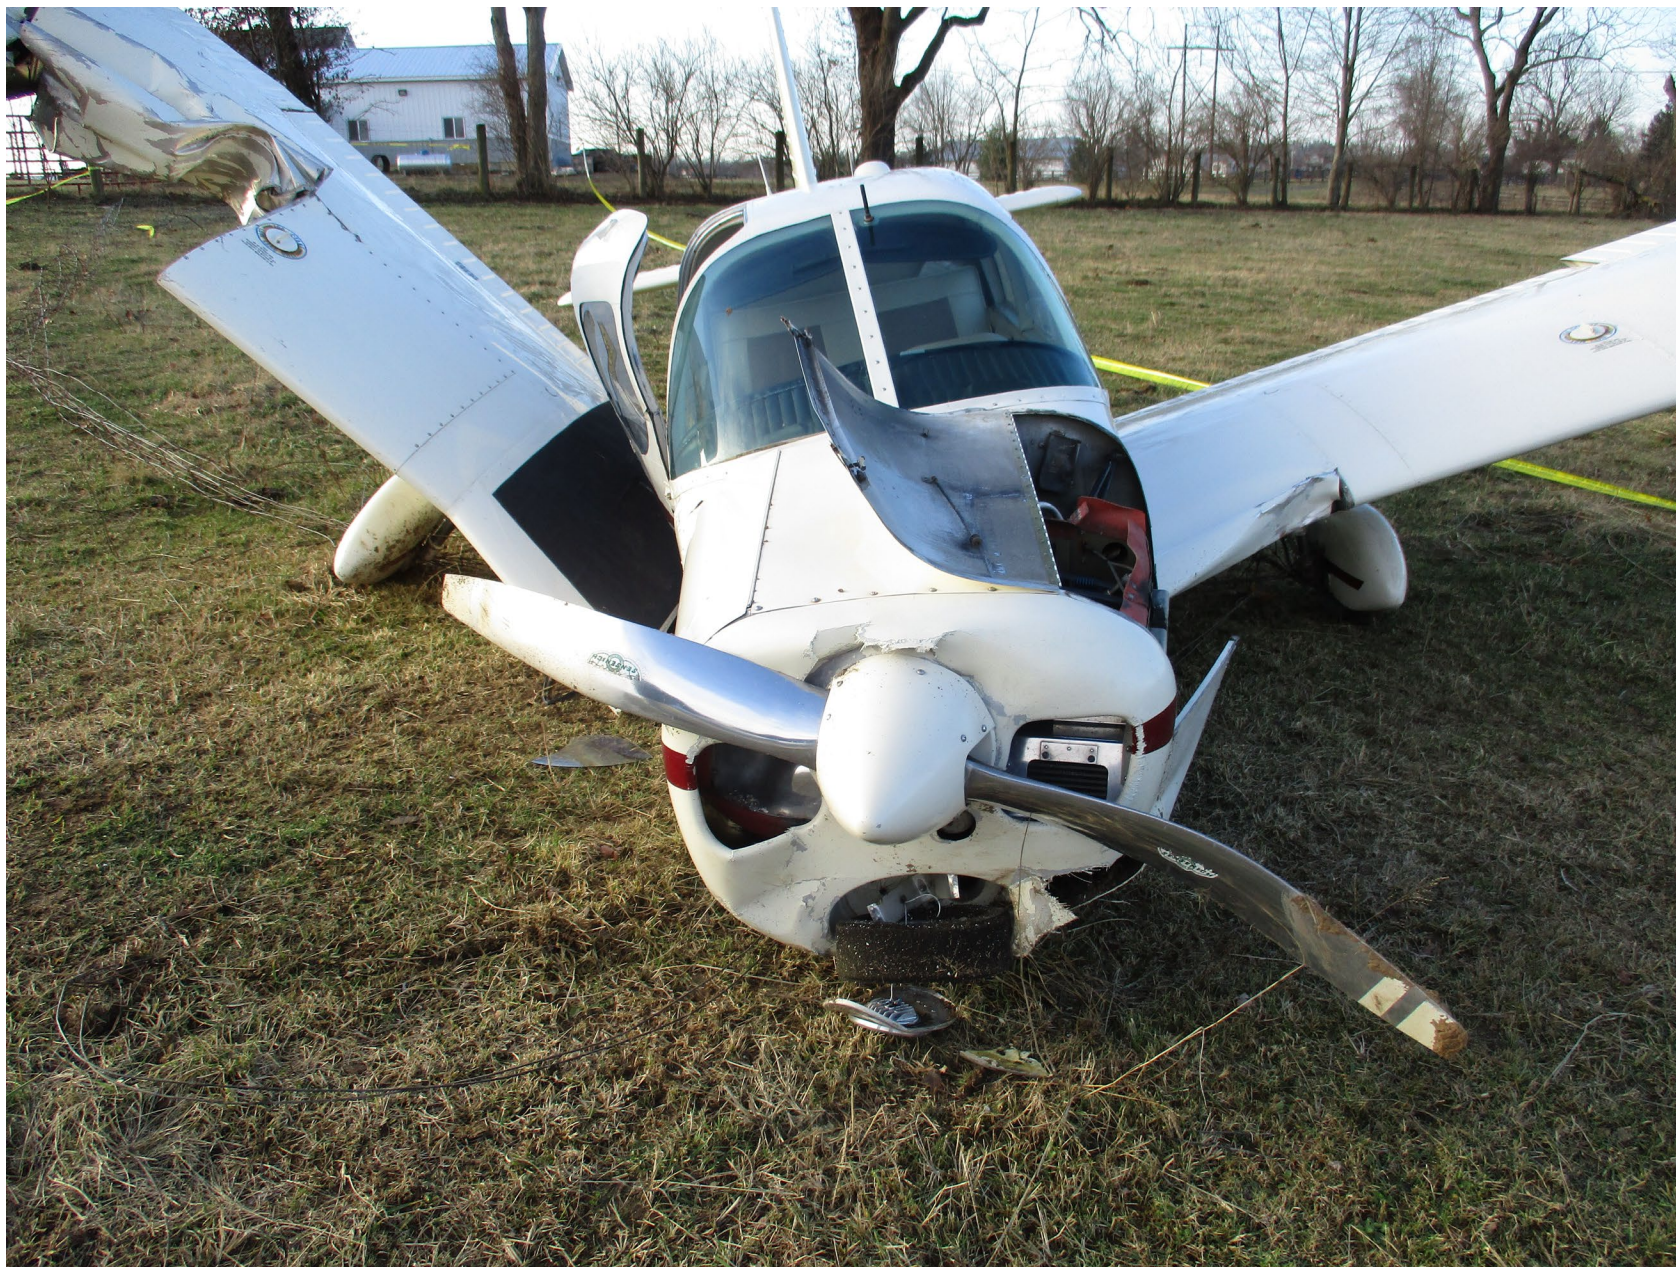
**Photo 1 – View of airplane from the front showing damage to engine cowling (FAA Photo)**

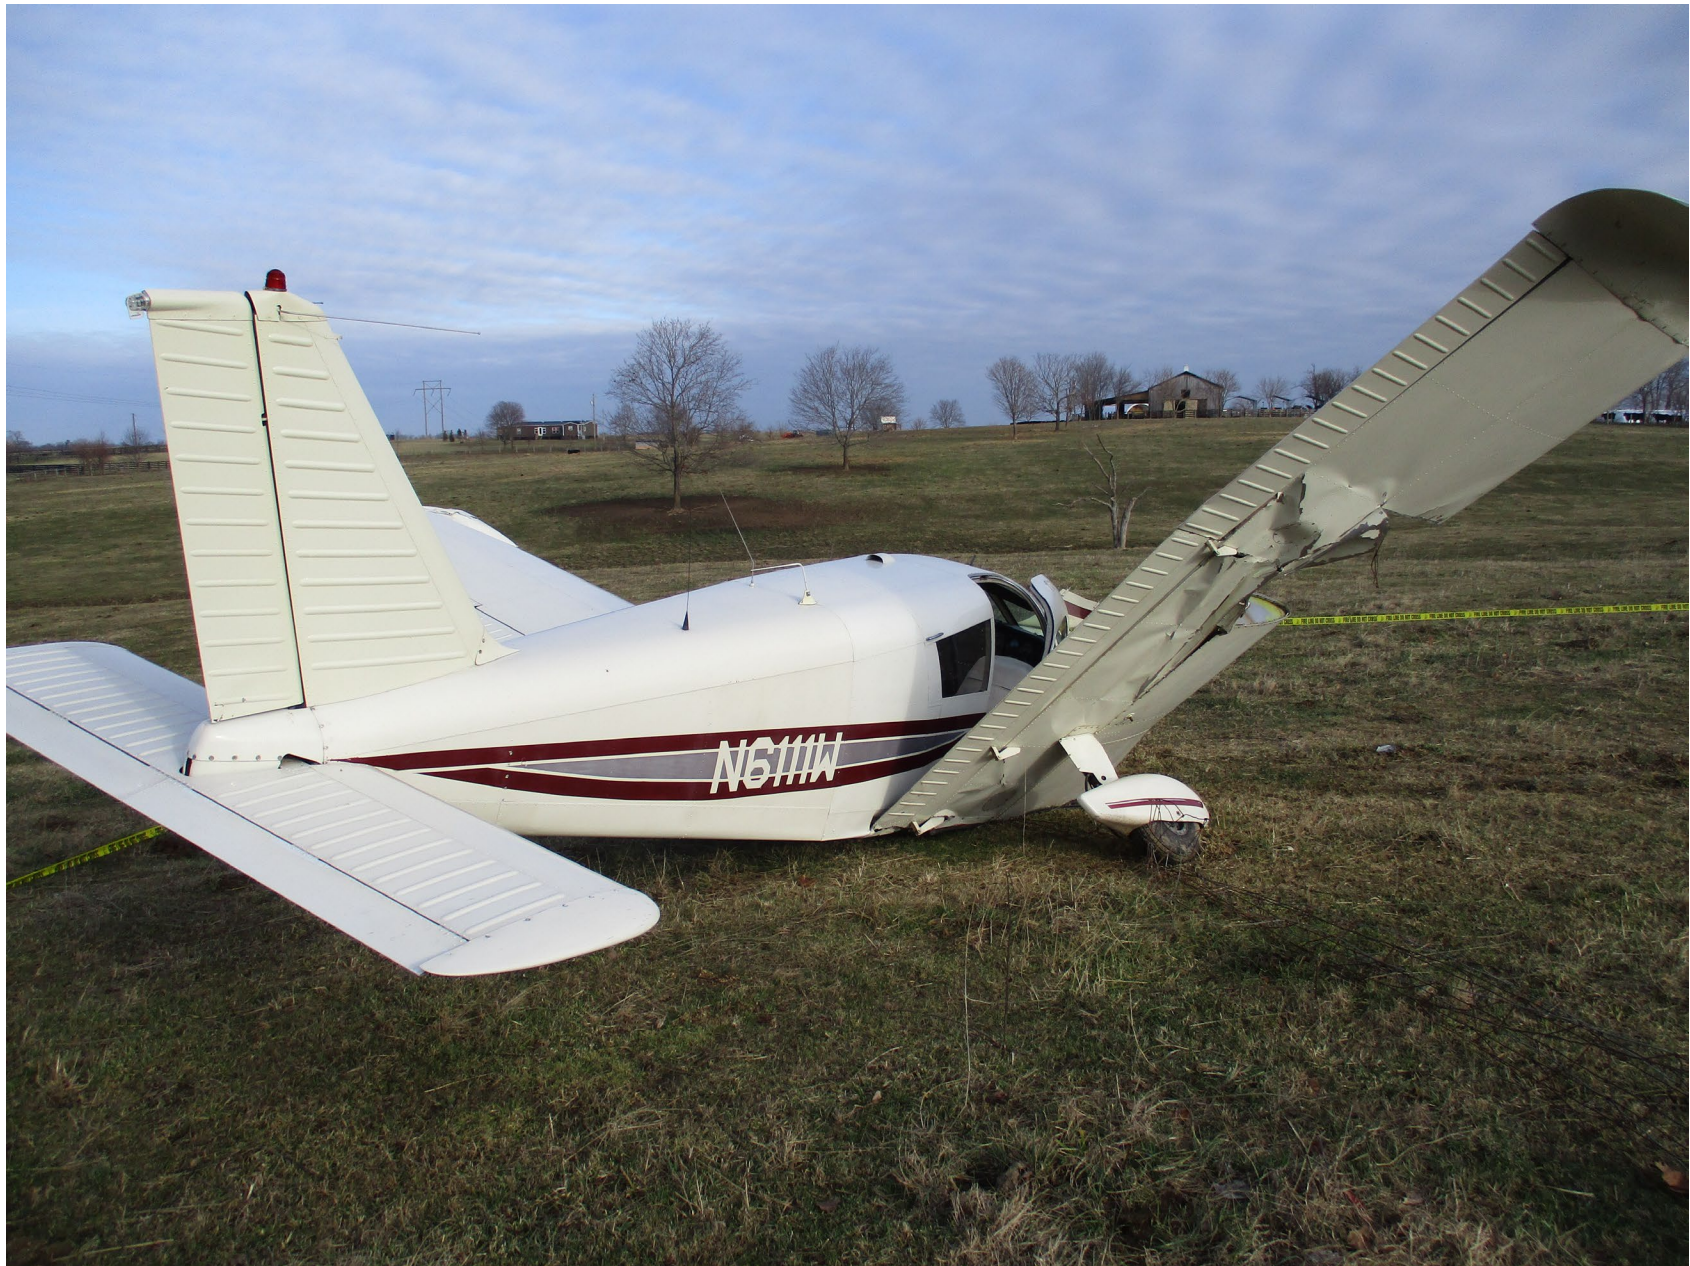
**Photo 2 – View of airplane from right side showing damage to right wing (FAA Photo)**
