RT WS 187.55

Cape Air

Cessna 402C

N26407

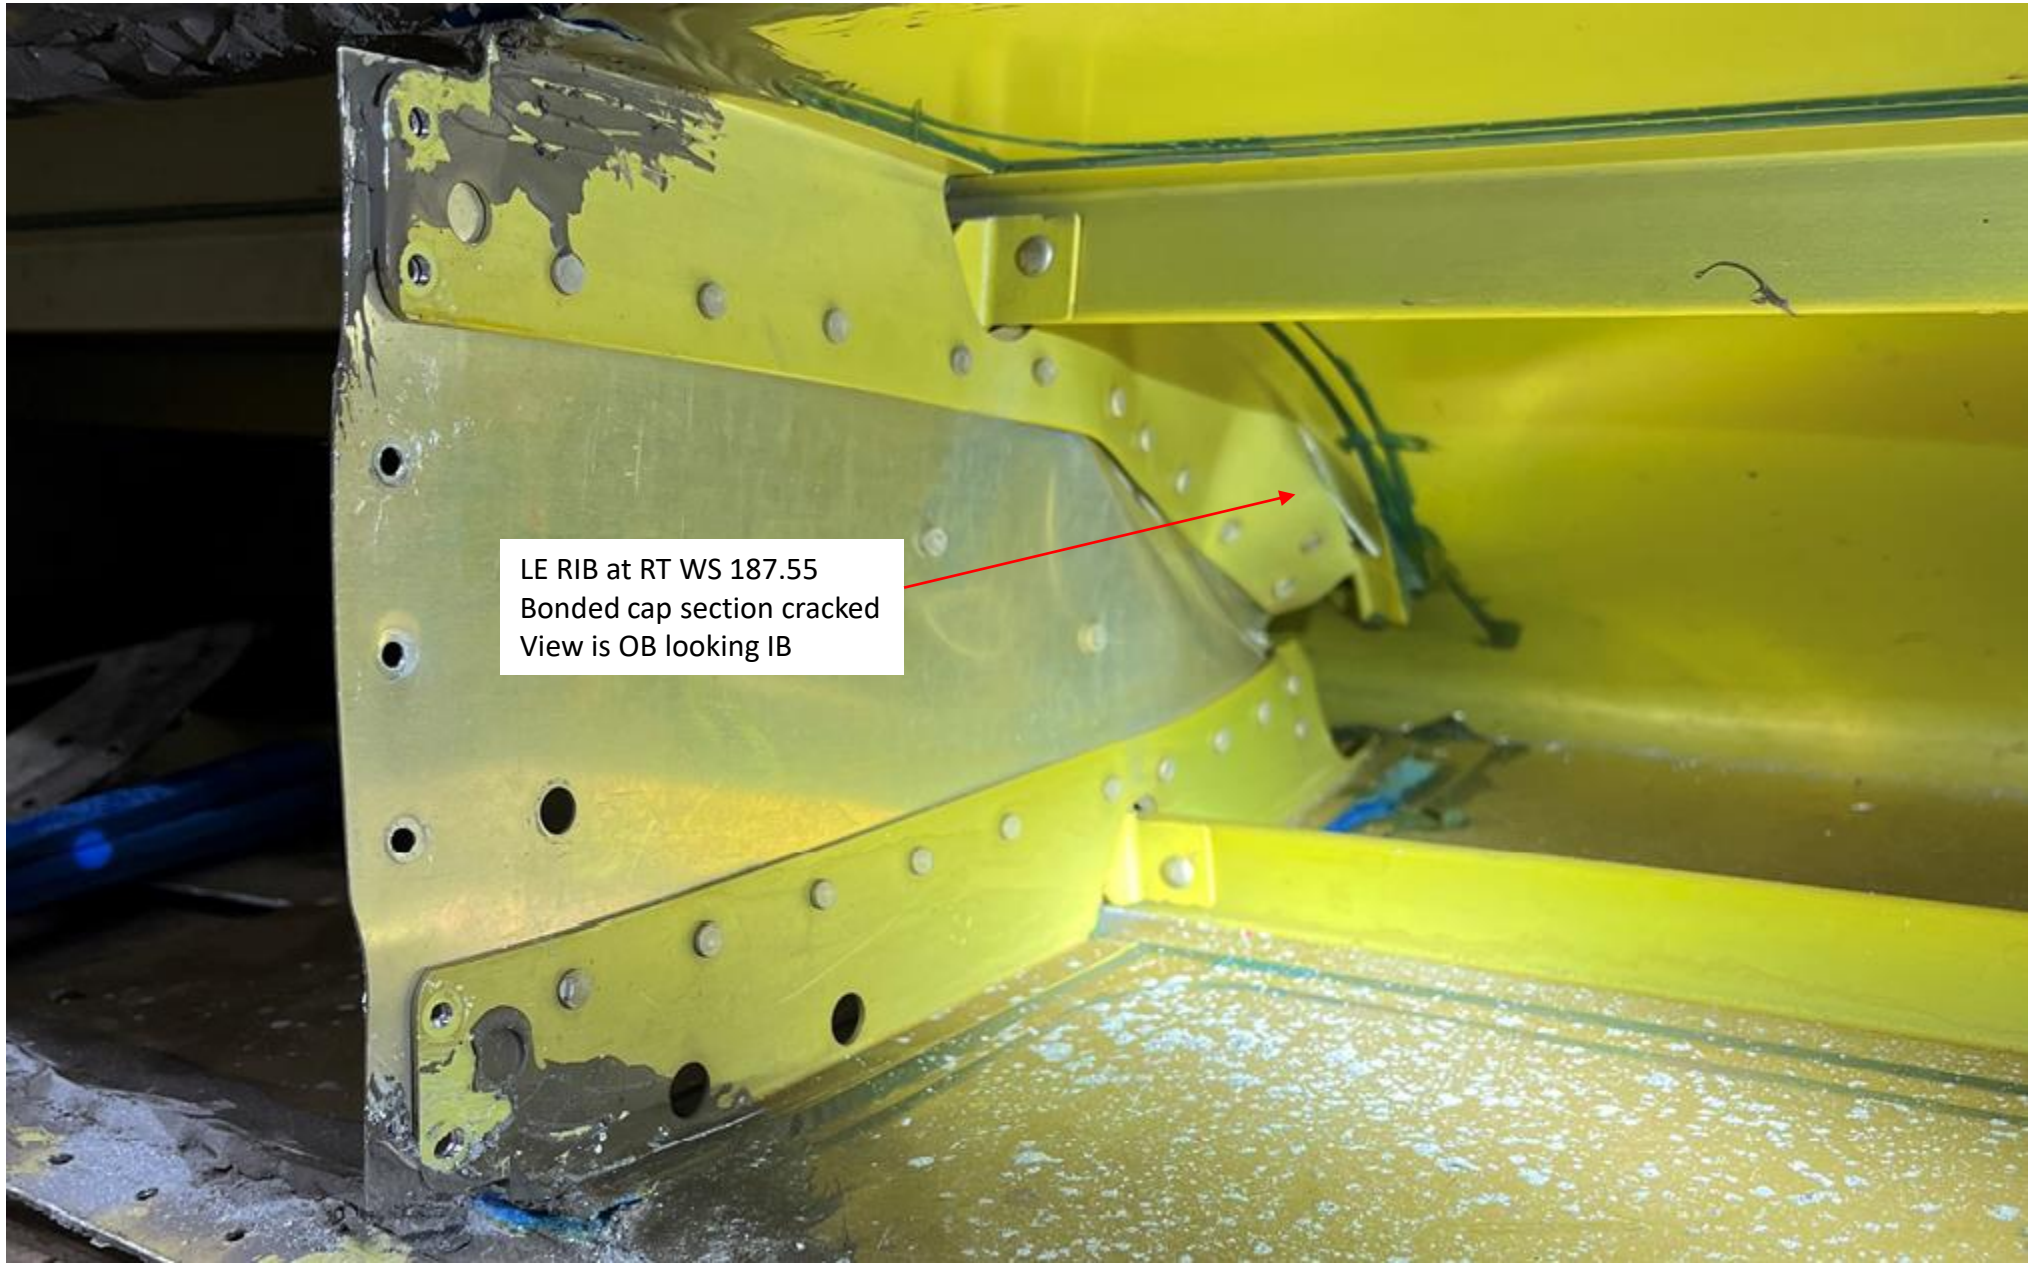
LE RIB at RT WS 187.55  
Bonded cap section cracked  
View is OB looking IB

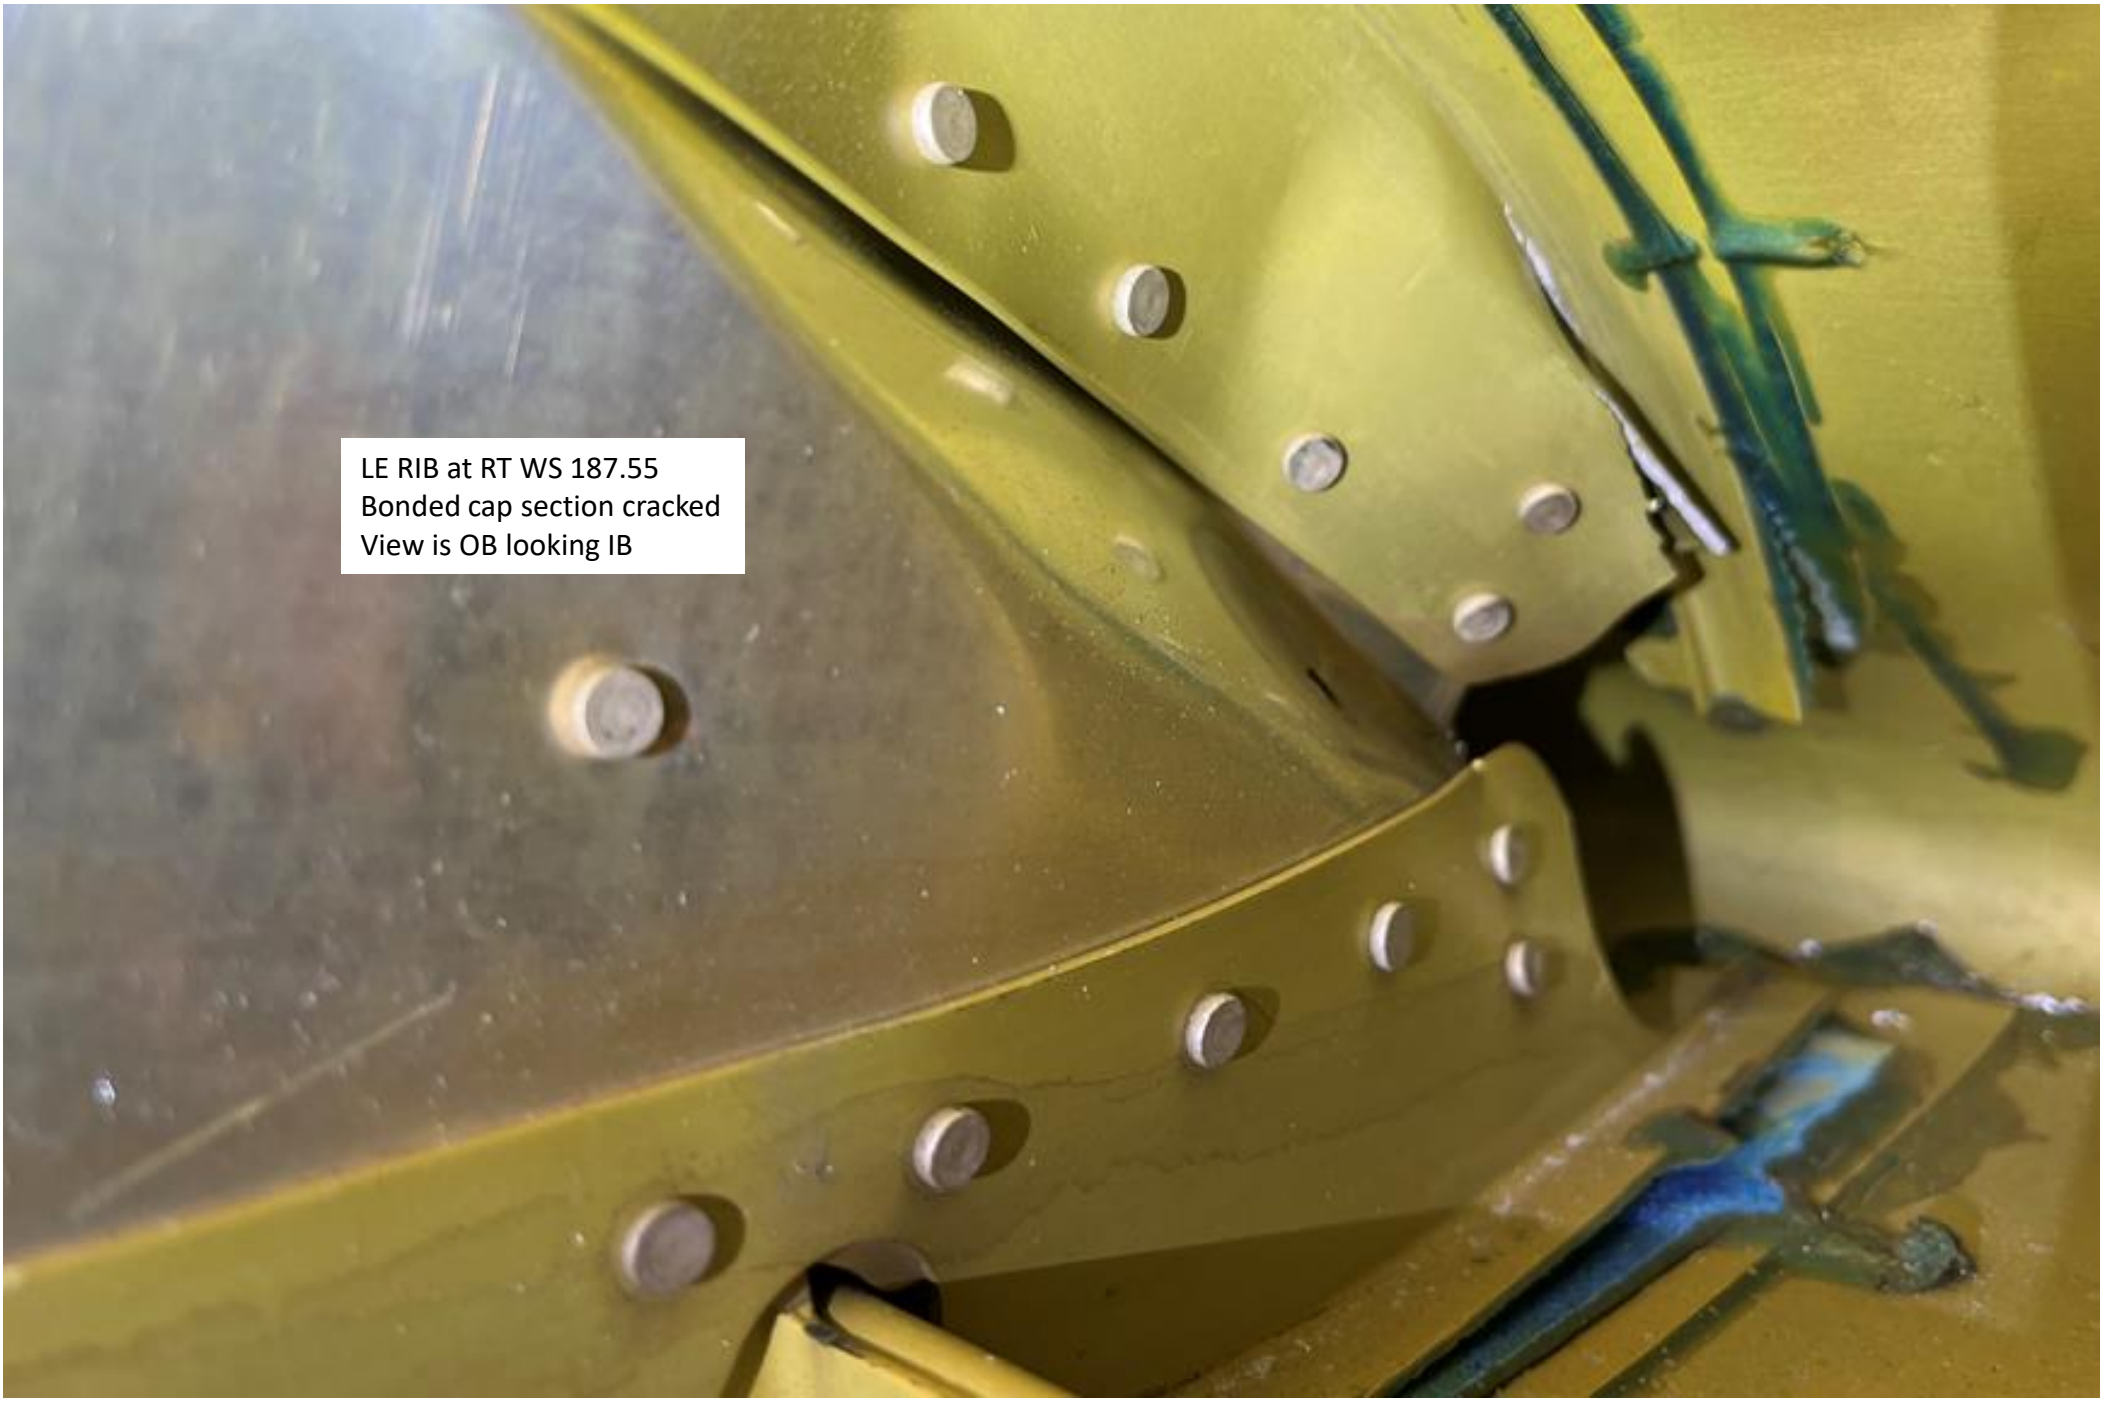
LE RIB at RT WS 187.55  
Bonded cap section cracked  
View is OB looking IB

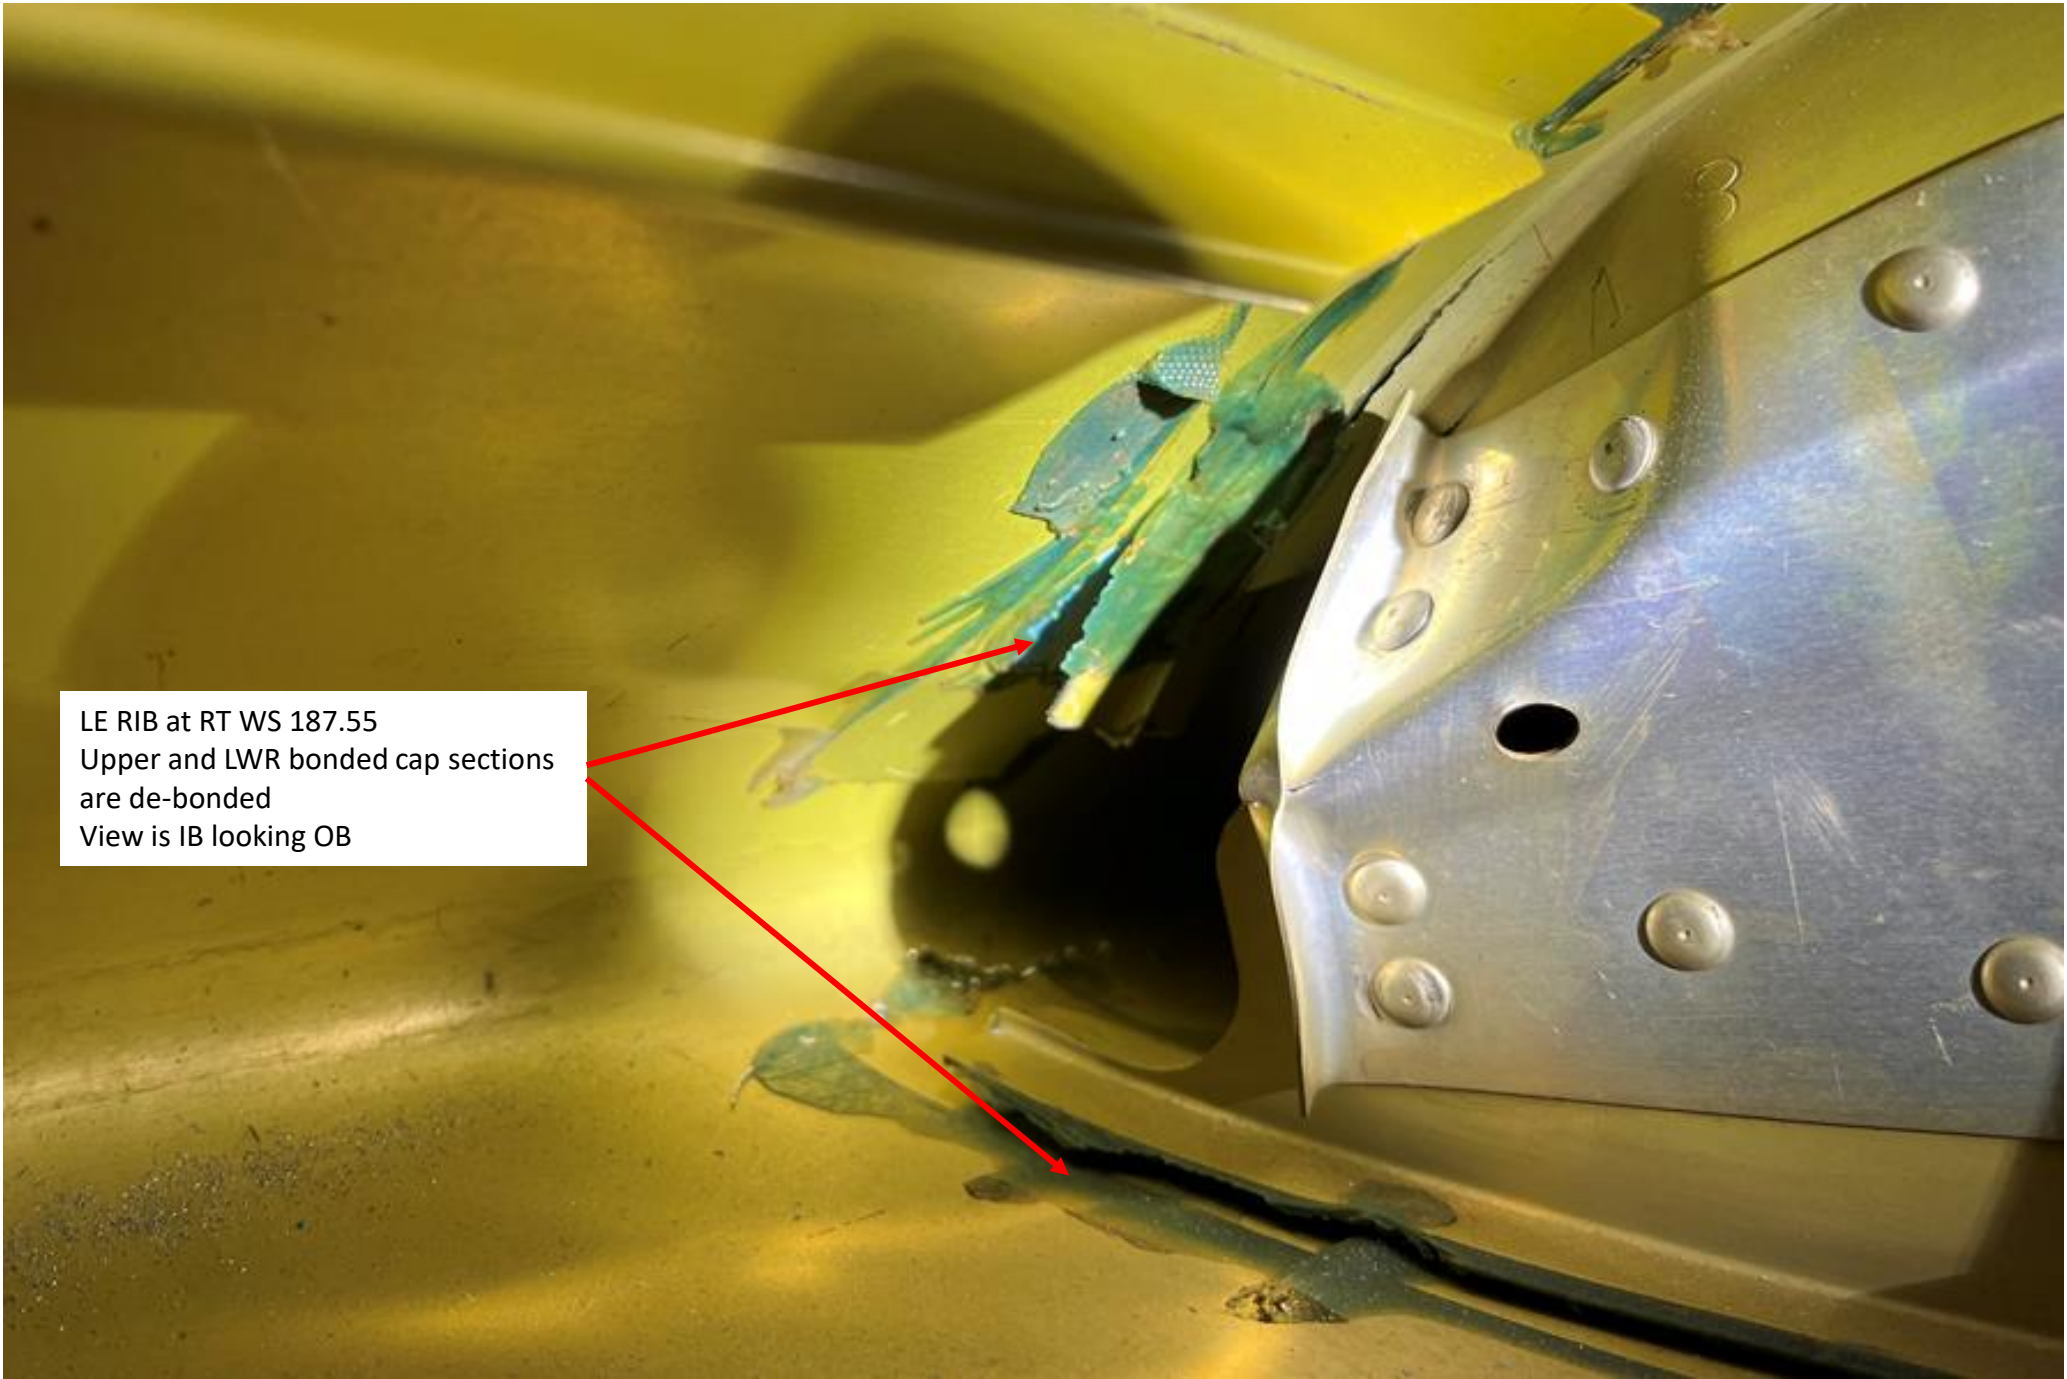
LE RIB at RT WS 187.55  
Upper and LWR bonded cap sections  
are de-bonded  
View is IB looking OB
