**NATIONAL TRANSPORTATION SAFETY BOARD**

**Photo Array**

**ERA23LA111**

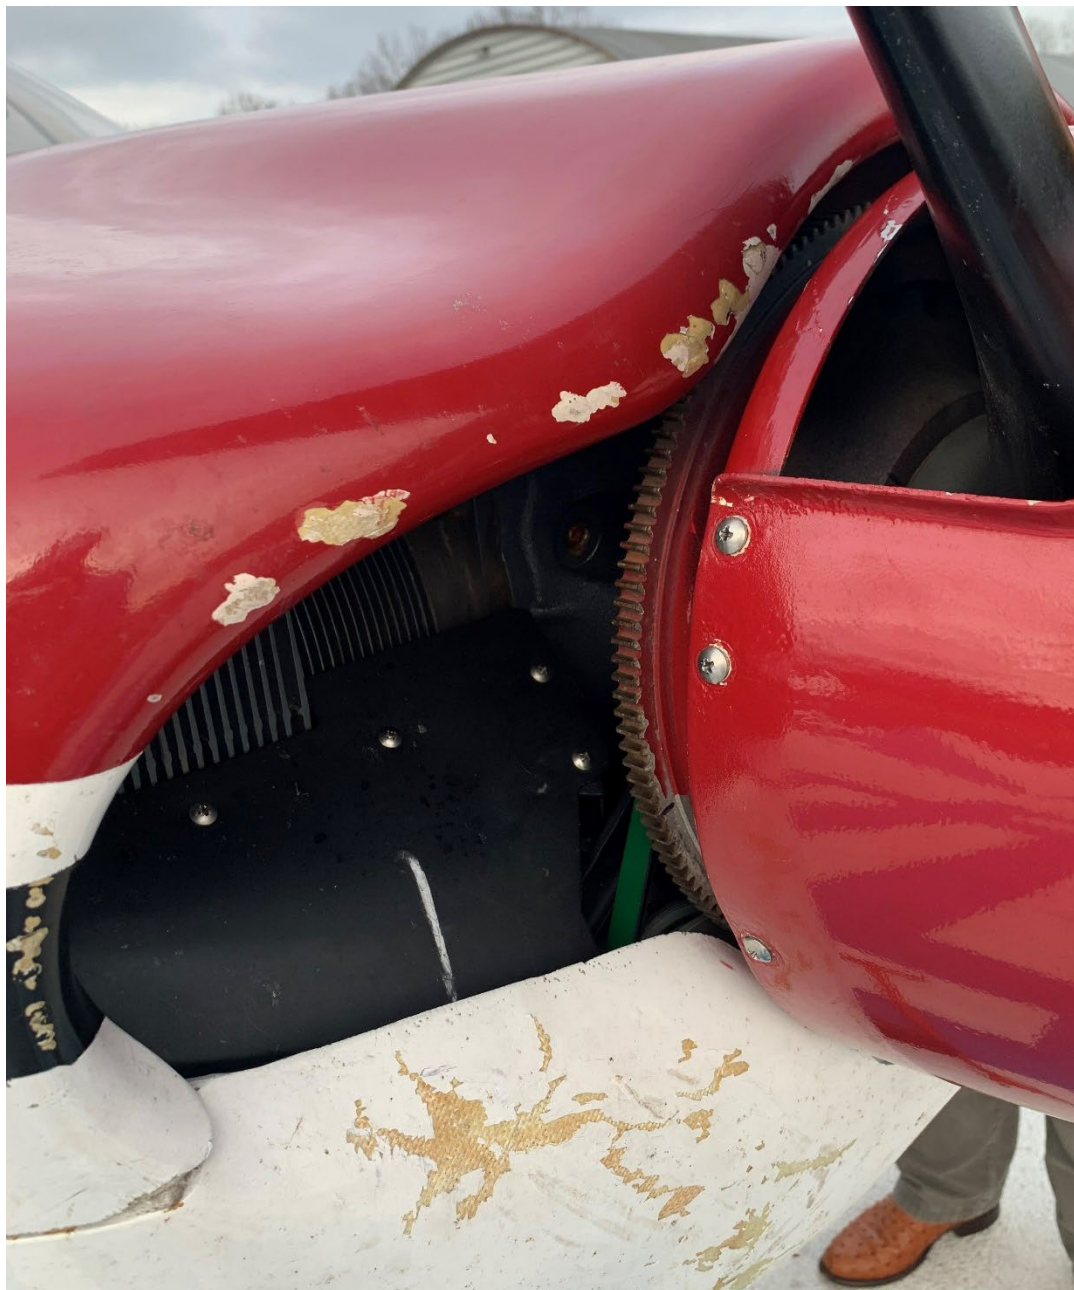
**Photo 1 – View of Engine Cowling (Courtesy of Operator)**

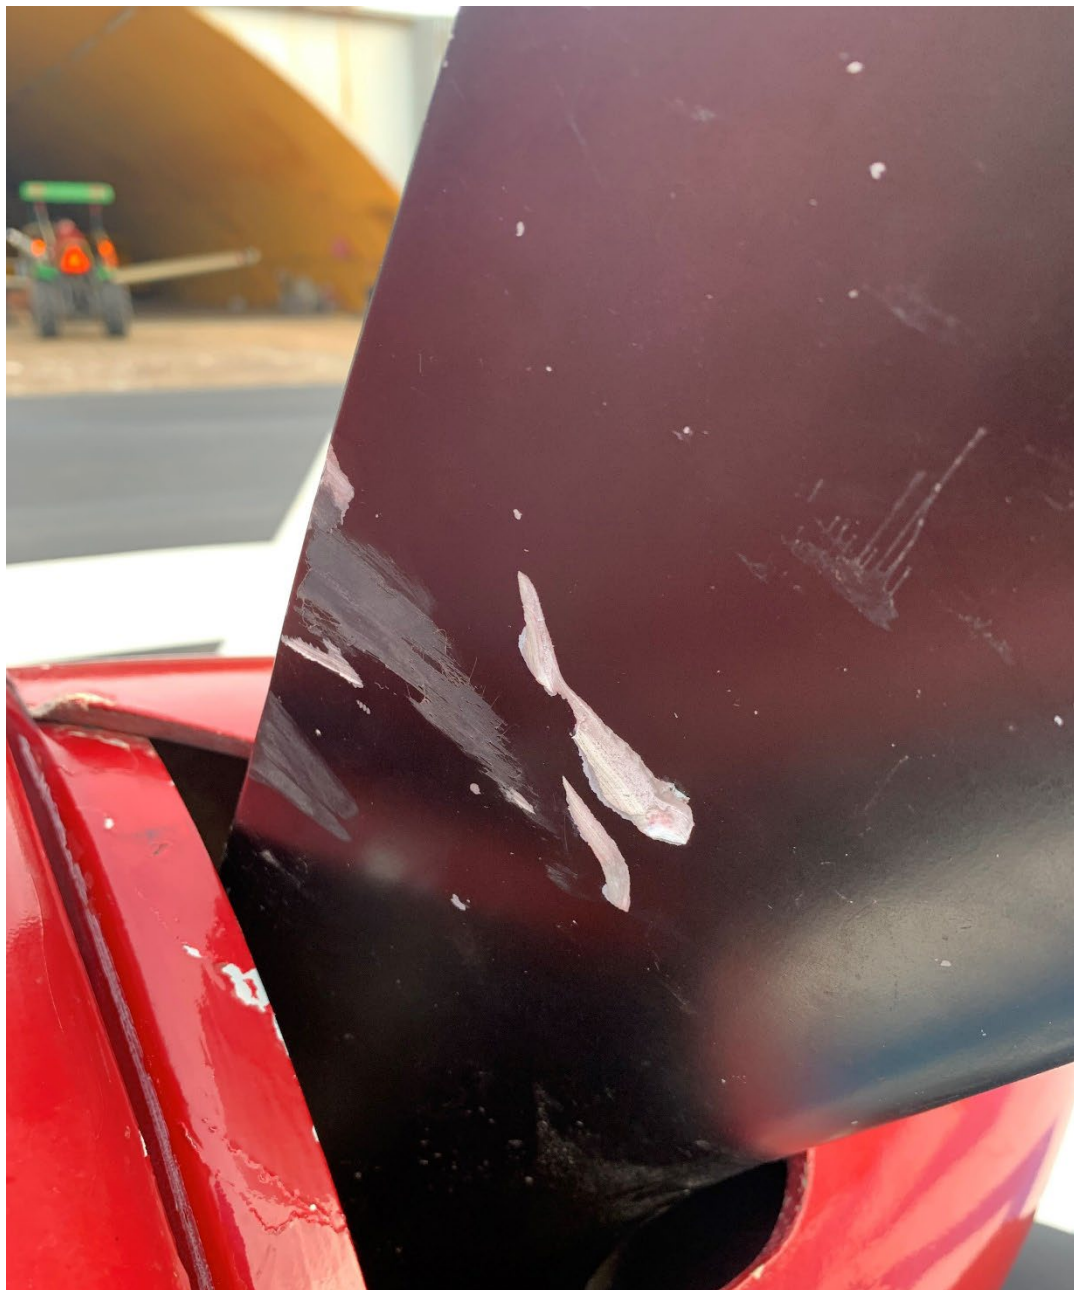
**Photo 2 – Closeup of Damage to Rear Side of Propellor Blade (Courtesy of Operator)**
