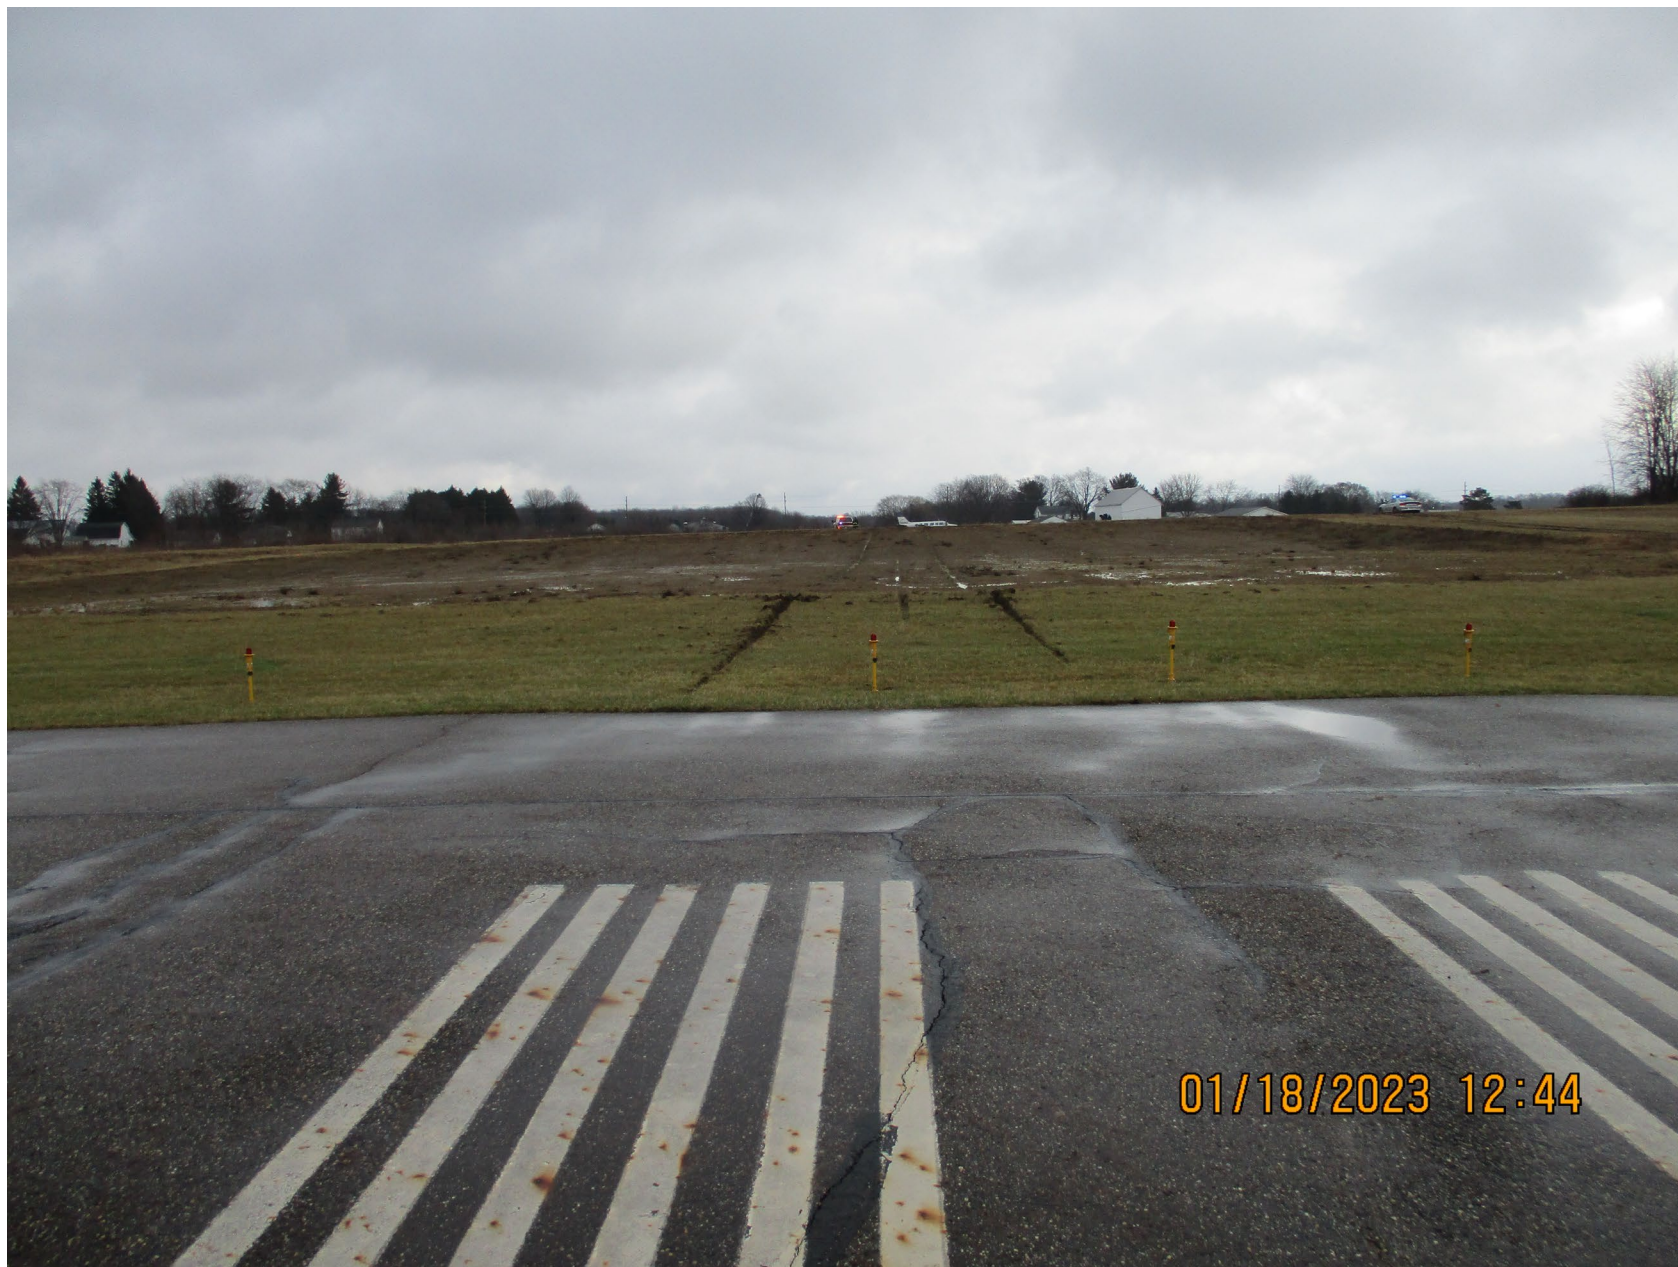
**Photo 1 – View of Runway Departure End, Ground Tracks, Berm, and Airplane at Rest Where Found (FAA)**

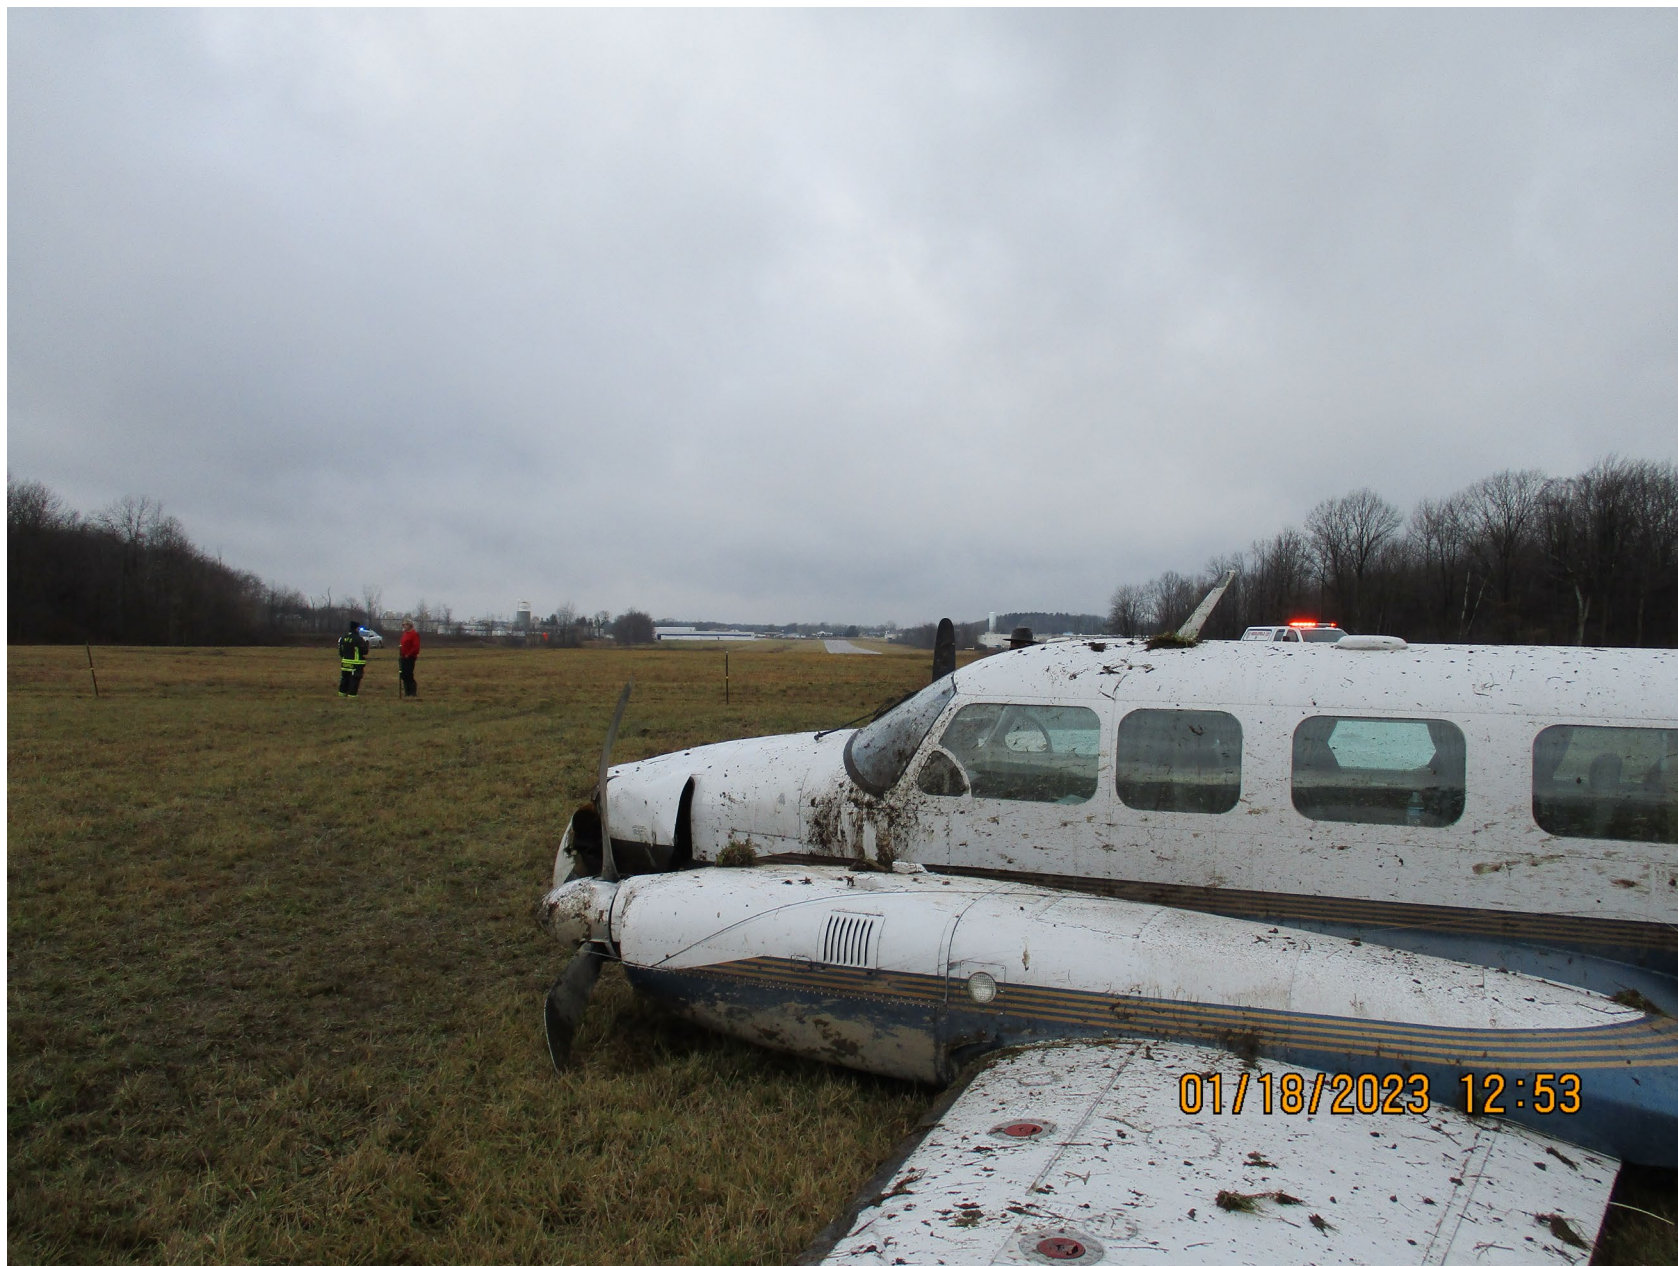
**Photo 2 – View of Airplane Facing Opposite Direction of Travel (FAA)**

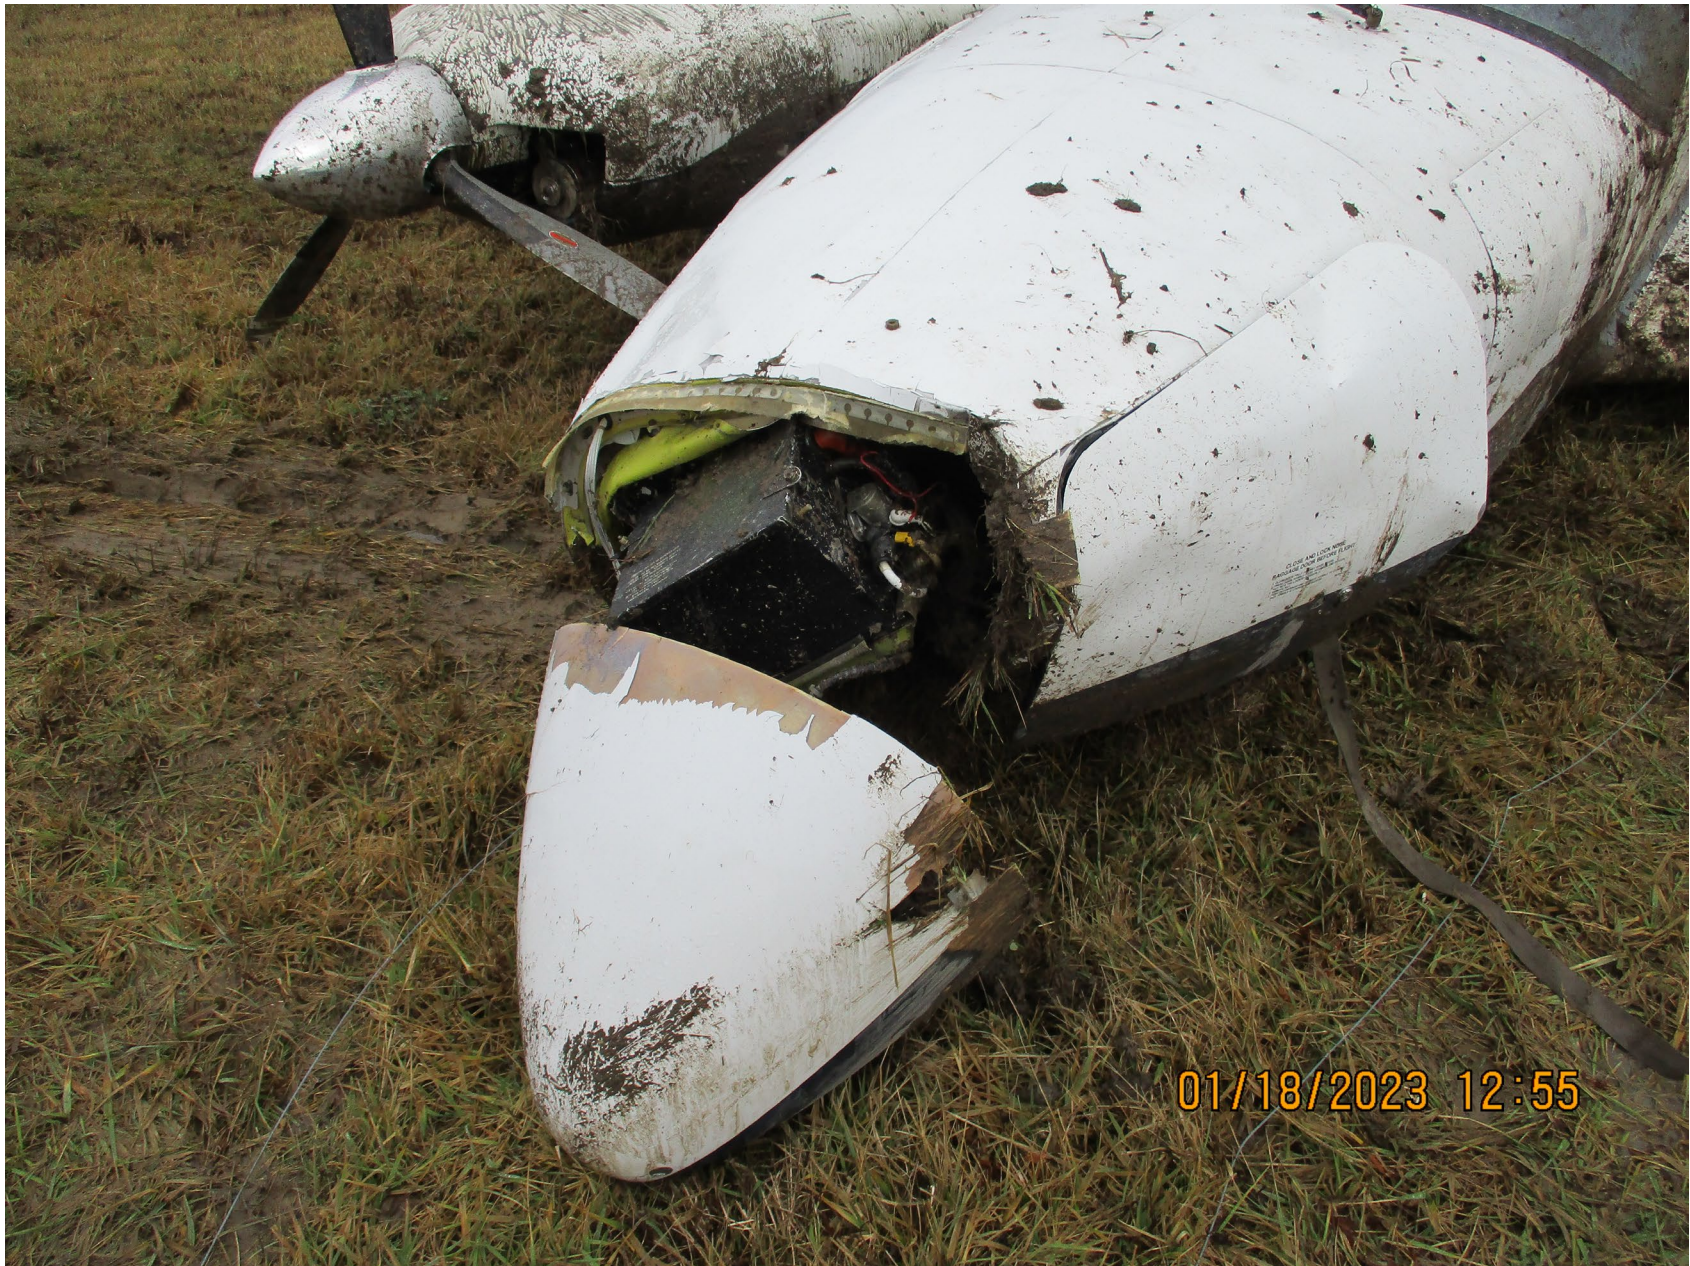
**Photo 3 – View of Damage to Nose Compartment (FAA)**

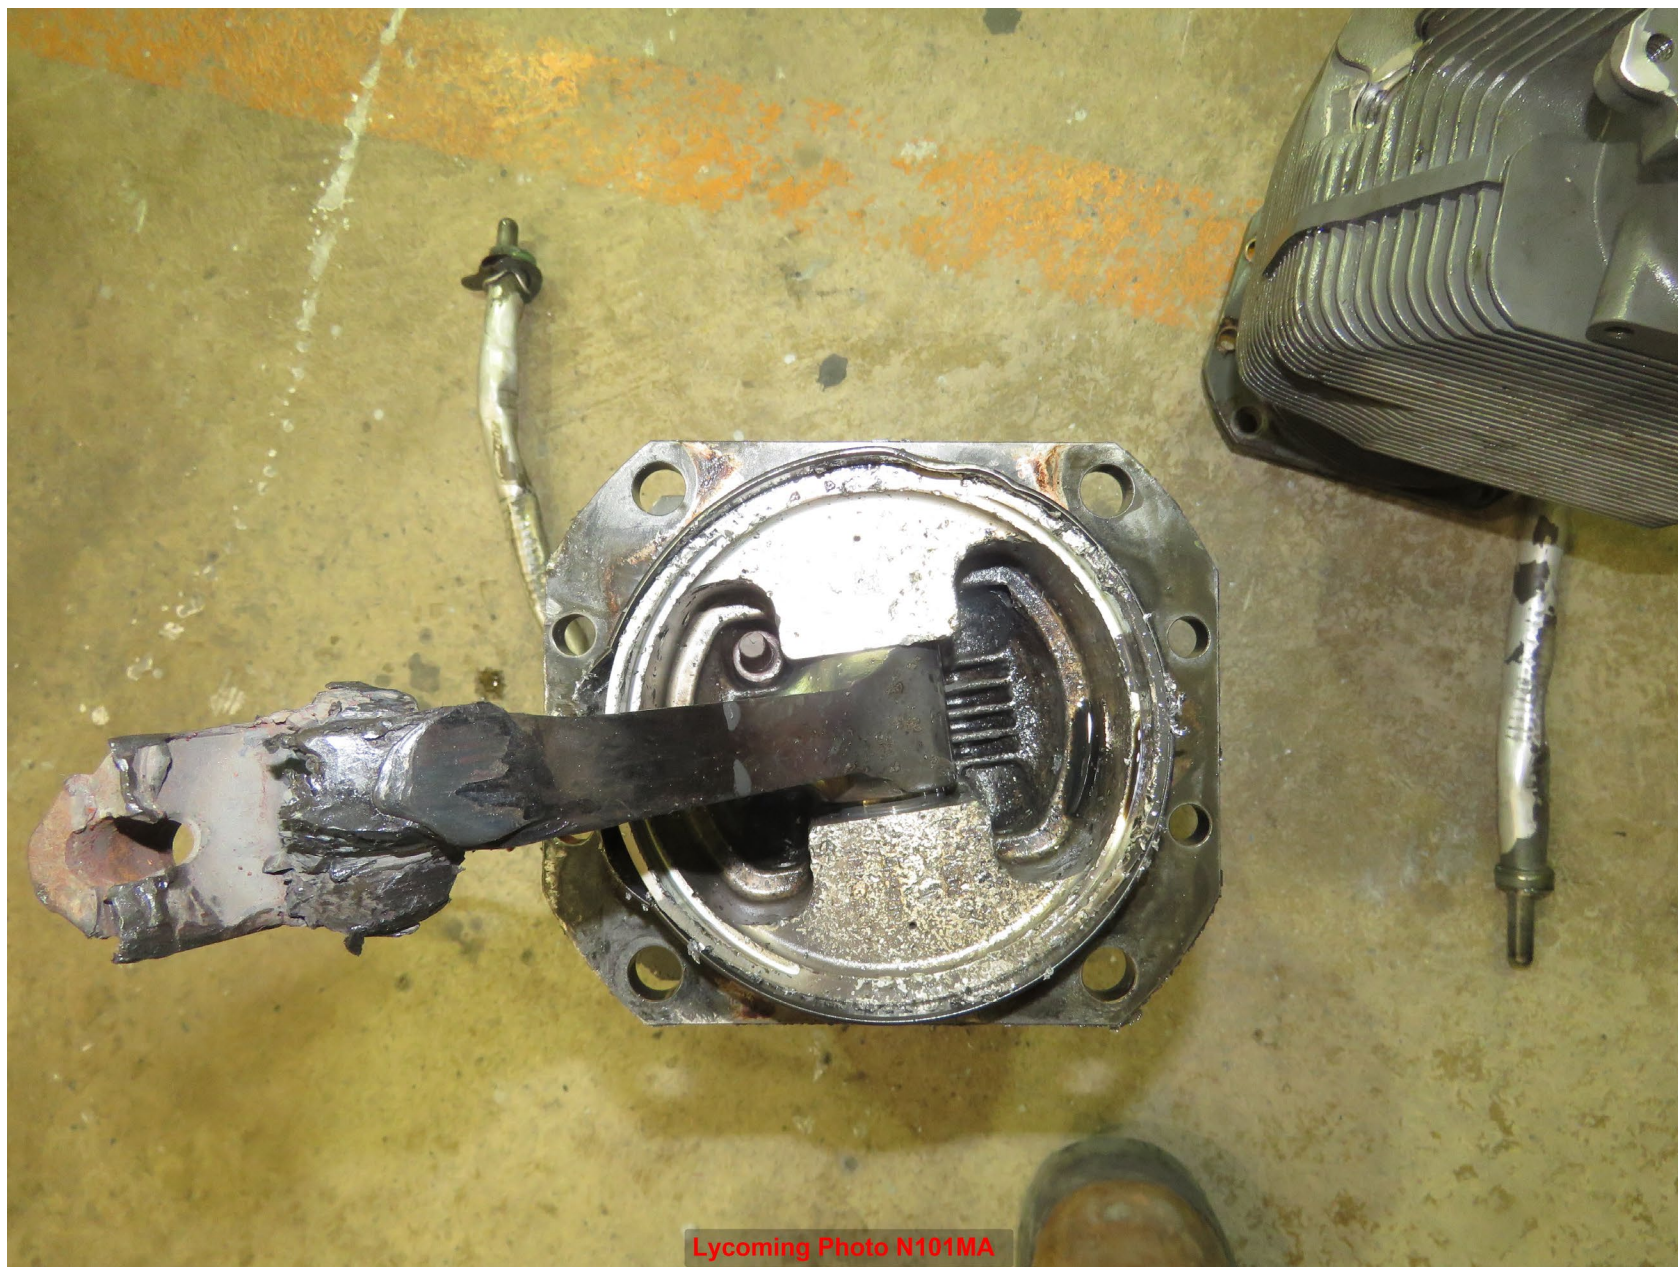
**Photo 5 – View of #5 Piston with Broken Connecting Rod inside #5 Cylinder (Lycoming)**

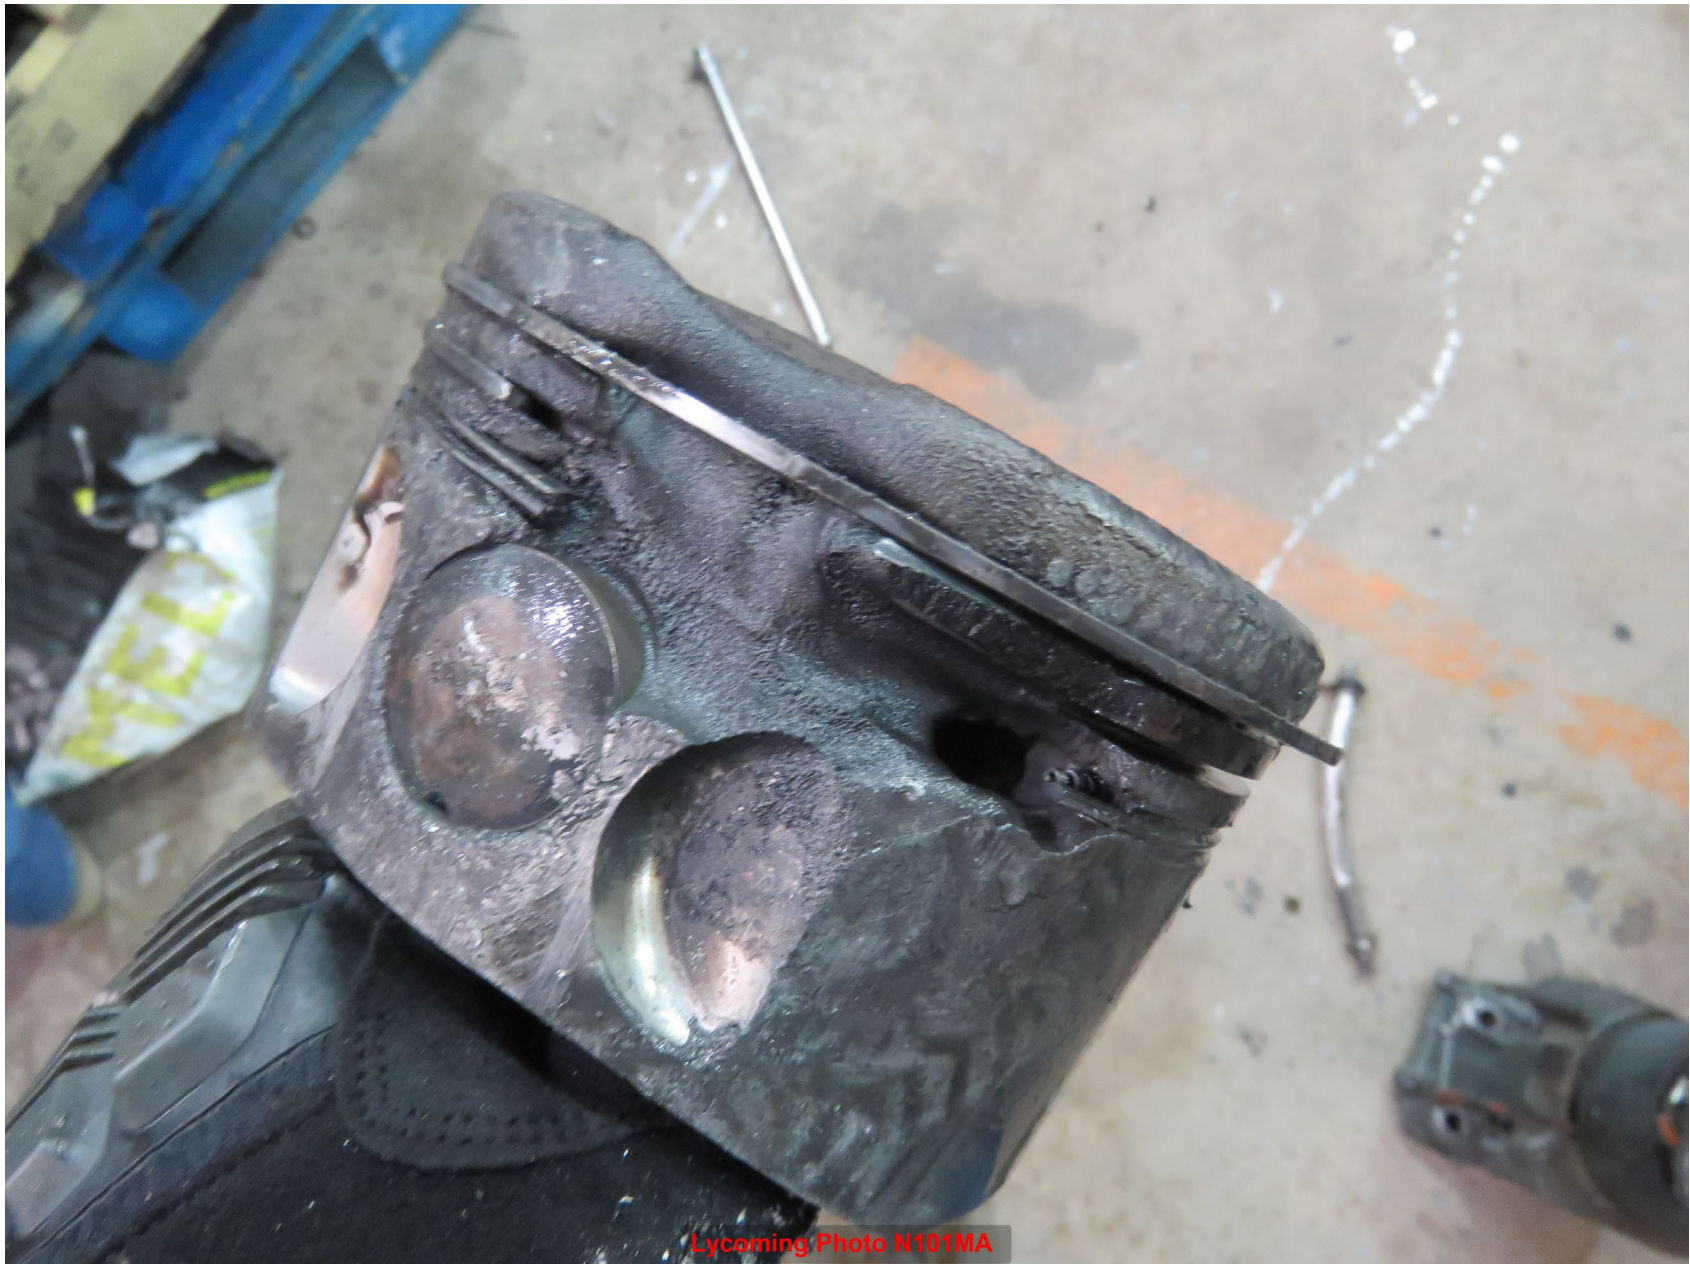
**Photo 6 – View of #5 Piston Displaying Damage Signatures Consistent with Detonation (Lycoming)**

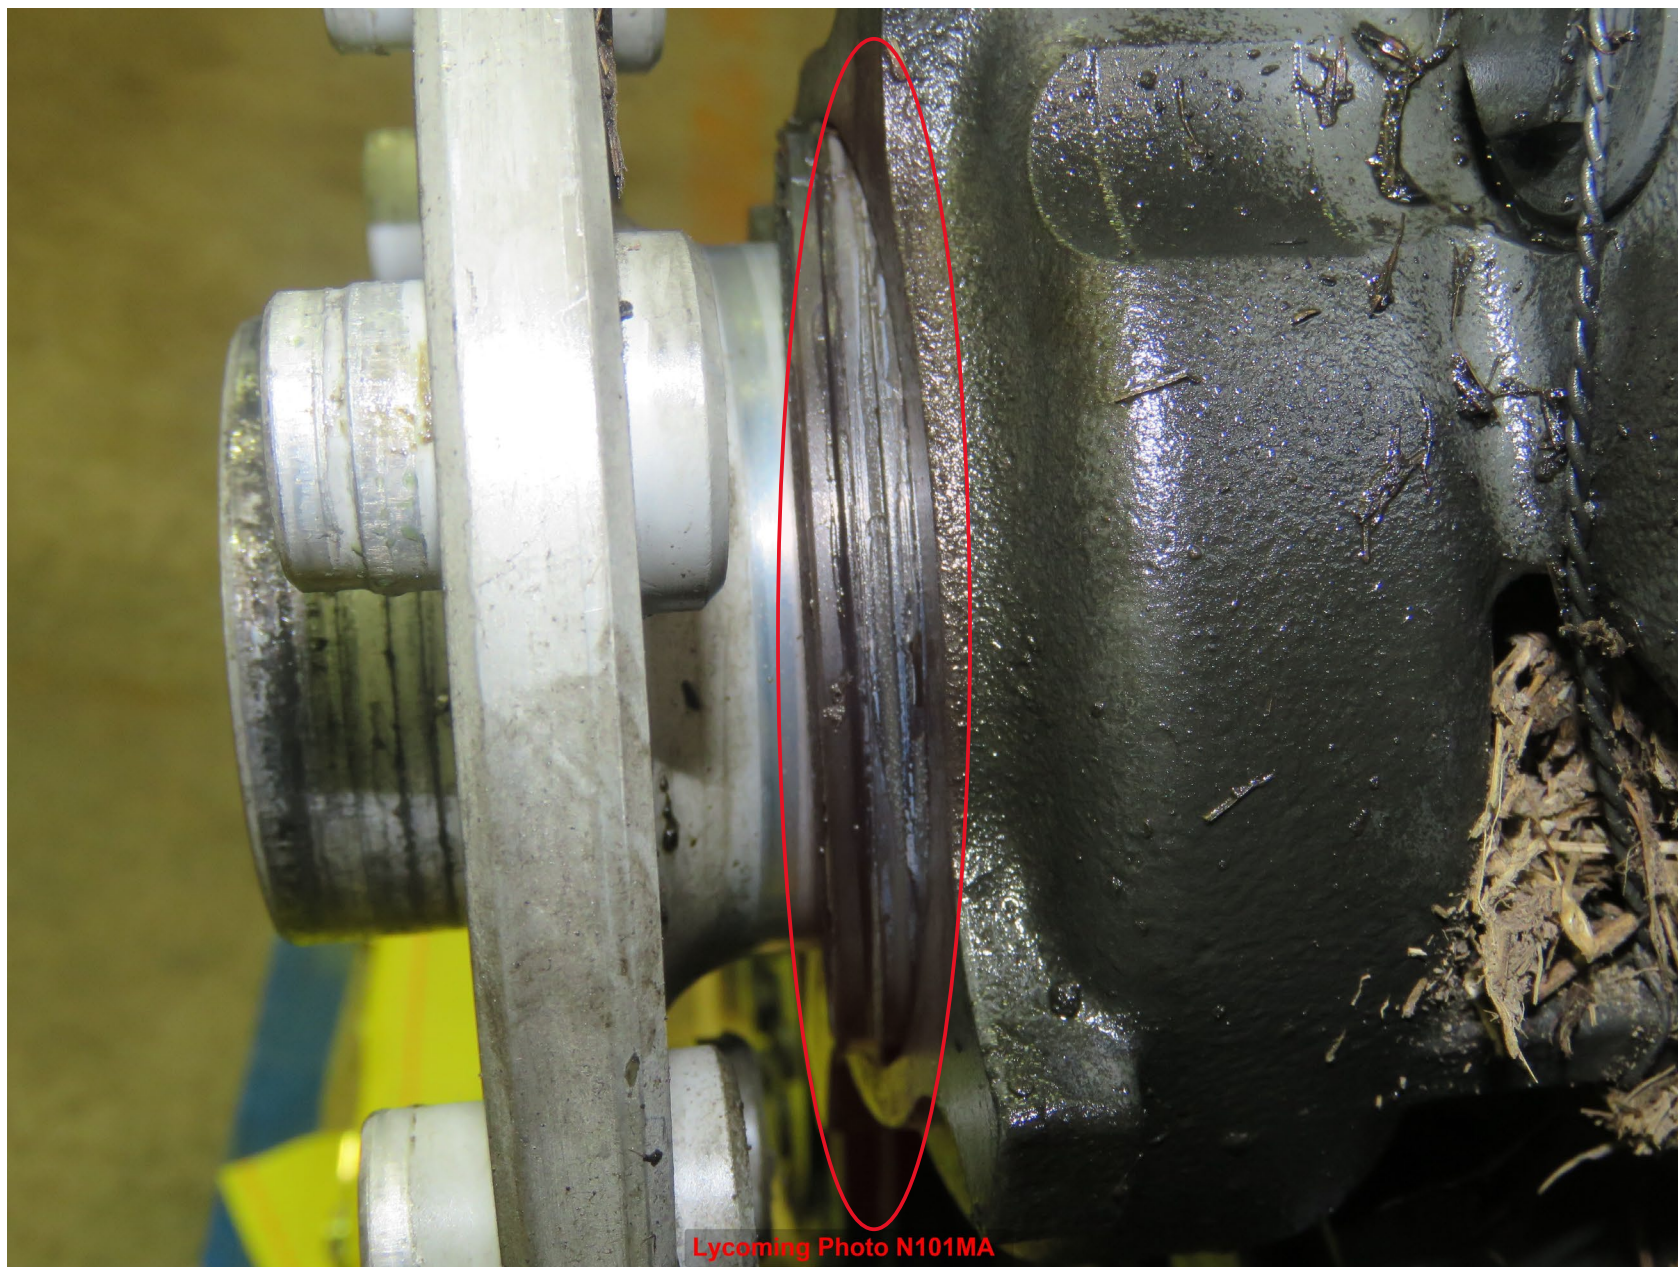
**Photo 7 – View of Extruded Crankshaft Nose Seal (Lycoming)**
