**NATIONAL TRANSPORTATION SAFETY BOARD**

**Photo Array**

**ERA23LA116**

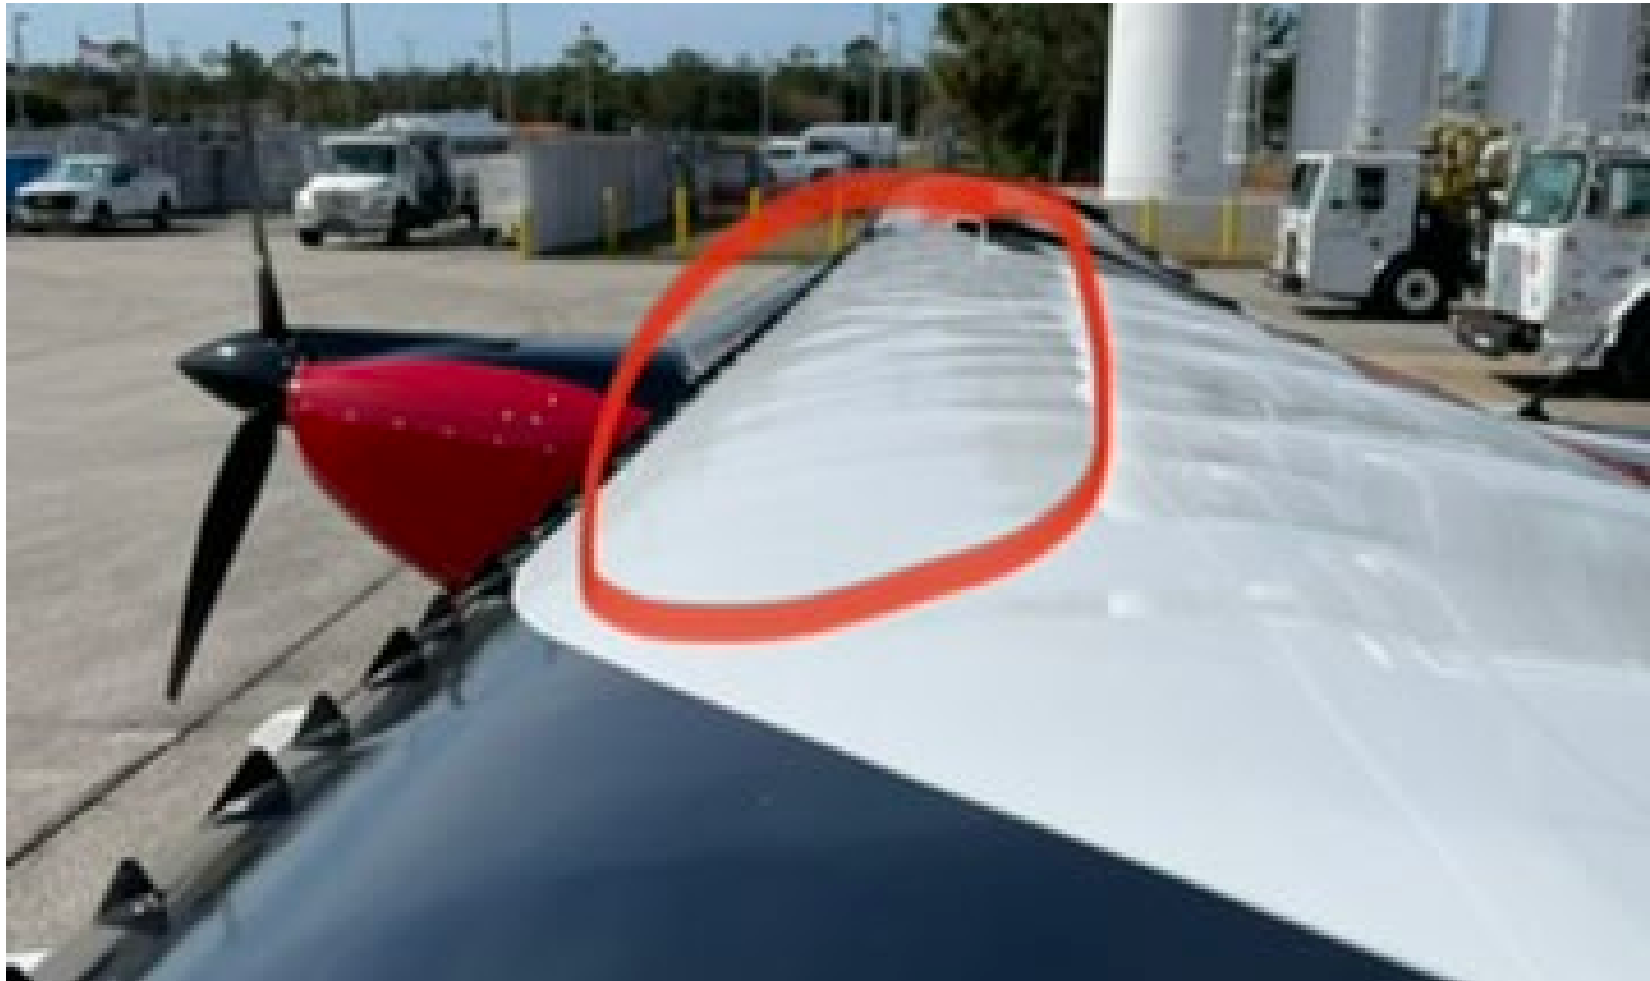
**Photo 2 – View of Lift Strut Attachment Damage – Note Area Circled (Courtesy of Pilot)**

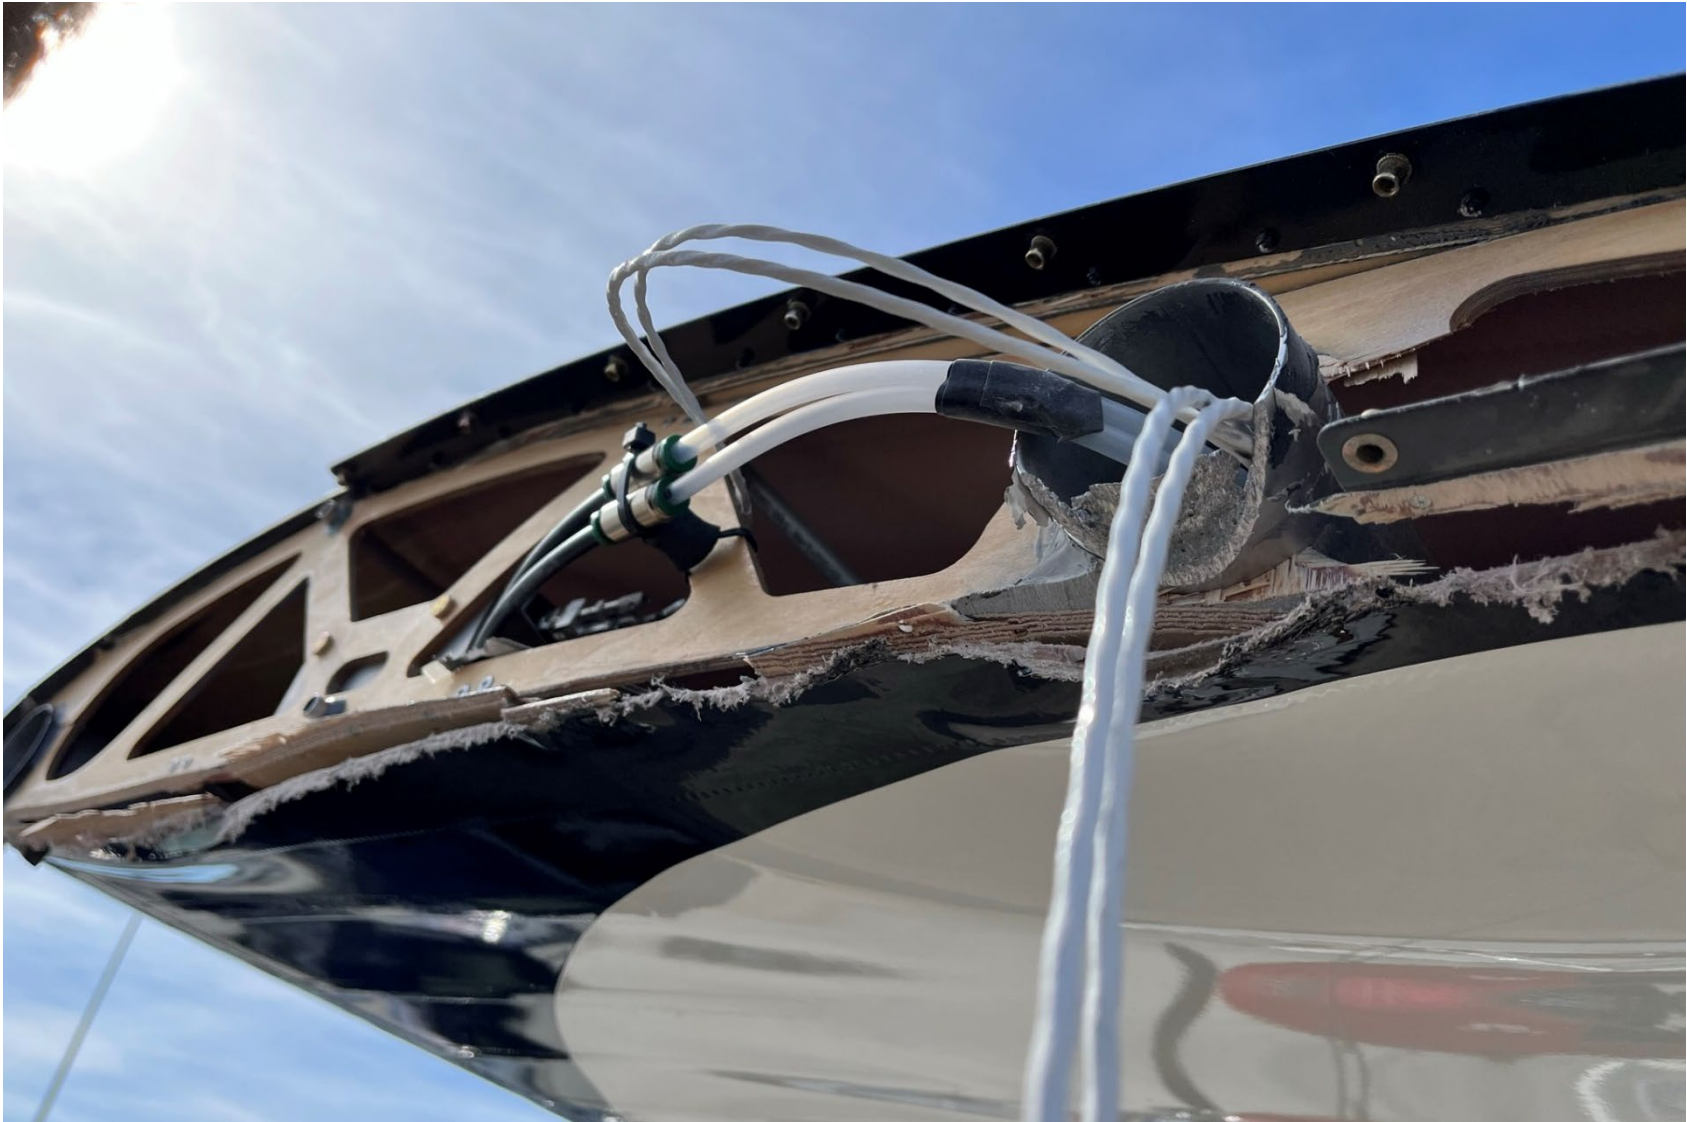
**Photo 3 – View of Left Wing, Rear Spar Damage (Courtesy of Pilot)**
