ERA23LA120

## INVESTIGATION PHOTOGRAPHS

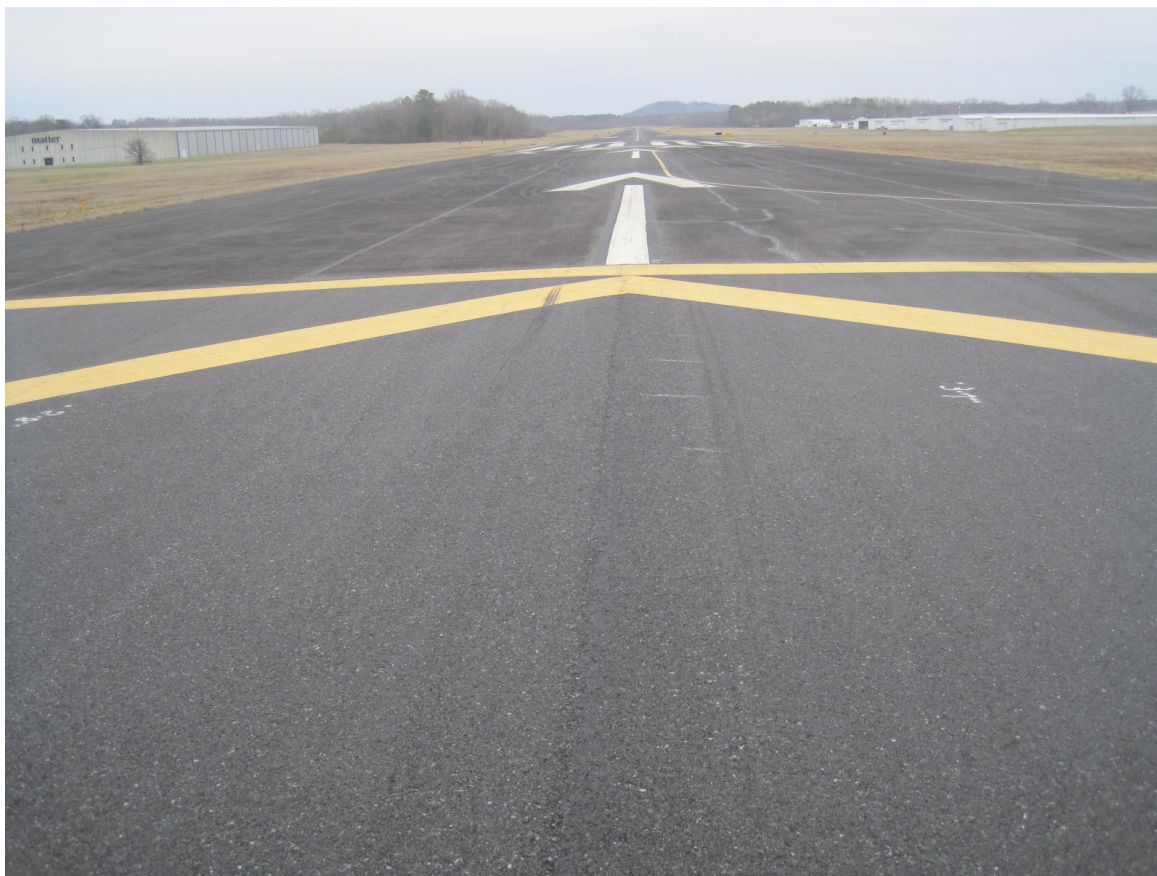
**Photograph 1 - Propeller Strike Marks on Displaced Threshold (Courtesy of FAA)**

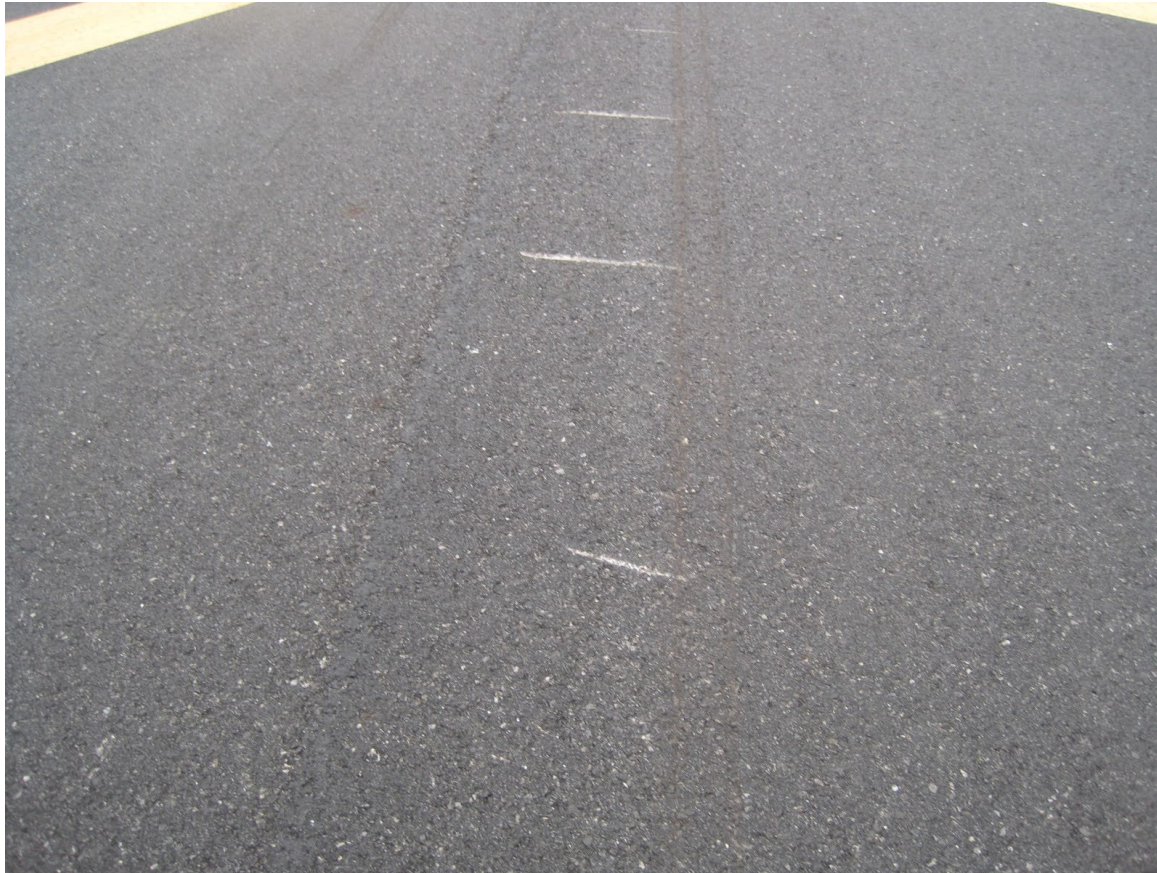
**Photograph 2 - Close Up of Propeller Strike Marks (Courtesy of FAA)**

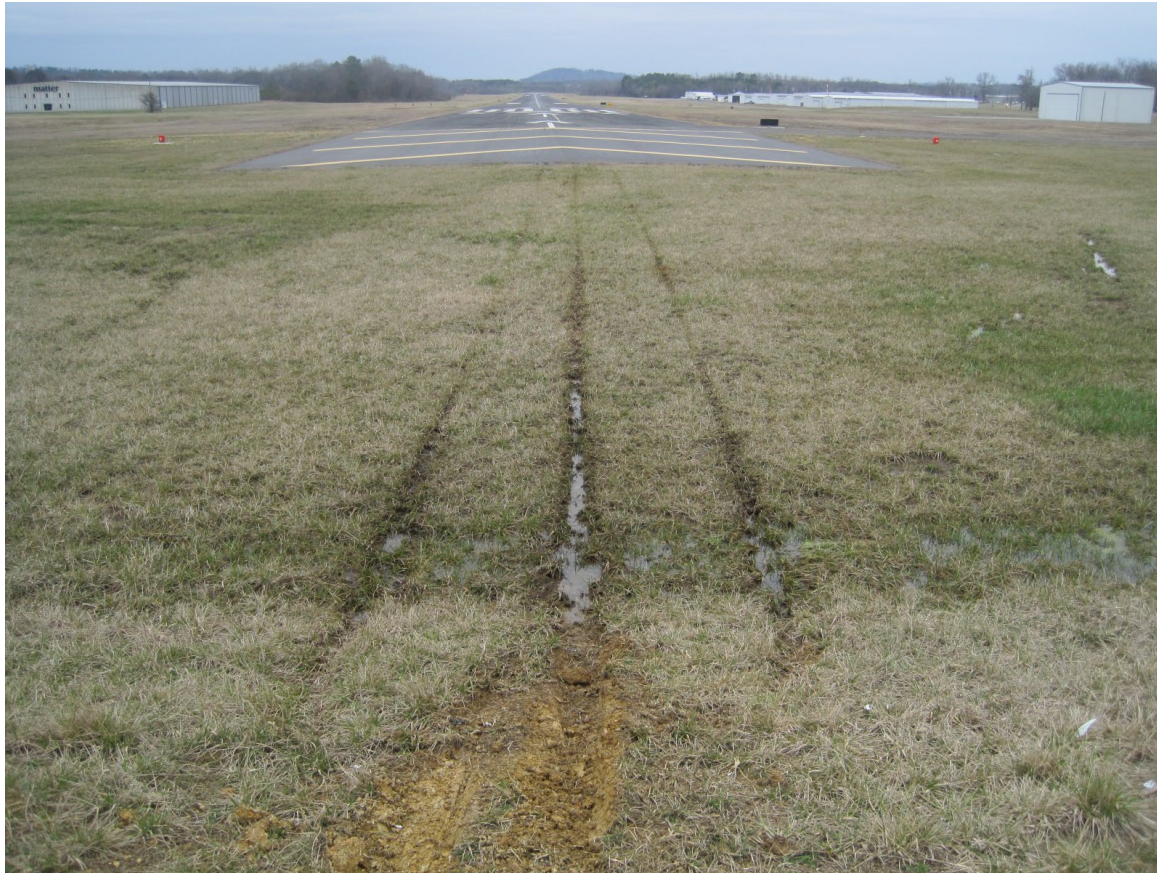
**Photograph 3 - Tire Tracks / Skid Marks (Courtesy of FAA)**

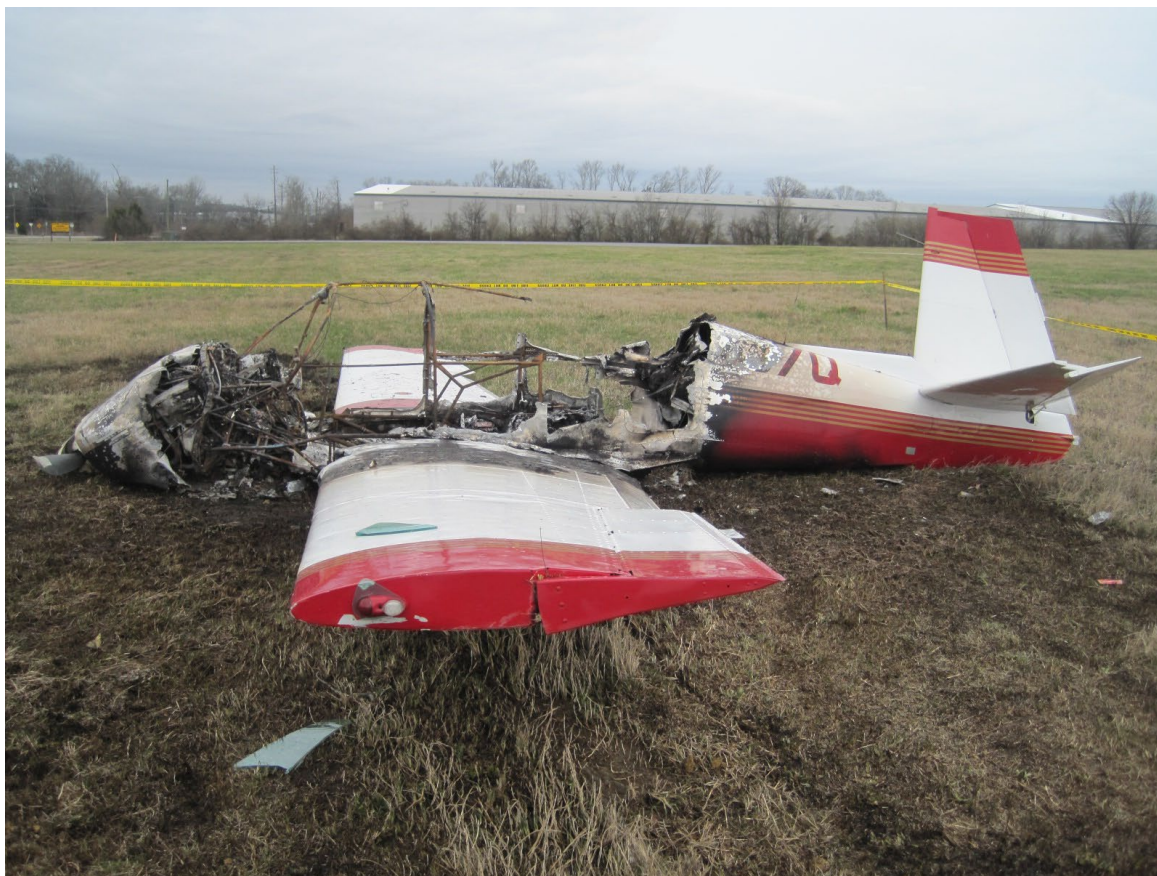
**Photograph 4 - main Wreckage (Courtesy of FAA)**

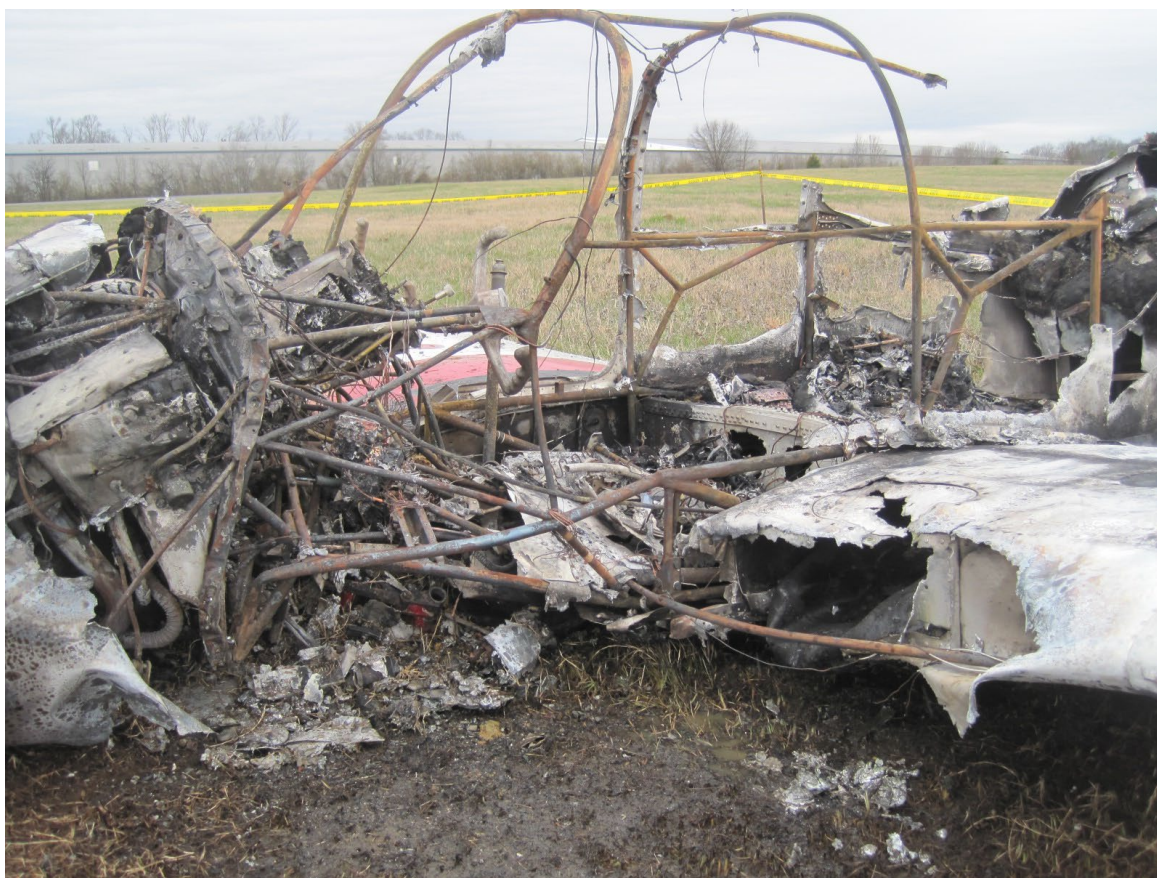
**Photograph 5 - Close Up of Cabin Area (Courtesy of FAA)**

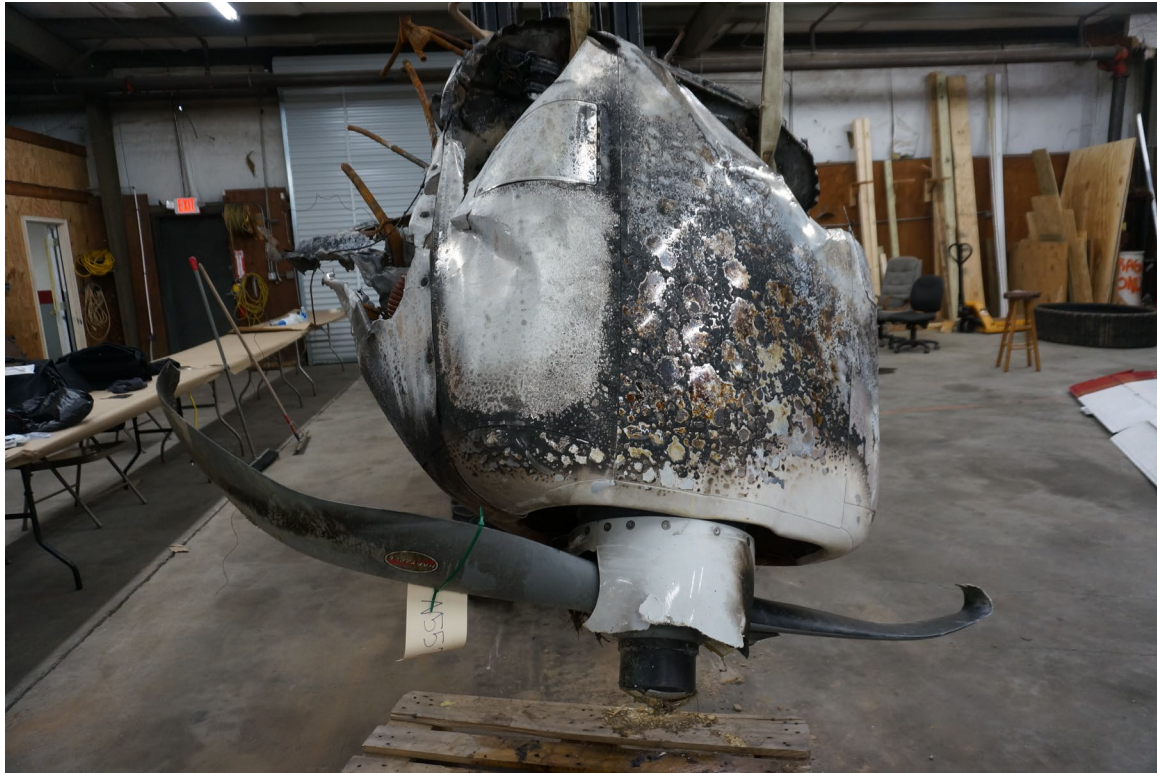
**Photograph 6 - Propeller and Engine Cowling**

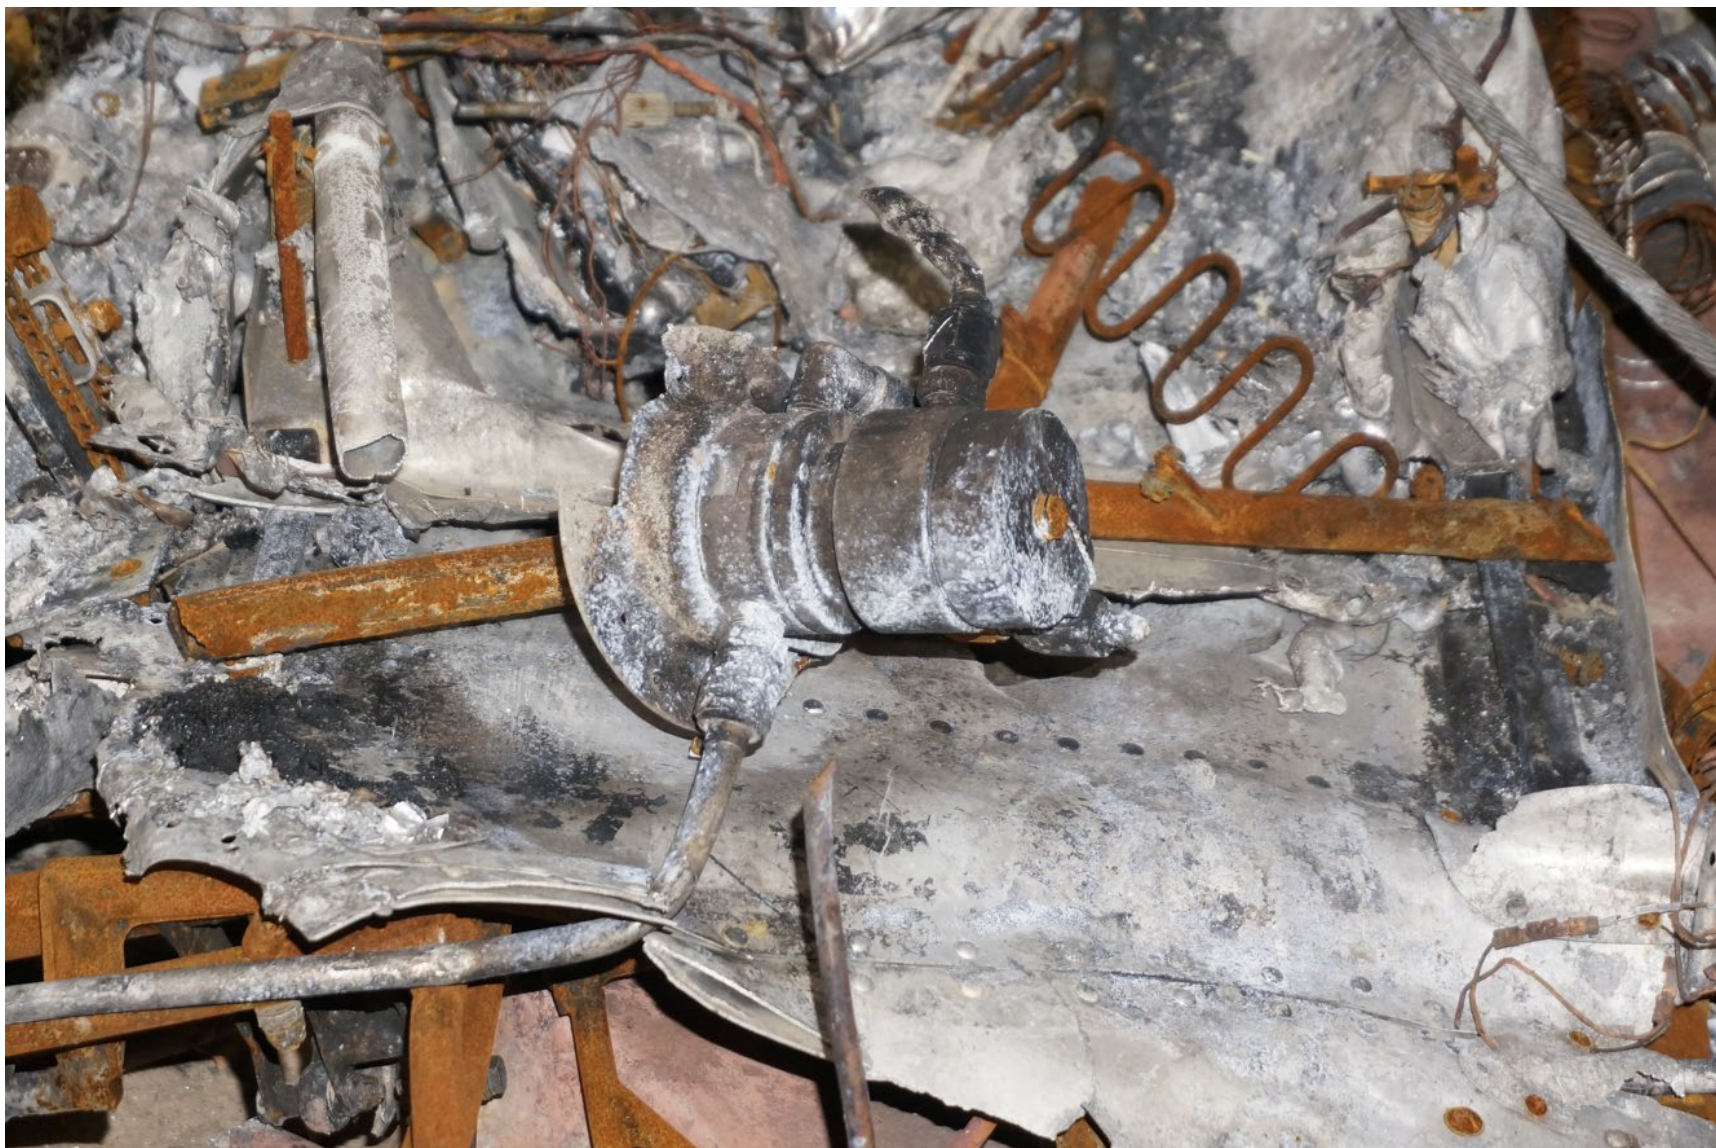
**Photograph 8 - Fuel Selector Valve**

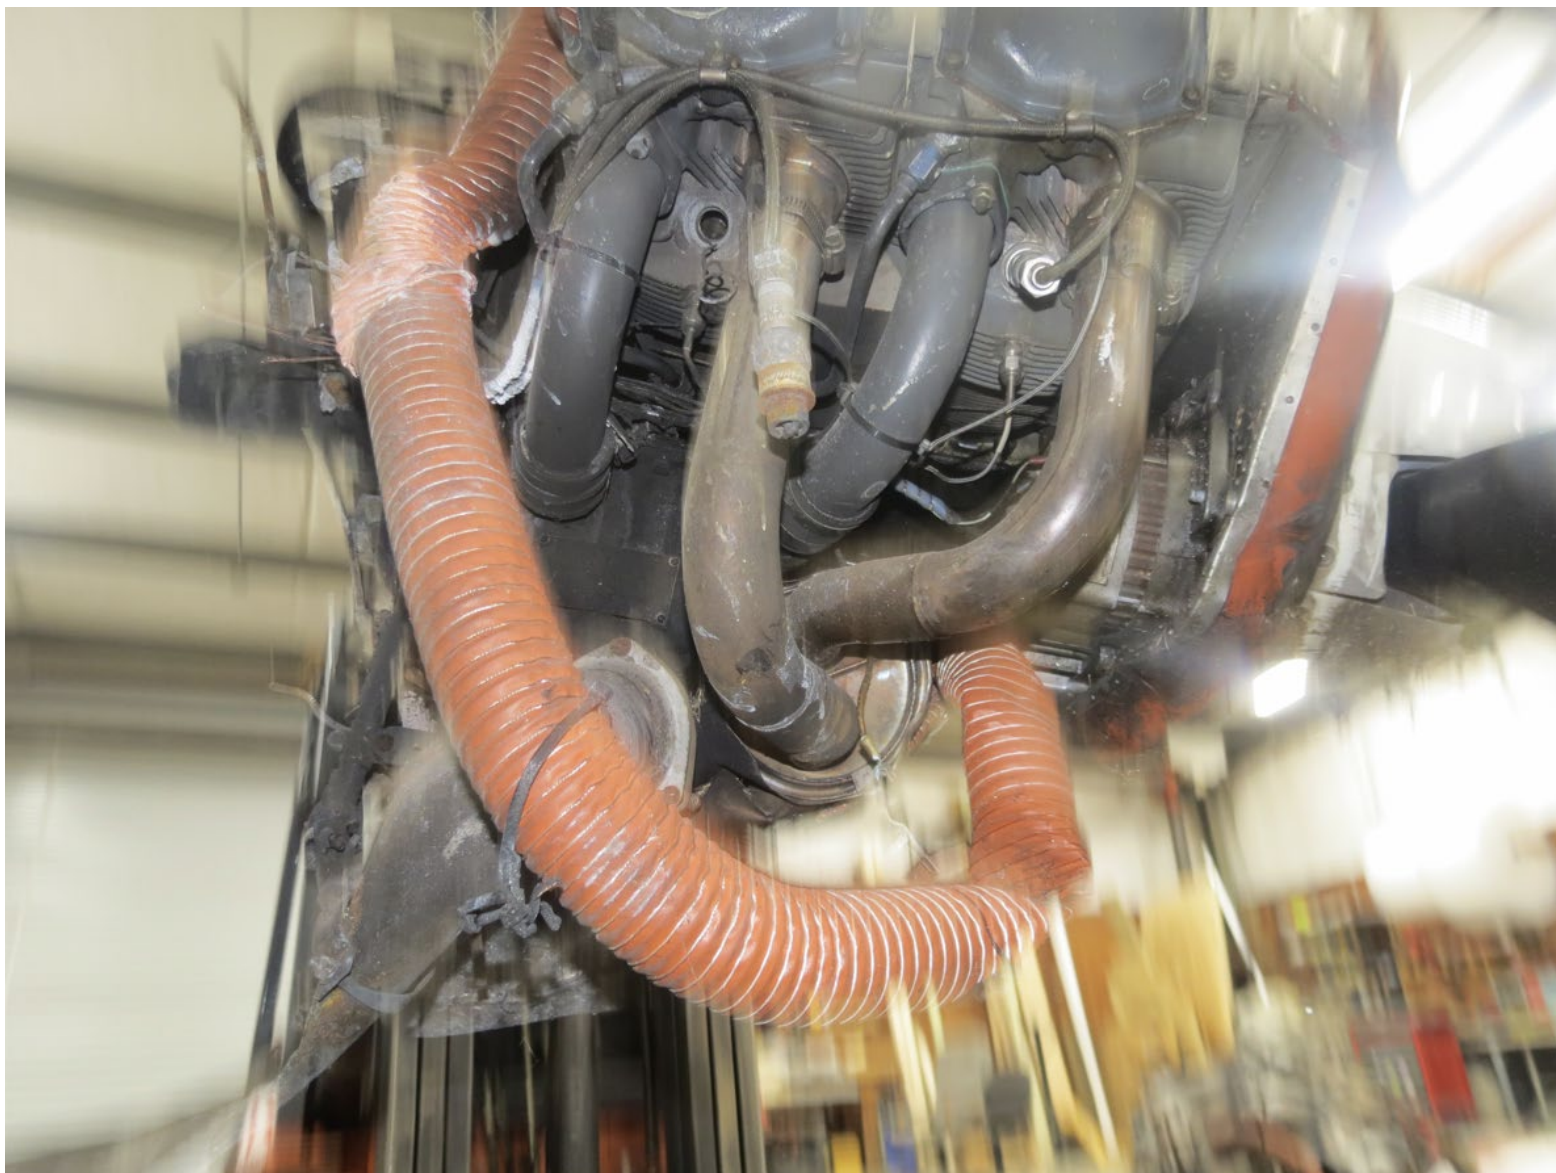
**Photograph 9 - No.3 Bottom Spark Plug and Spark Plug Hole (Courtesy of Lycoming Engines)**

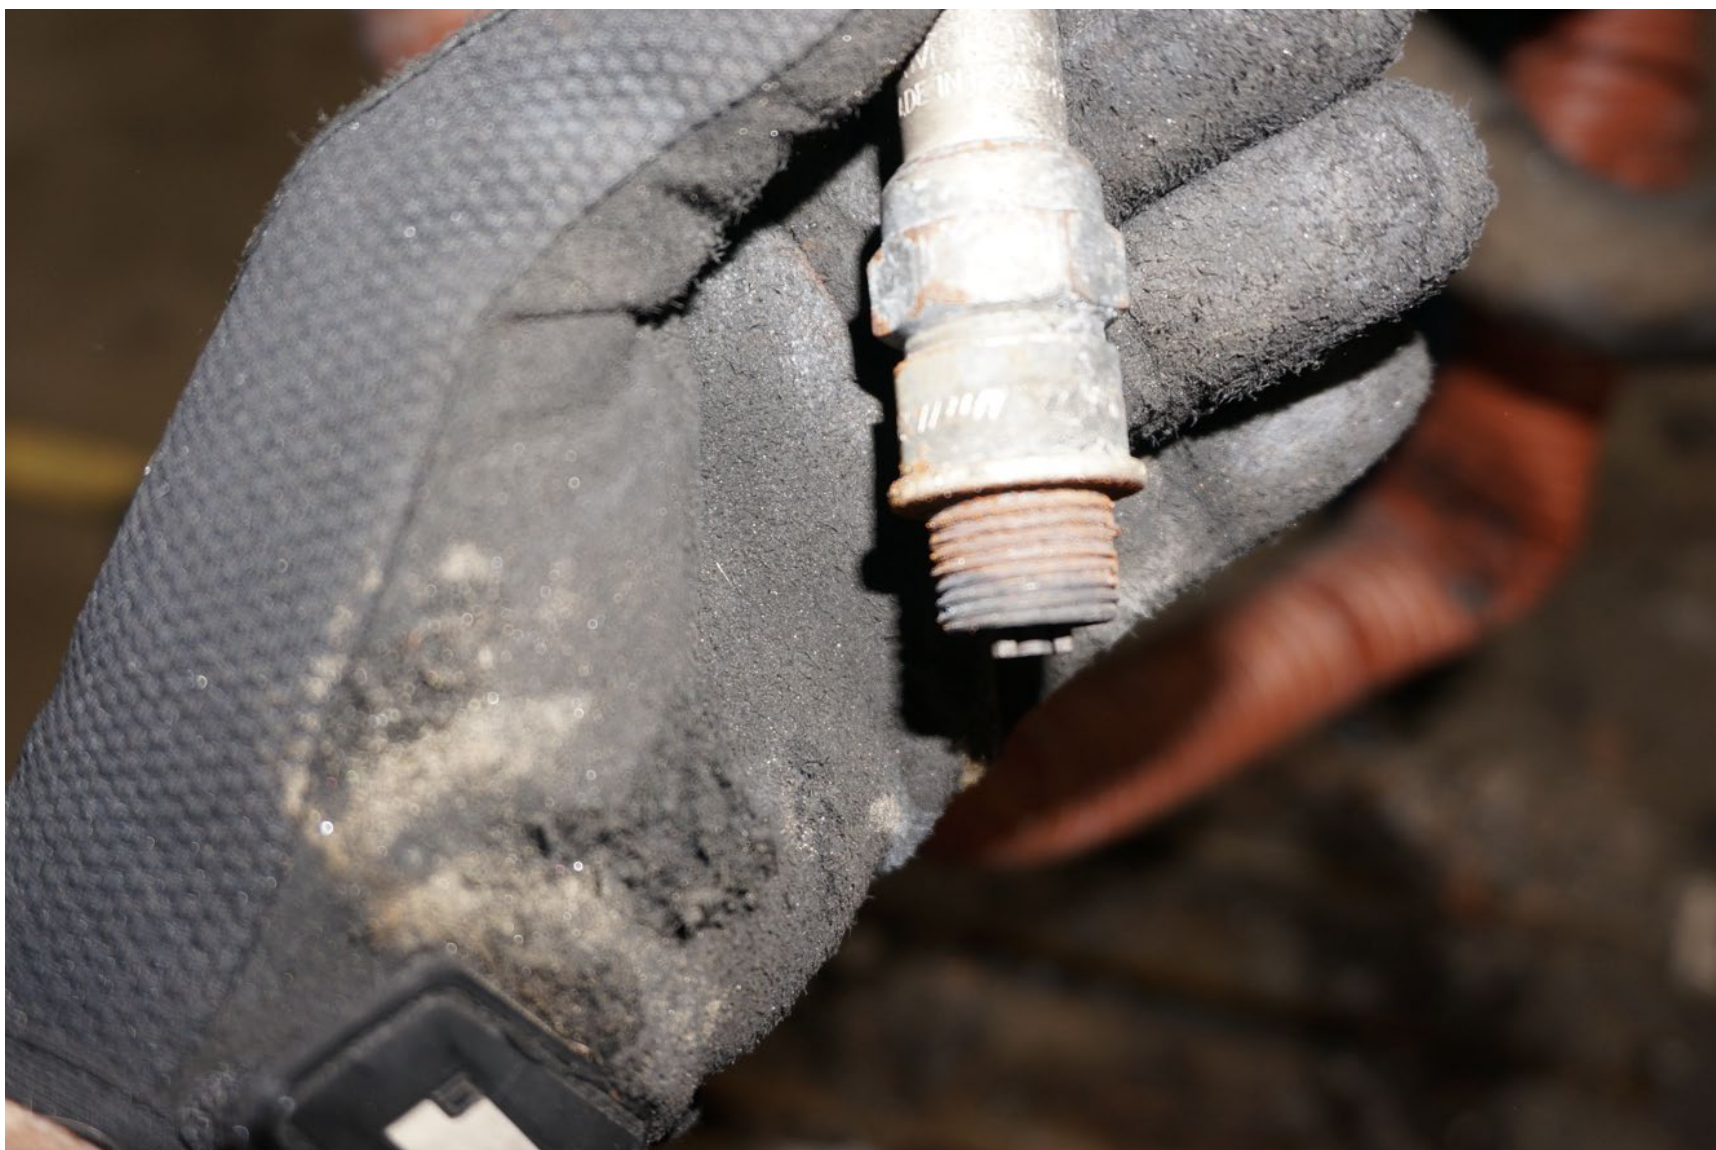
**Photograph 10 - Close Up of No.3 Bottom Spark Plug**

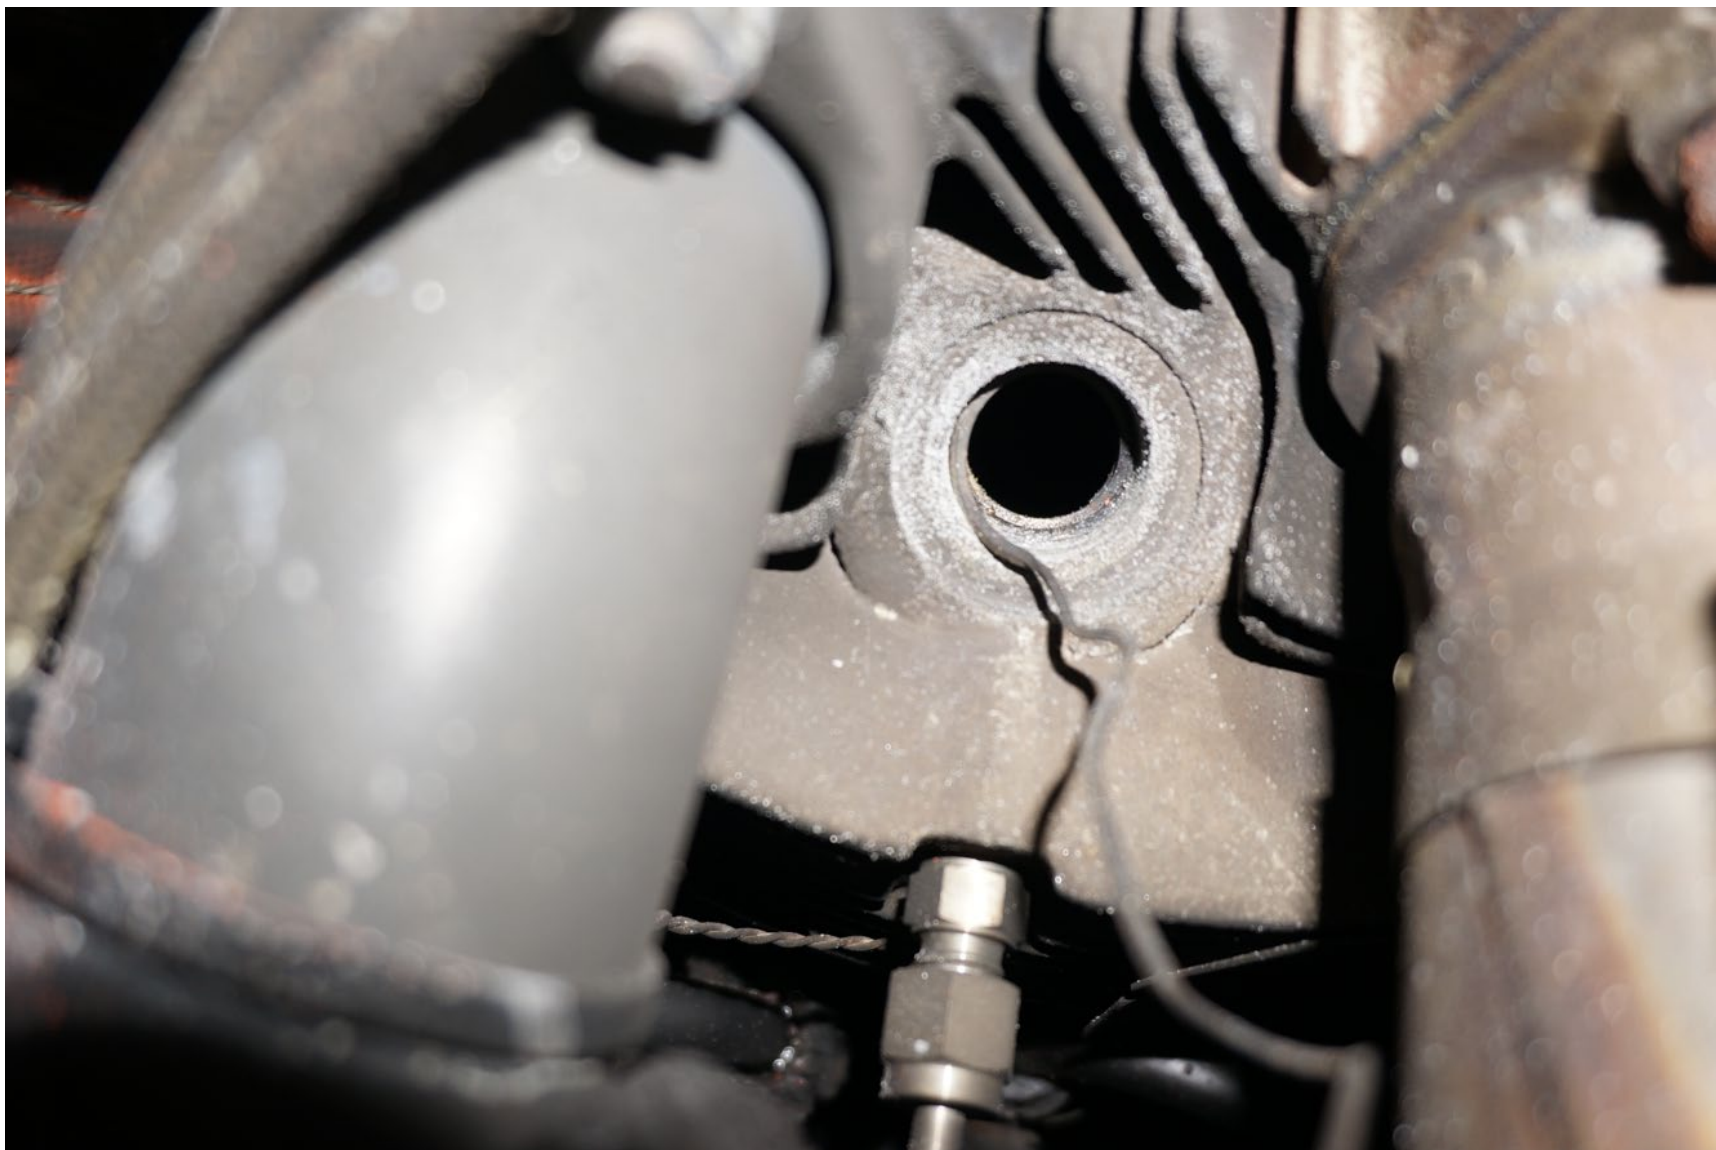
**Photograph 11 - No.3 Bottom Spark Plug Hole and Helicoil**

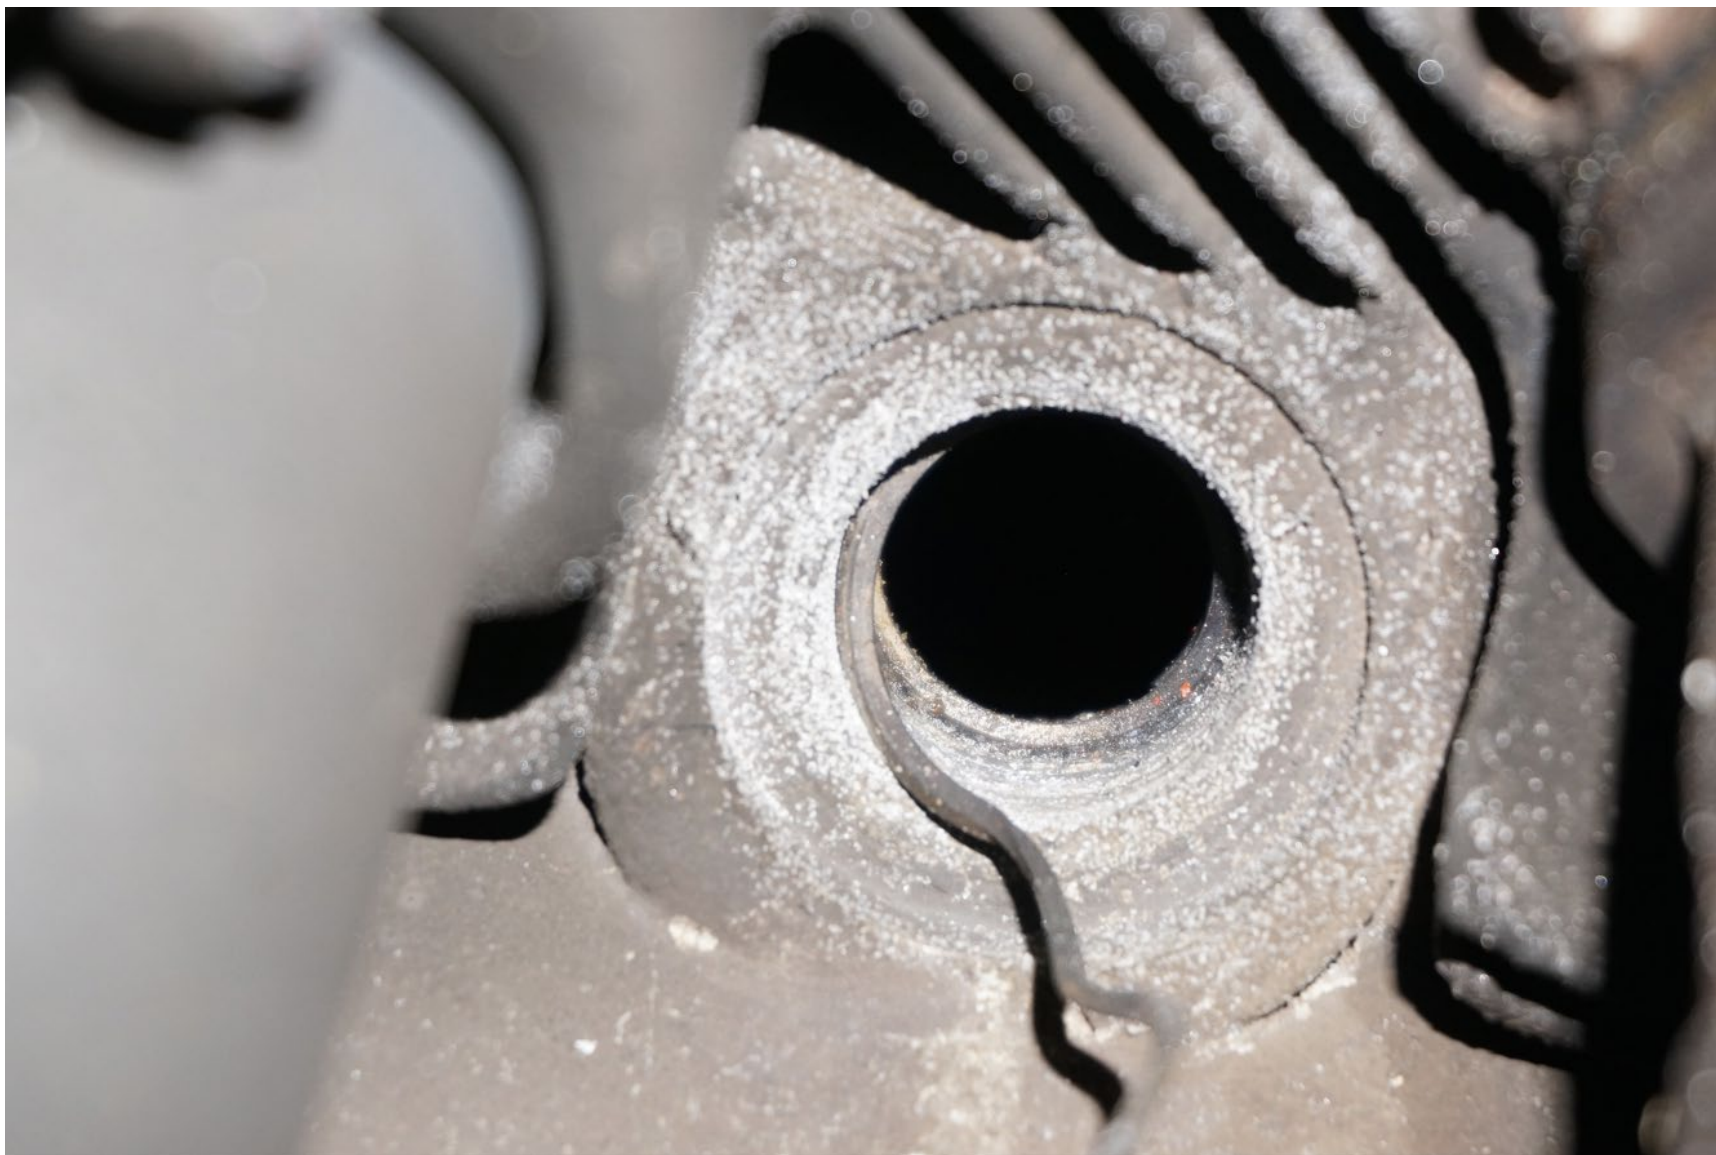
**Photograph 12 - Close Up of No.3 Bottom Spark Plug Hole and Helicoil**
