# National Transportation Safety Board

ERA23LA124

## **ENGINE EXAMINATION**

Location: Jacksonville, Florida  
Date: February 6, 2023  
Time: 1432 EST  
1932 UTC  
Airplane: N330PC; RV-6

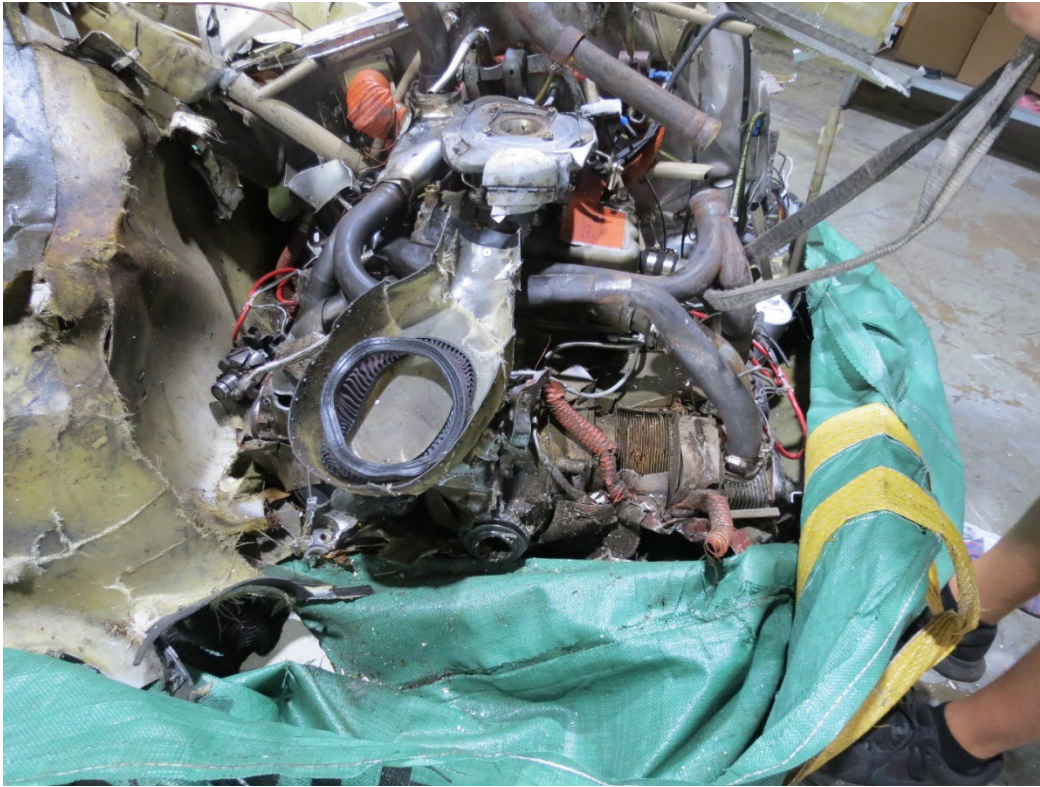
As first viewed, the engine was in a bag laying inverted on the floor at the facilities of Florida Air Recovery and remained partially attached to the firewall through the tubular mount. The engine was rolled upright and suspended from a lift. The crankshaft was separated about 1 inch aft of the propeller flange. The crankshaft flange remained attached to the propeller hub and the two were separated from the engine. The induction airbox and the engine exhaust tubing were impact damaged.

**Photo 1: Engine as first viewed.**

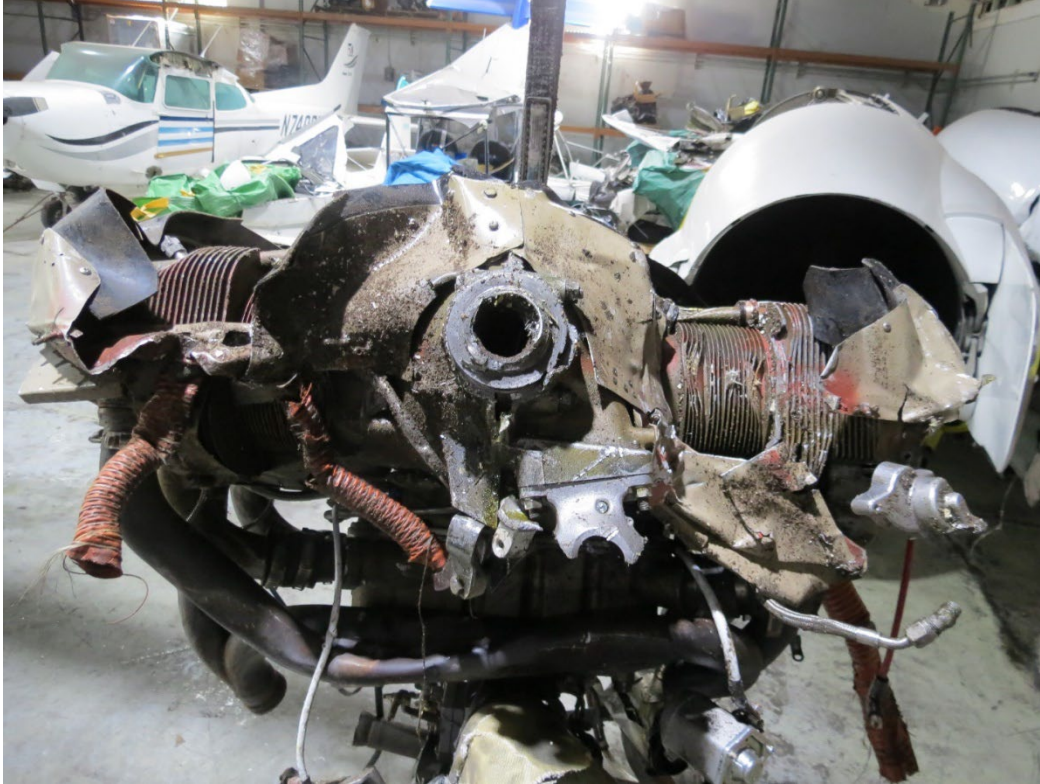
The crankcase was examined and had no holes. The cylinders were examined with a lighted borescope and no anomalies were noted. The crankshaft was rotated using a tool inserted in an accessory case drive pad. Crankshaft continuity was confirmed from the fracture at the crankshaft flange through the rear accessory gears. Compression and suction were confirmed on all cylinders when the crankshaft was

**Photo 2: Impact separation of the crankshaft flange.**

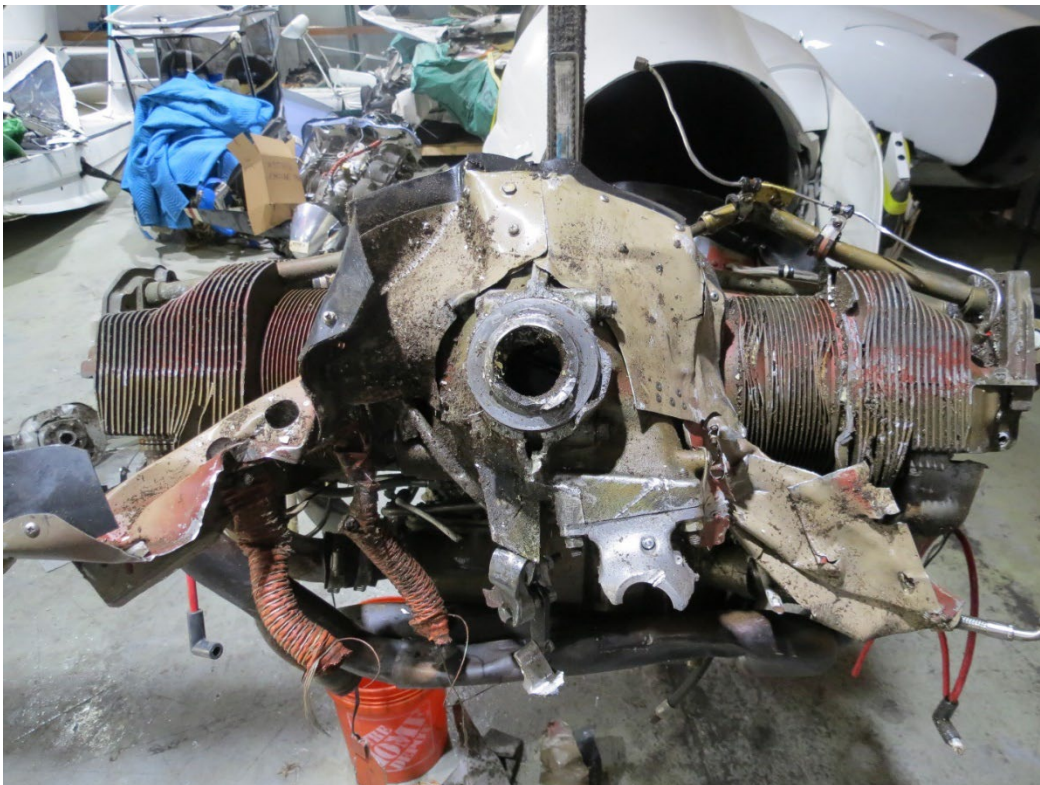
rotated through 720° of rotation. The rocker covers were removed, and valve train continuity was confirmed when the crankshaft was rotated through 720° of rotation.

**Photo 3: View of engine from the front with heat shielding and rocker covers removed.**

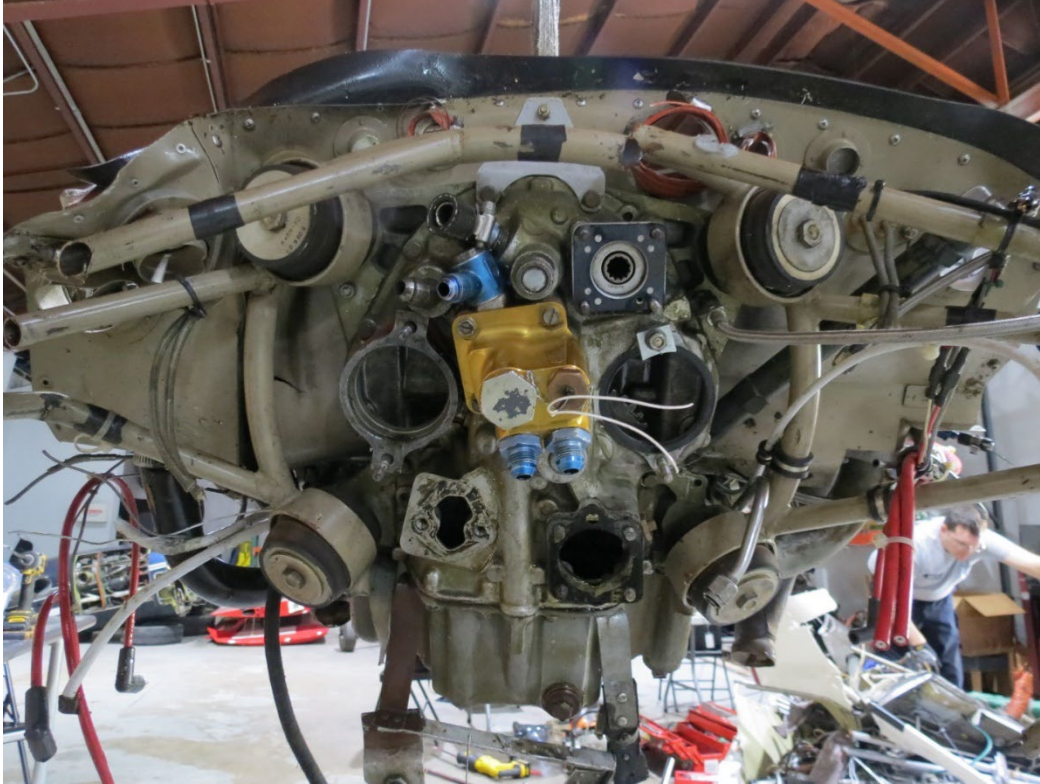
**Photo 4: View of the engine from the rear with accessories removed.**

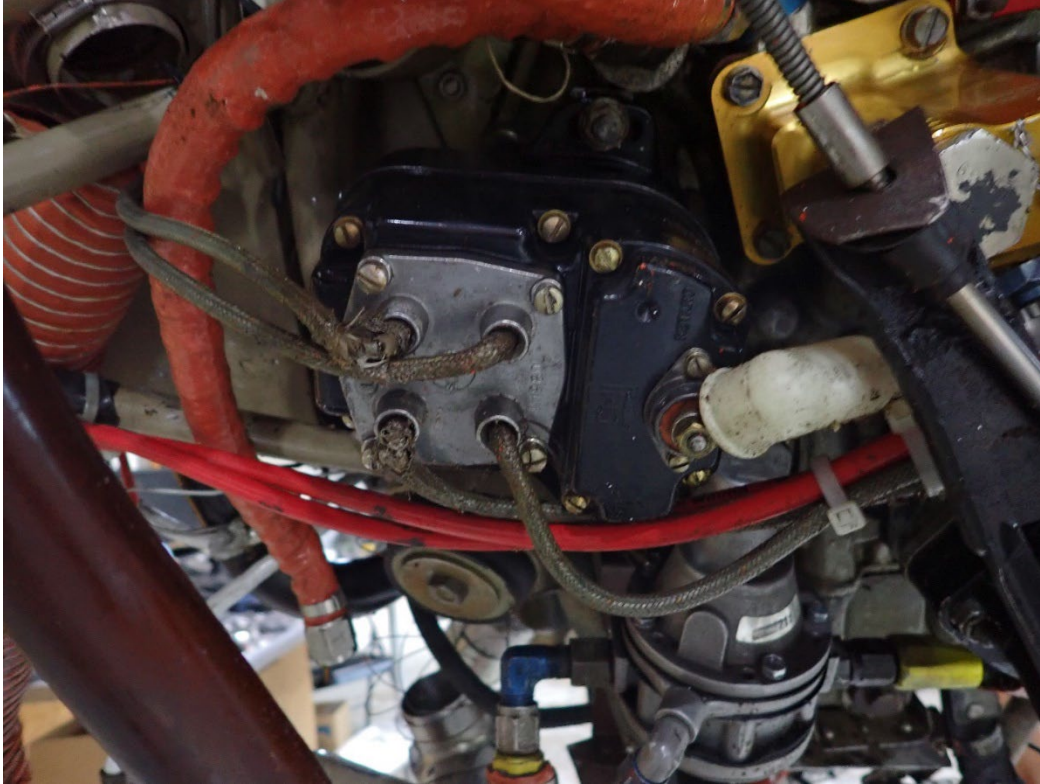
**Photo 5: View of the left standard magneto.**

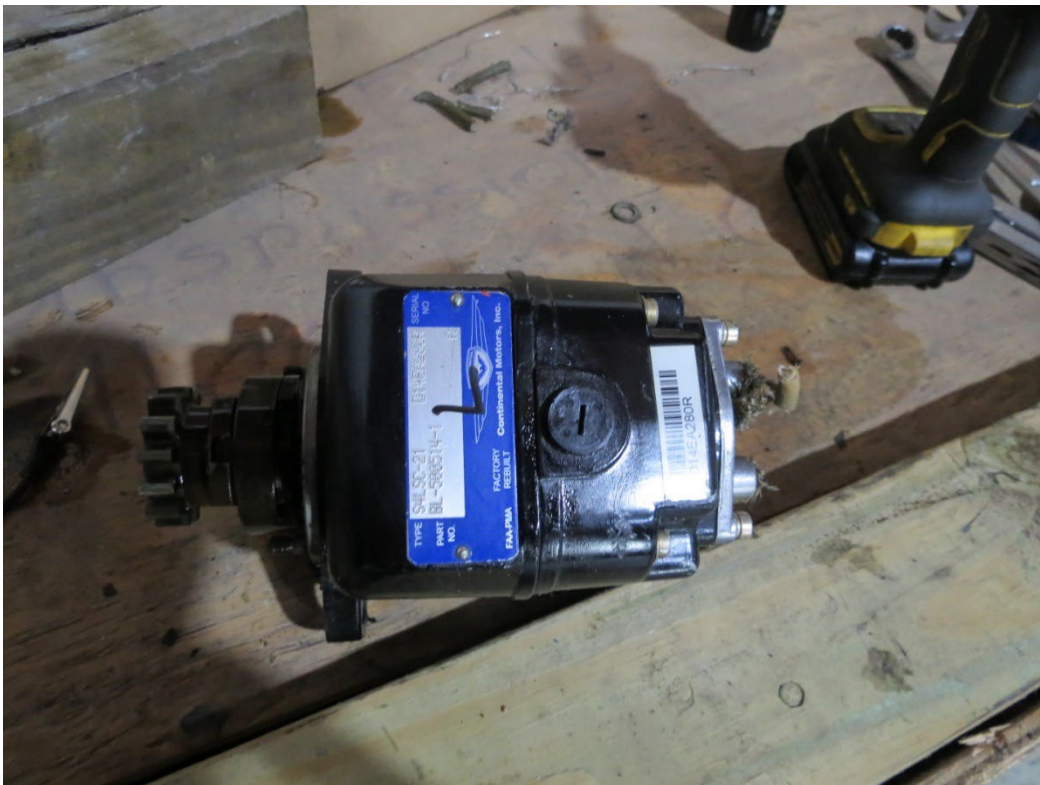
The airplane was equipped with one standard magneto (left) and one electronic magneto (right) which remained attached to the accessory case and were removed for examination. The standard magneto sparked at all leads when rotated by hand. The electronic magneto sparked at all leads when connected to a power source and rotated by hand.

**Photo 6: View of the left standard magneto removed for examination.**

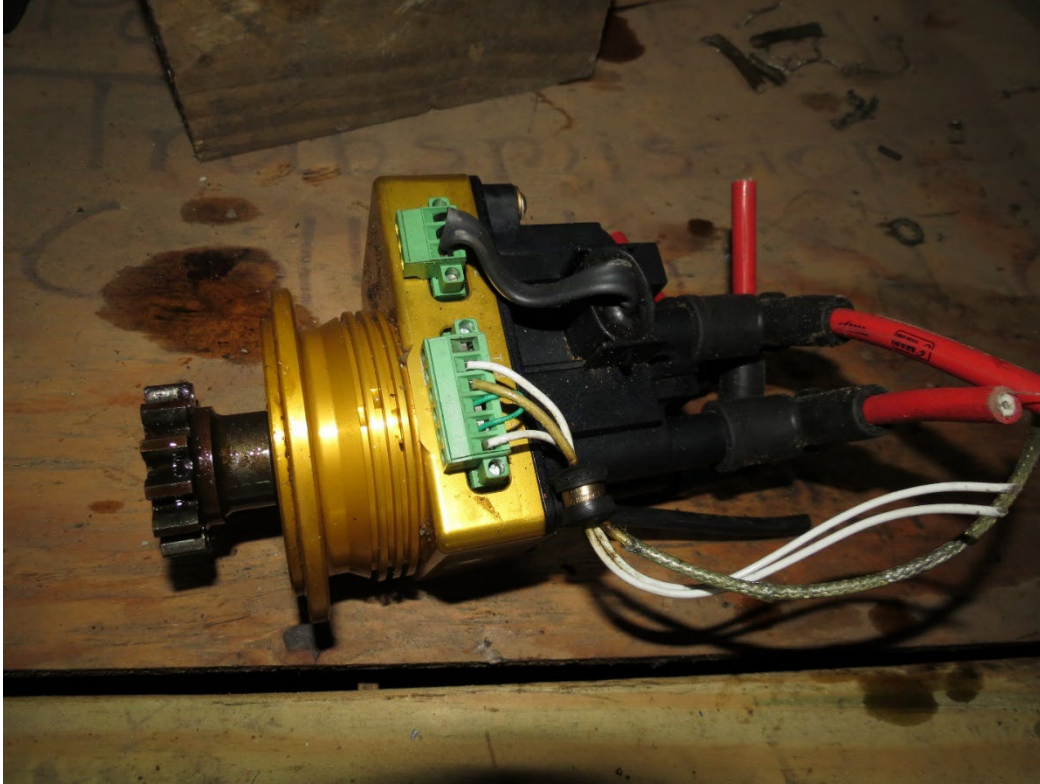
**Photo 7: View of the electronic magneto removed for examination.**

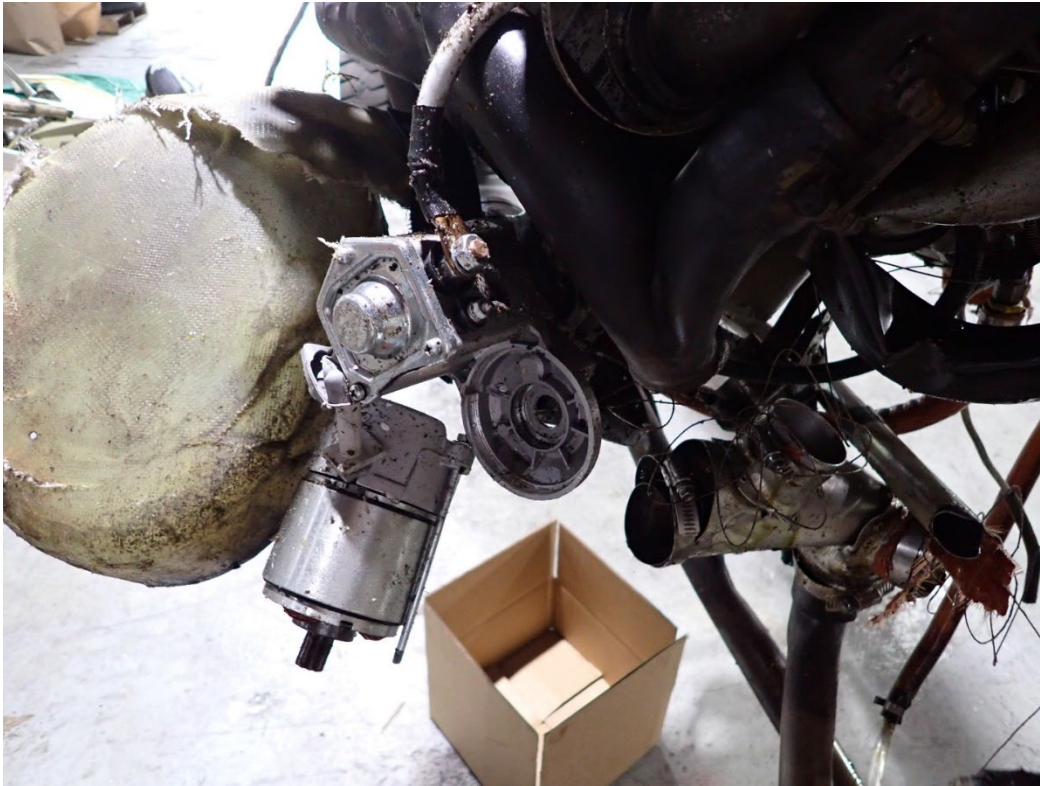
**Photo 8: View of the starter motor hanging from the engine.**

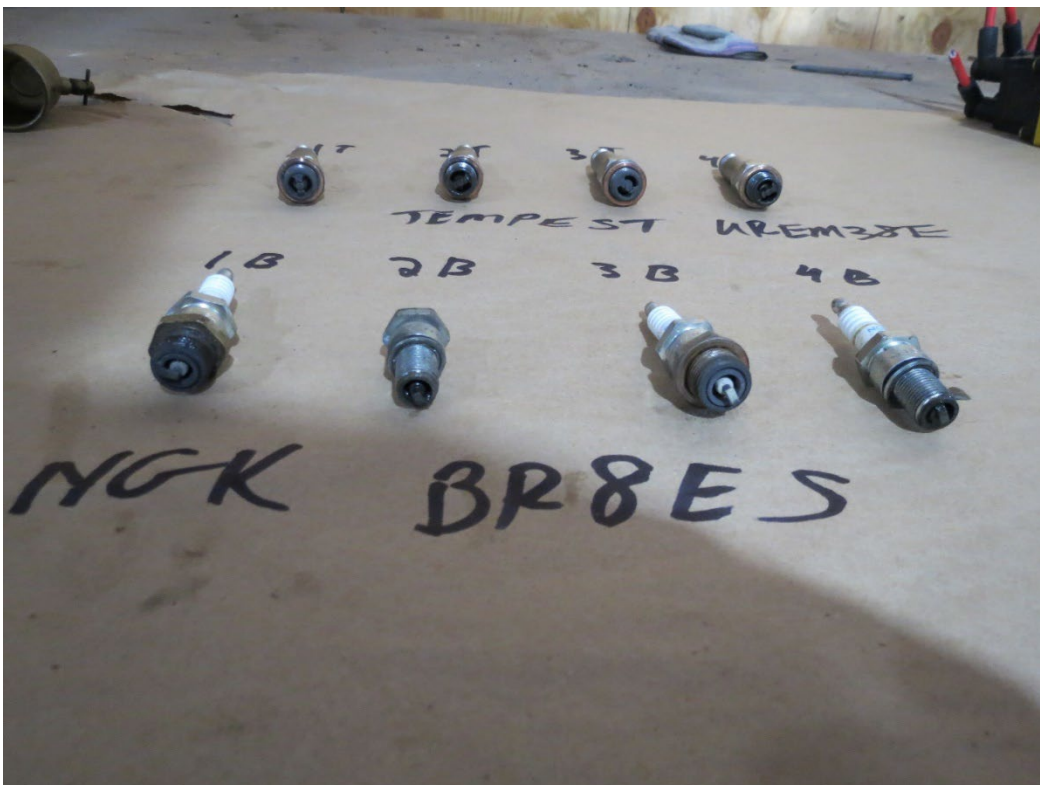
The starter motor was impact separated and fragmented. The top and bottom sparkplugs were removed for examination. All exhibited normal wear when compared to the Champion Aerospace Aviation Check-A-Plug chart. The electrodes of the Nos. 2 and 4 upper spark plugs were oily. The electrodes of the Nos. 2 and 4 lower spark plugs were oily. The No. 2 lower spark plug was impact damaged. The ignition harness was impact damaged.

**Photo 9: View of the top and bottom sparkplugs.**

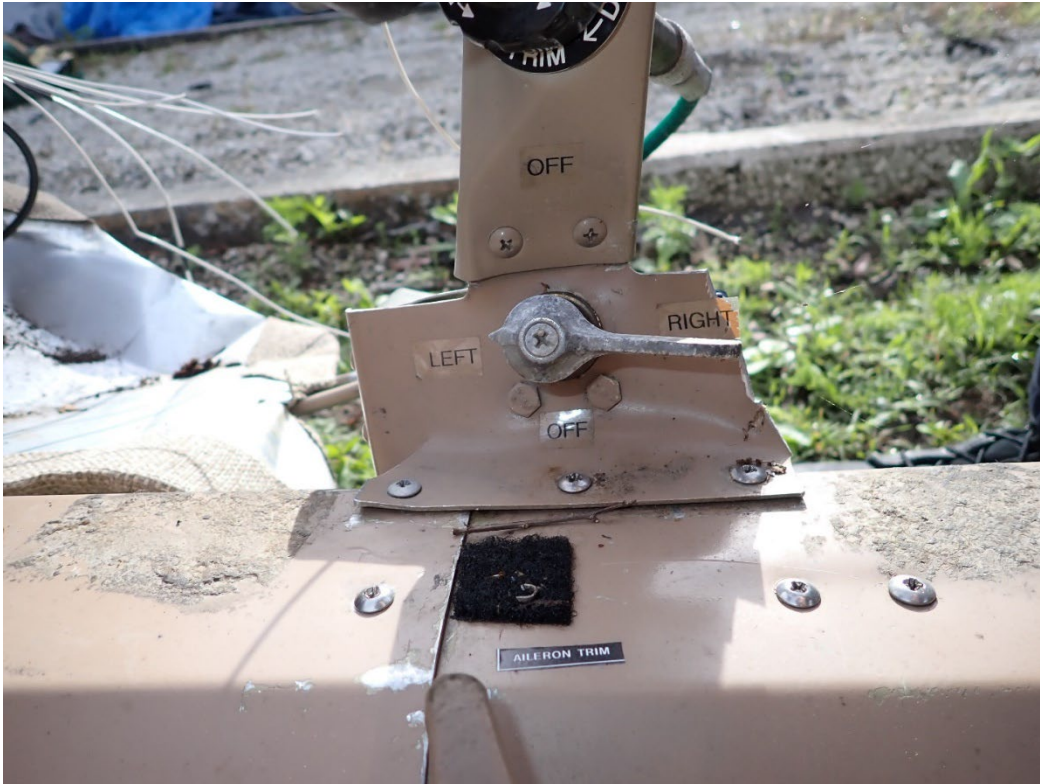
Fuel selector was found in the left position and no obstructions were noted from the selector to impact damage at the wing root when air was blown through the line.

**Photo 10: Fuel selector as first seen at the recovery facility.**

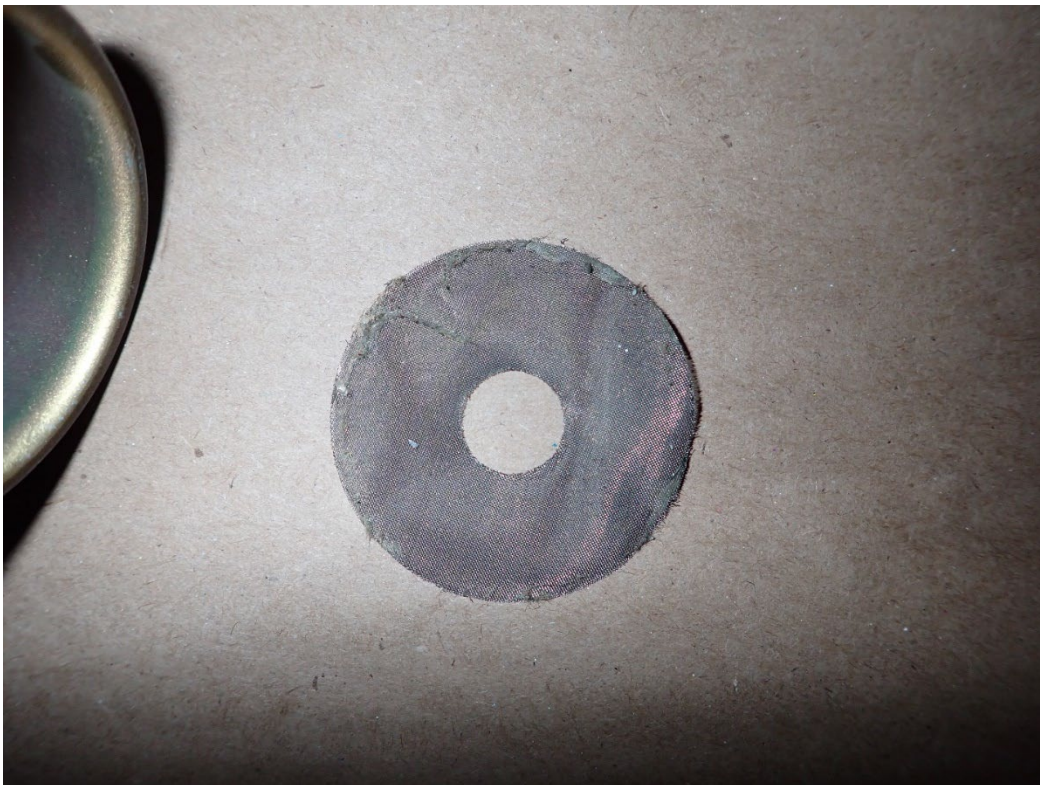
The fuel strainer bowl was removed and examined with no anomalies noted, the fuel strainer screen was removed and exhibited minimal debris.

**Photo 11: View of the fuel strainer screen.**

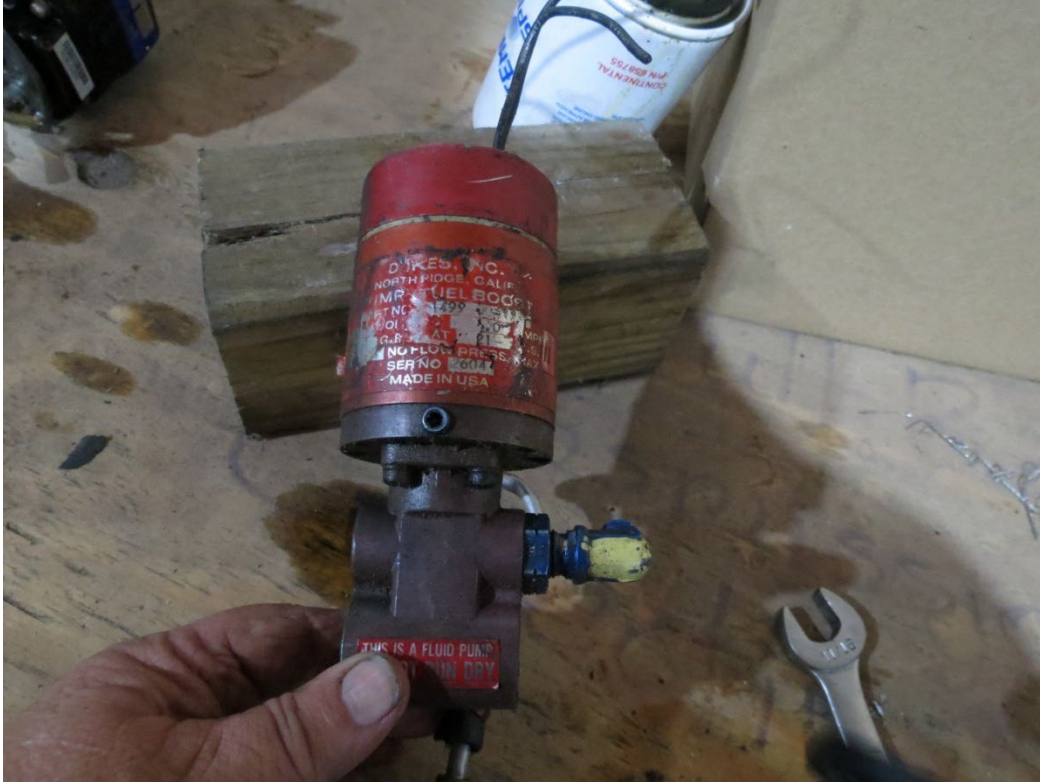
The fuel boost pump remained attached to the firewall and was removed for examination. Power was applied to the airframe fuel boost pump, and it produced air at the outlet port.

**Photo 12: View of the fuel boost pump removed for examination.**

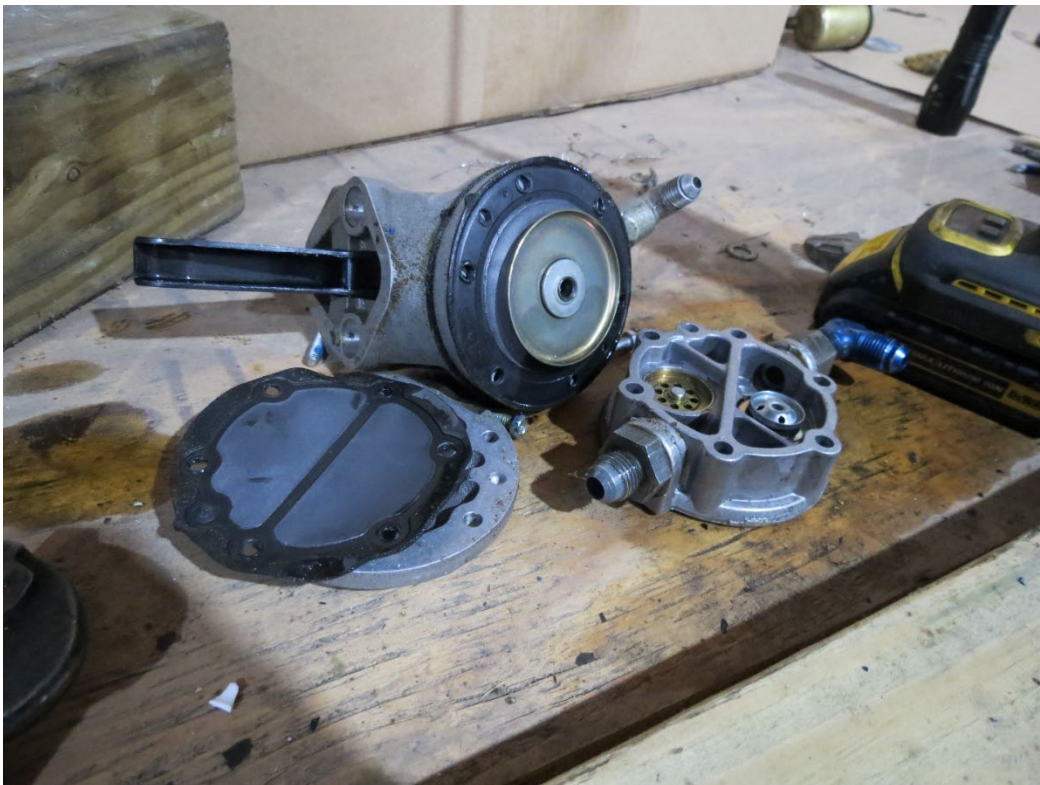
The engine driven fuel pump remained attached to the engine and no damage was noted. Air was produced from the outlet port when the pump was actuated by hand. The pump was partially disassembled and exhibited no damage to the rubber diaphragms or internal check valves.

**Photo 13: View of the engine driven fuel pump disassembled for examination.**

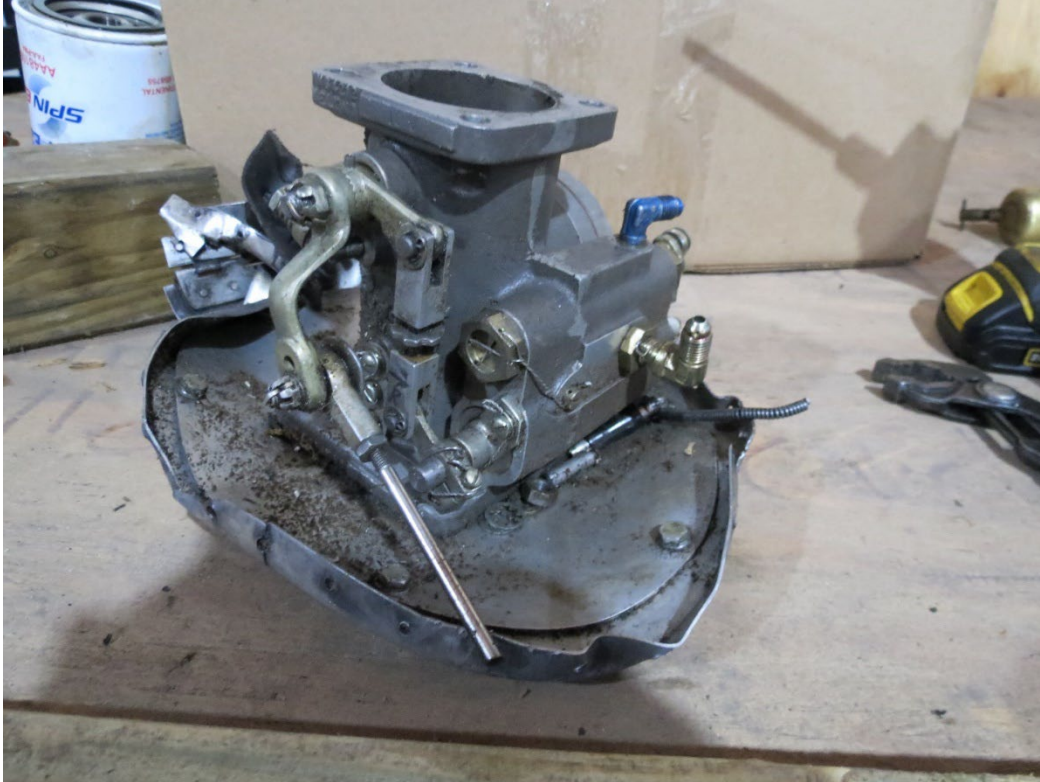
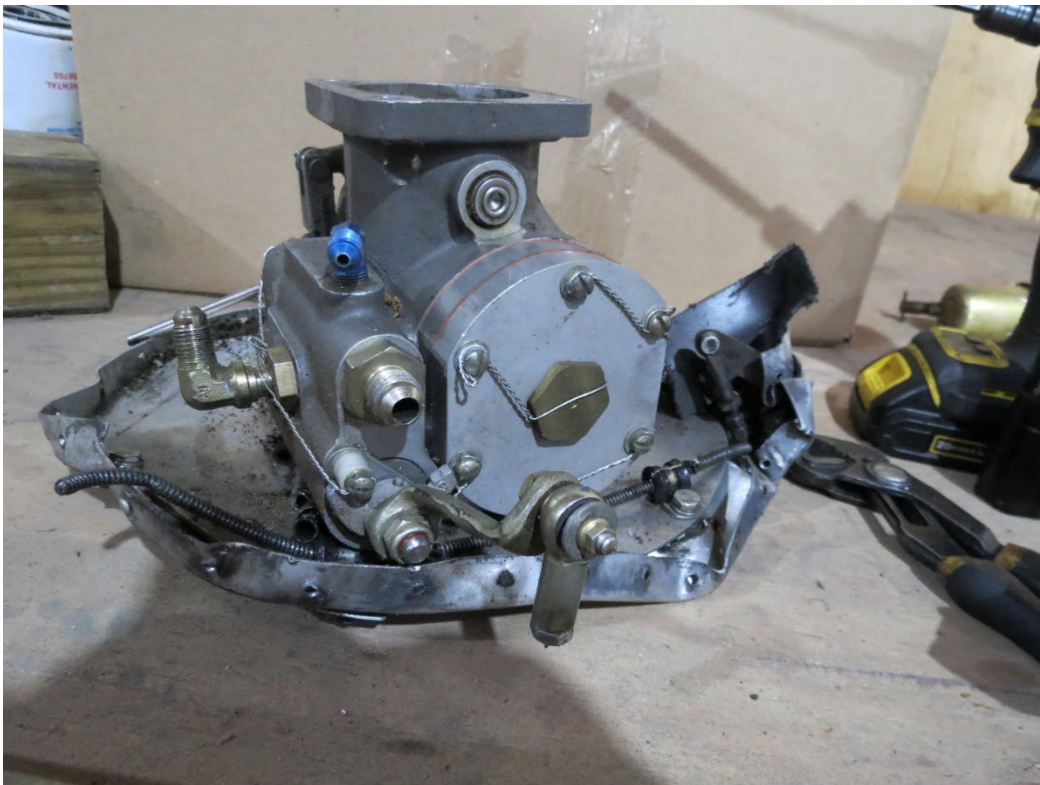
**Photo 14: View of the fuel injector servo removed for examination.**

**Photo 15: View of the fuel injector servo removed for examination.**

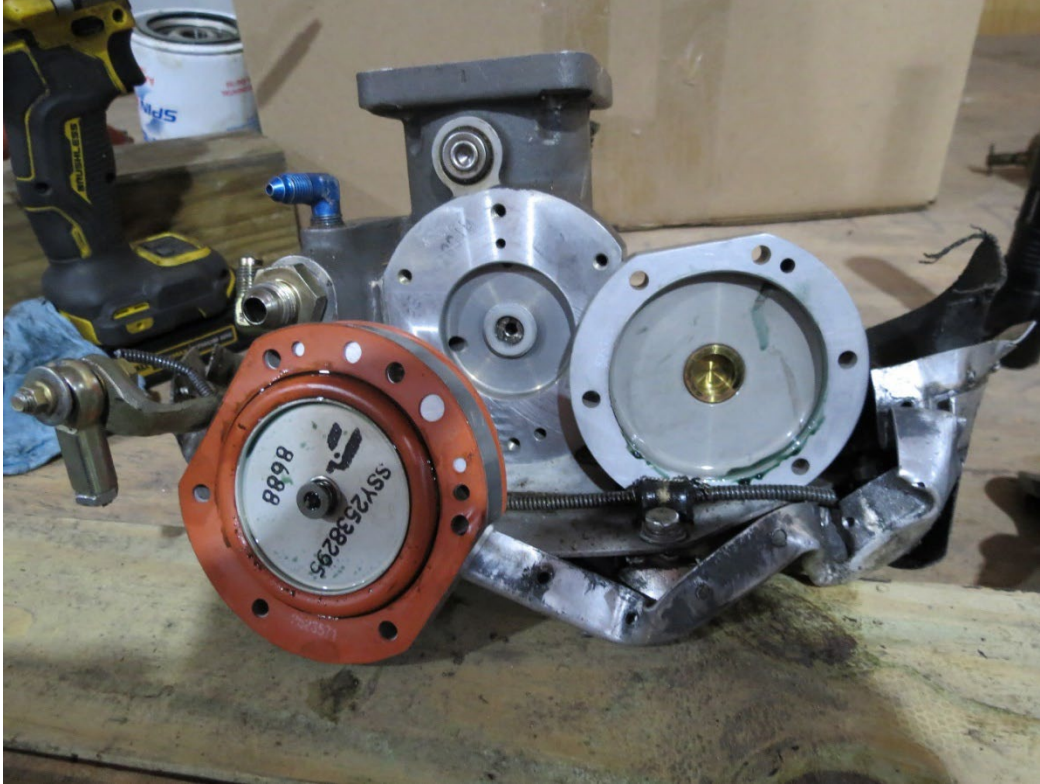
The fuel injector servo remained attached to the engine and no damage was noted. The throttle control cable remained attached to the servo throttle control arm and the arm remained attached to the servo. The mixture control cable remained attached to the servo mixture control arm. The mixture control cable was impact separated at the rod end and the rod end remained attached to the servo. The servo fuel regulator section was partially disassembled and no damage to the rubber diaphragms or other internal components observed. The servo fuel inlet screen was absent of debris.

**Photo 16: View of the fuel injector servo partially disassembled for examination.**

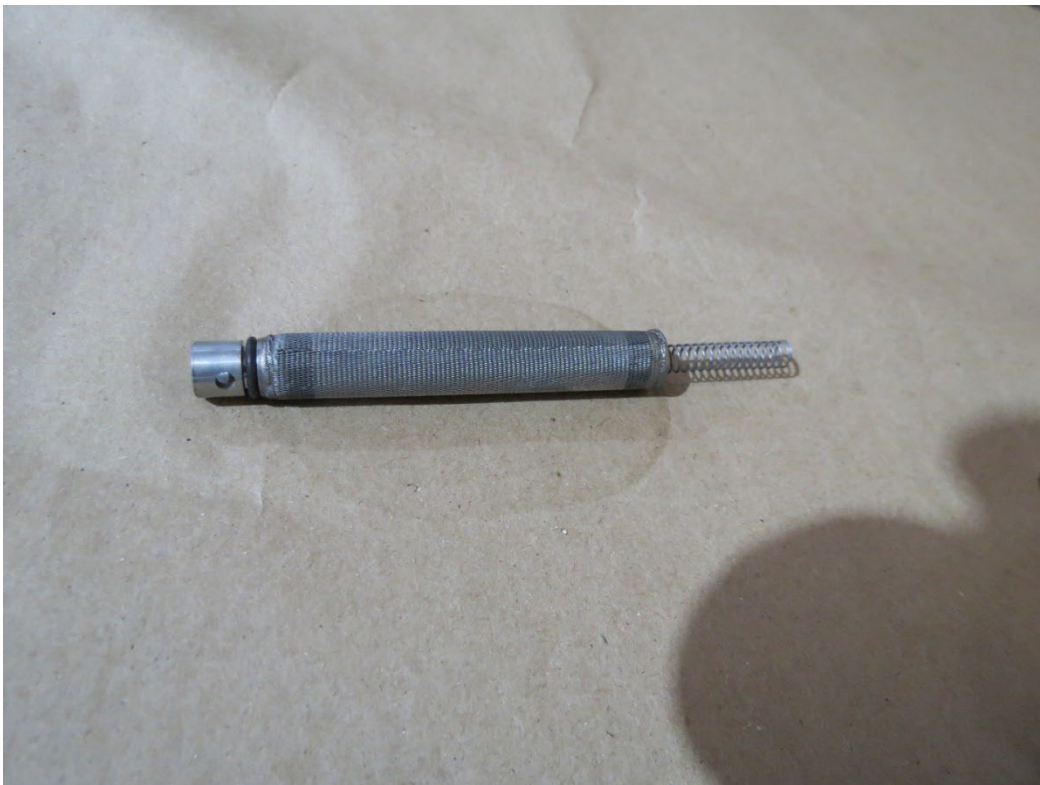
**Photo 17: View of the servo fuel inlet screen.**

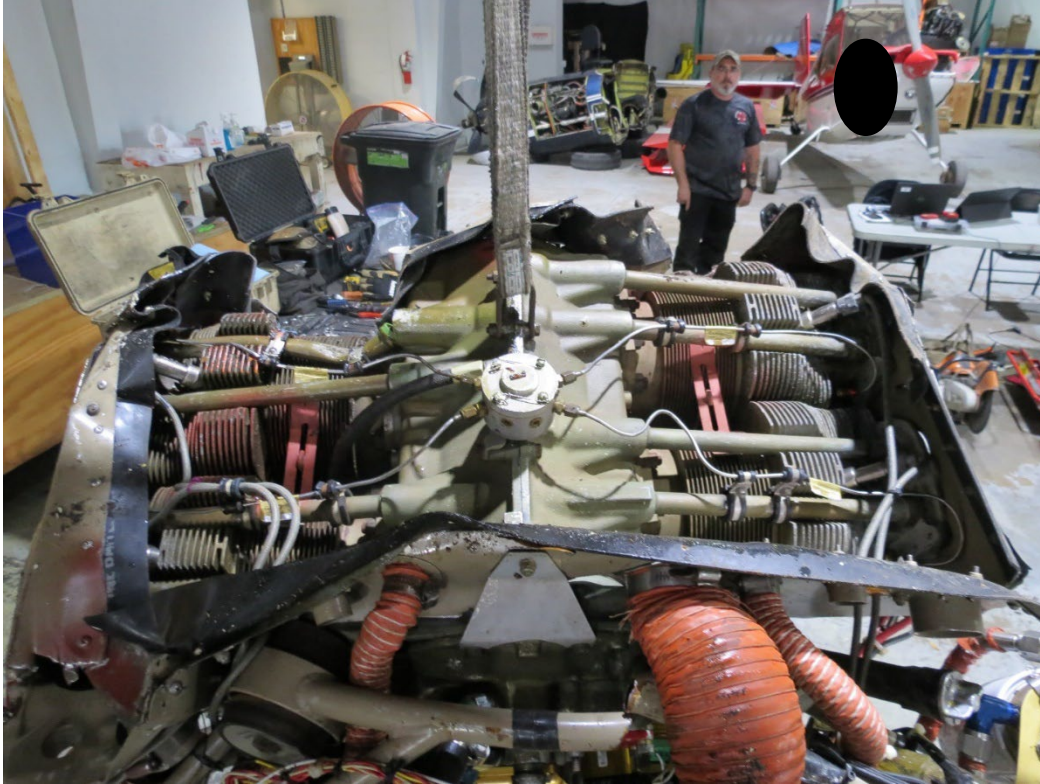
**Photo 18: View of the fuel flow divider attached to the engine.**

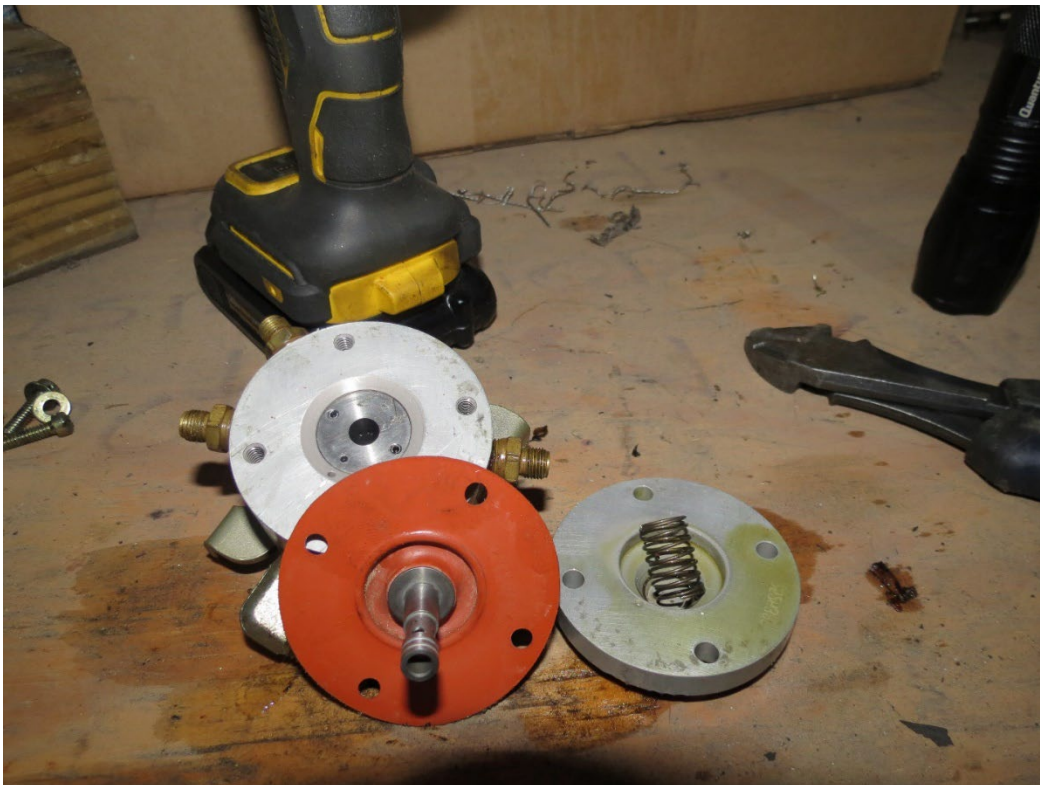
The fuel flow divider remained attached to the engine and no damage was noted. It was partially disassembled, and the rubber diaphragm was observed intact.

**Photo 19: View of the fuel flow divider disassembled for examination.**

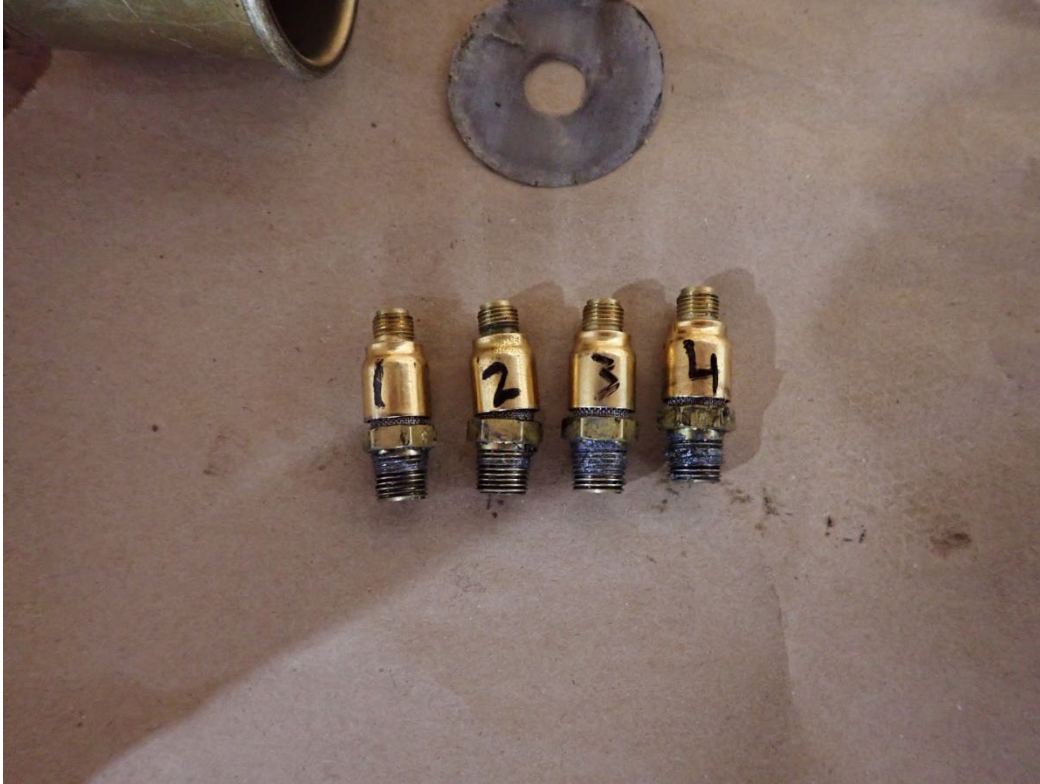
The one-piece GamiJector fuel injector nozzles were unobstructed. The #2 nozzle was impact damaged.

**Photo 20: View of all four fuel injector nozzles.**

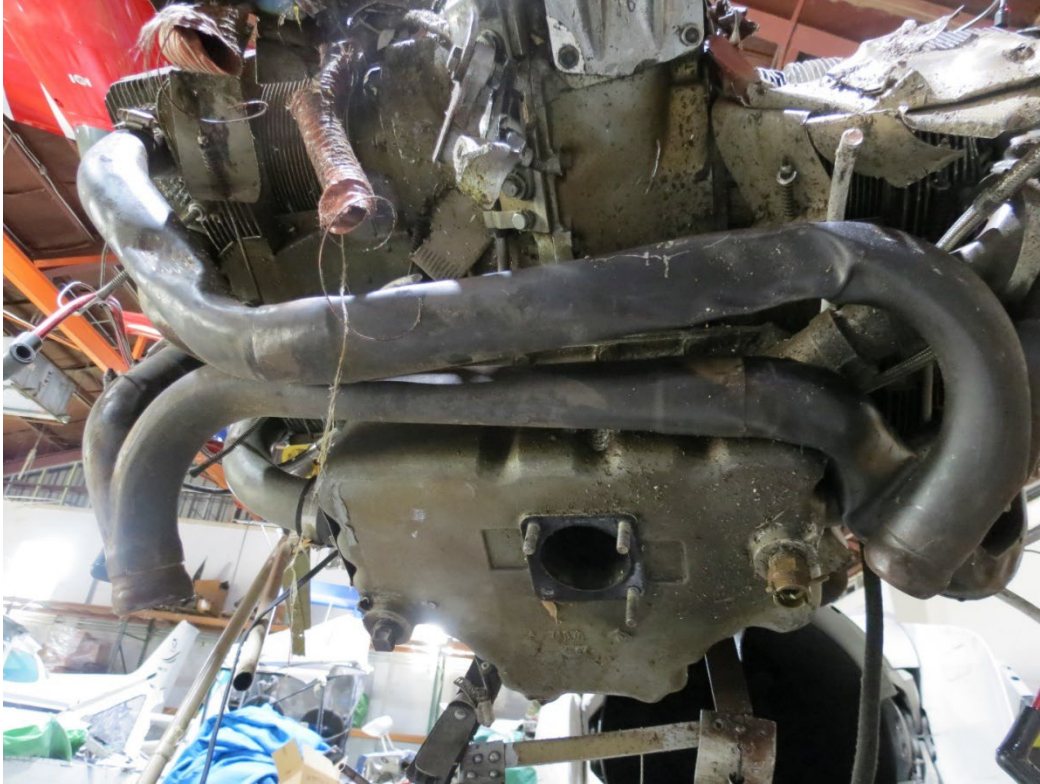
**Photo 21: View of the oil pan from the bottom with the fuel injector servo removed.**

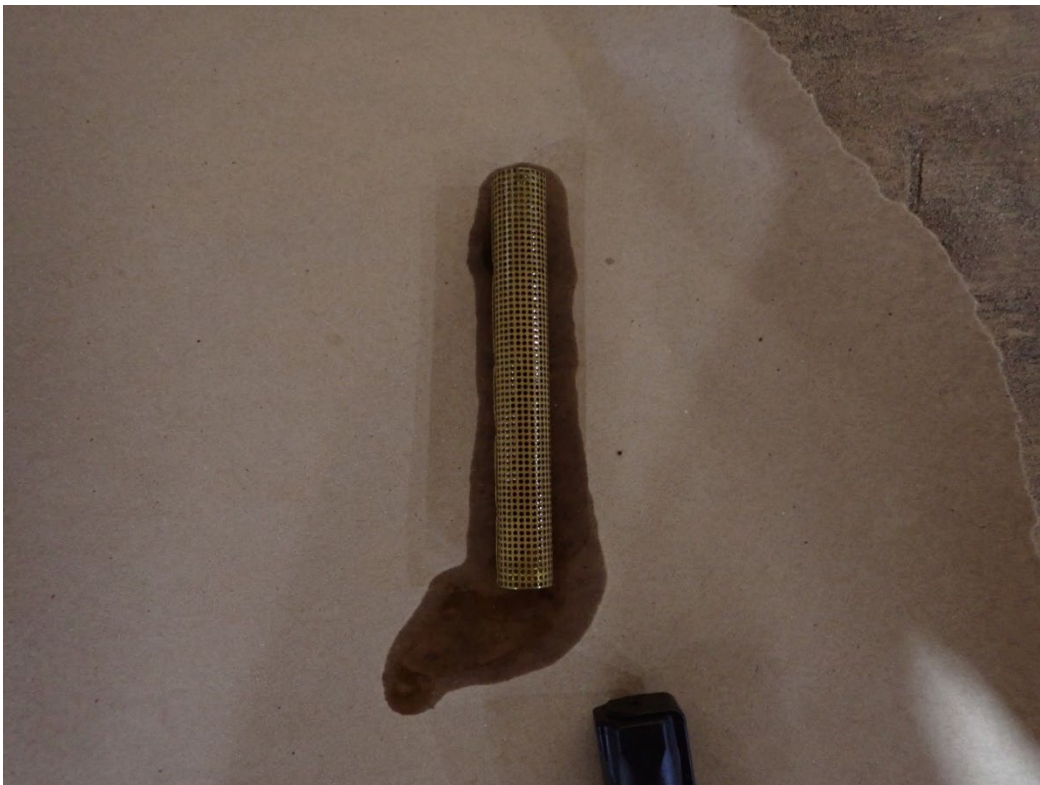
**Photo 22: View of the oil suction screen removed for examination.**

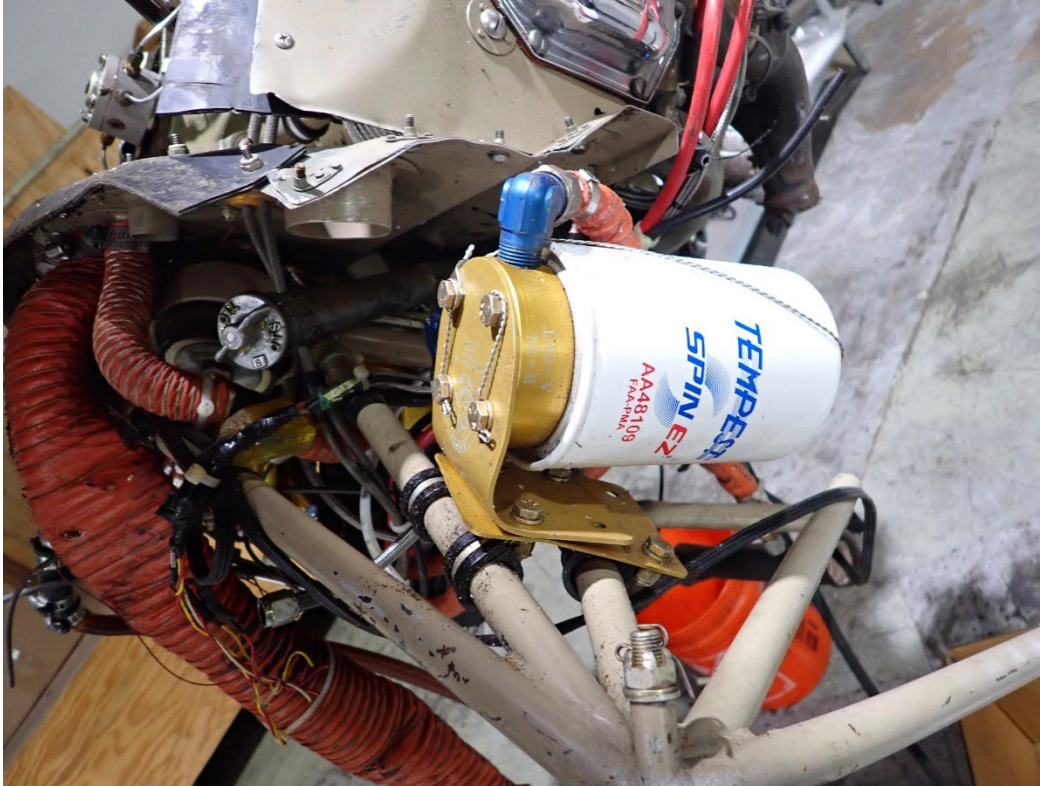
**Photo 23: View of the oil filter attached to its mount.**

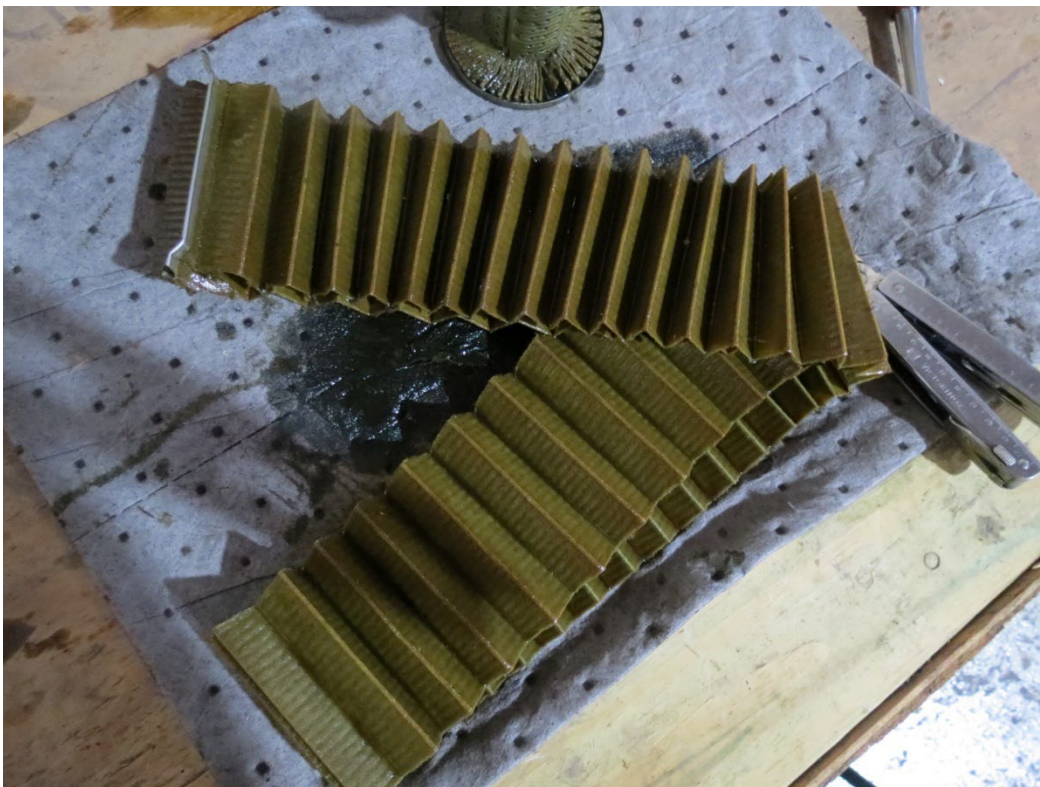
Oil was observed in the engine. The oil sump remained attached to the crankcase and was not damaged. The oil suction screen was removed and examined with no debris noted. The oil filter remained attached to its mount and was removed for examination. The filter was removed, cut open, and the pleats were examined with no debris noted.

**Photo 24: View of the oil filter pleats.**

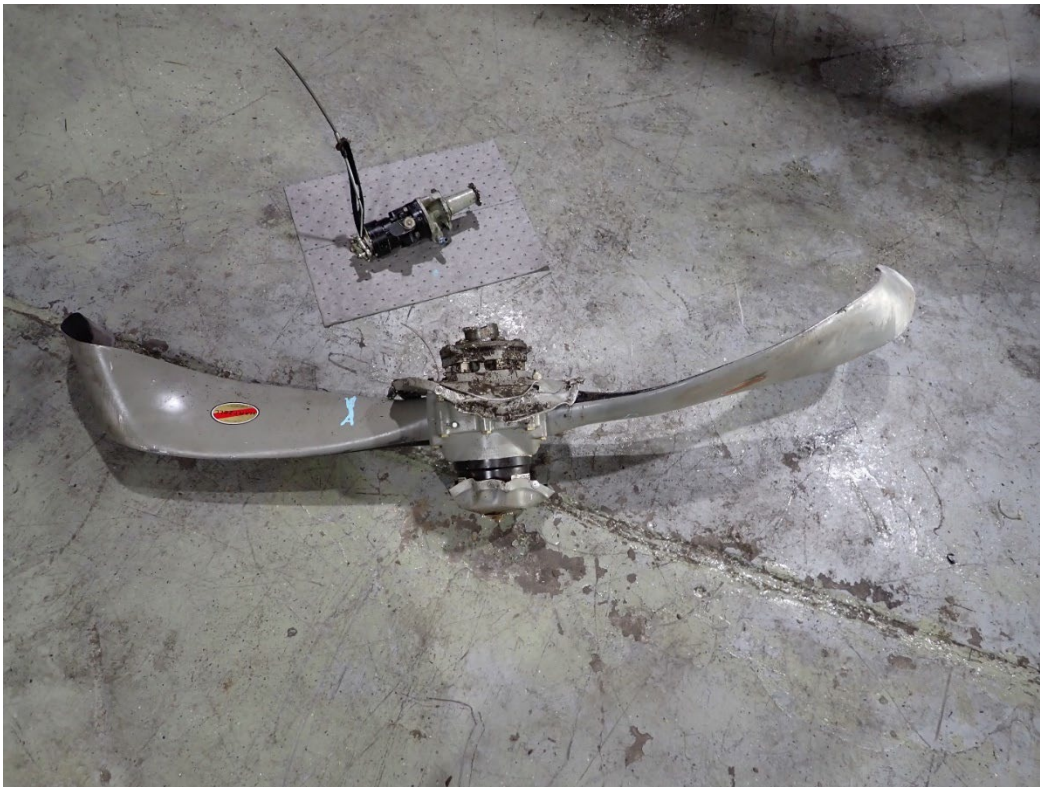
**Photo 25: Overview of the propeller.**

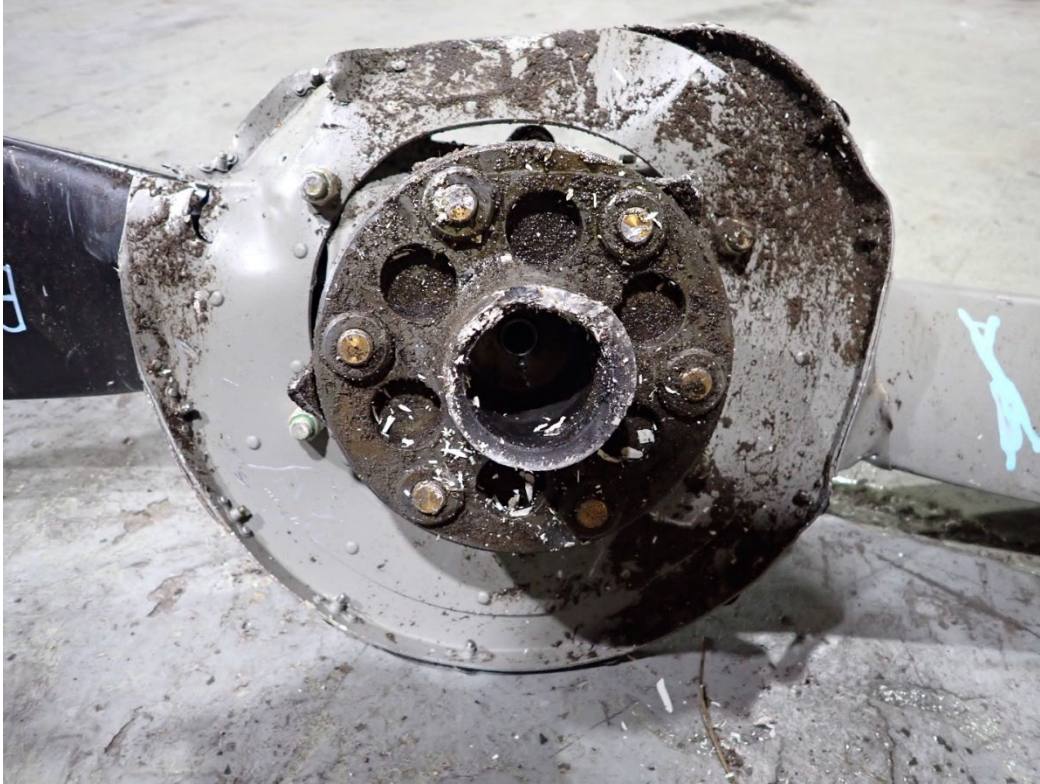
**Photo 26: View of the crankshaft flange which remained attached to the propeller hub.**
