# National Transportation Safety Board

ERA23LA124

## **ENGINE EXAMINATION**

Location: Jacksonville, Florida  
Date: February 6, 2023  
Time: 1432 EST  
1932 UTC  
Airplane: N330PC; RV-6

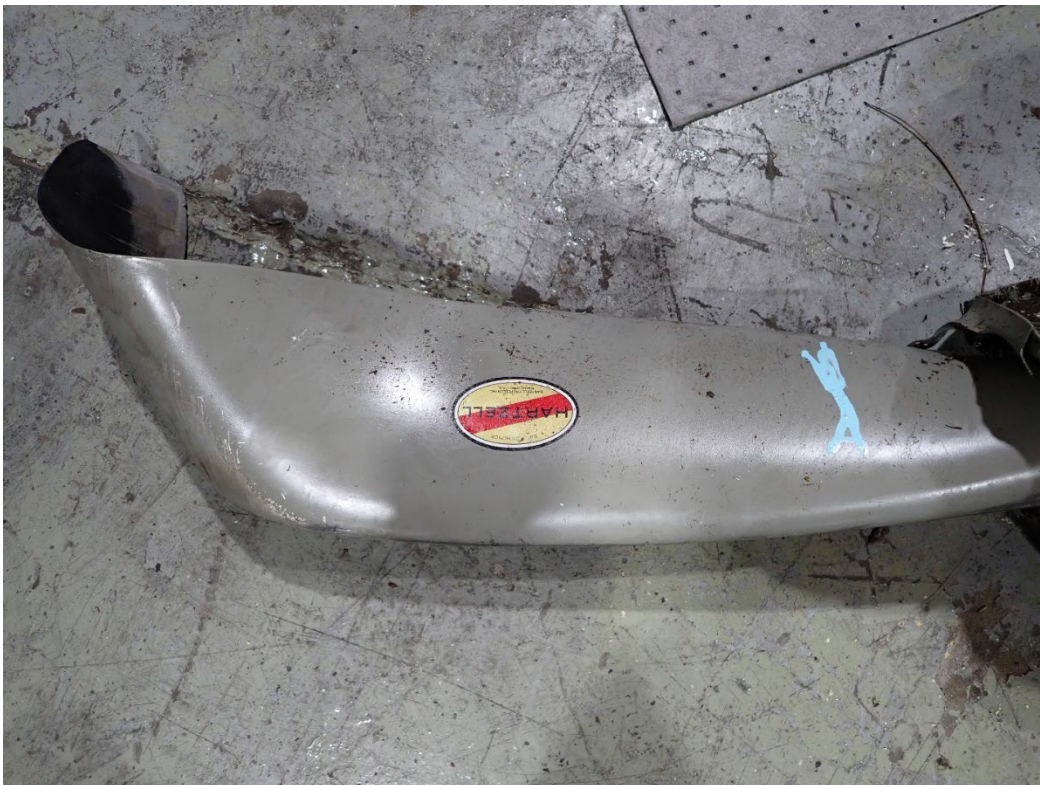
**Photo 27: Camber side of propeller blade A.**

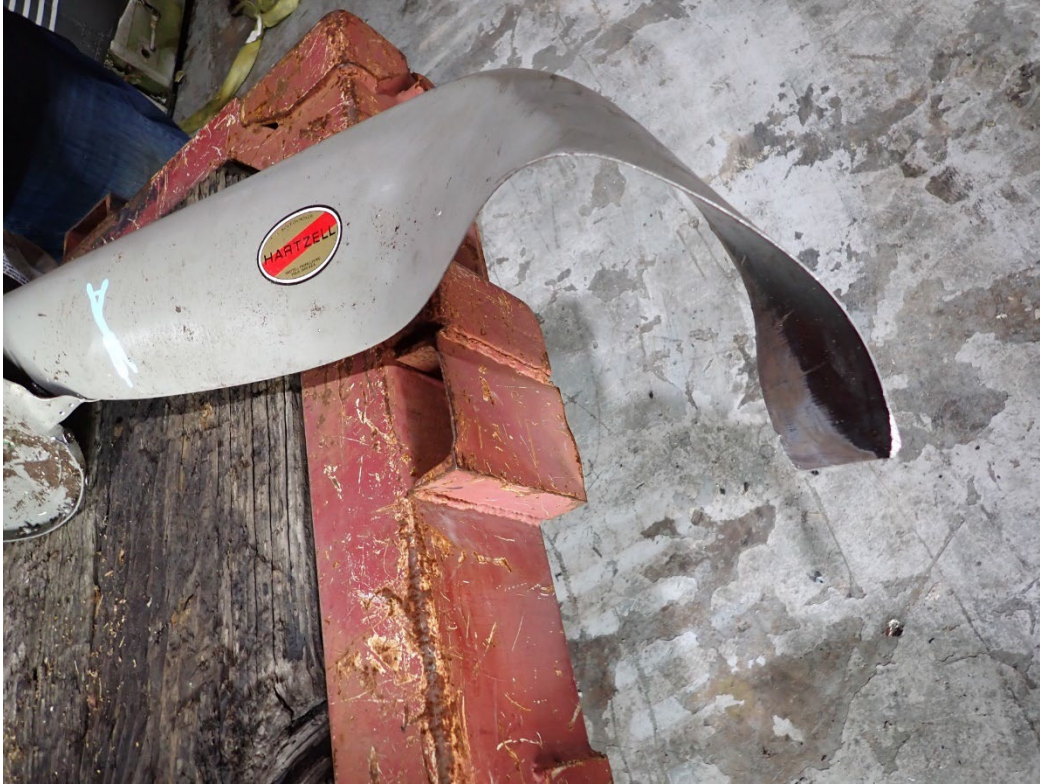
The propeller and crankshaft propeller flange were impact separated from the engine. The propeller spinner was separated from the propeller. The propeller blade marked "A" was rotated about 90 degrees in the hub such that the leading edge faced forward and was curled aft beginning about 1 foot from the tip. That blade also exhibited trailing edge "S" bending, spanwise twisting, chord-wise abrasion and leading-edge gouges. The blade marked "B" was curled aft beginning about 8 inches from the tip and exhibited spanwise twisting, chord-wise abrasion and leading-edge gouges.

**Photo 28: S-bending of propeller blade A.**

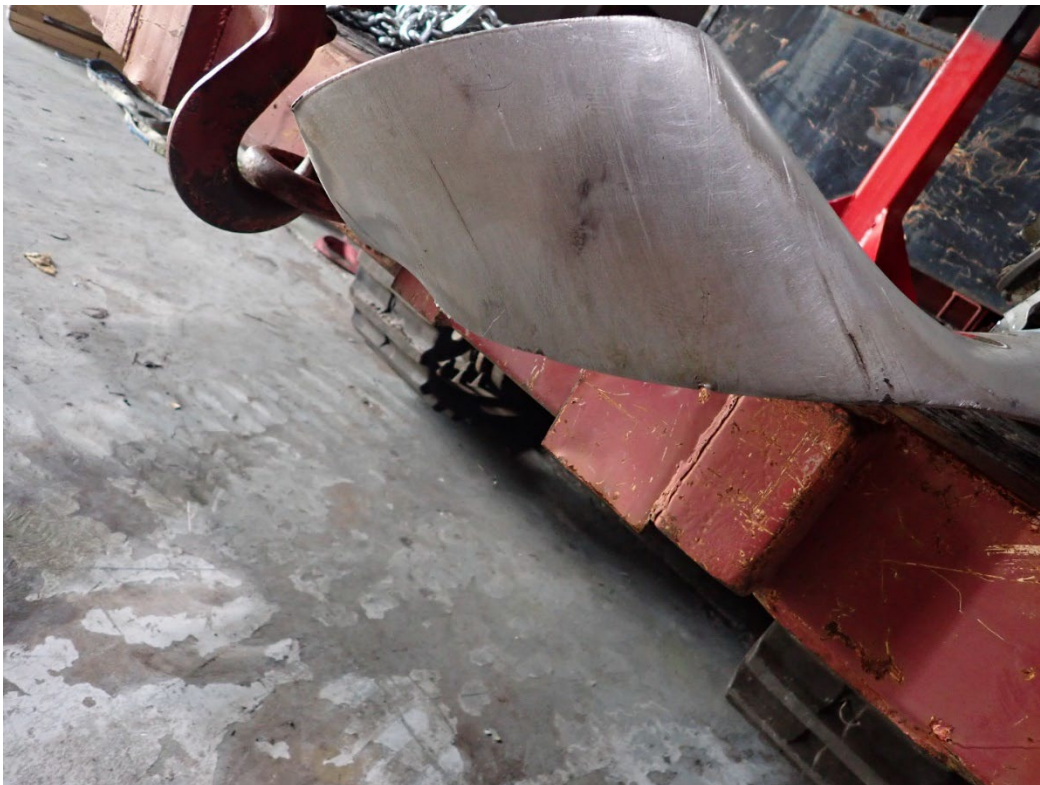
**Photo 29: Polishing and leading-edge gouging of propeller blade A.**

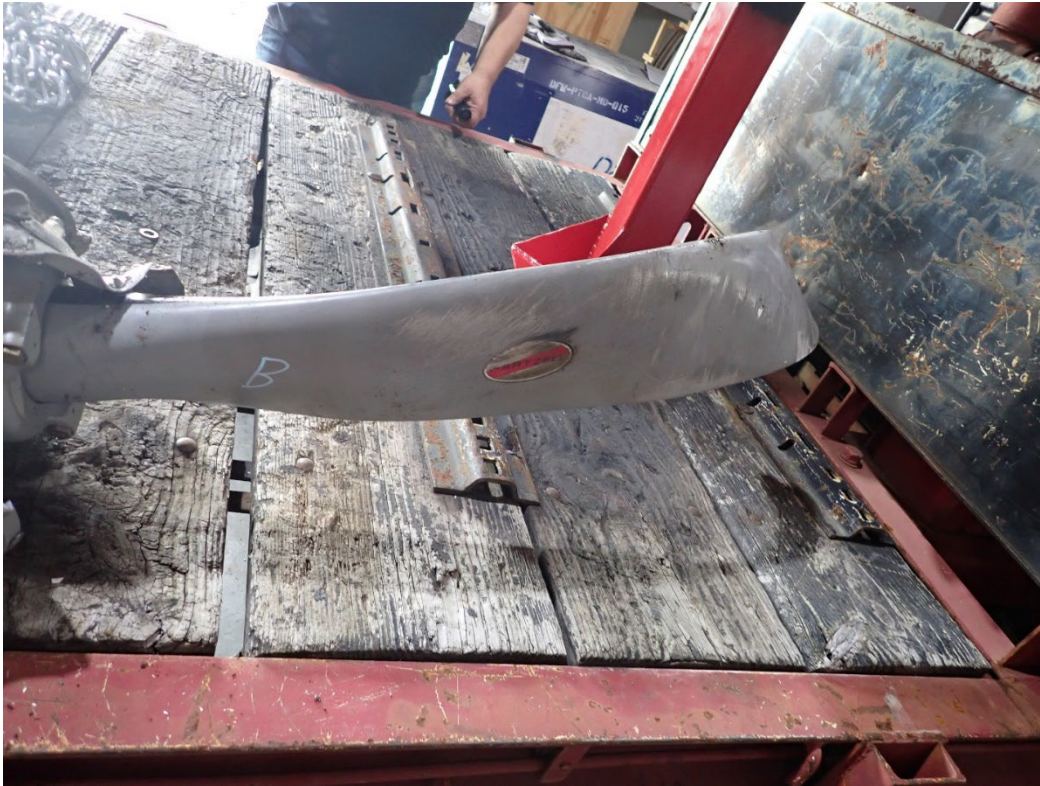
**Photo 30: View of the camber side of propeller blade B.**

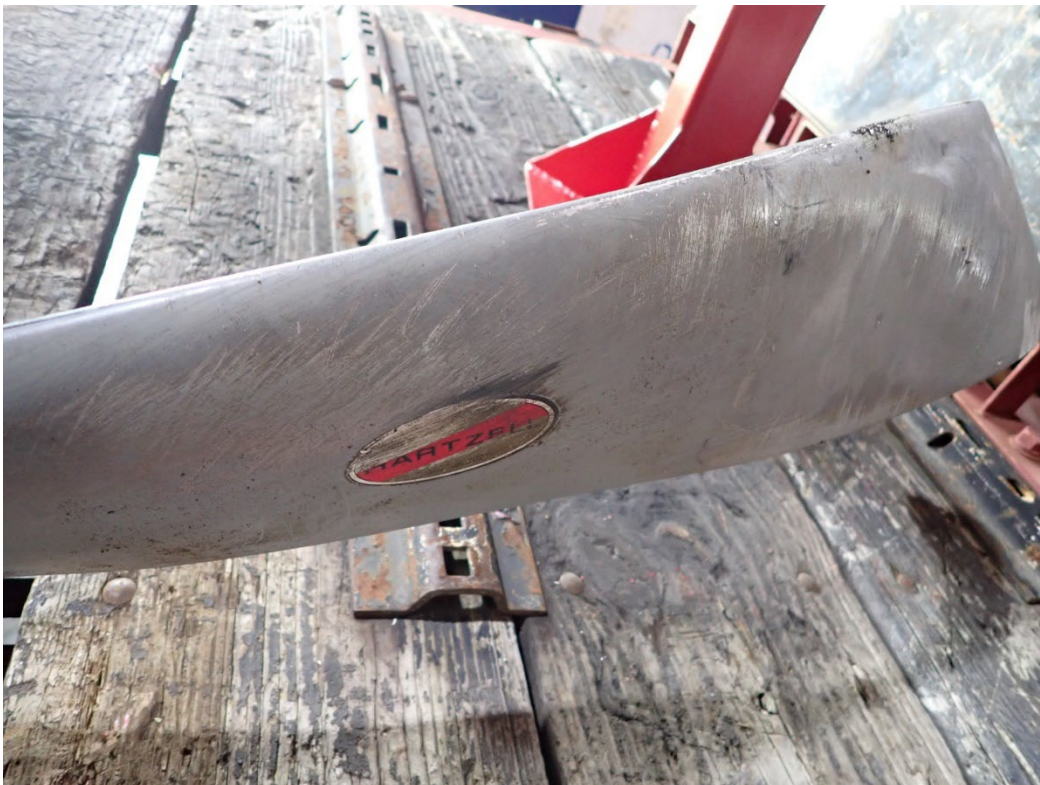
**Photo 31: Chordwise scratching and polishing of propeller blade B.**

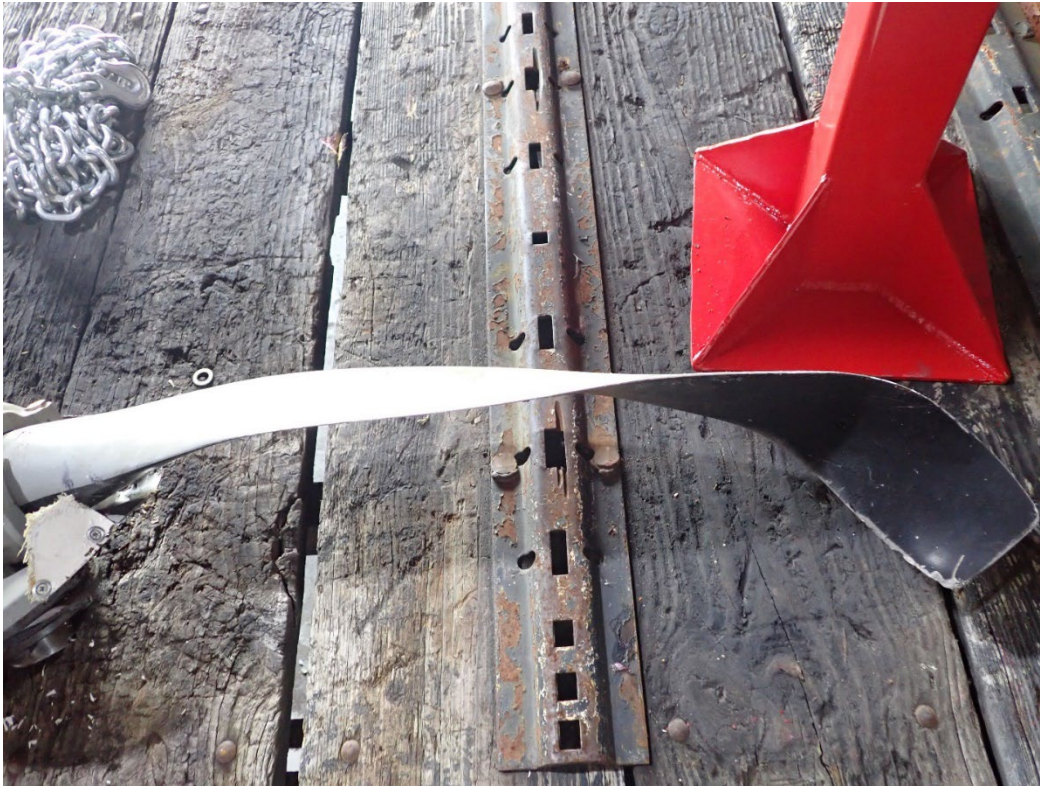
**Photo 32: Trailing edge of propeller blade B.**

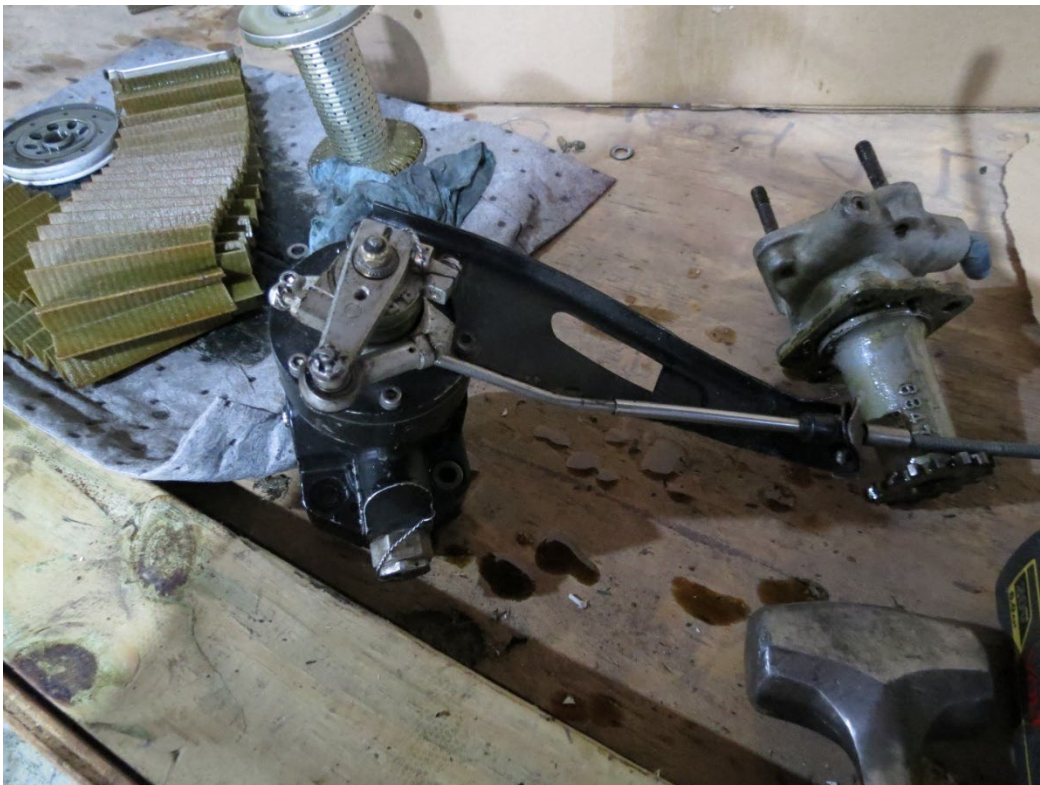
The propeller governor remained attached to the engine and no damage was noted. The propeller control cable was fractured at the rod end near the governor. The rod end remained attached to the governor control arm and the arm remained attached to the governor. The governor drive assembly was rotated freely by hand. The governor oil screen was absent of debris.

**Photo 33: Overview of the propeller governor partially disassembled for examination.**

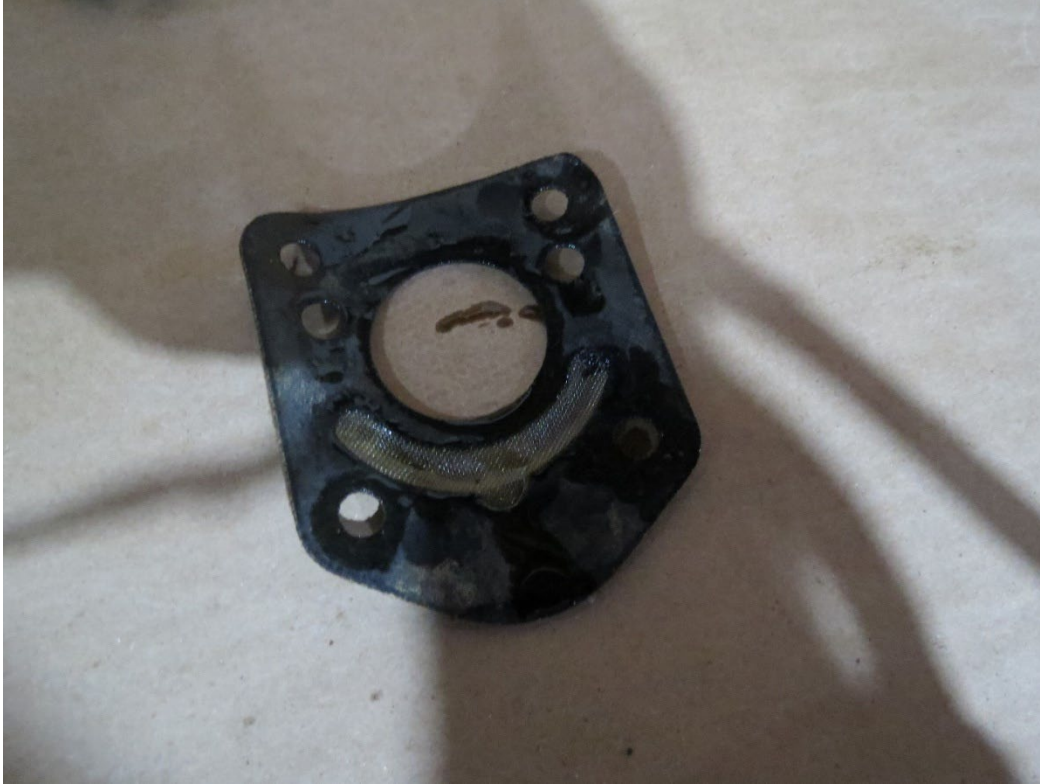
**Photo 34: Propeller governor oil screen.**
