NTSB ERA23LA124

N330PC, RV-6

Photo Array

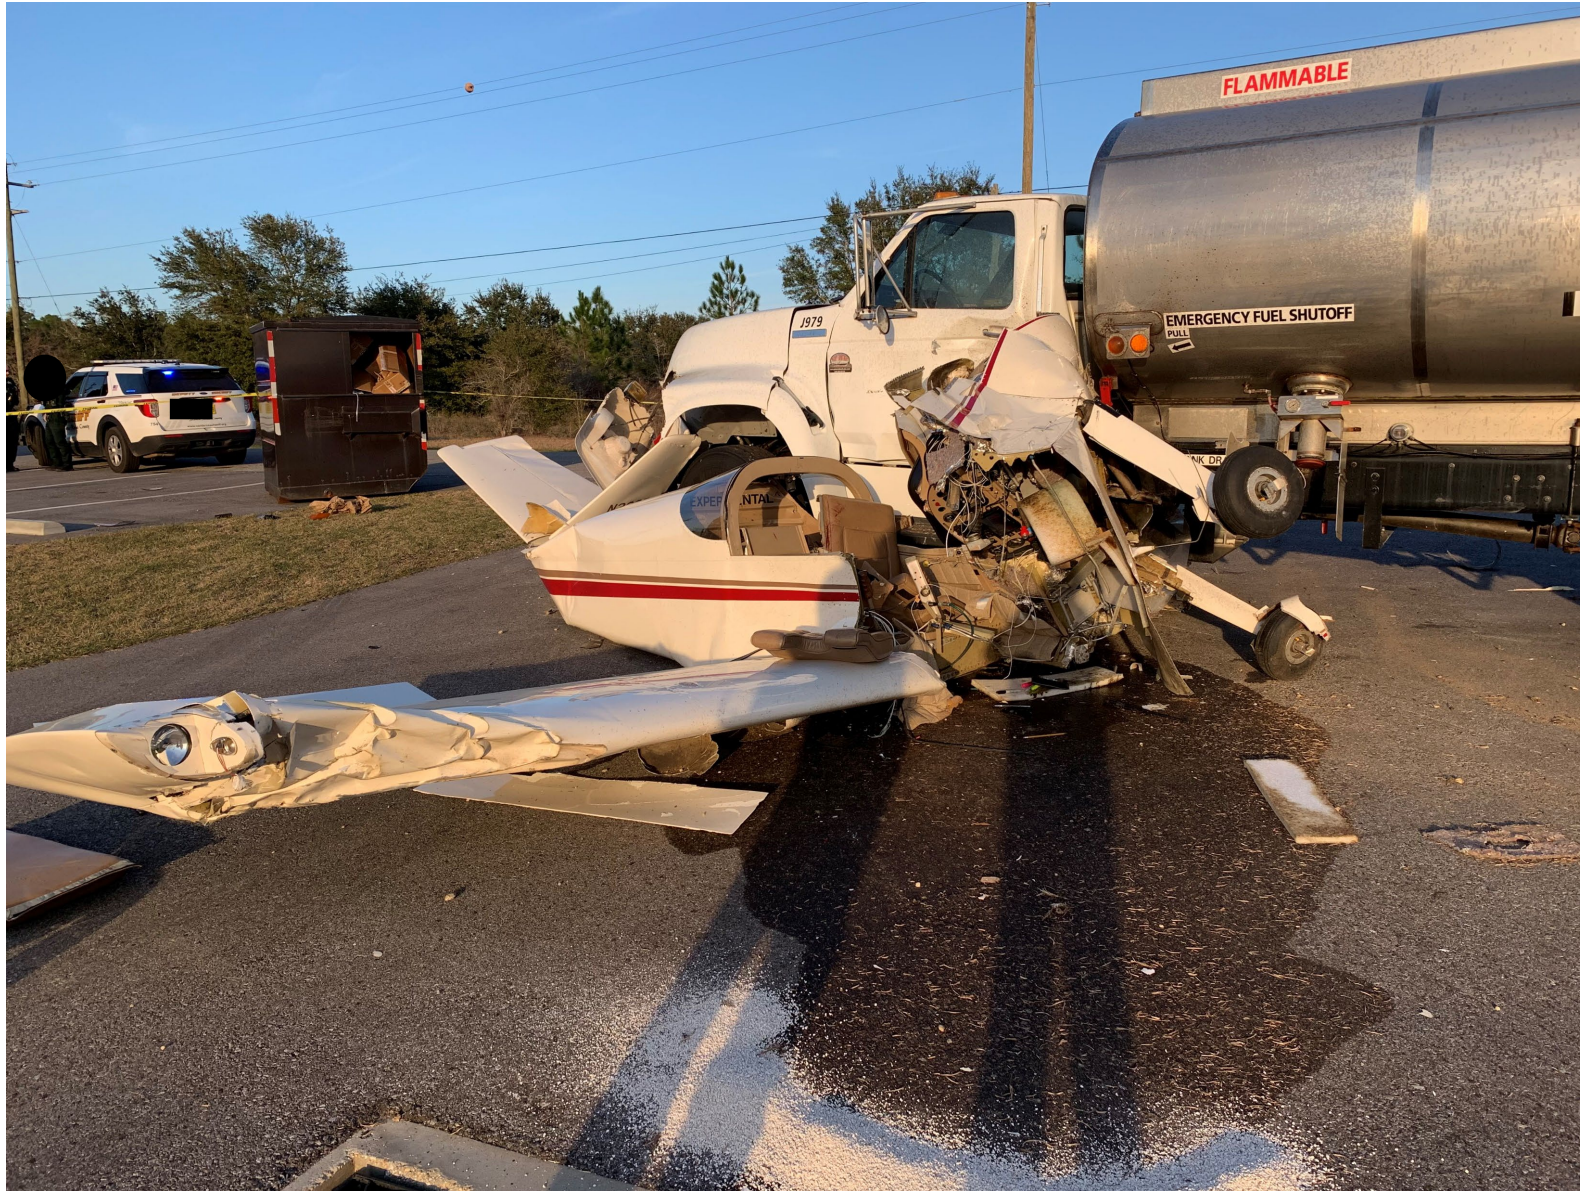
Photo 1: View of the airplane at the accident site (Photo Courtesy of FAA)

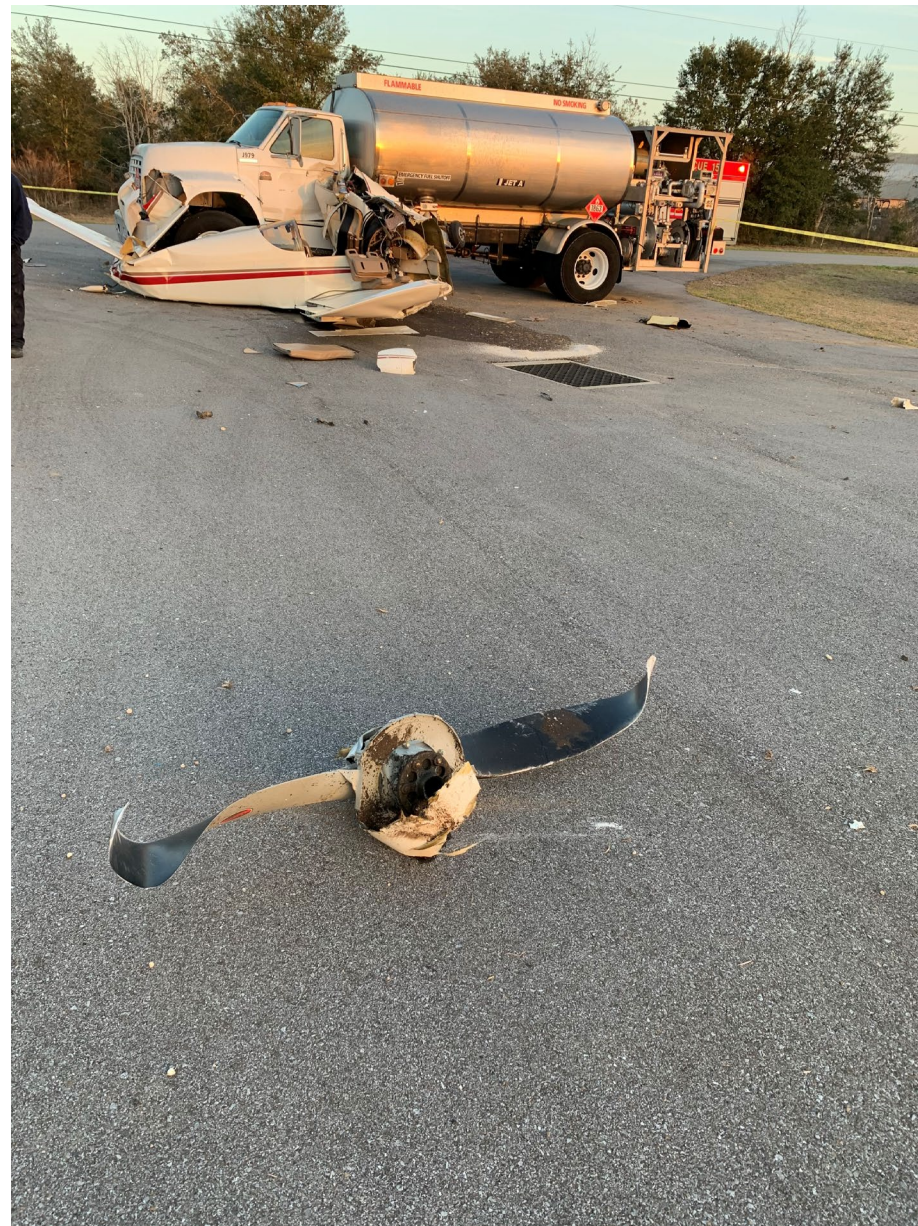
Photo 2: View of the propeller and airplane at the accident site (Photo Courtesy of FAA)

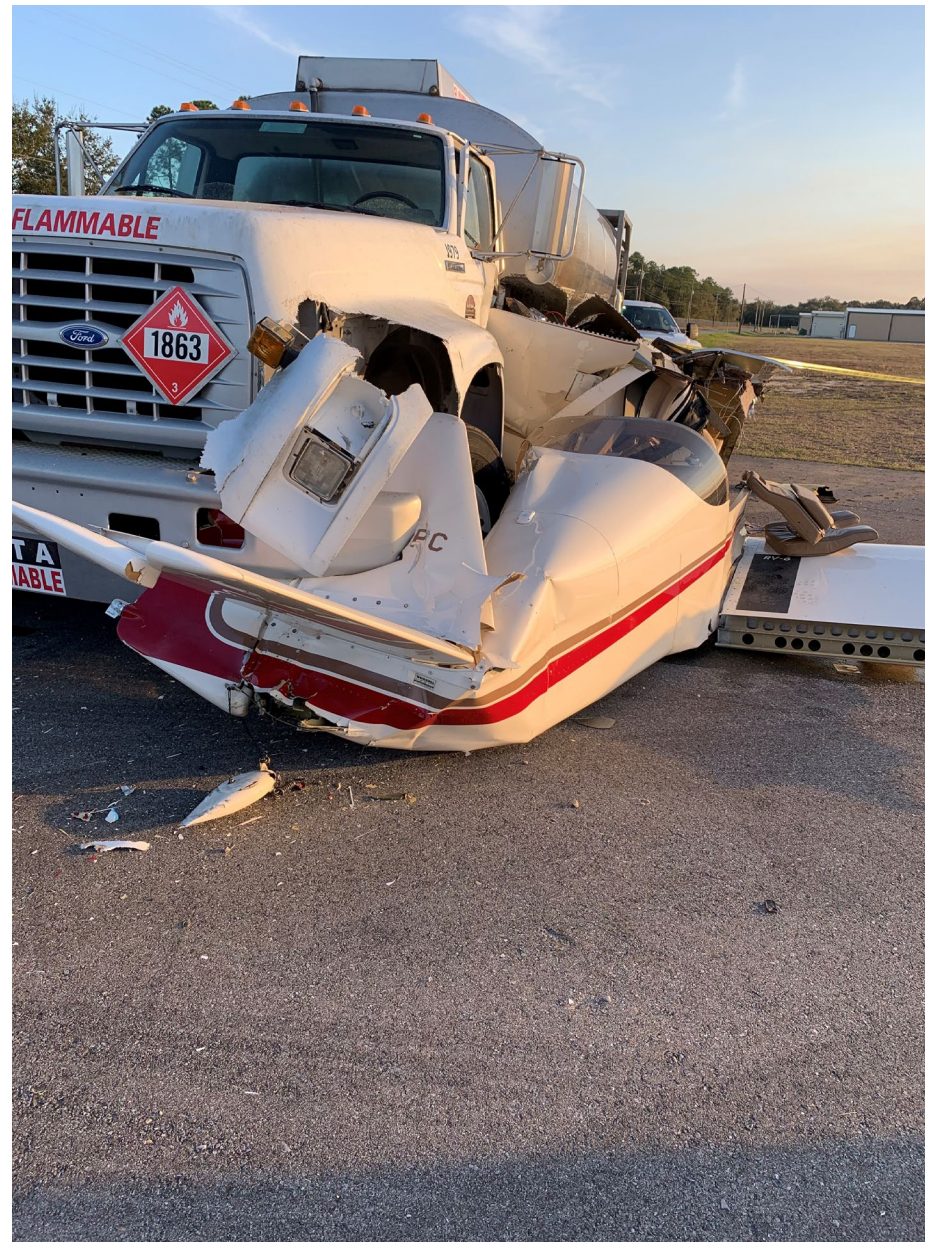
Photo 3: View of the tail of the airplane at the accident site (Photo Courtesy of FAA)

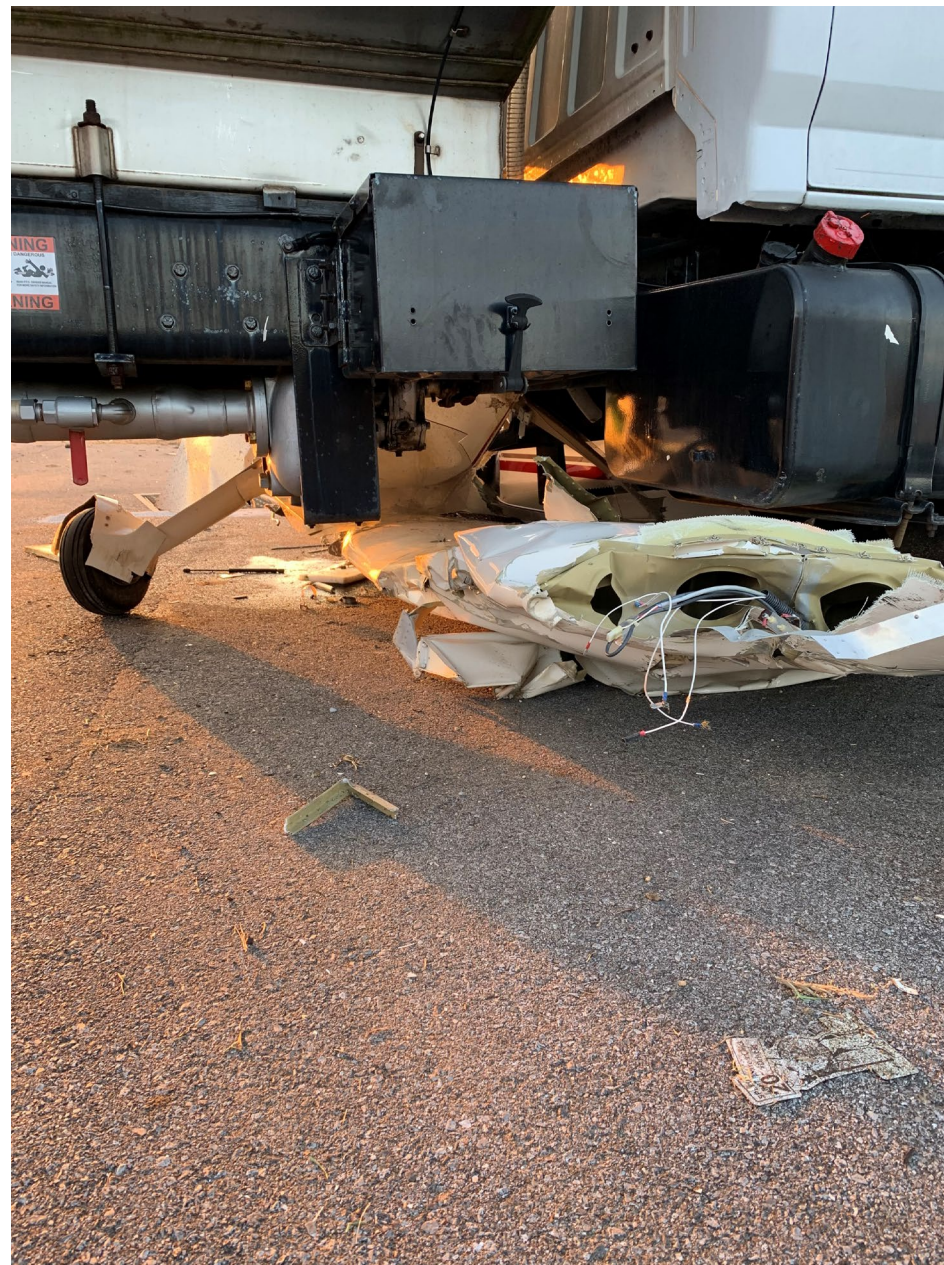
Photo 4: View of the left wing under the fuel truck. (Photo Courtesy of FAA)

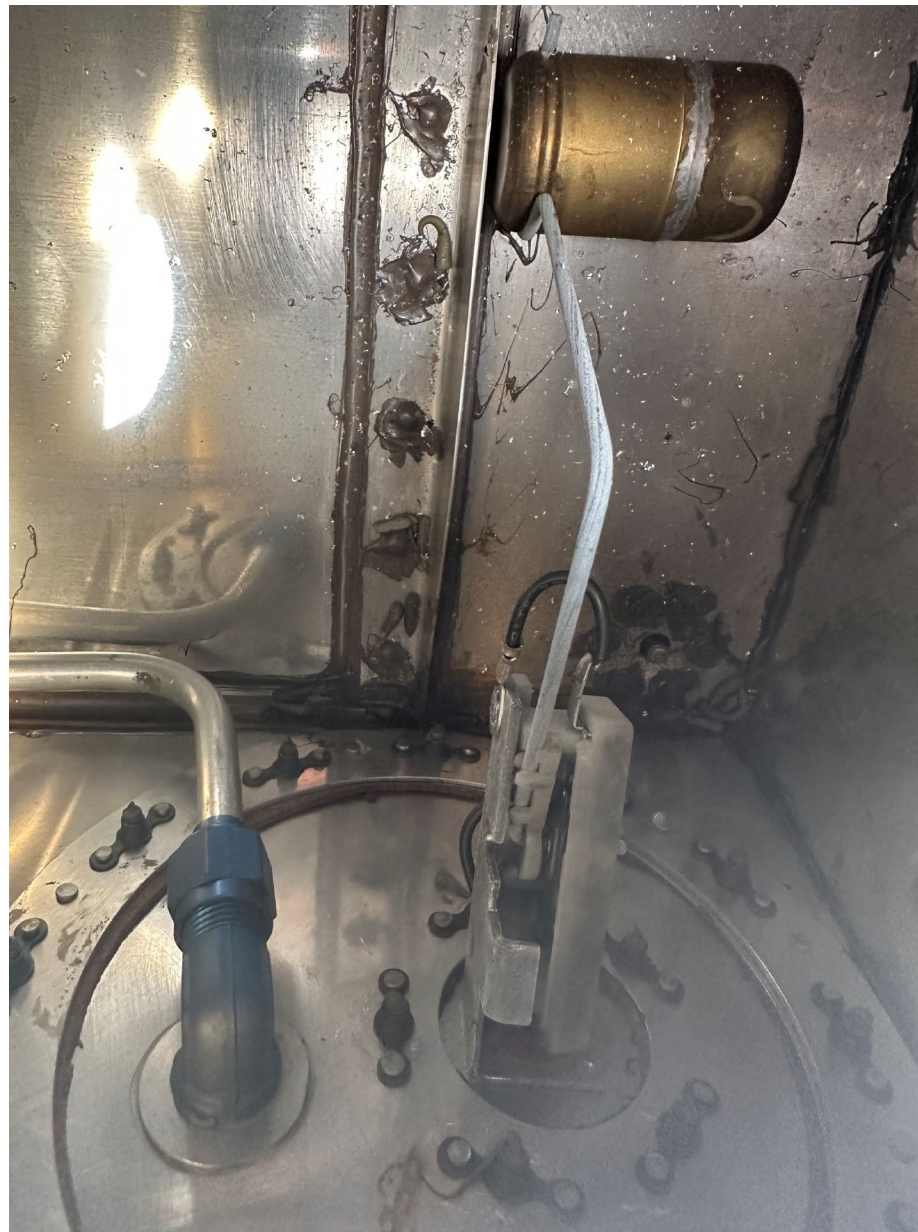
Photo 5: View of the right fuel tank fuel pickup and fuel sending unit (Photo Courtesy of Florida Air Recovery)

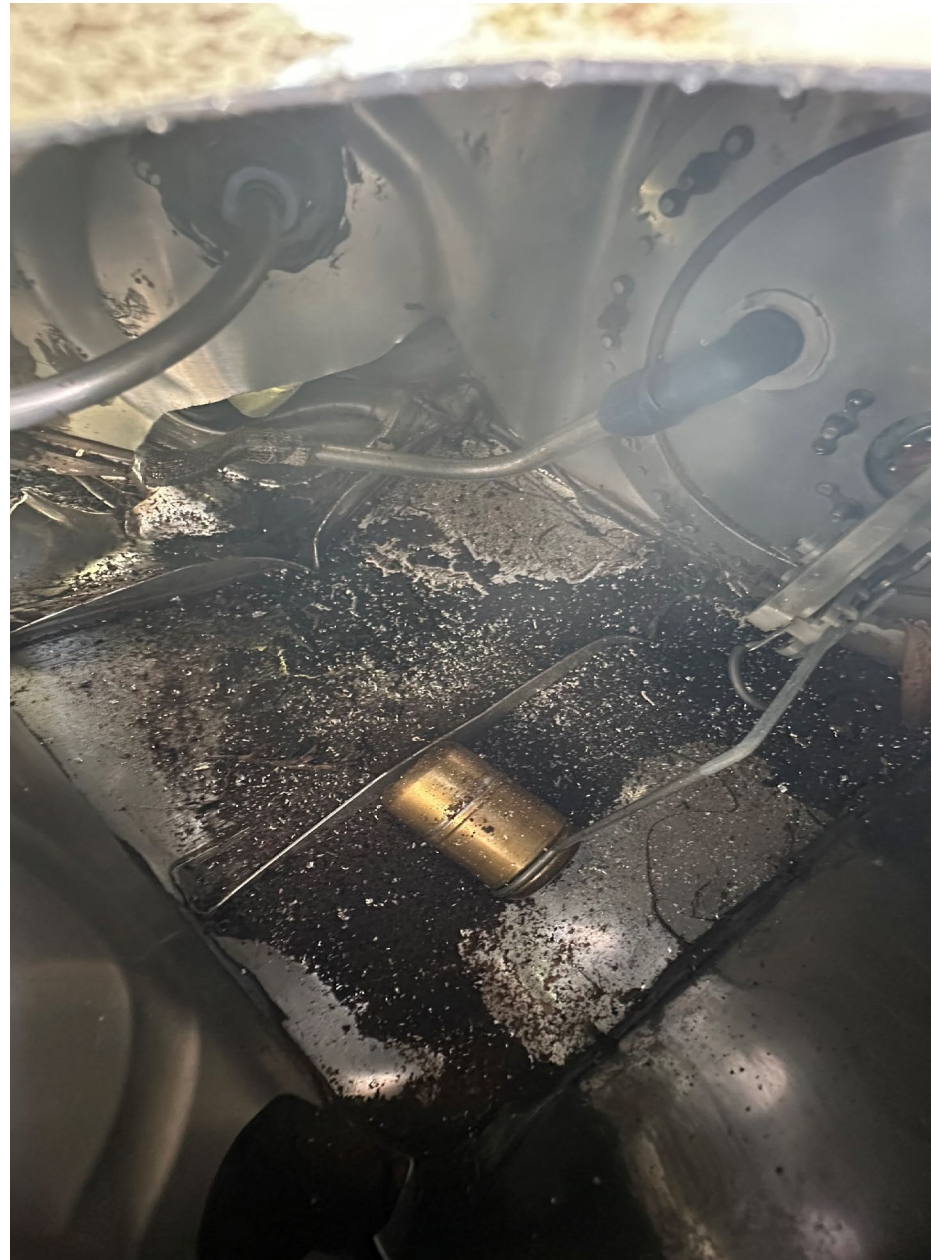
Photo 6: View of left fuel tank fuel pickup and sending unit (Photo Courtesy of Florida Air Recovery)
