**NTSB ERA23LA125**

N116CL, Diamond DA-20-C1

Photo Array

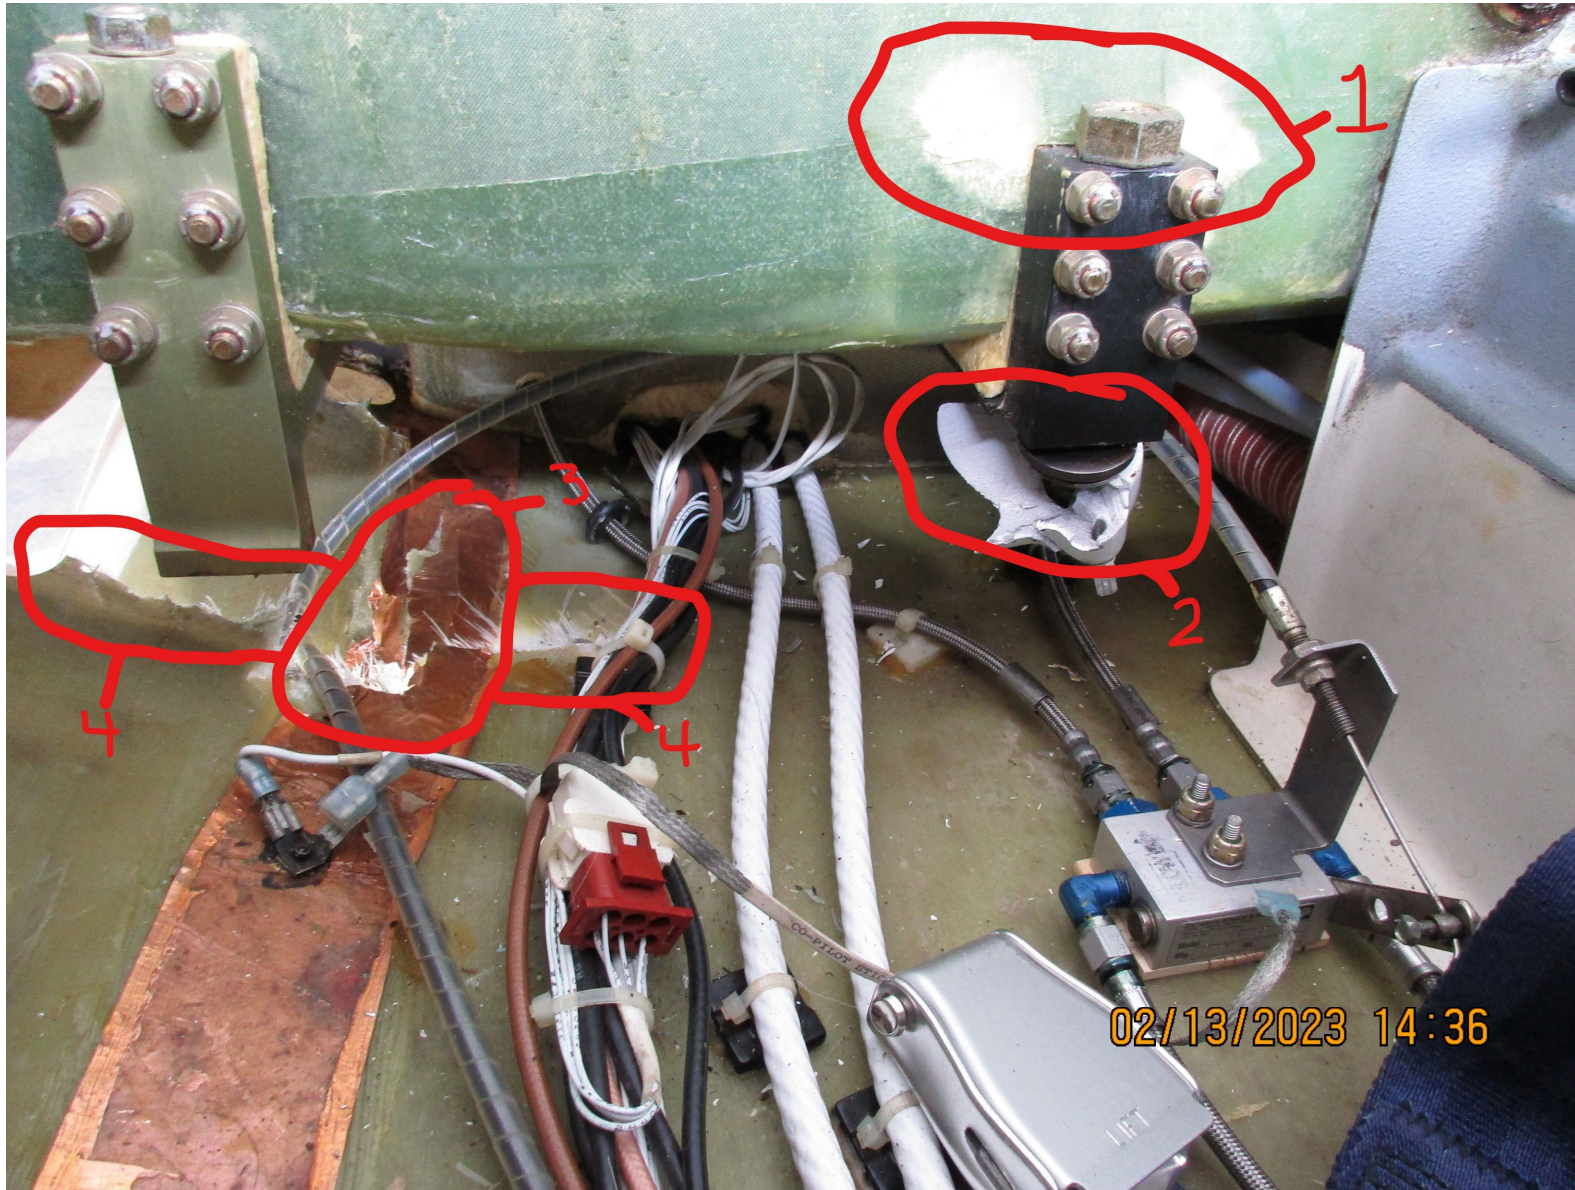
Photo 1: Overview of the airplane center spar delamination damage (red circled #1) (Photo Courtesy of FAA)

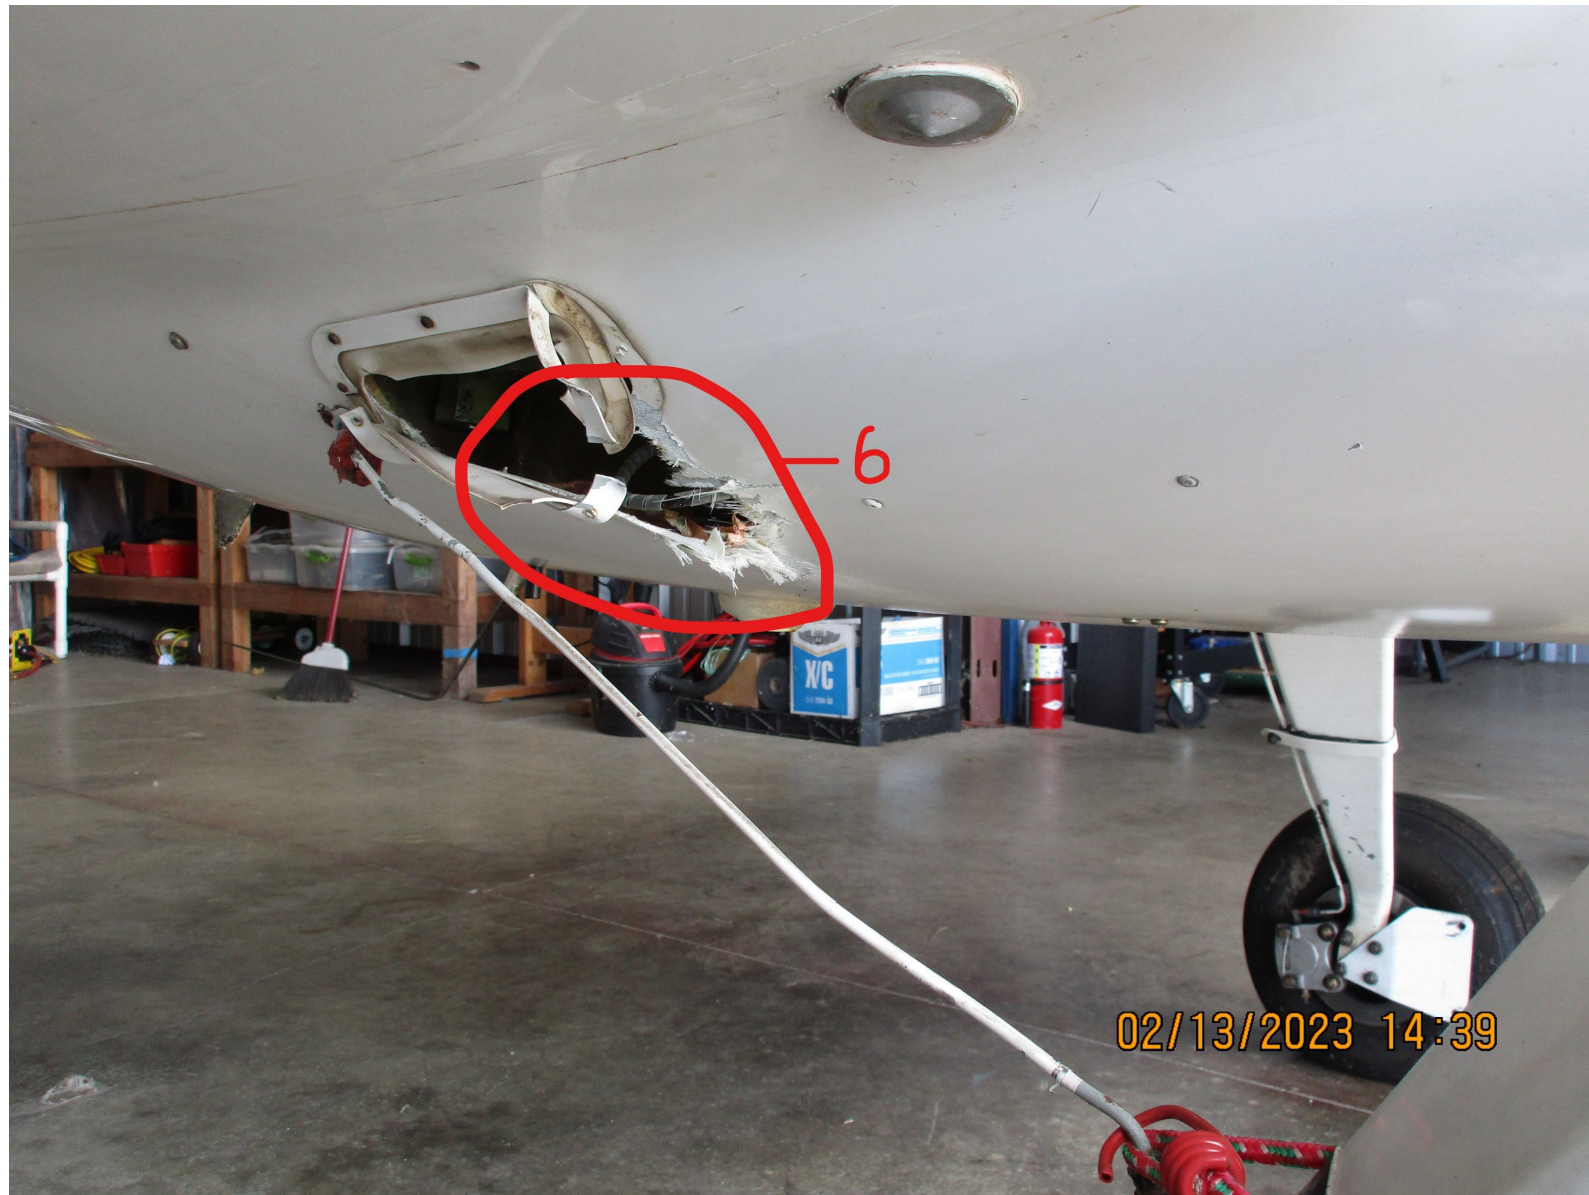
Photo 2: Overview of the airplane's fuselage damage (Photo Courtesy of FAA)

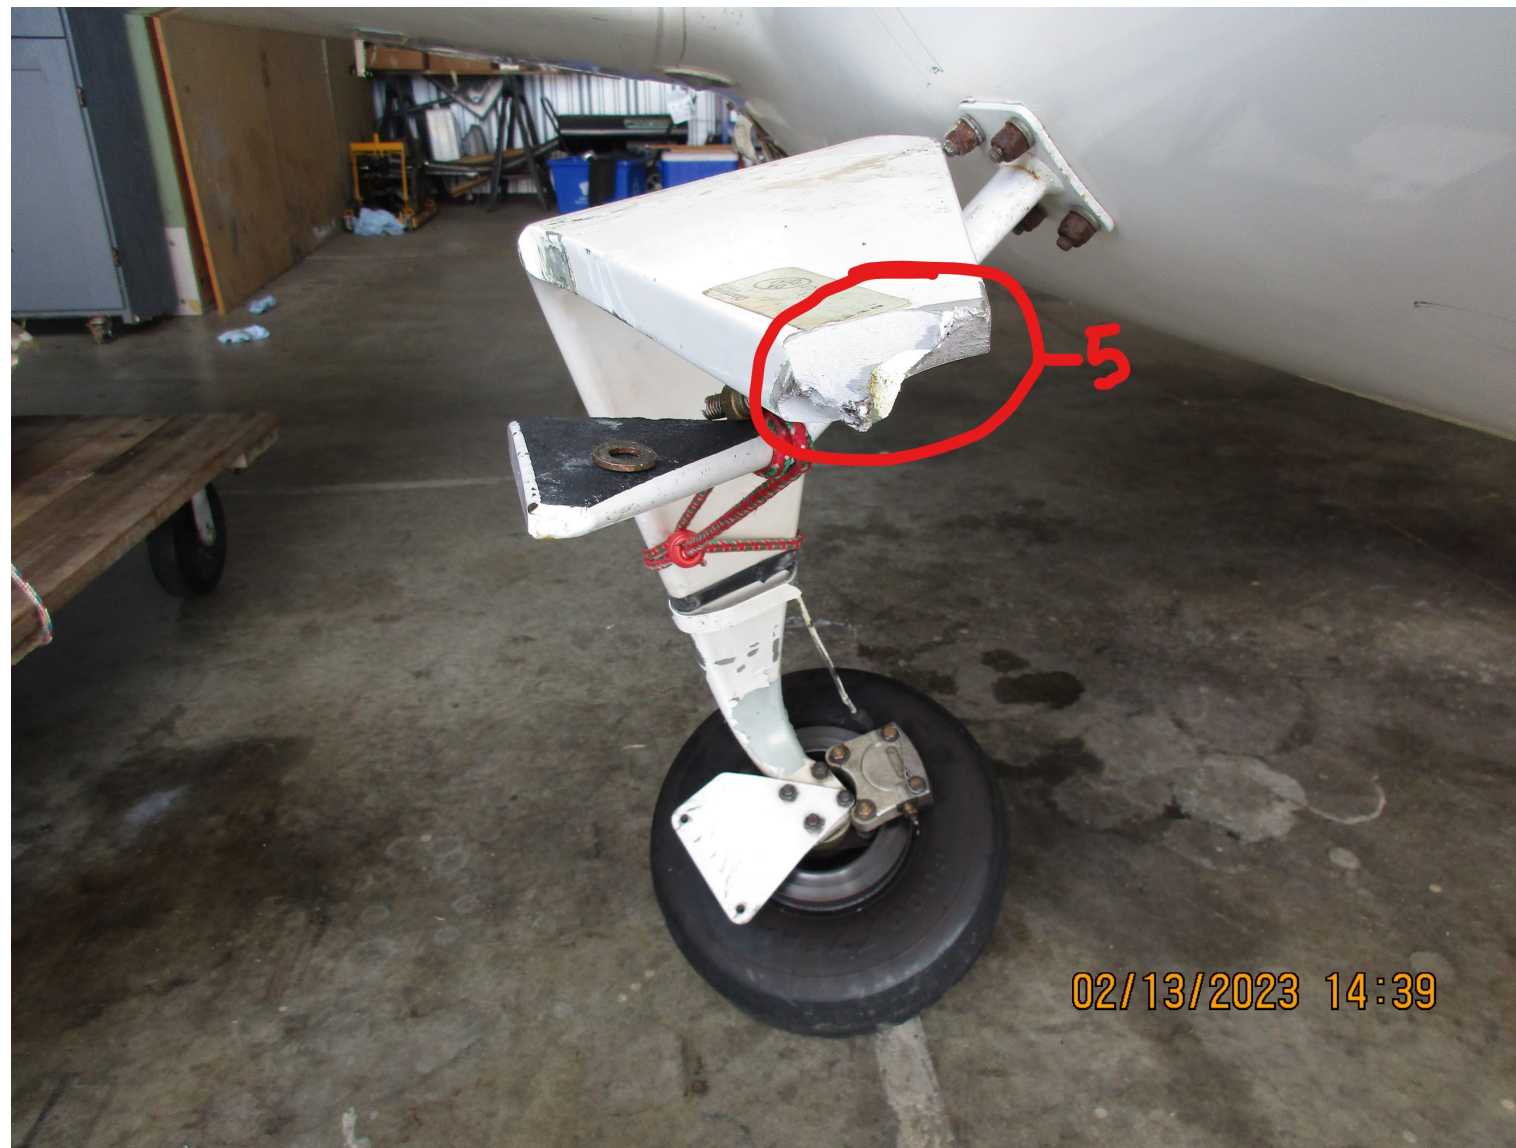
Photo 3: Main Landing gear which sheared off during collapse (Photo Courtesy of FAA)
