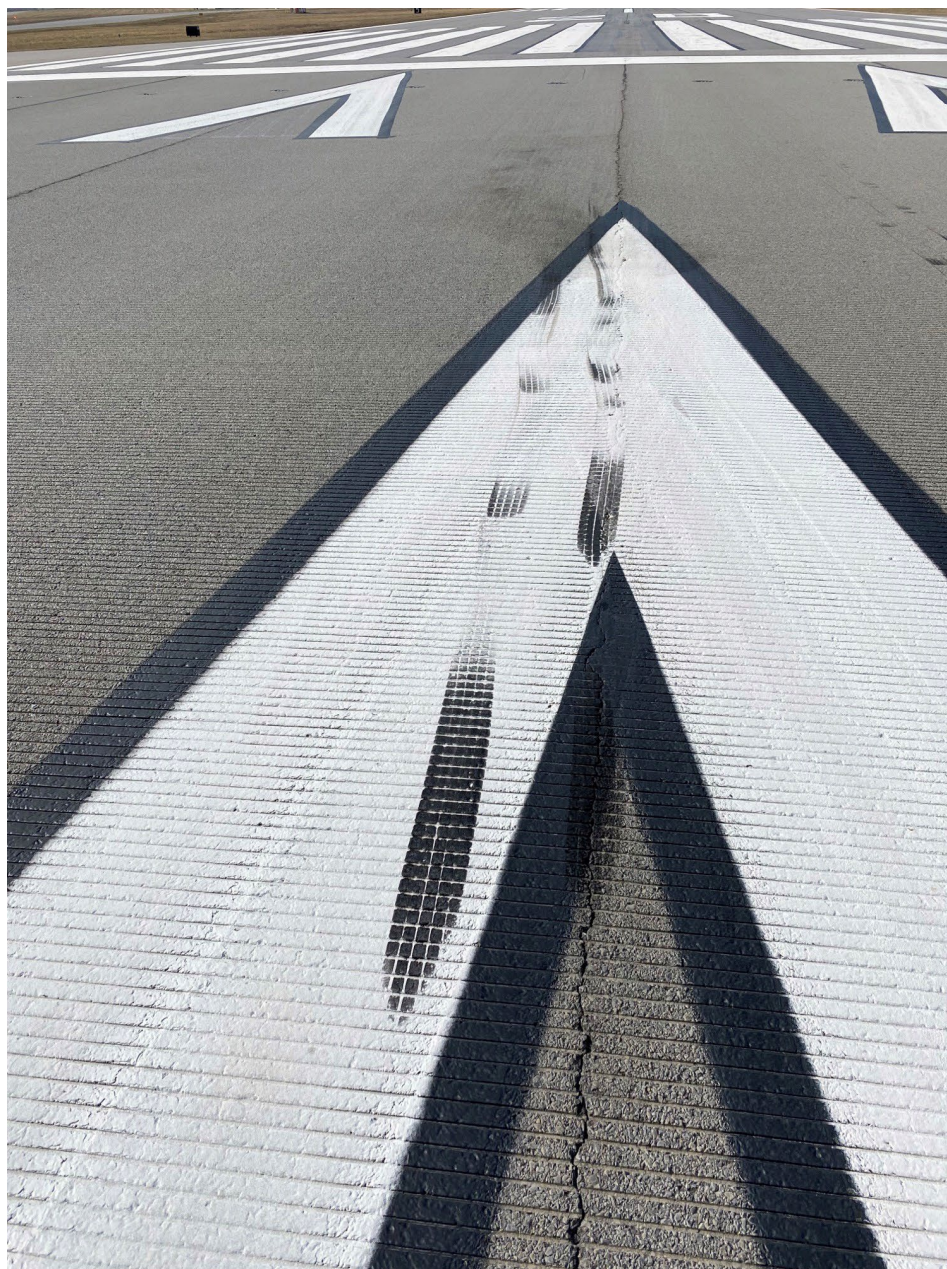
**Photo 1 – View of Ground Scars and Rubber Transfer Marks Consistent with Left Main Landing Gear (FAA)**

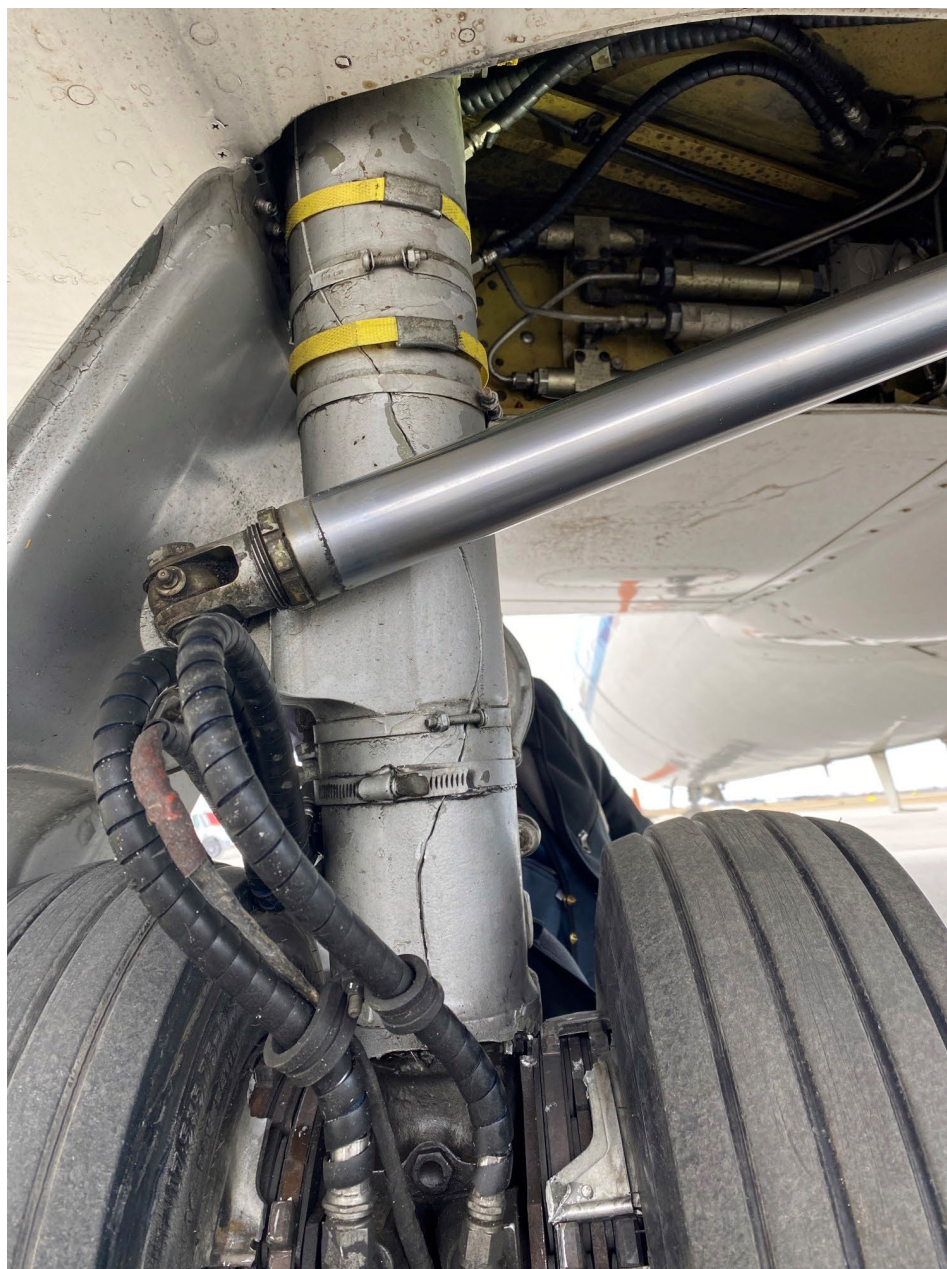
**Photo 2 - View of Fractured Landing Gear Leg and Fractured Brake Caliper Retention Caps (FAA)**

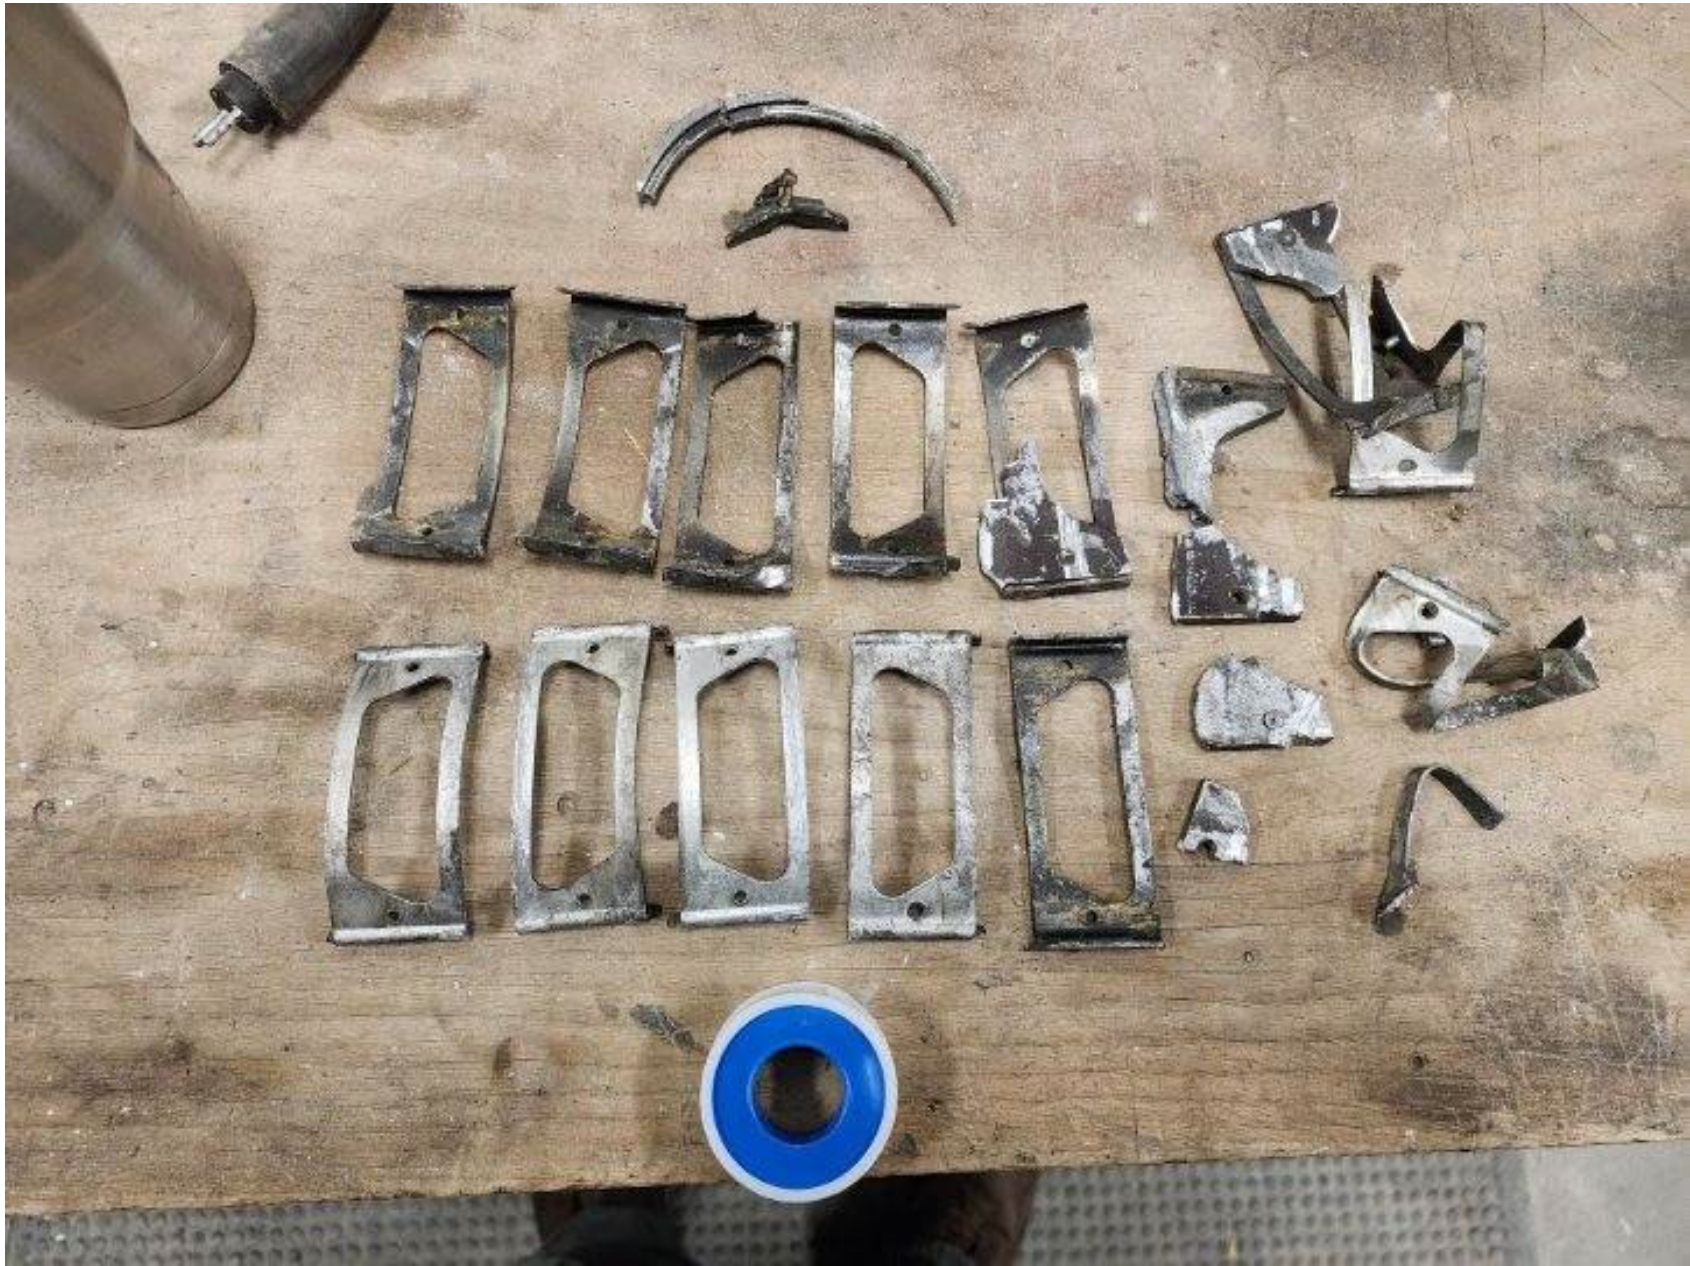
**Photo 3 - View of Fractured Brake Caliper Retention Caps Harvested from Runway (FAA)**

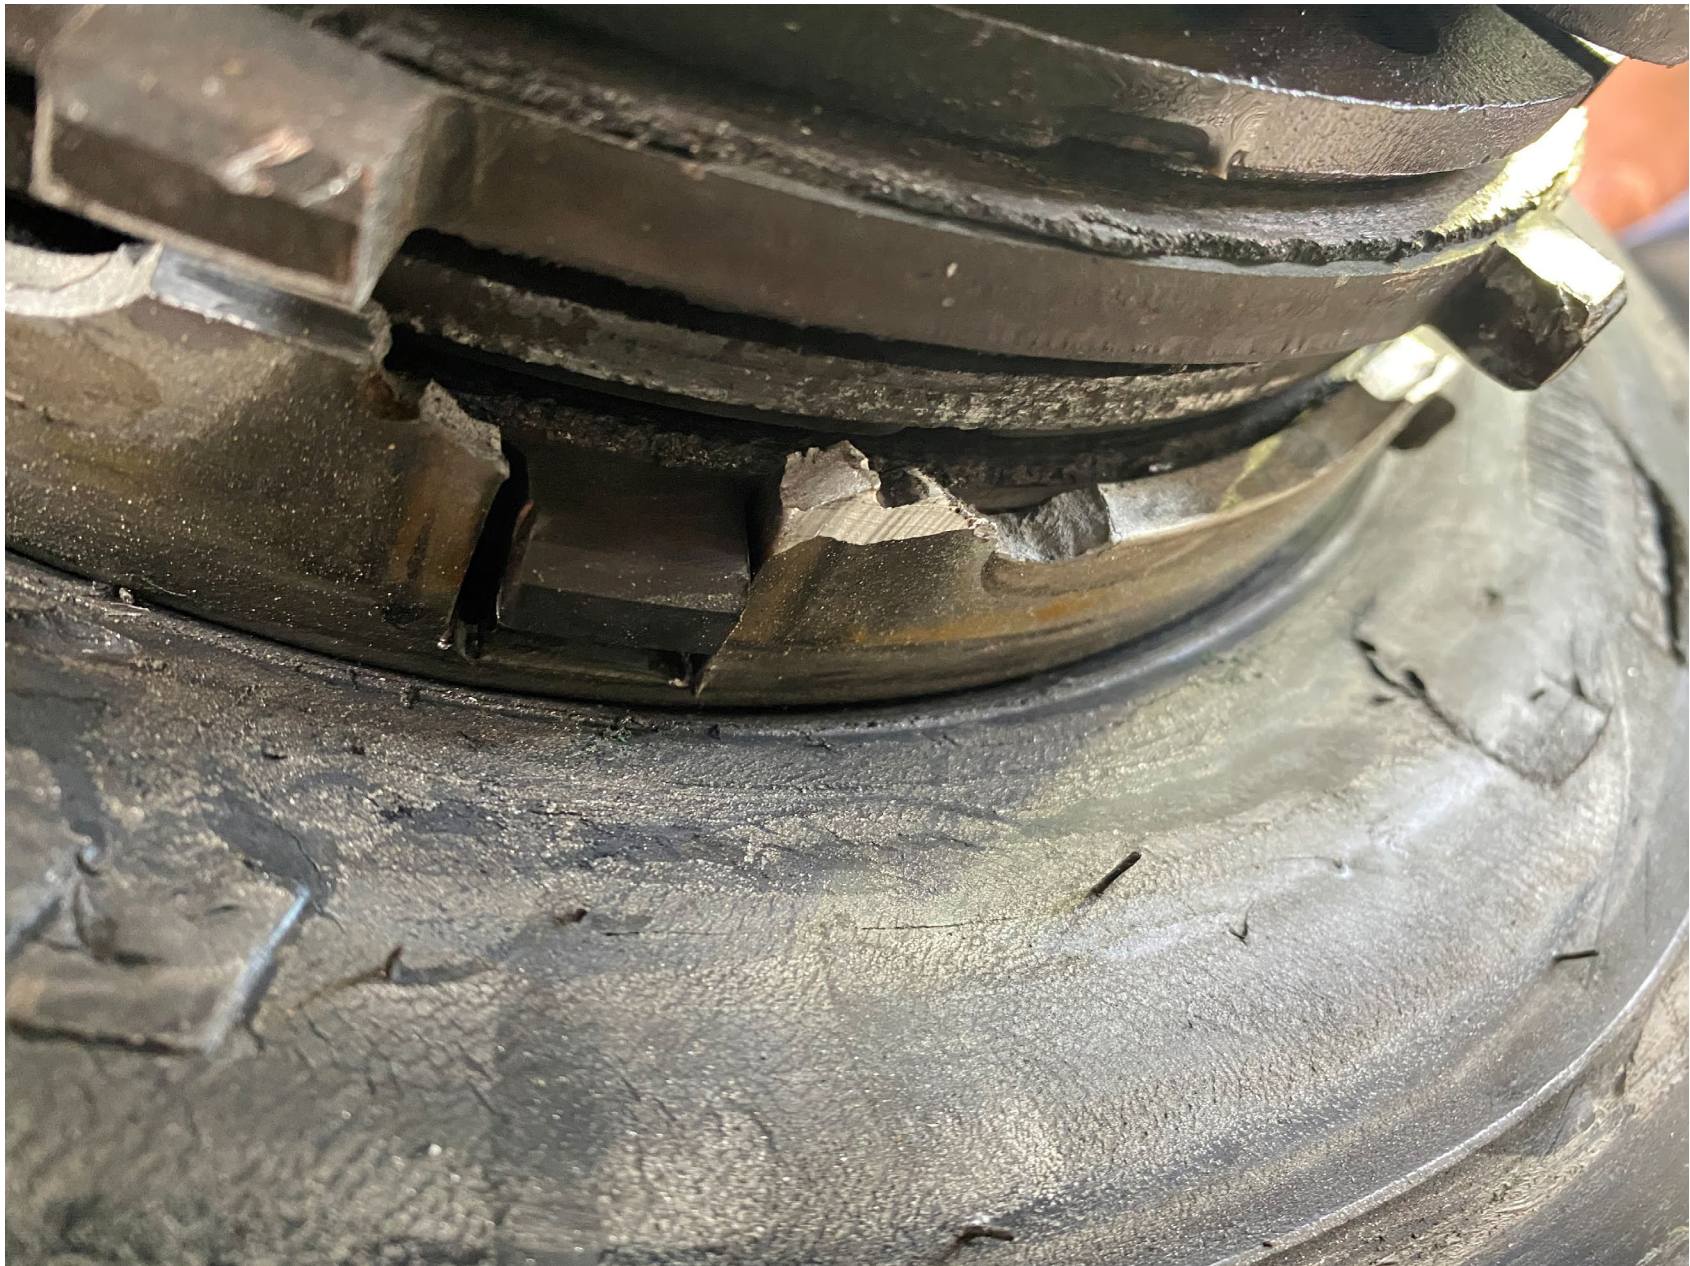
**Photo 4 – View of Left Landing Gear Trunnion (FAA)**

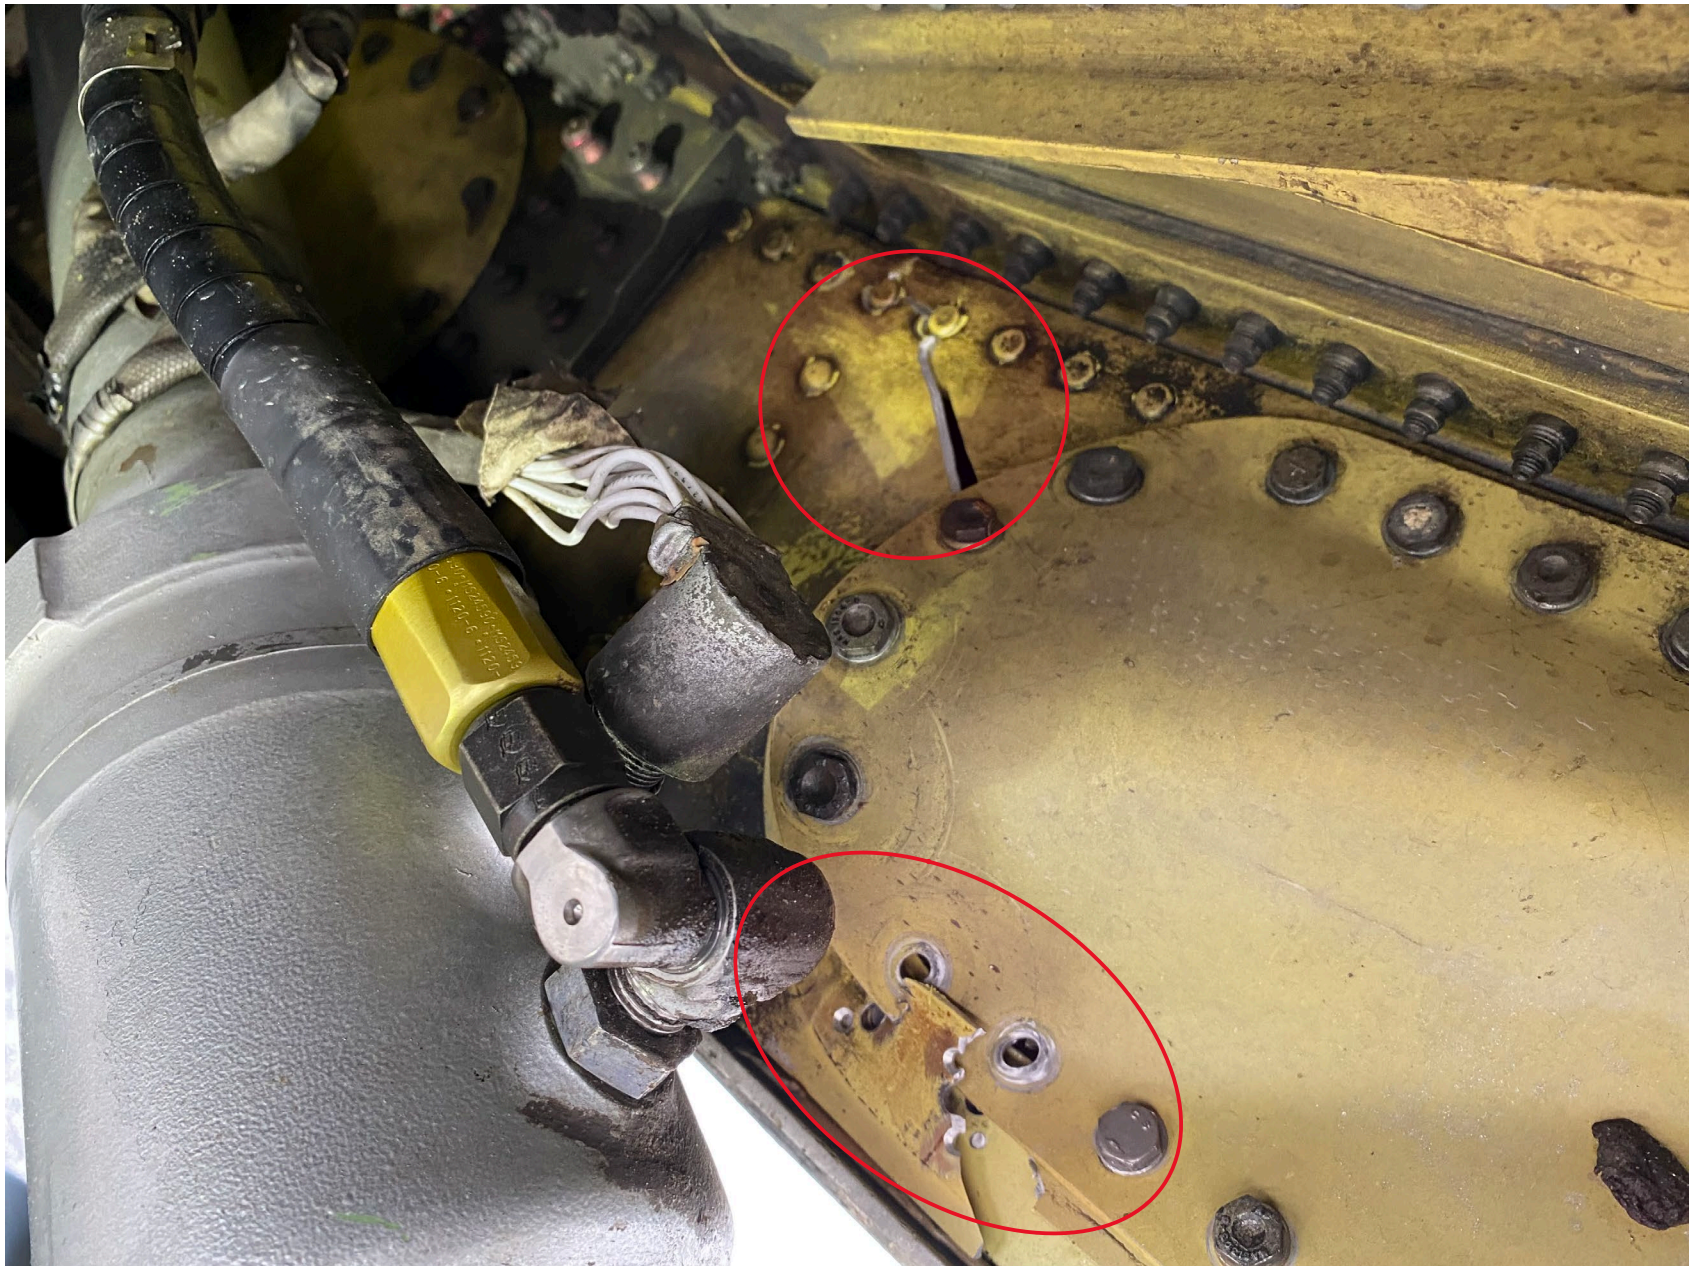
**Photo 1 – View of Wing Spar Damage (FAA)**

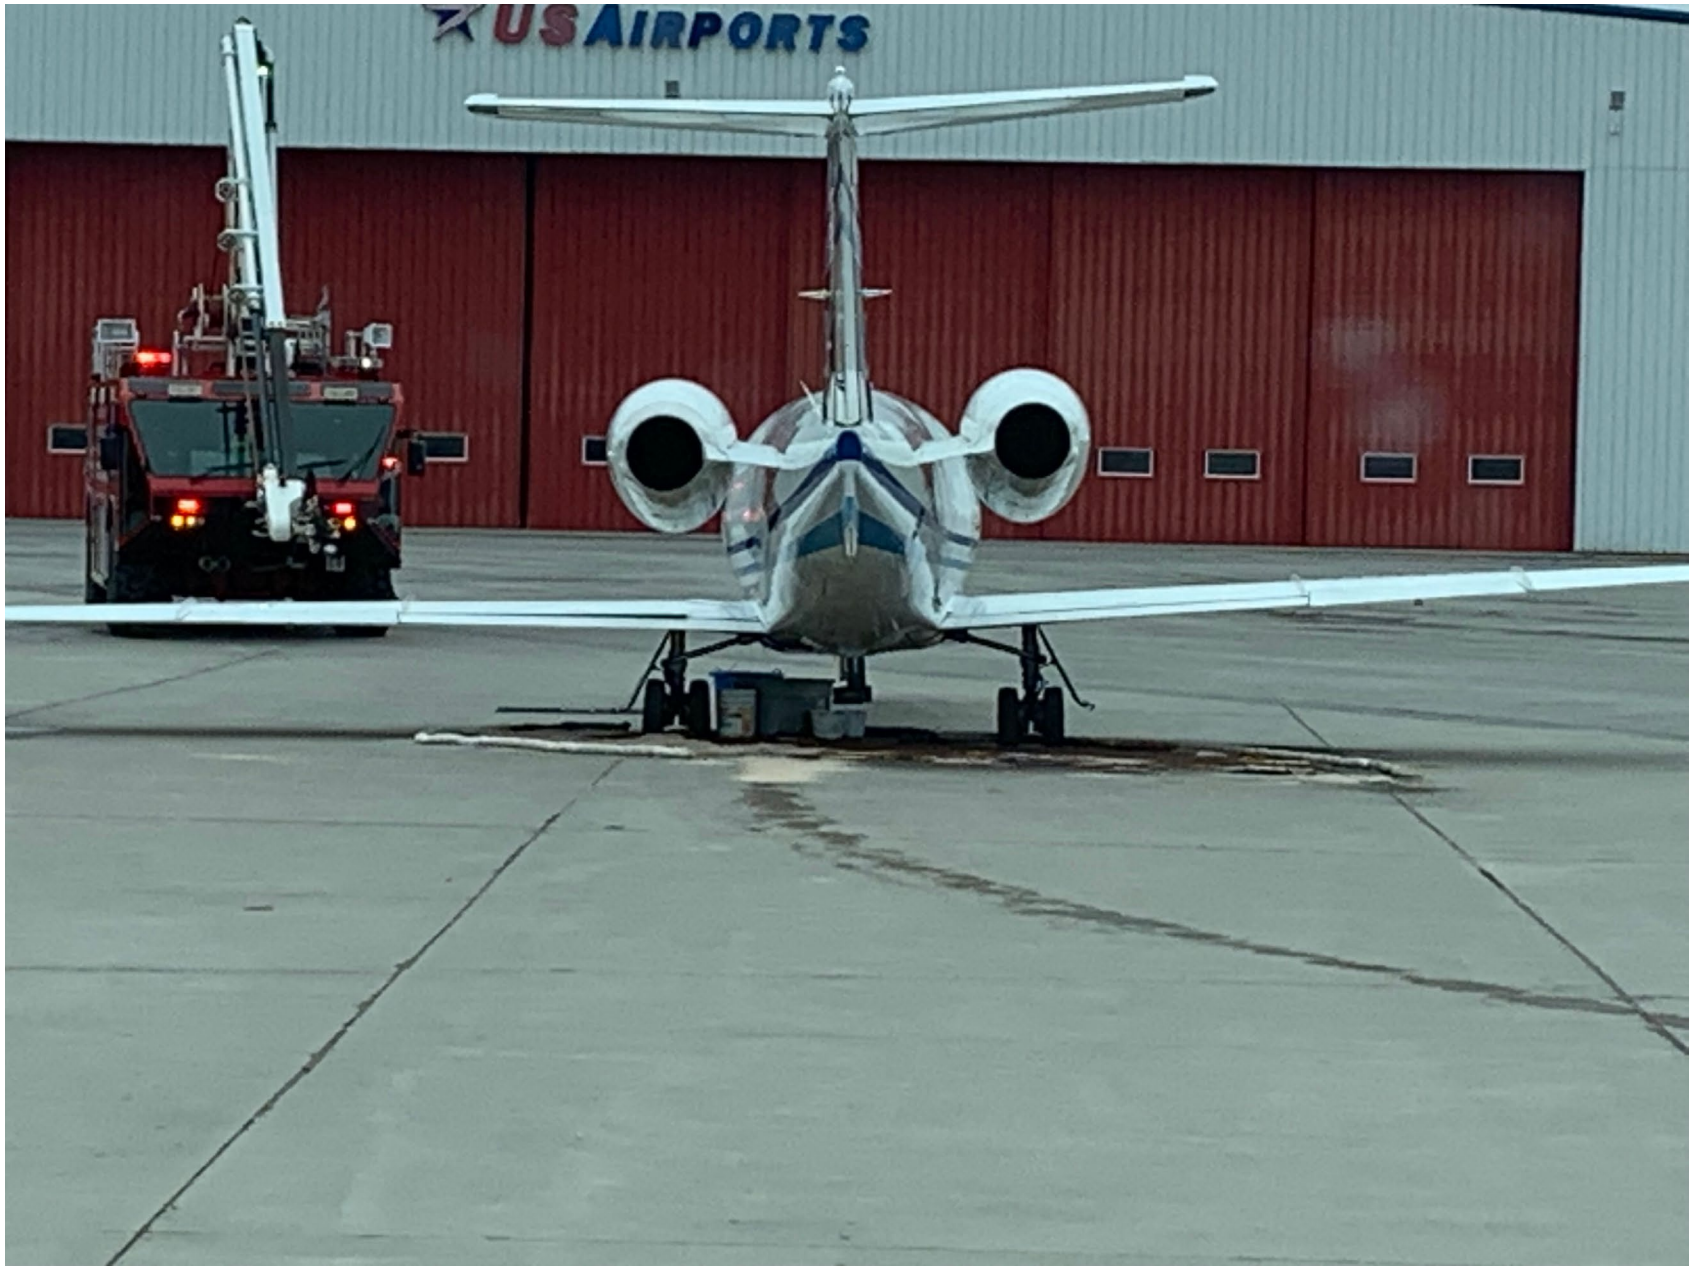
**Photo 6 – View of Damaged Left Wing (FAA)**
