## Memorandum For Record

**Date: April 5, 2023**  
**NTSB Accident Number: ERA23LA128**

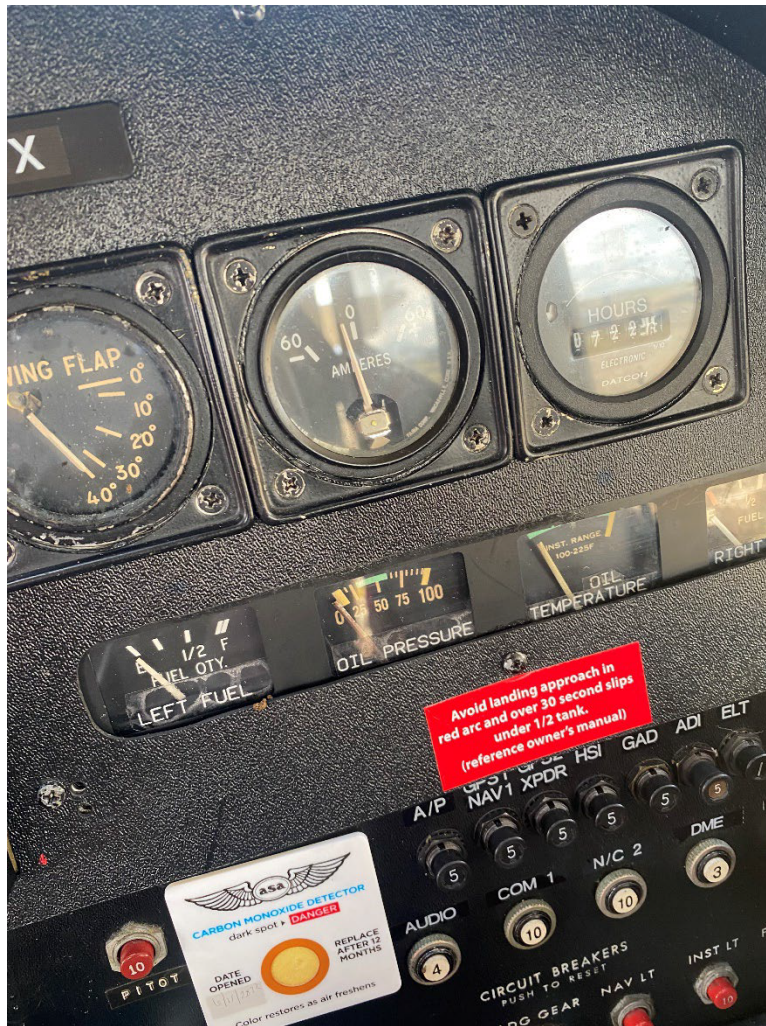
Figure 1: AMF Aviation Digital Photograph. View of a Portion Of the Instrument Panel With the Airplane Upright and Battery Power On Showing the Left Fuel Gauge at Empty and the Right Fuel Gauge Less than Empty.

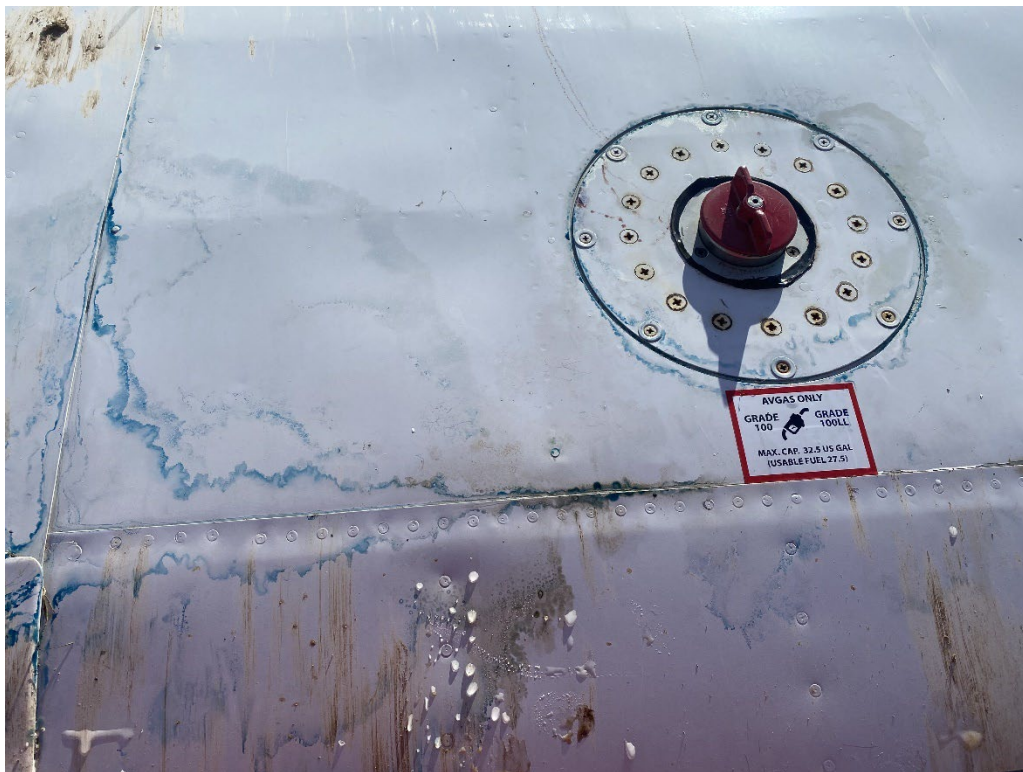
Figure 2: AMF Aviation Digital Photograph. View Looking Aft Showing the Fuel Staining By the Left Fuel Filler Cap.

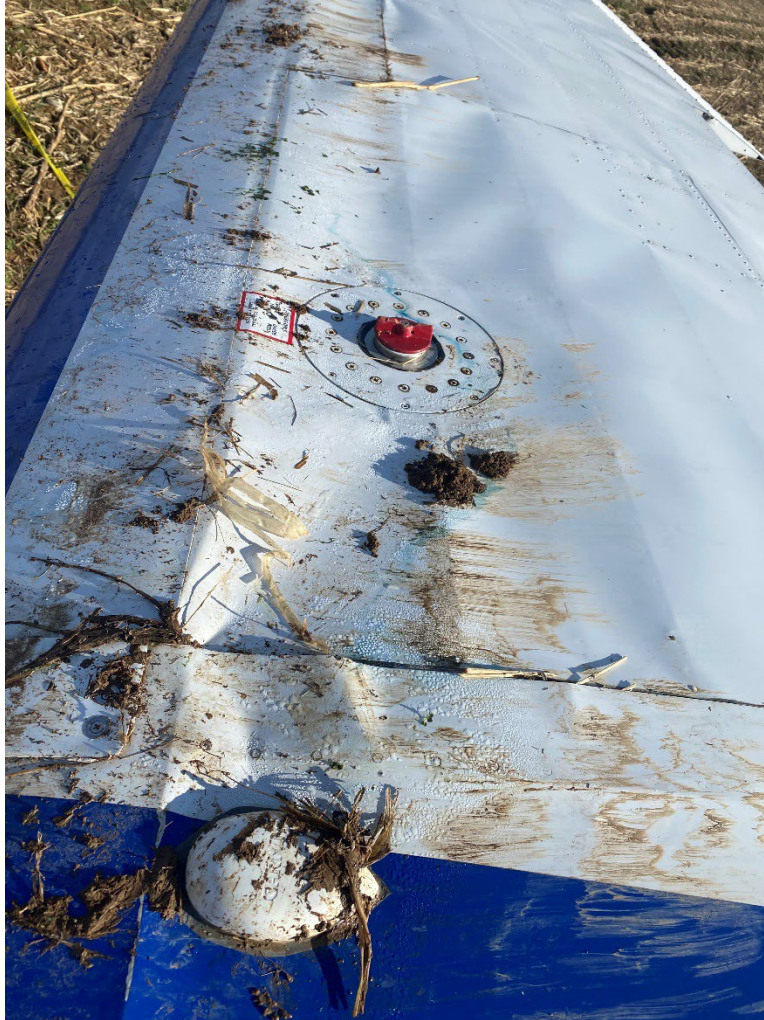
Figure 3: AMF Aviation Digital Photograph. View Looking Outboard Showing the Fuel Staining By the Right Fuel Filler Cap.

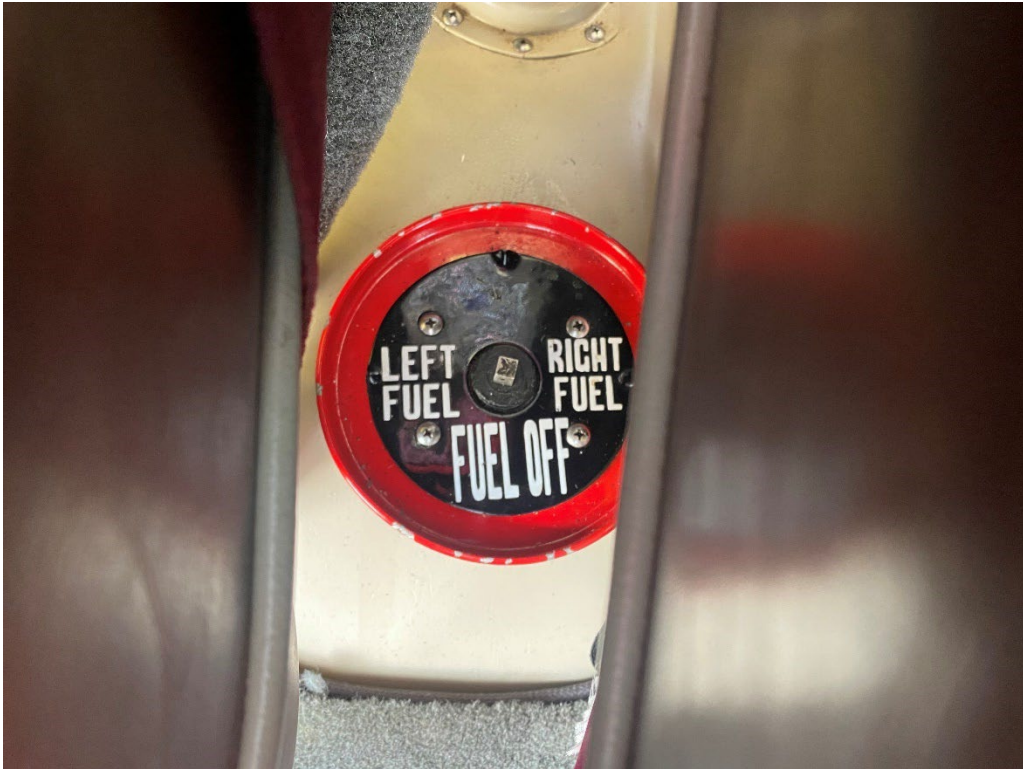
1. Picture of the tachometer and hour meter
  - The Tachometer was reading 3493.6 and the hour meter was reading 722.65<sup>1</sup>
2. Once upright, turn battery power on and photograph each fuel gauge reading (Figure 1).
3. Once upright, take a picture behind each fuel cap showing whether there is any fuel staining
  - Fuel staining was noted by the left fuel filler cap (Figure 2) and also the right fuel filler cap (Figure 3).
4. Picture of the fuel selector valve and handle
  - The handle and the adjustable wrench used by the pilot were not located. The valve is depicted in Figure 4.

Figure 4: AMF Aviation Digital Photograph. View Showing the Fuel Selector Valve, Placard, and No Handle.

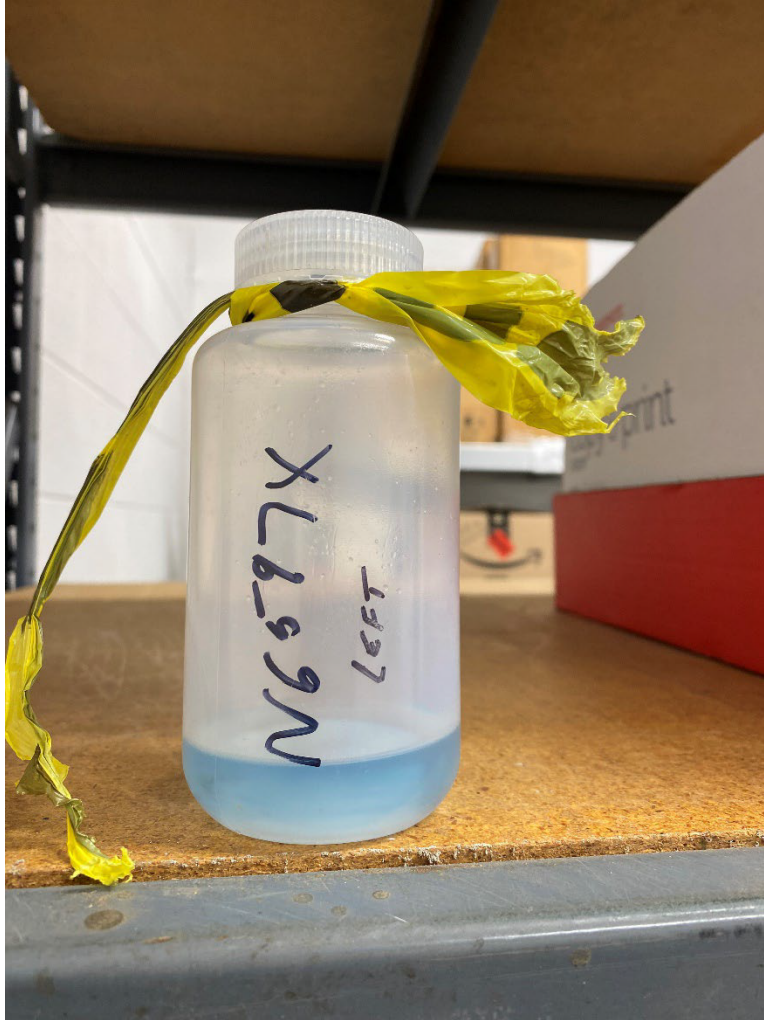
5. Once upright, take a sample of fuel from each fuel tank into a clean glass jar and label. Take a picture.
  - The right fuel tank did not contain fuel while the left fuel tank contained only residual fuel (Figure 5).
6. Once upright take a sample of fuel from the airframe fuel strainer into a clean glass jar and label. Take a picture.
  - The fuel strainer did not contain any fuel.
7. Once upright, drain each fuel tank into a separate clean container and quantify the fuel amount. Take a picture.
  - Only residual fuel was noted in the left fuel tank and no fuel was noted in the right fuel tank.
8. During separation of both wings, document with photos any fuel quantity indicating system connectors or wiring issues or where cut or disconnected.
  - The wiring harness of each fuel transmitter was cut to facilitate removal of the wings.

Figure 5: AMF Aviation Digital Photograph. View of the Total Amount of Fuel Drained from the Left Fuel Tank.
