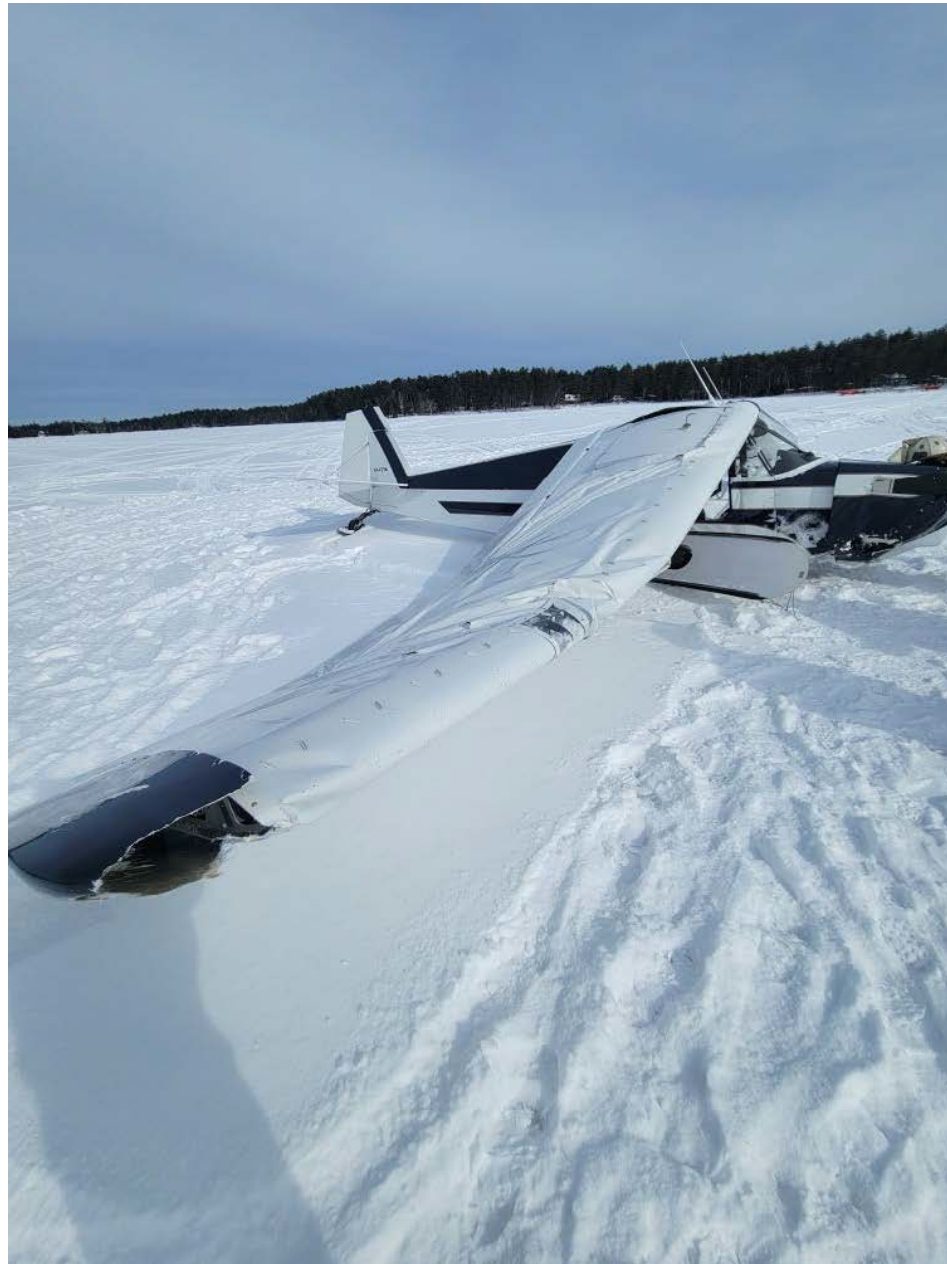
**Photo 1 – View of right wight damage (FAA Photo)**

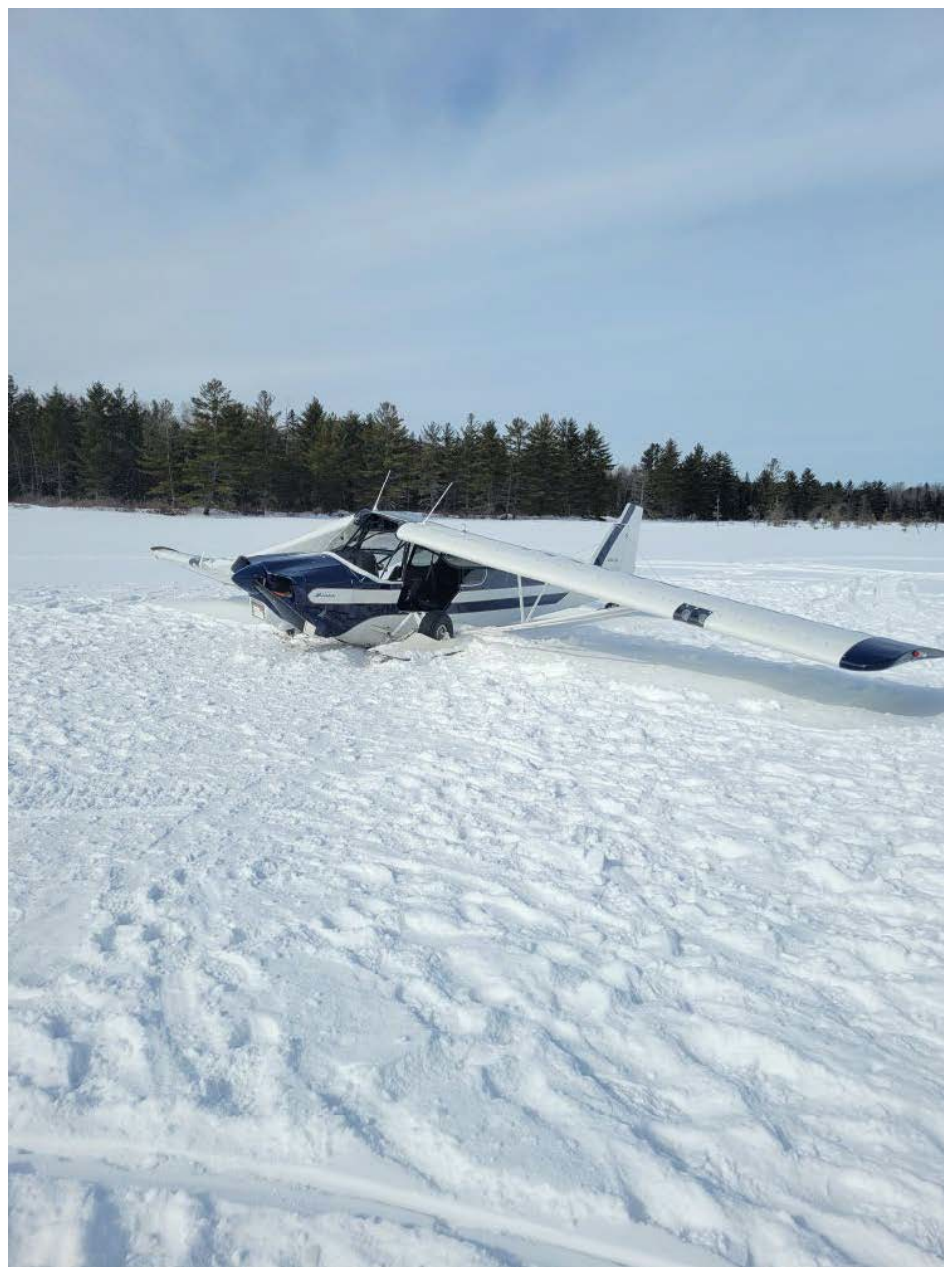
**Photo 2 – Left side of fuselage (FAA Photo)**

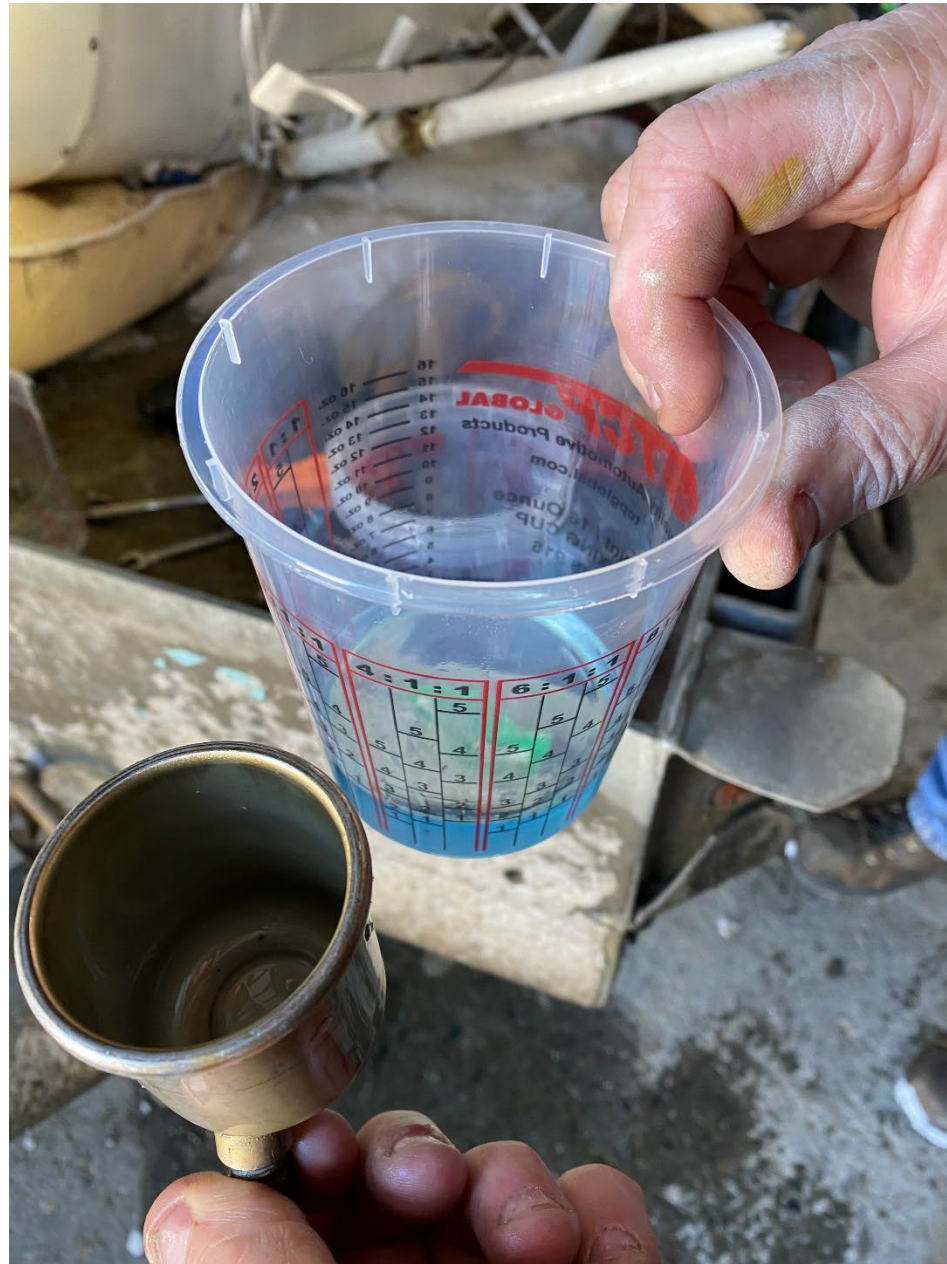
**Photo 3 – View of Fuel removed from fuel strainer (FAA Photo)**

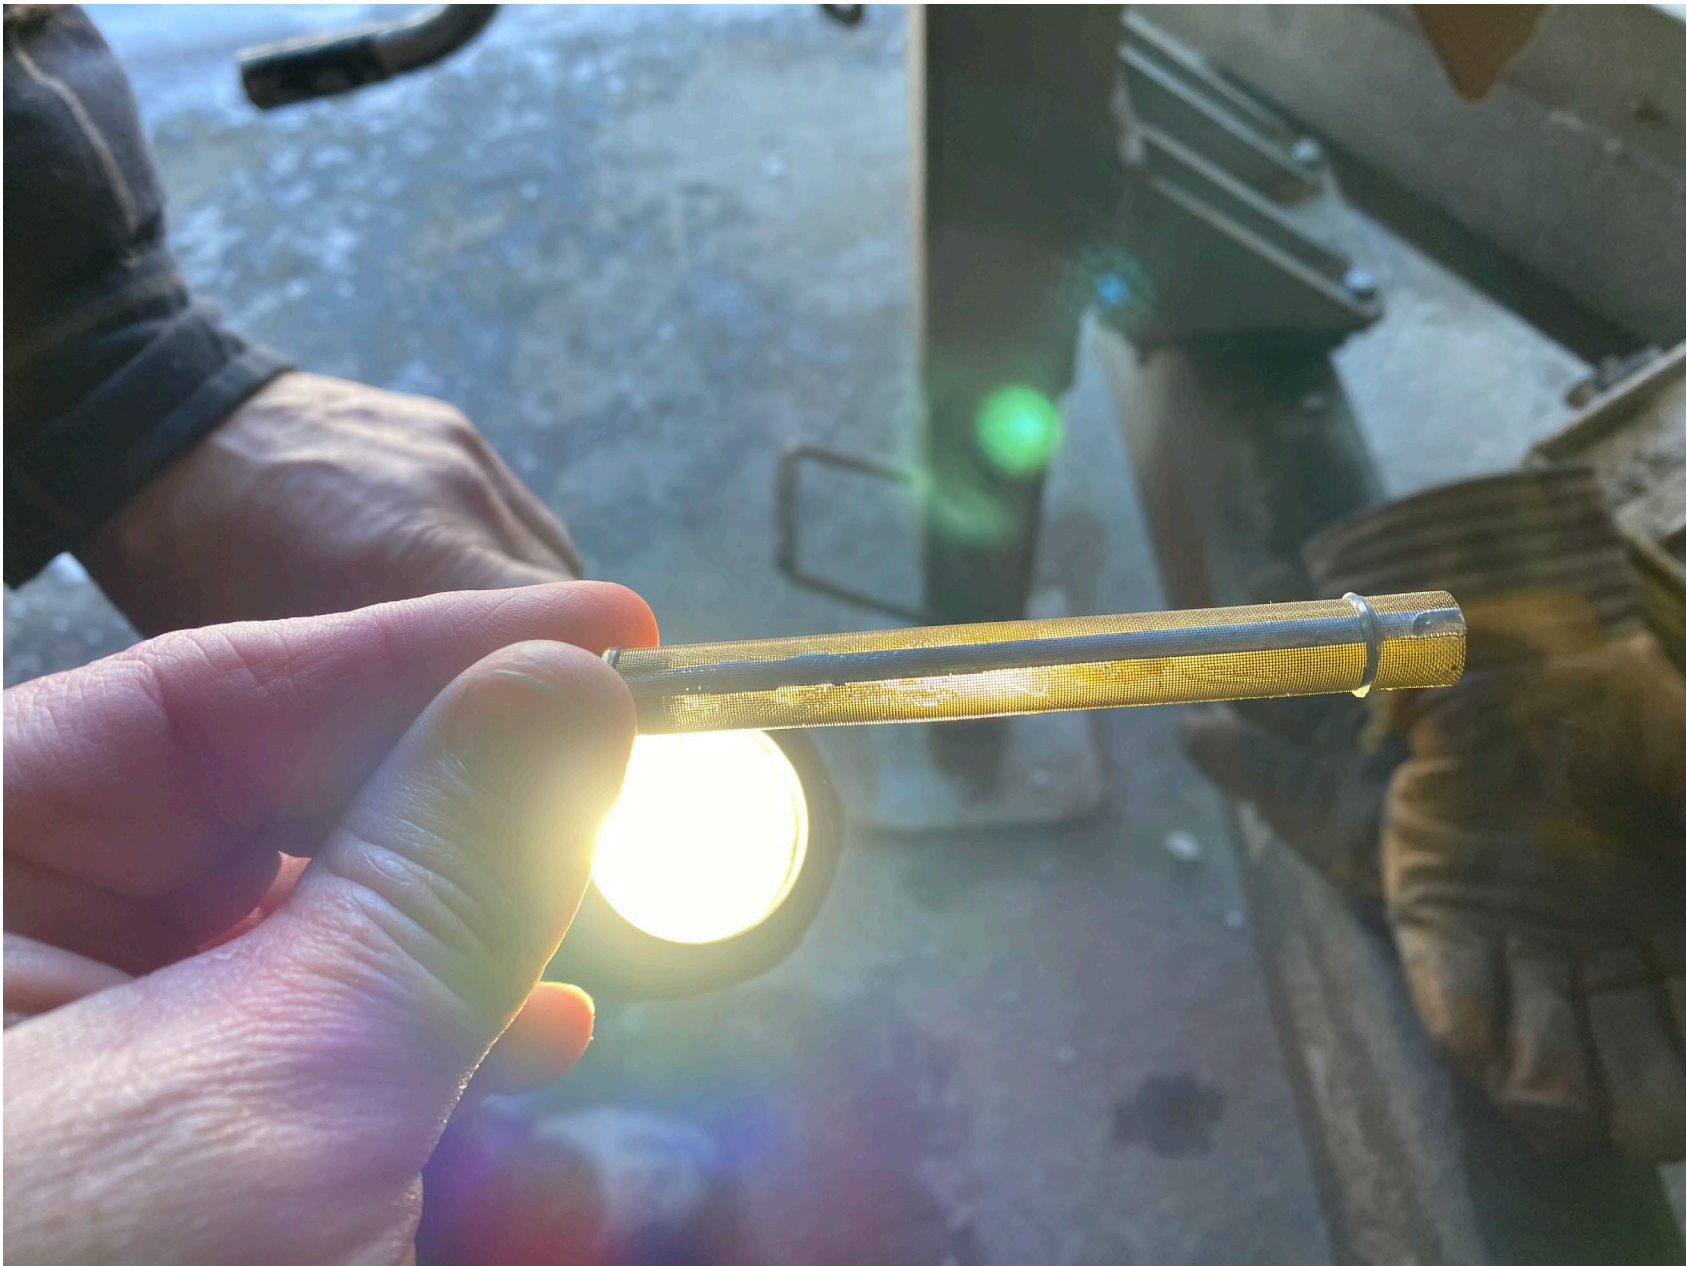
**Photo 4 – view carburetor fuel screen (FAA Photo)**
