**NTSB ERA23LA139**

N2419V, Cessna 140

Photo Array

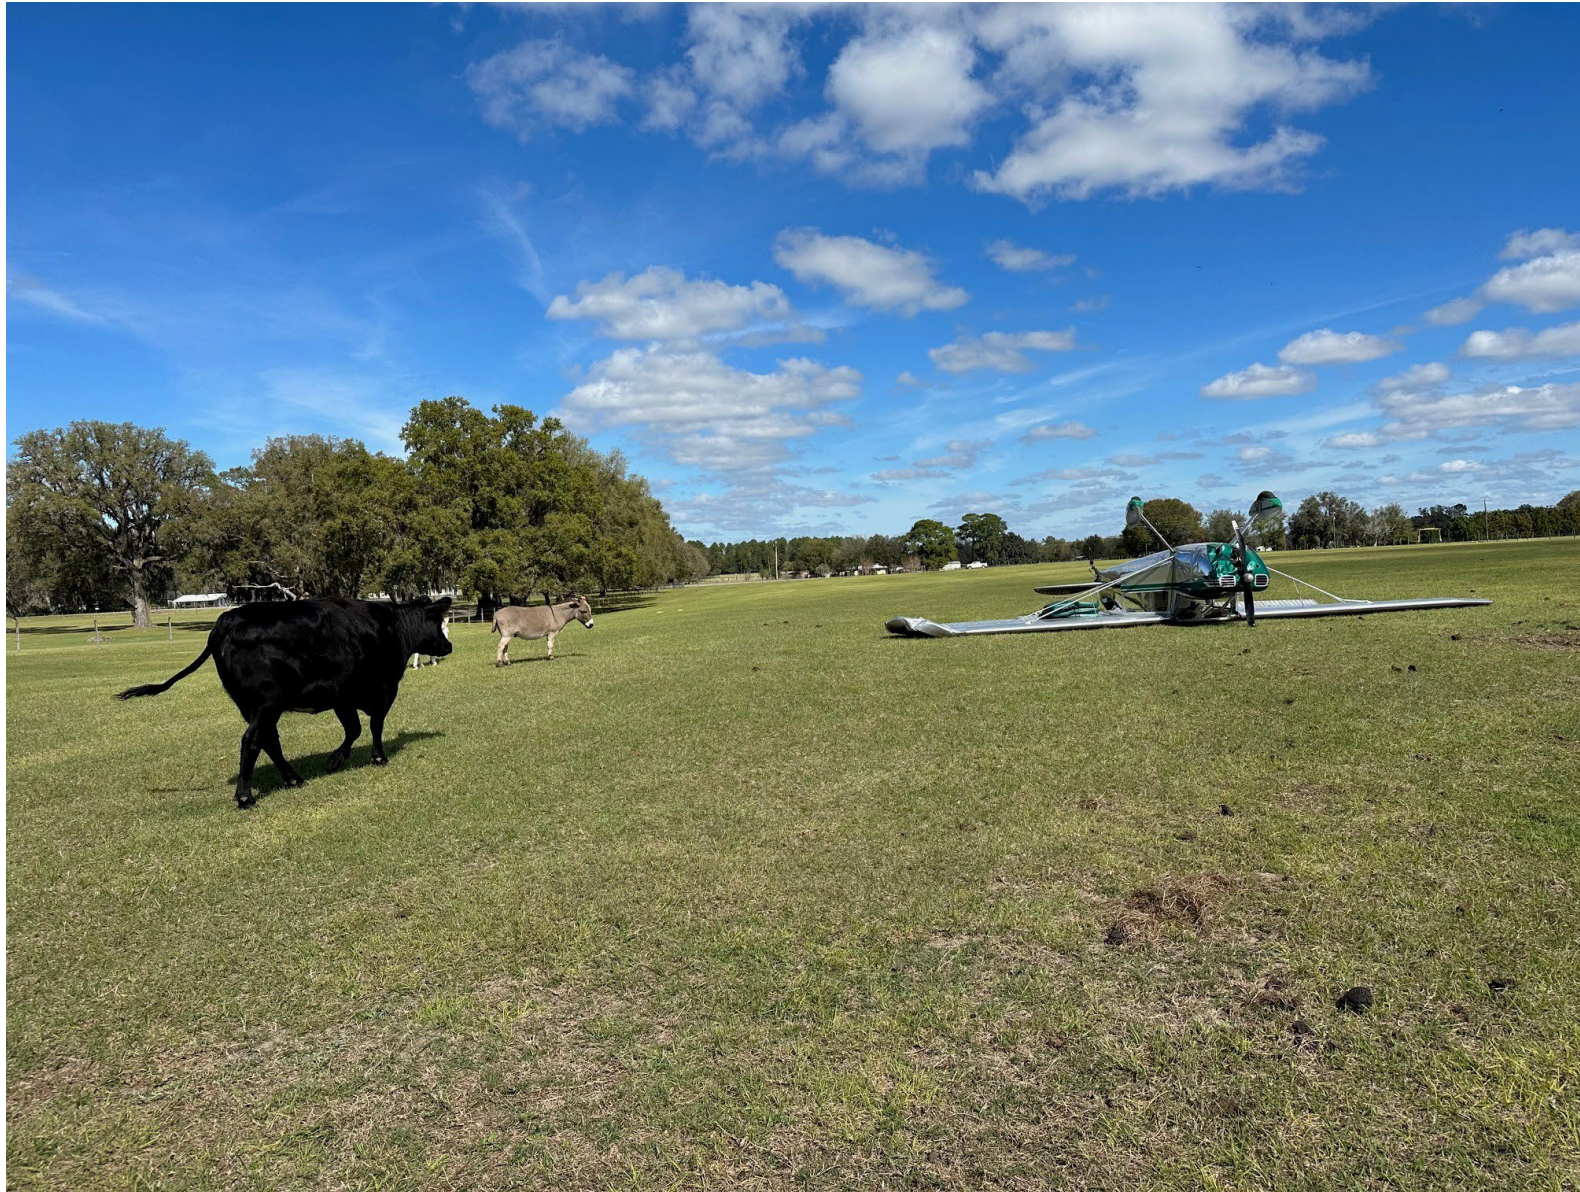
Photo 1: Overview of the airplane as it lay in the field (Photo Courtesy of FAA)

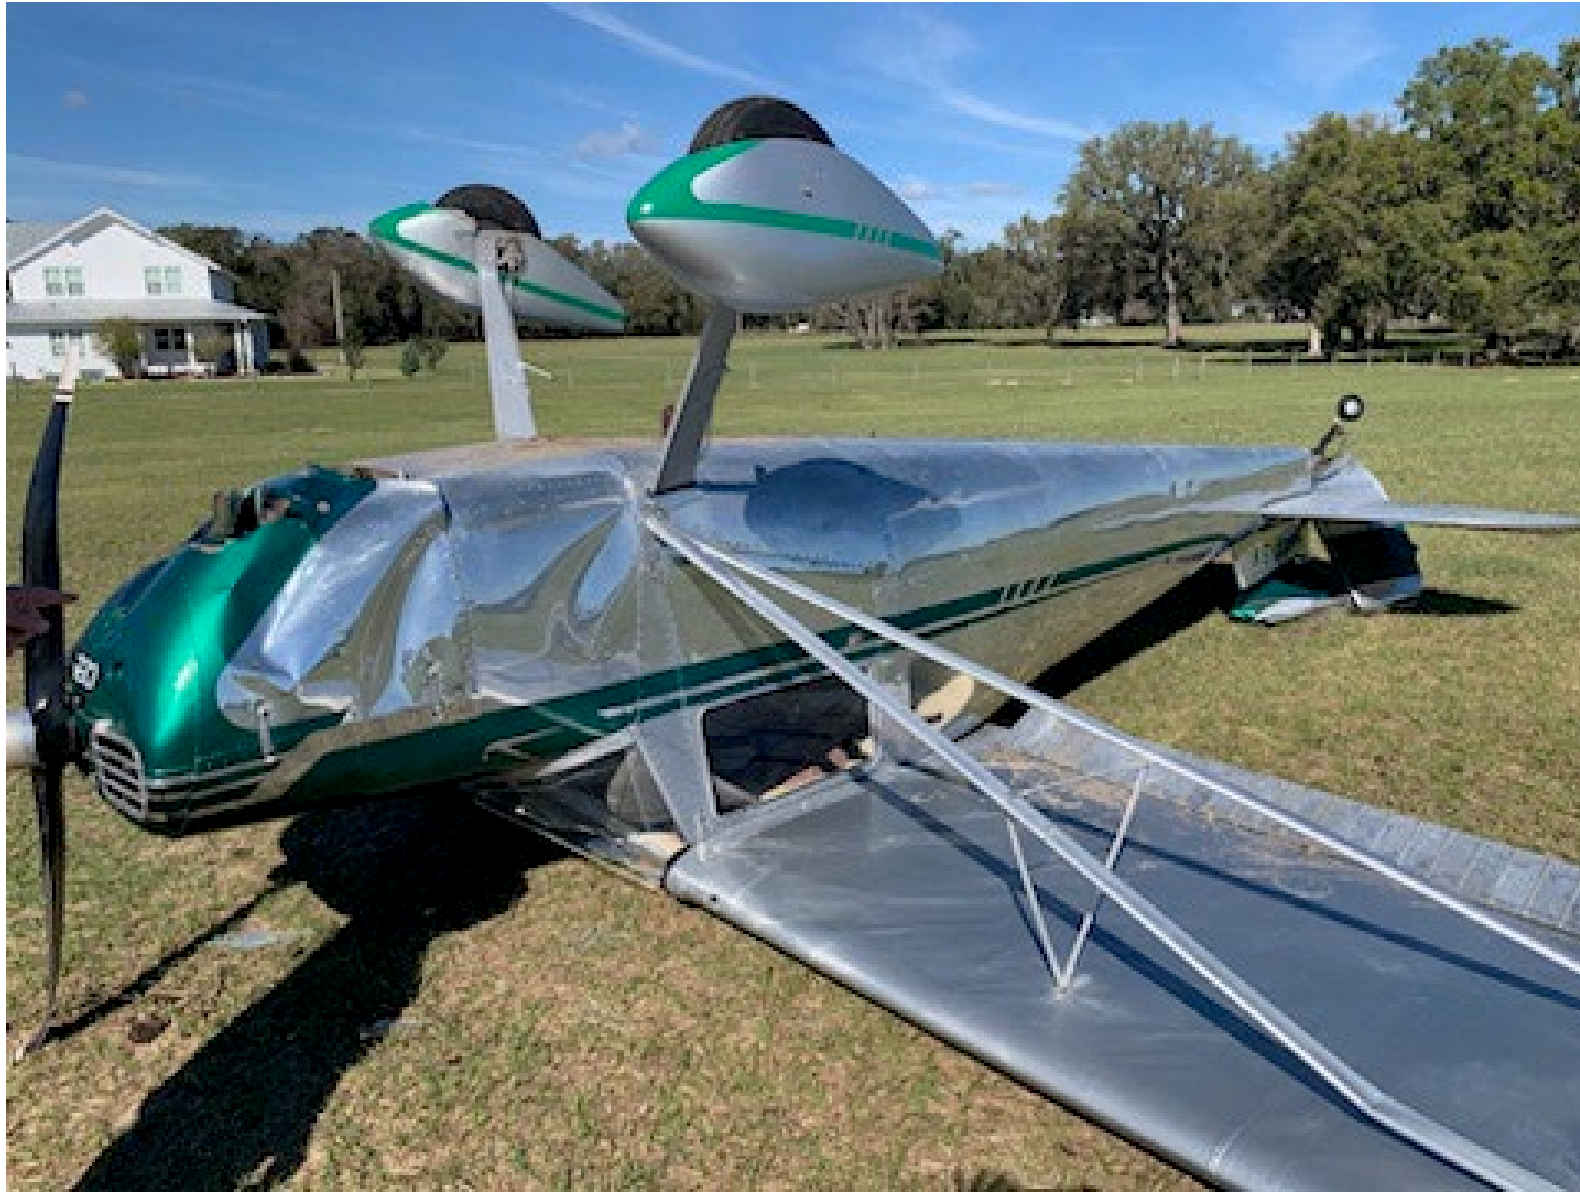
Photo 2: Overview of the airplane as it lay in the field with damage to the fuselage, vertical stabilizer and rudder (Photo Courtesy of FAA)

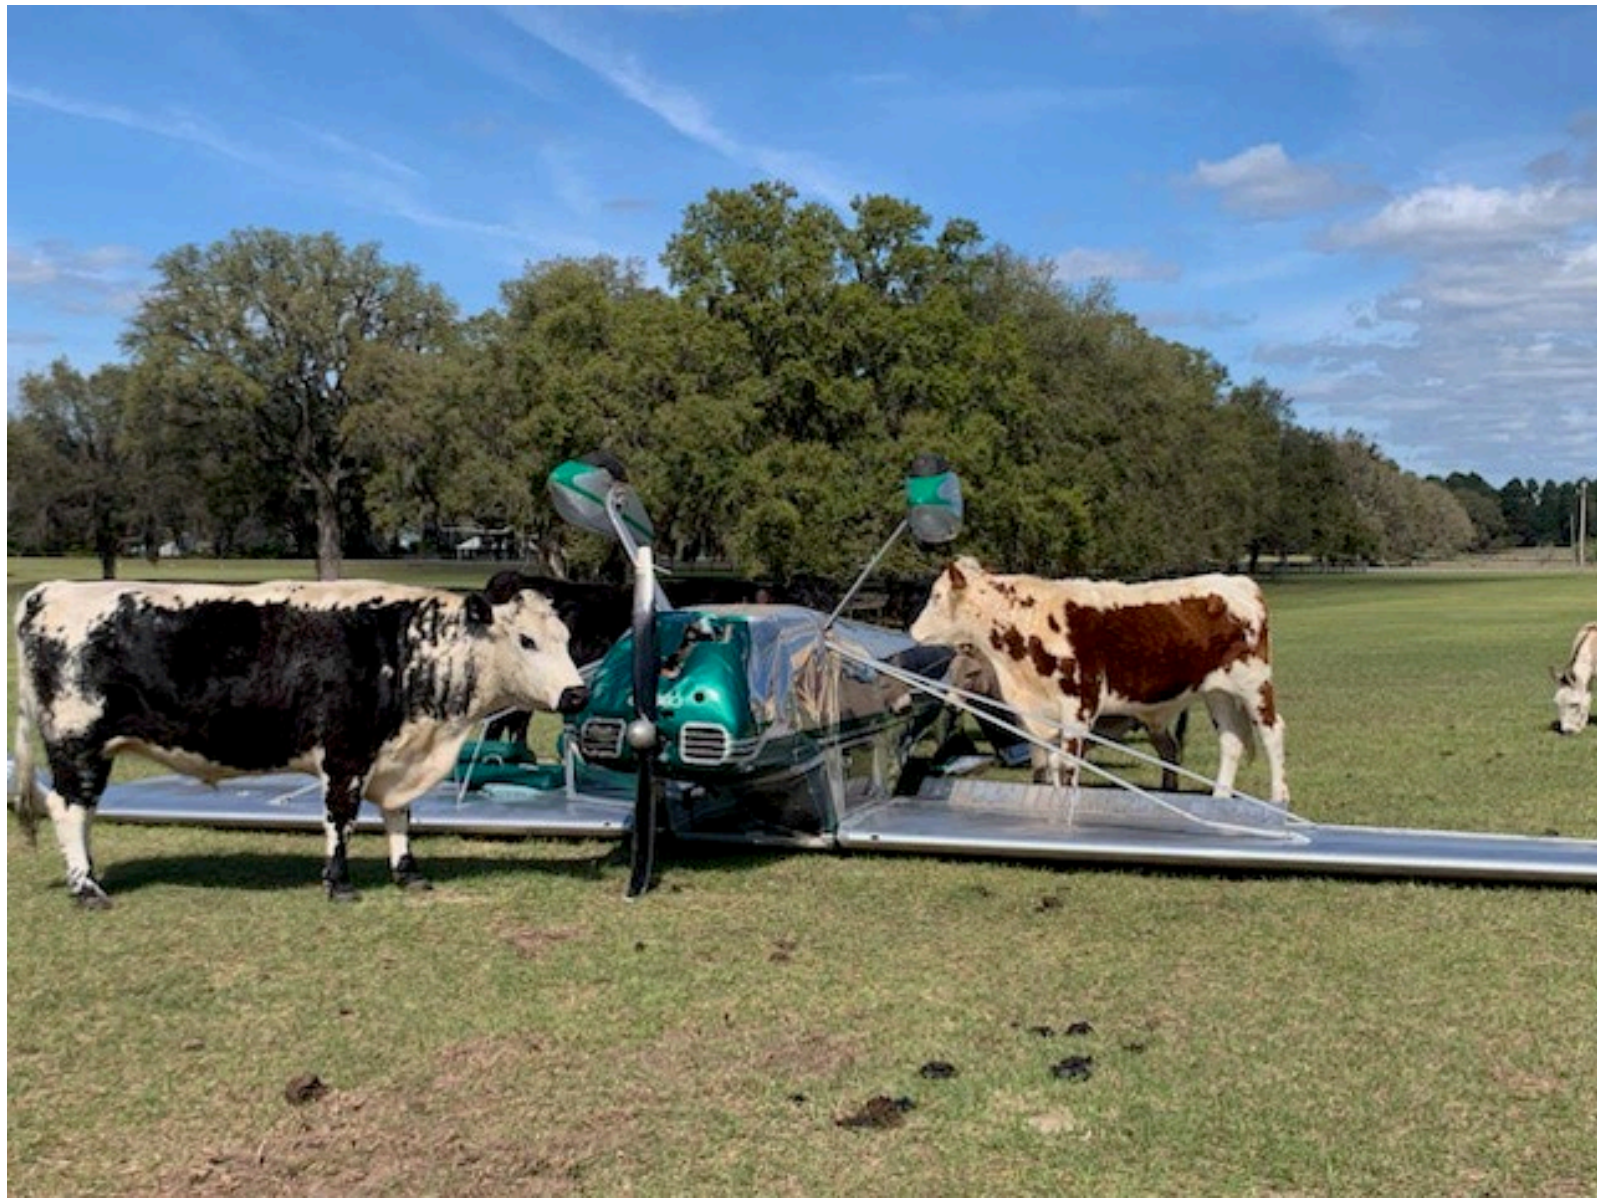
Photo 3: Overview of the airplane at the accident site (Photo Courtesy of FAA)

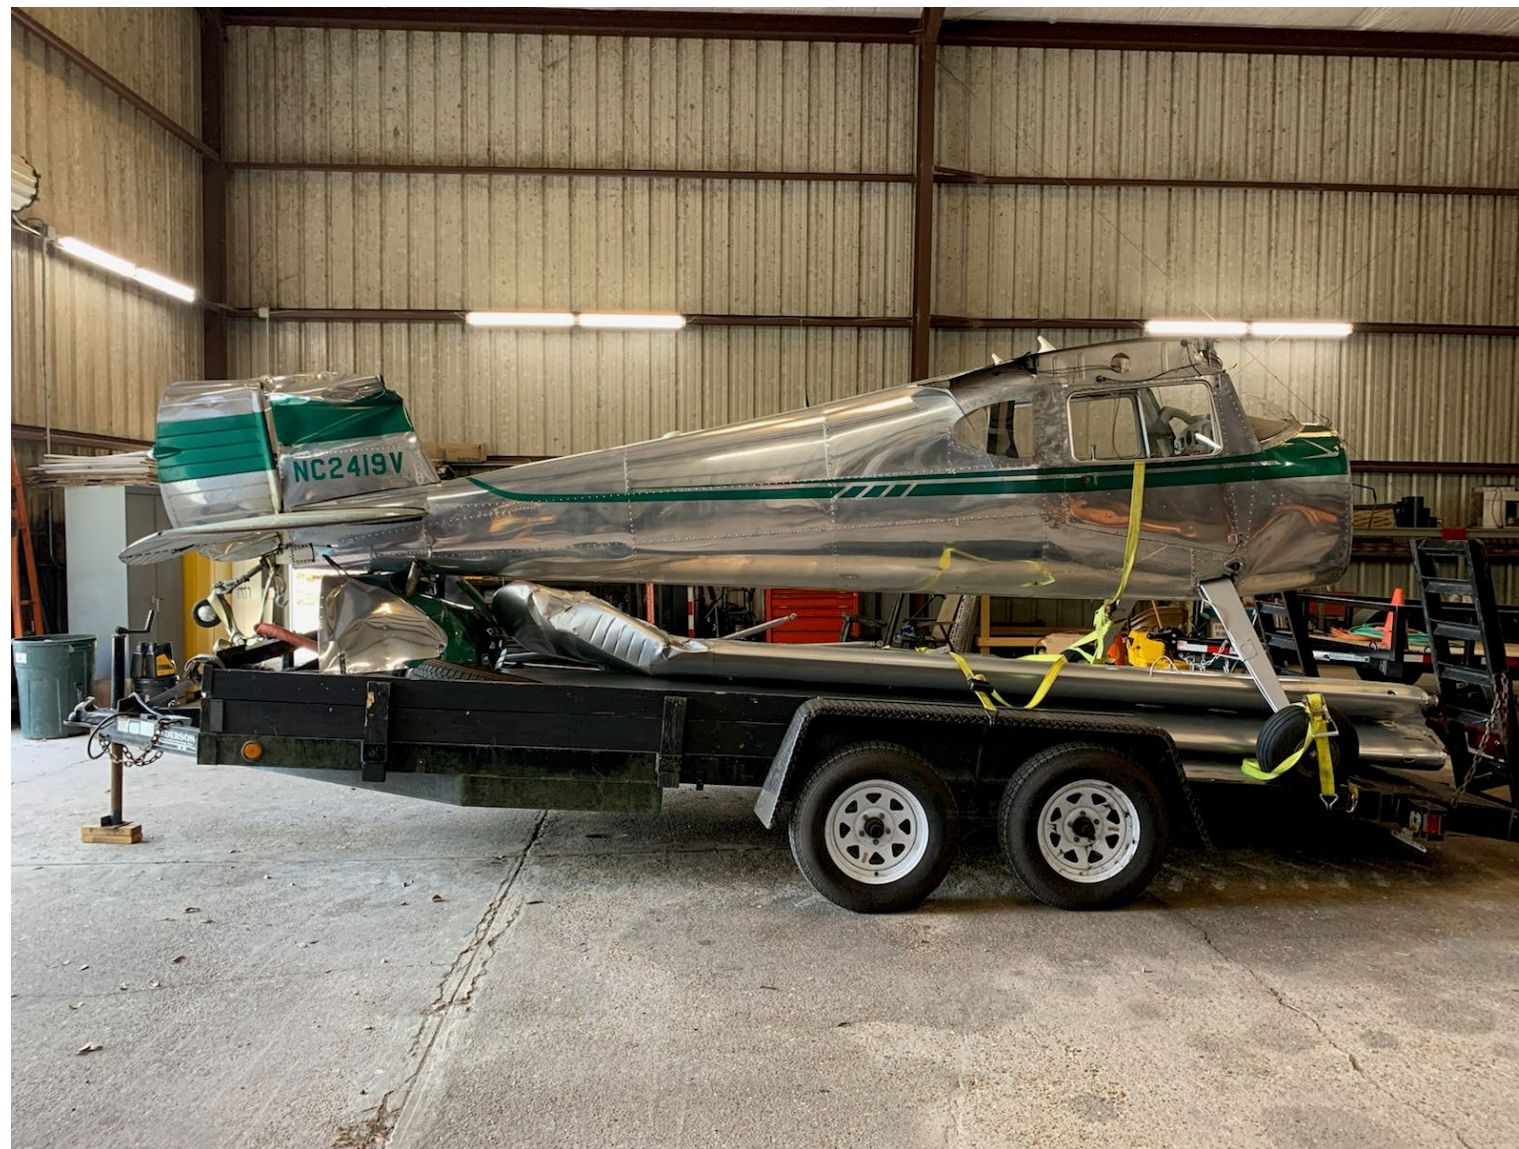
Photo 3: Overview of the airplane in a hangar after recovery with damage to the wings and tail (Photo Courtesy of FAA)
