## **NATIONAL TRANSPORTATION SAFETY BOARD**

Office of Aviation Safety  
Eastern Region

**Photo Array**

**ERA23LA140**

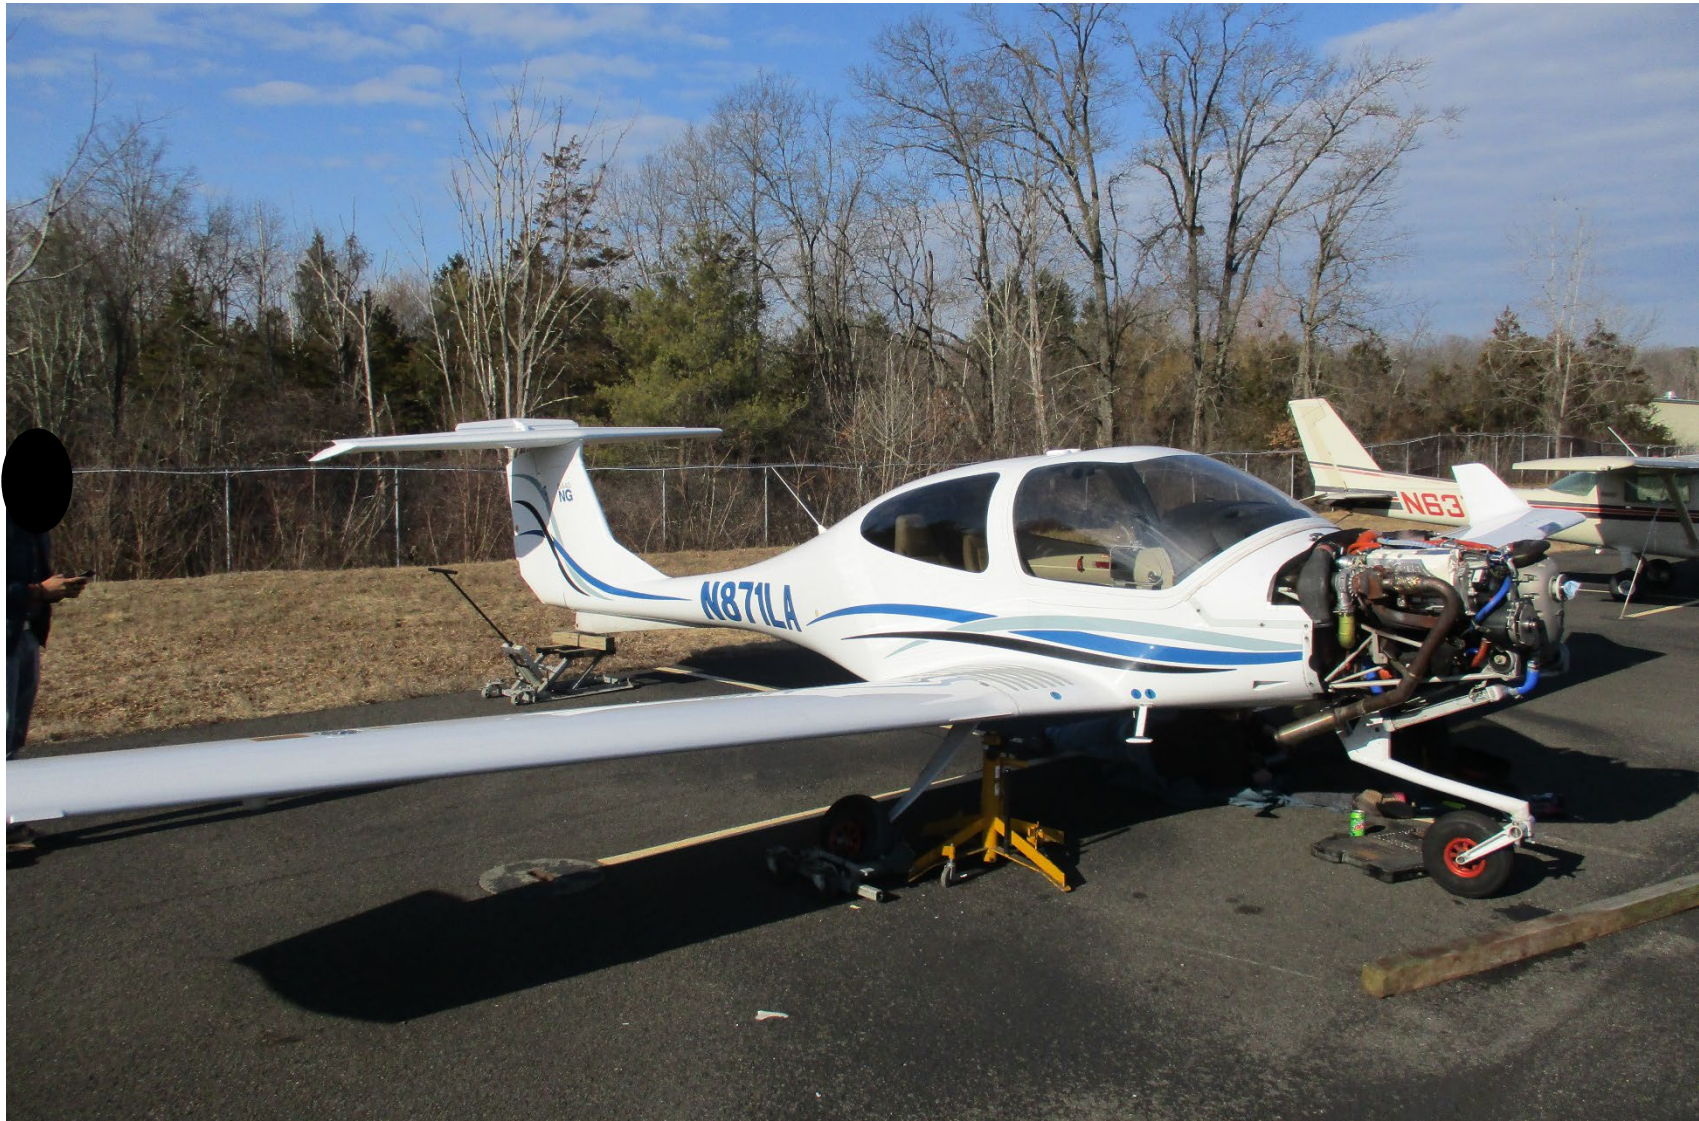
**Photo 1 – View of Accident Airplane from Front Right – Note Cowling and Propellor Removed (Courtesy of FAA)**

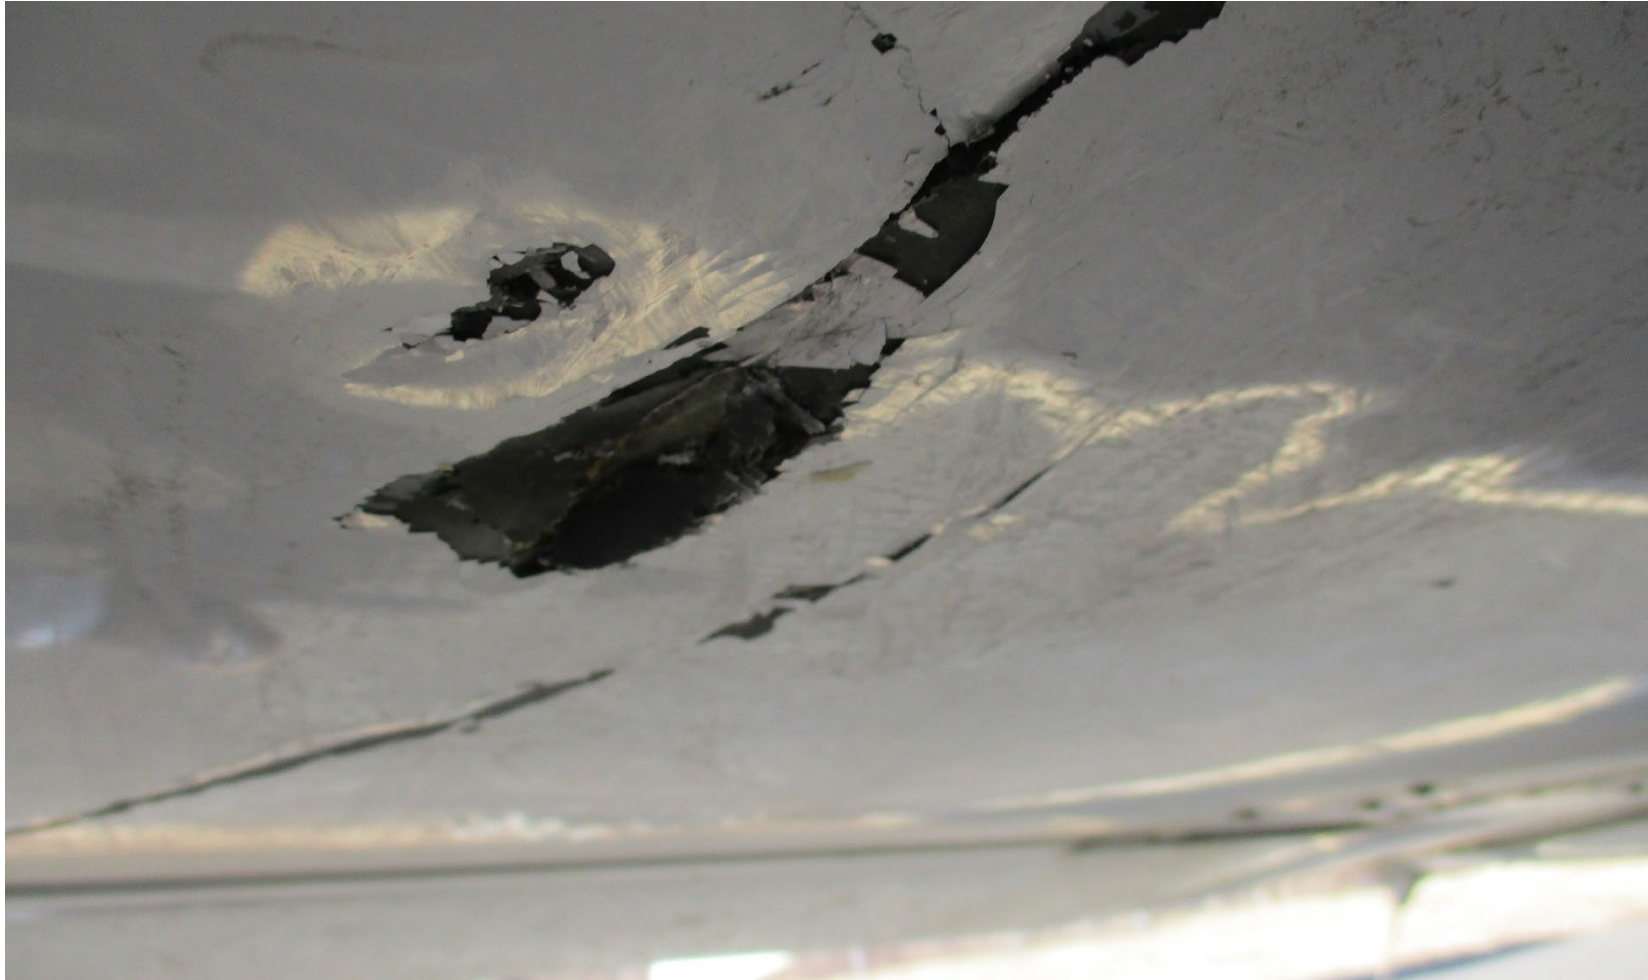
**Photo 2 – Closeup View of Right Wing Underside Damage – Note Composite Materials (Courtesy of FAA)**

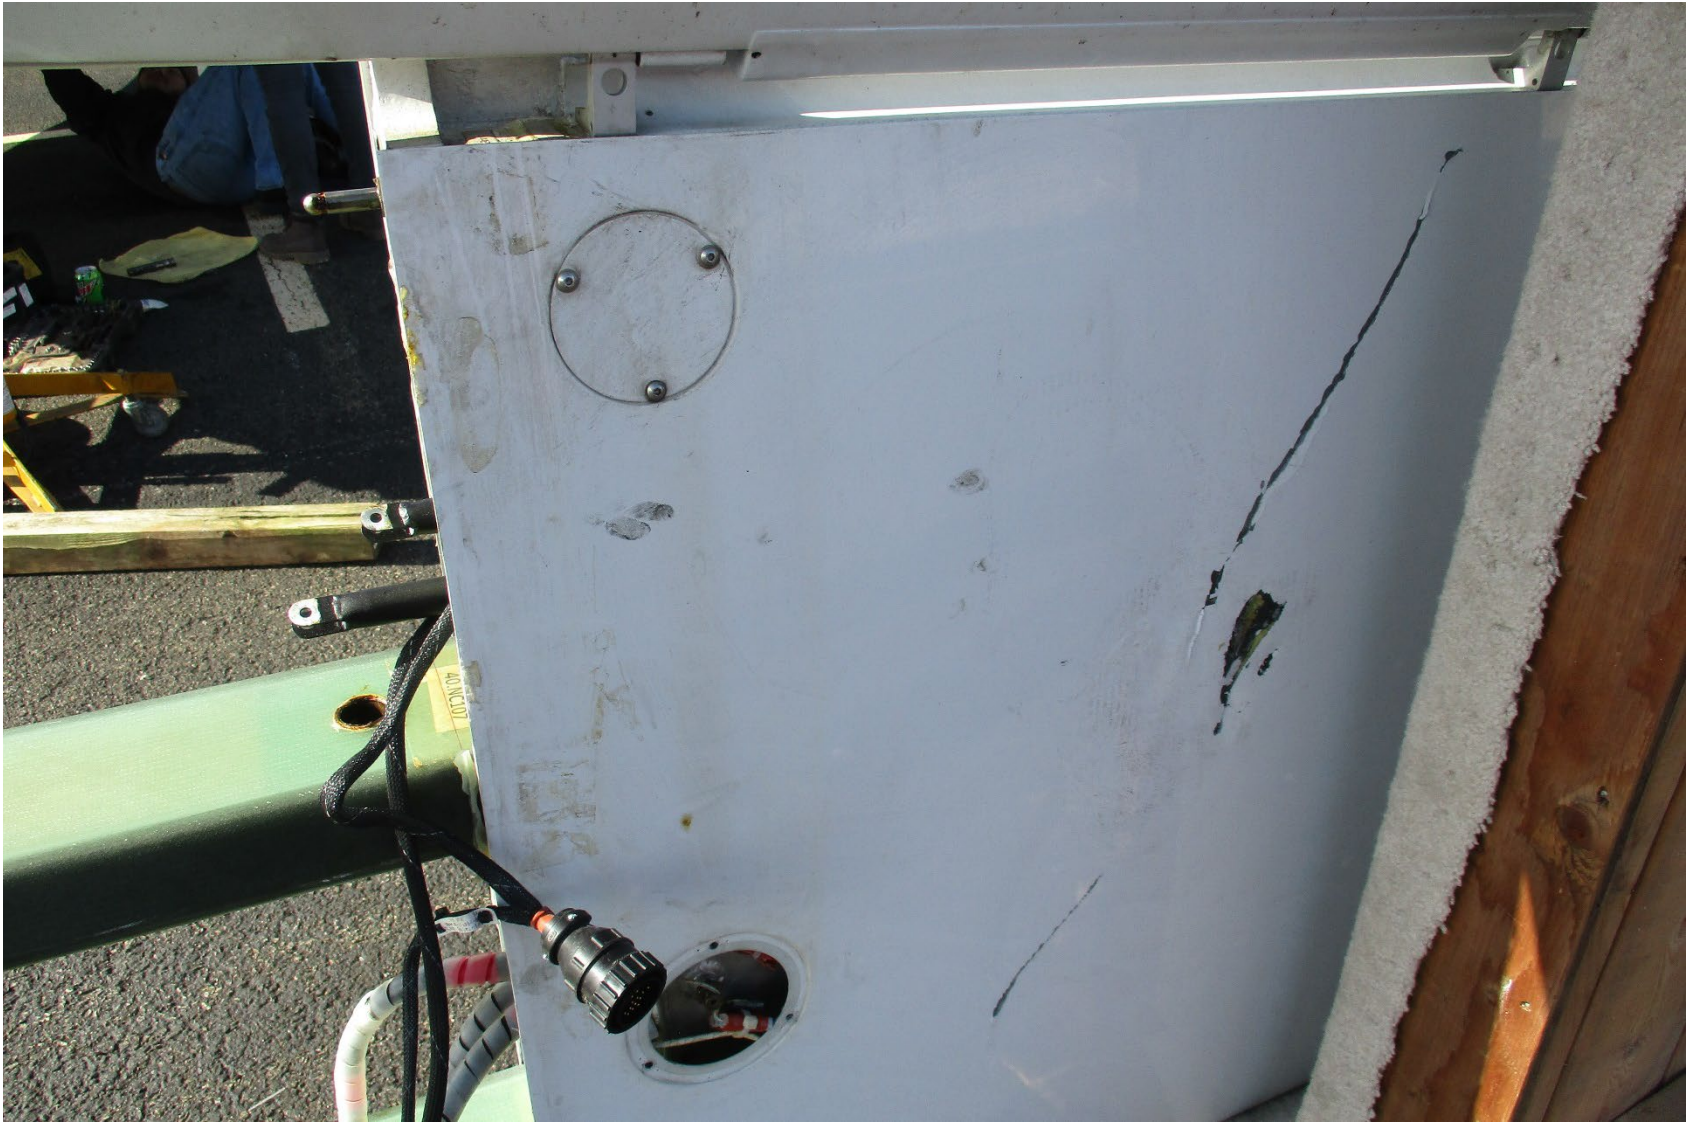
**Photo 3 – View of Right Wing Underside, Removed From Fuselage and Upright (Courtesy of FAA)**
