ERA23LA148

## INVESTIGATION PHOTOGRAPHS

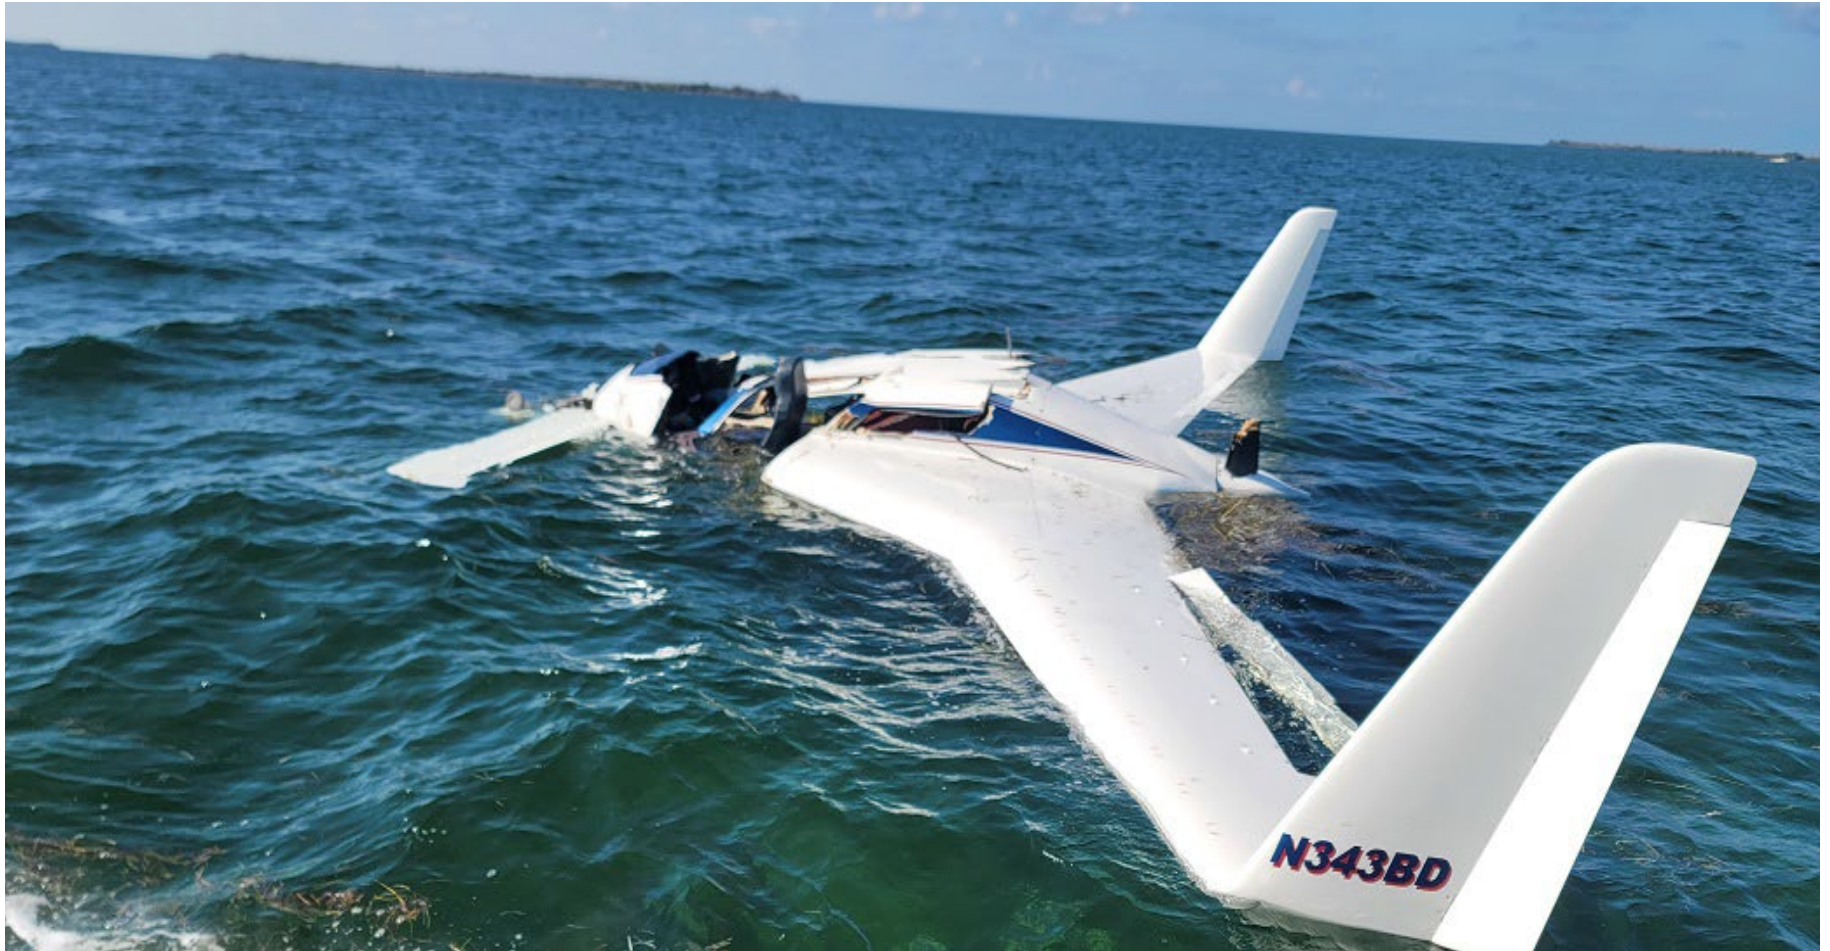
**Photograph 1 - Main Wreckage (Courtesy of Tow Boat US)**

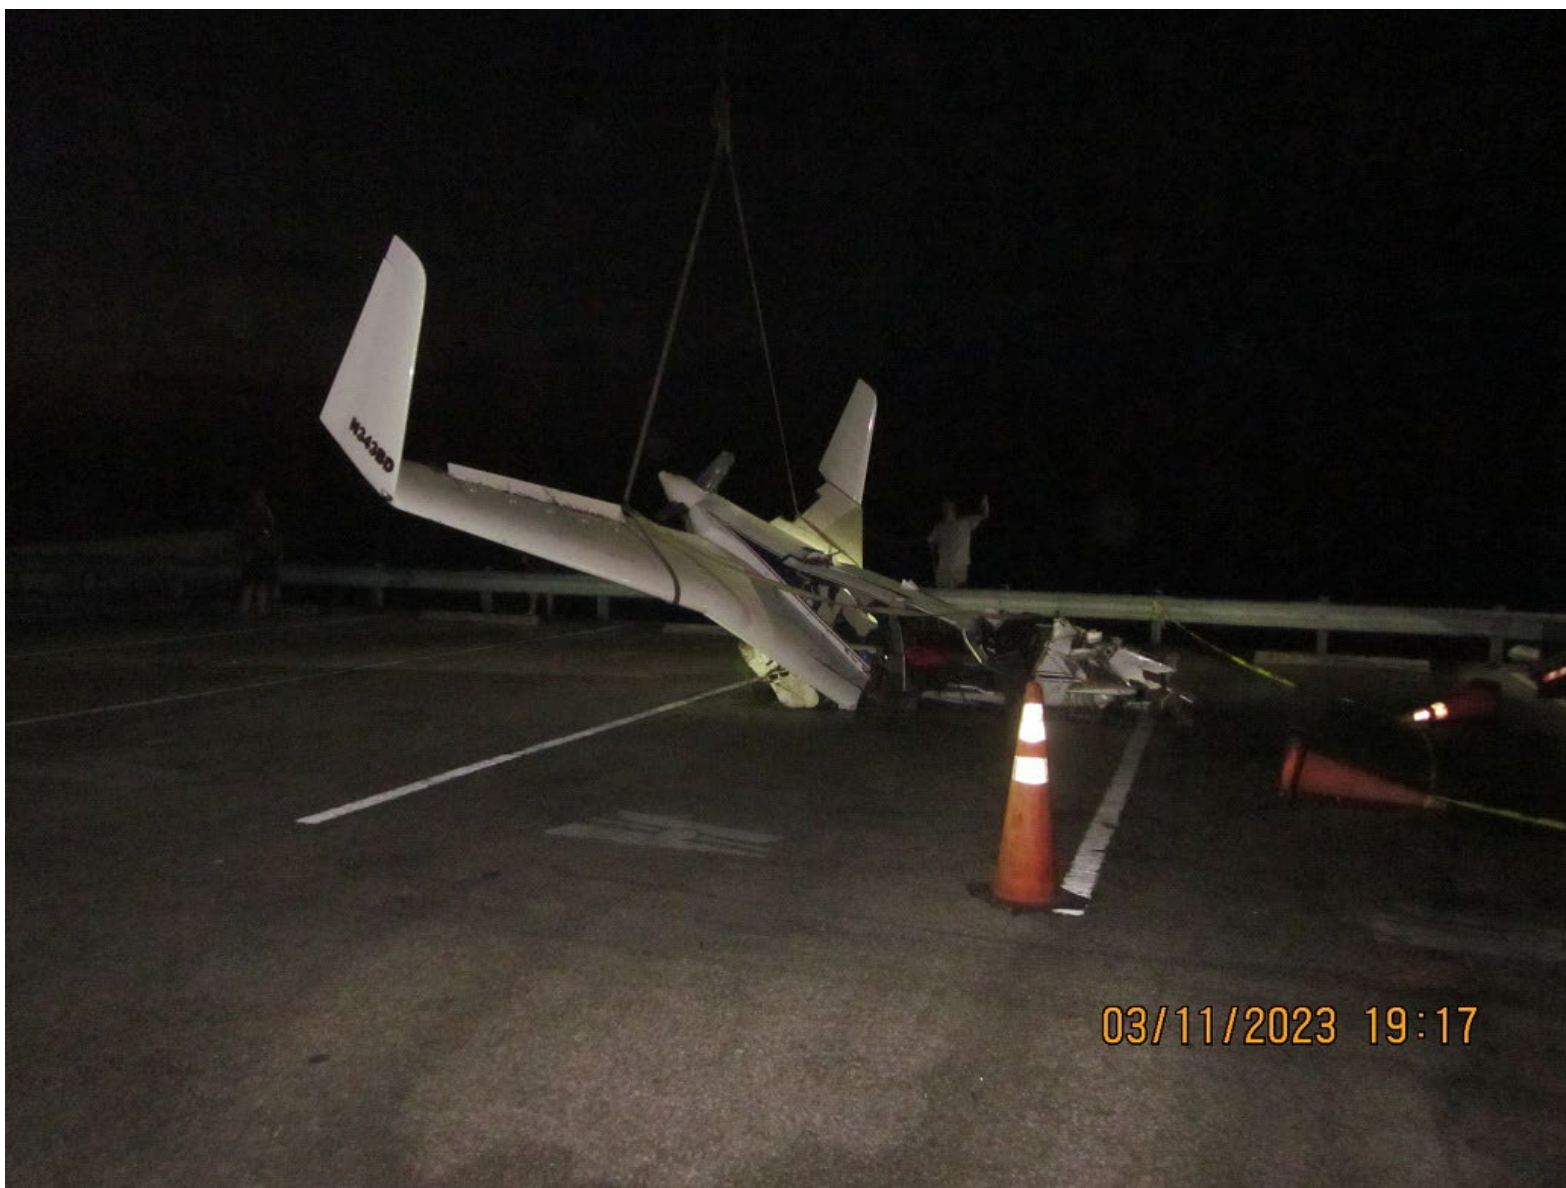
**Photograph 2 - Wreckage Recovered (Courtesy of FAA)**

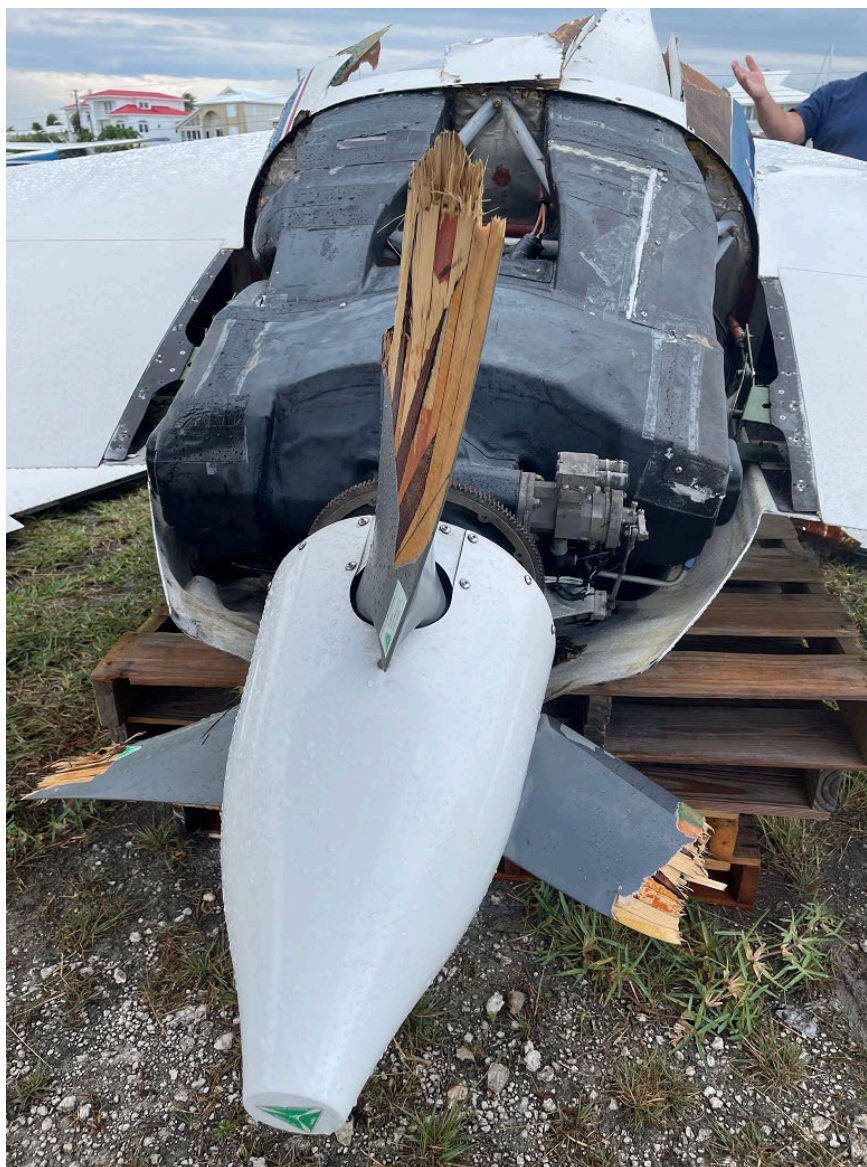
**Photograph 3 - Engine And Propeller (Courtesy of FAA)**

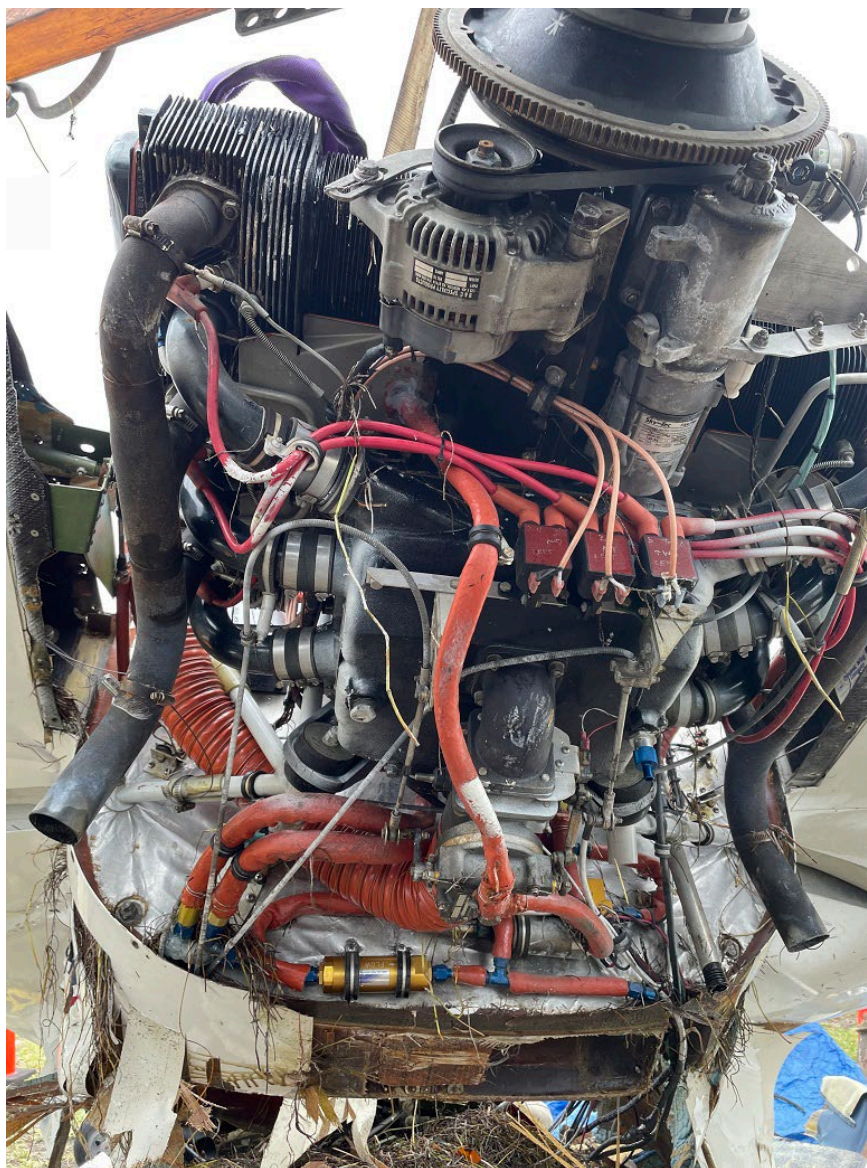
**Photograph 4 - Underside of Engine (Courtesy of FAA)**

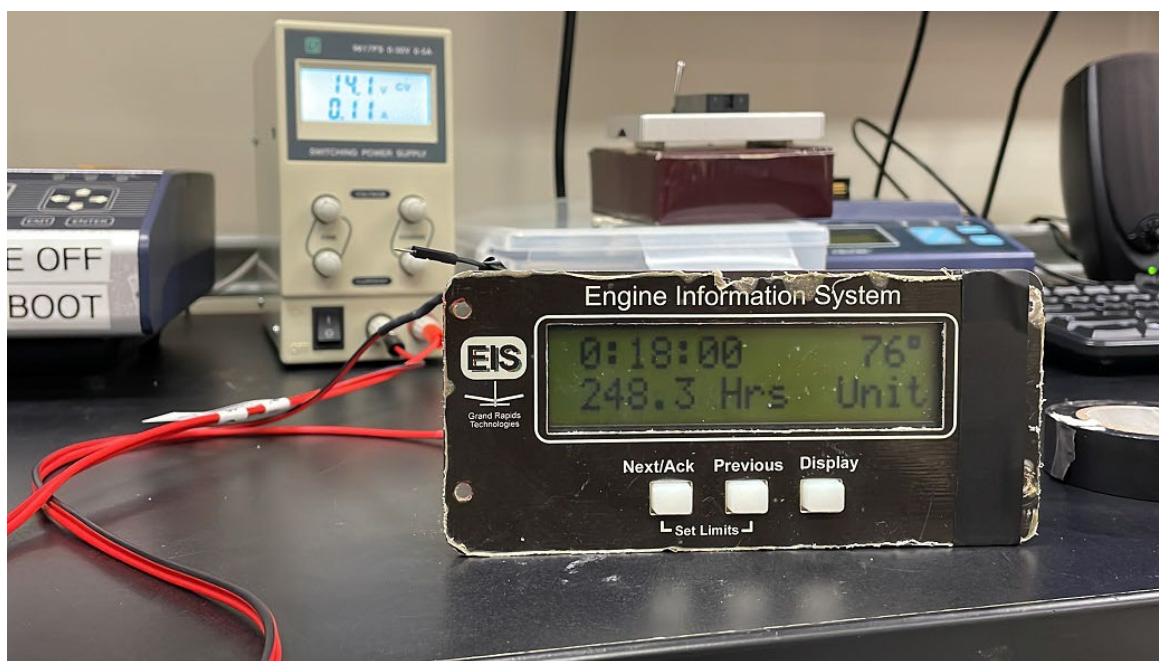
**Photograph 5 - EIS Test (Courtesy of NTSB)**
