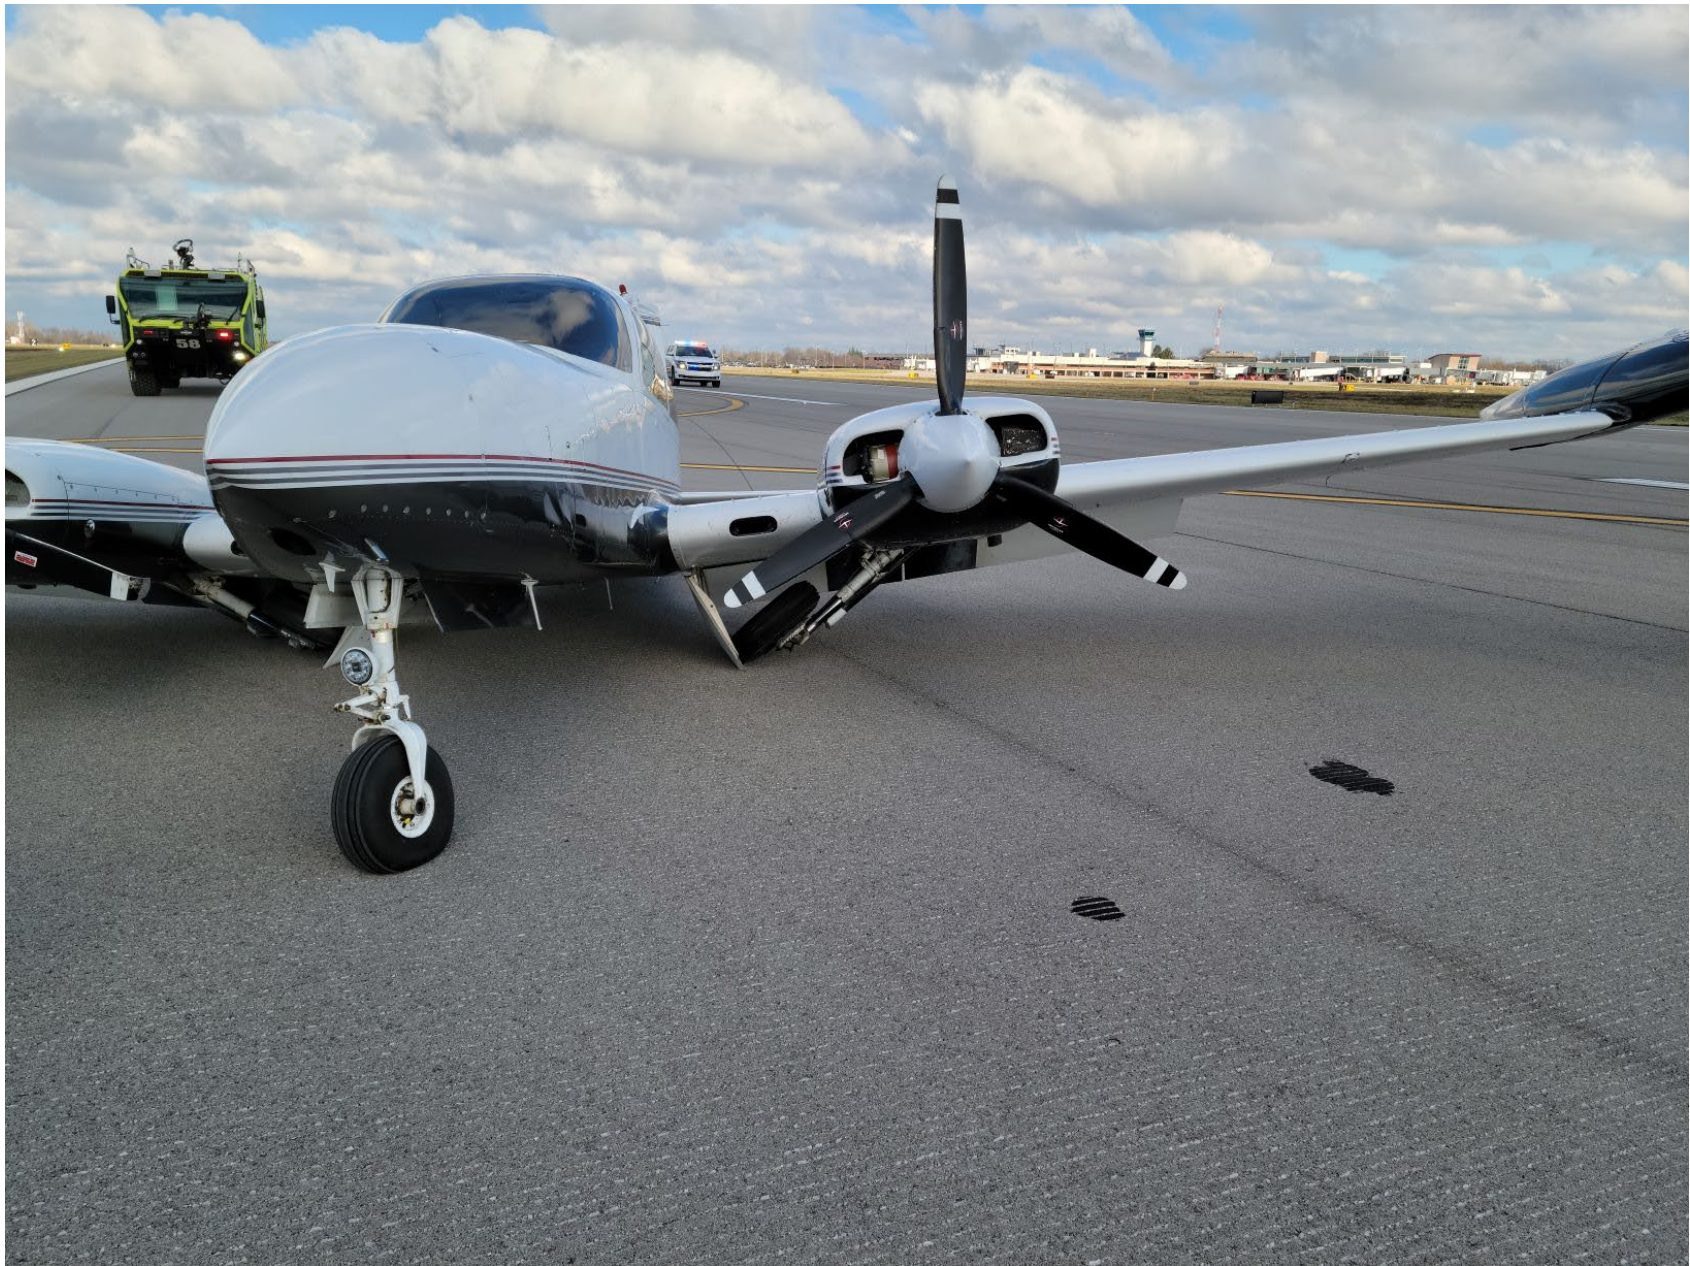
**Photo 1 – View of Airplane as Found (FAA)**

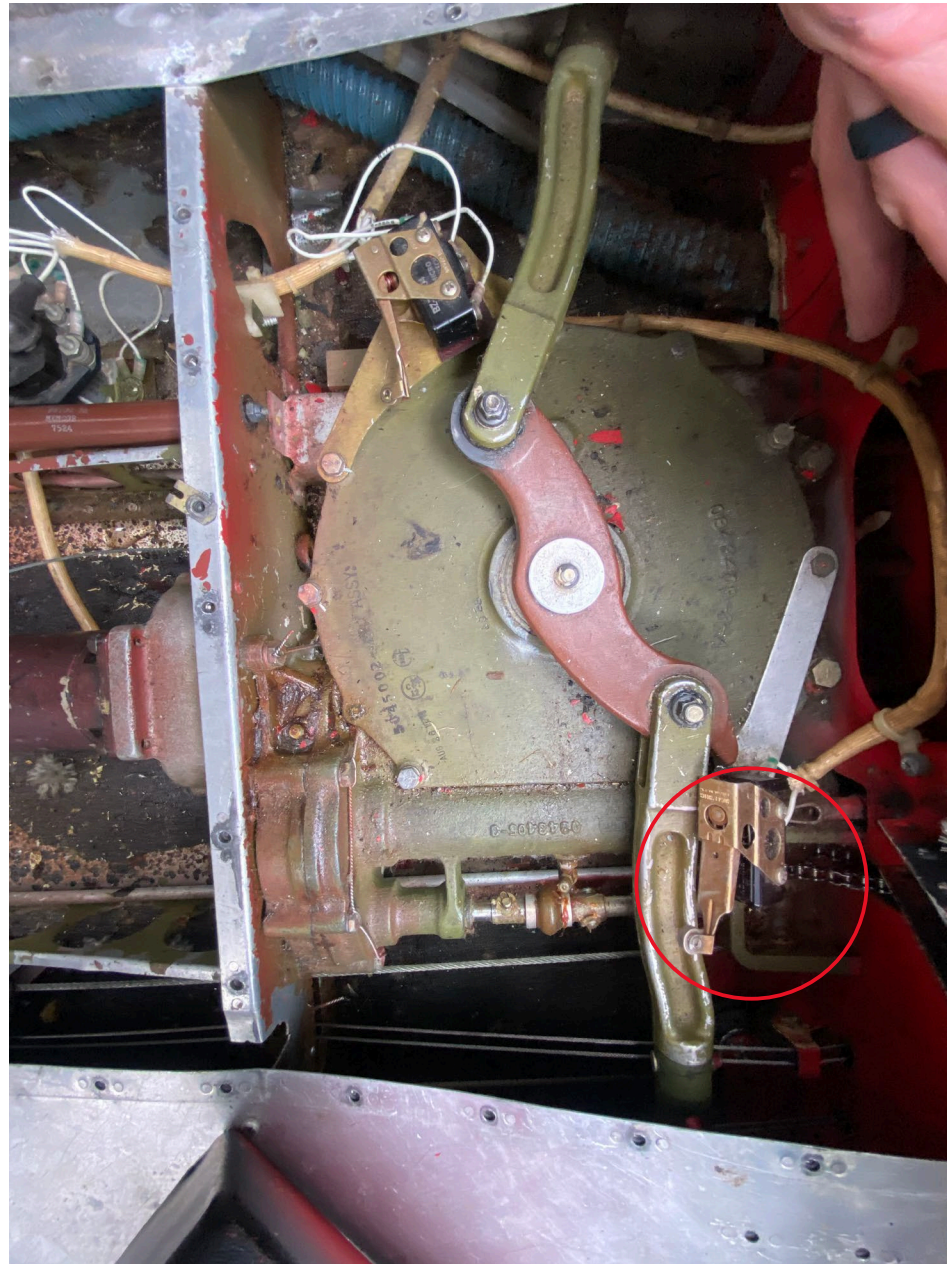
**Photo 2 – View of Upper Bellcrank Overtravel and Damaged Down-Limit Switch (Thoroughbred Aviation)**

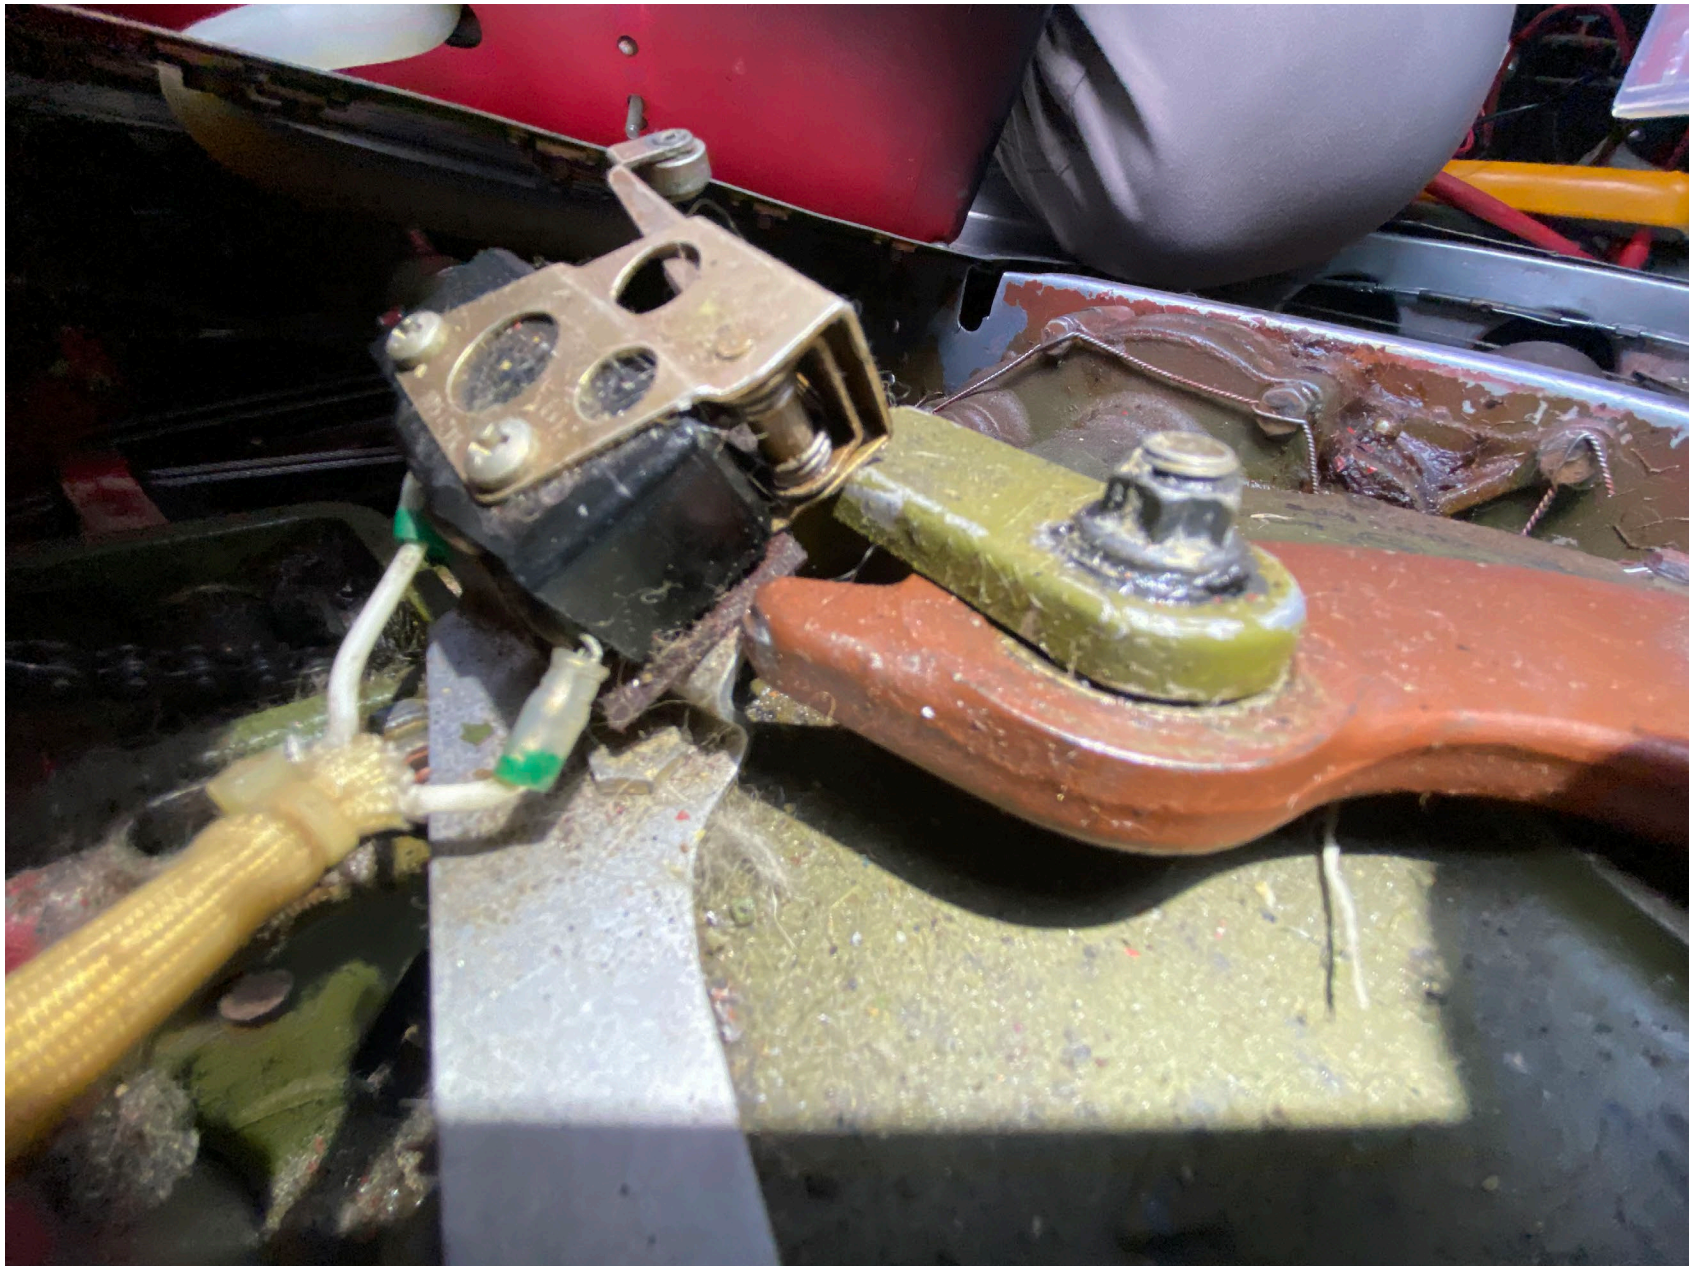
**Photo 3 – View of Bent Landing Gear Switch Mount (Thoroughbred Aviation)**

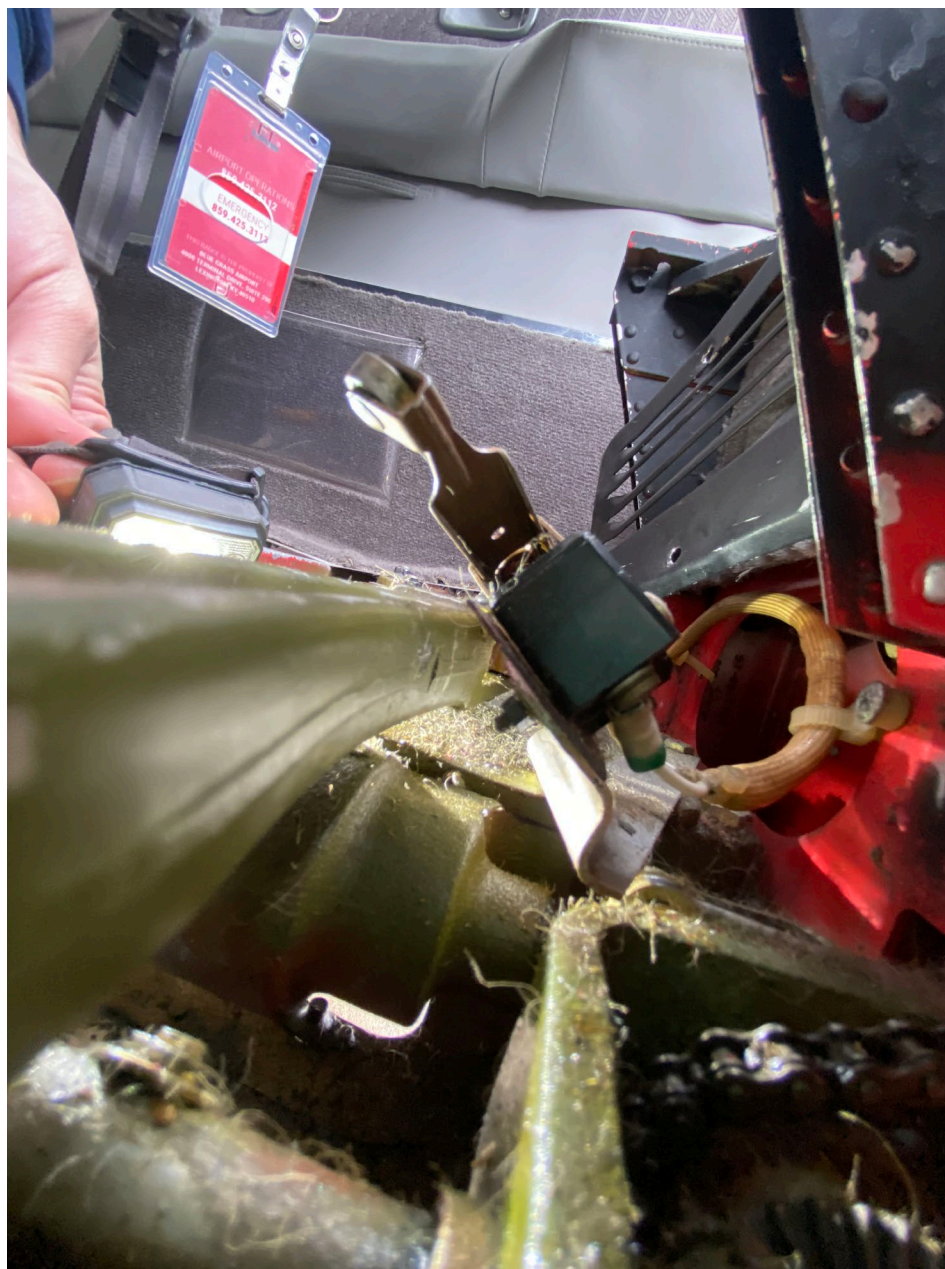
**Photo 4 – Profile View of Bent Down-Lock Switch Mount (Thoroughbred Aviation)**

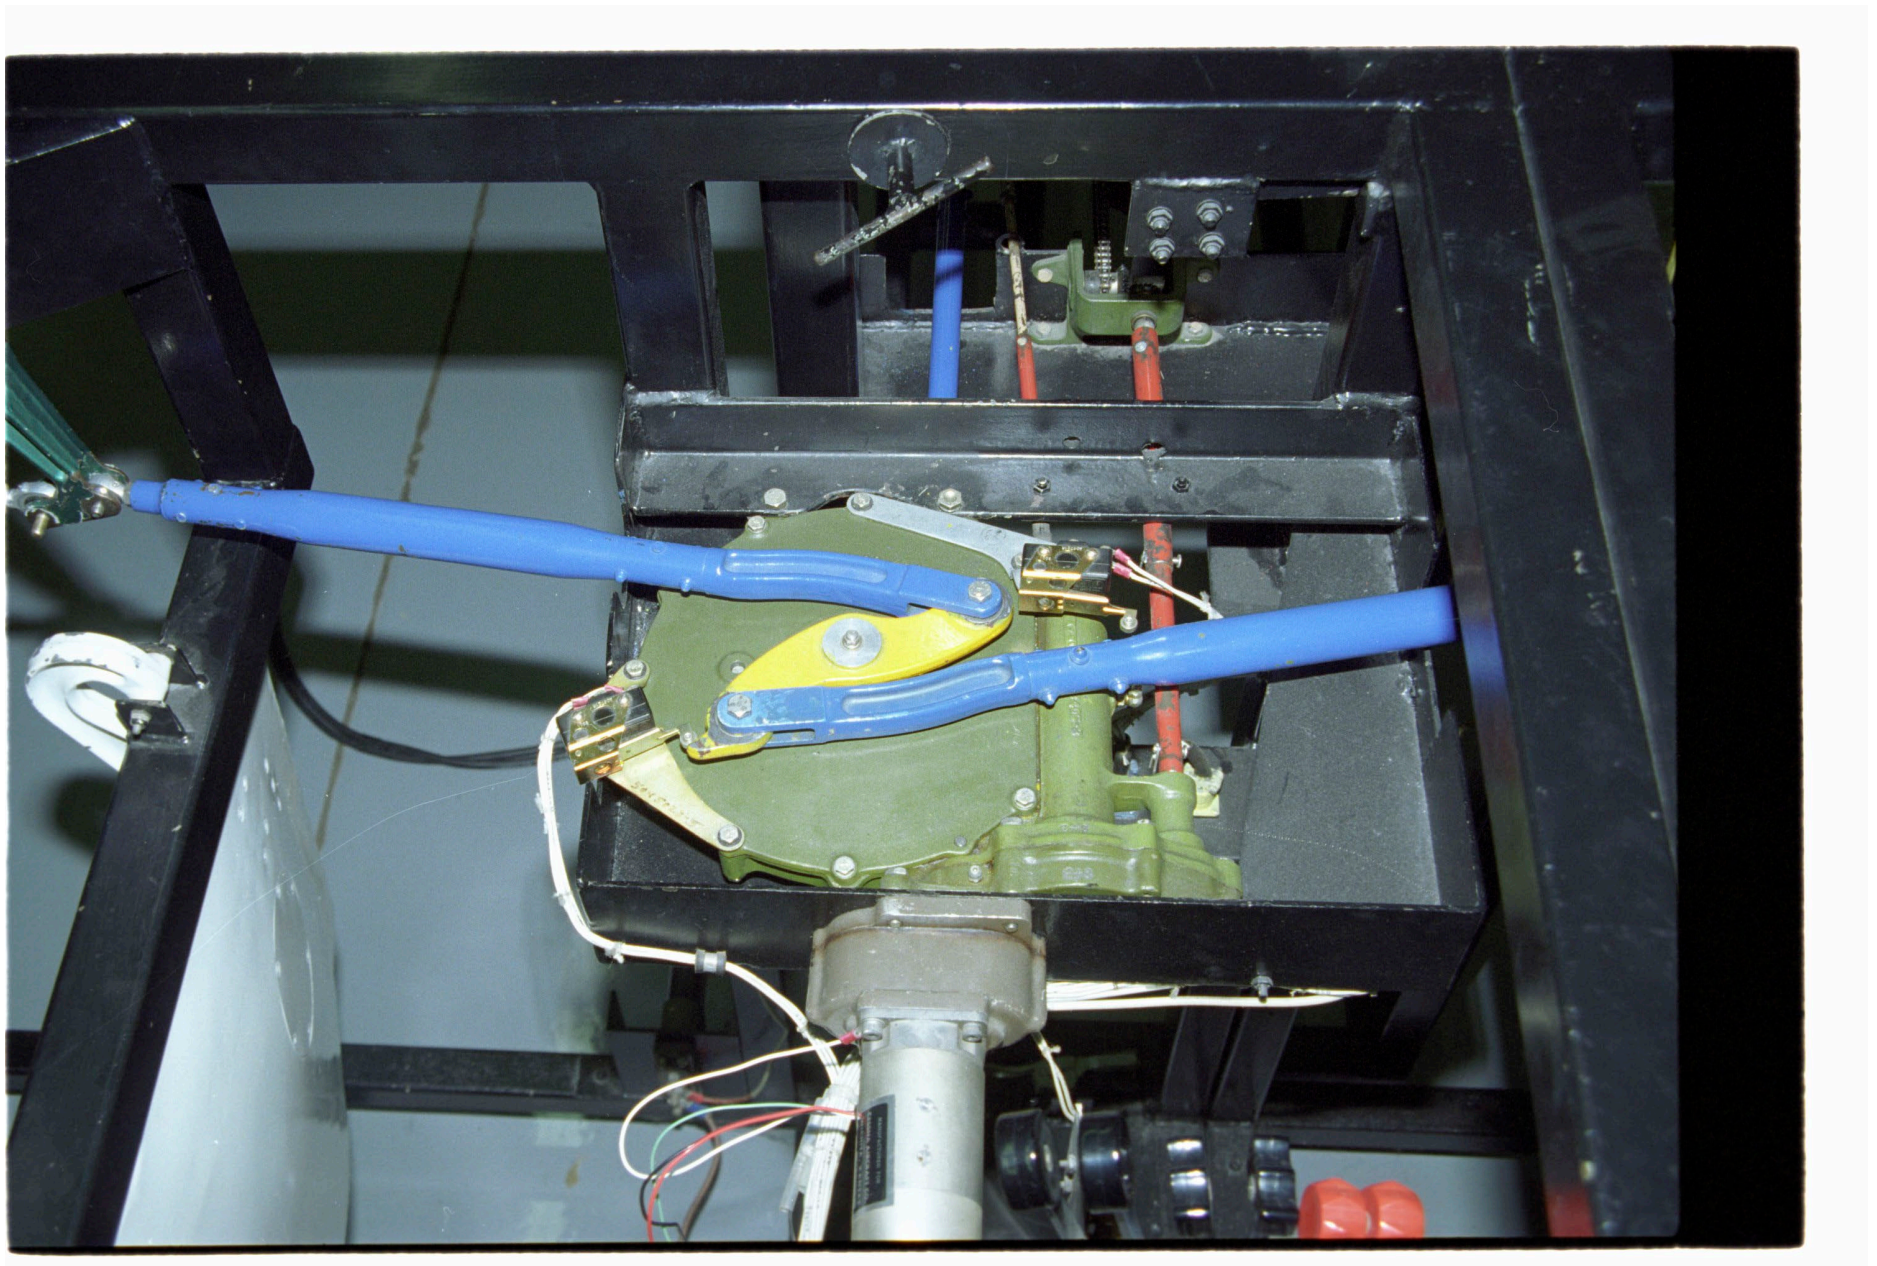
**Photo 5 – View of Exemplar Landing Gear Motor in Retracted Position (Textron)**

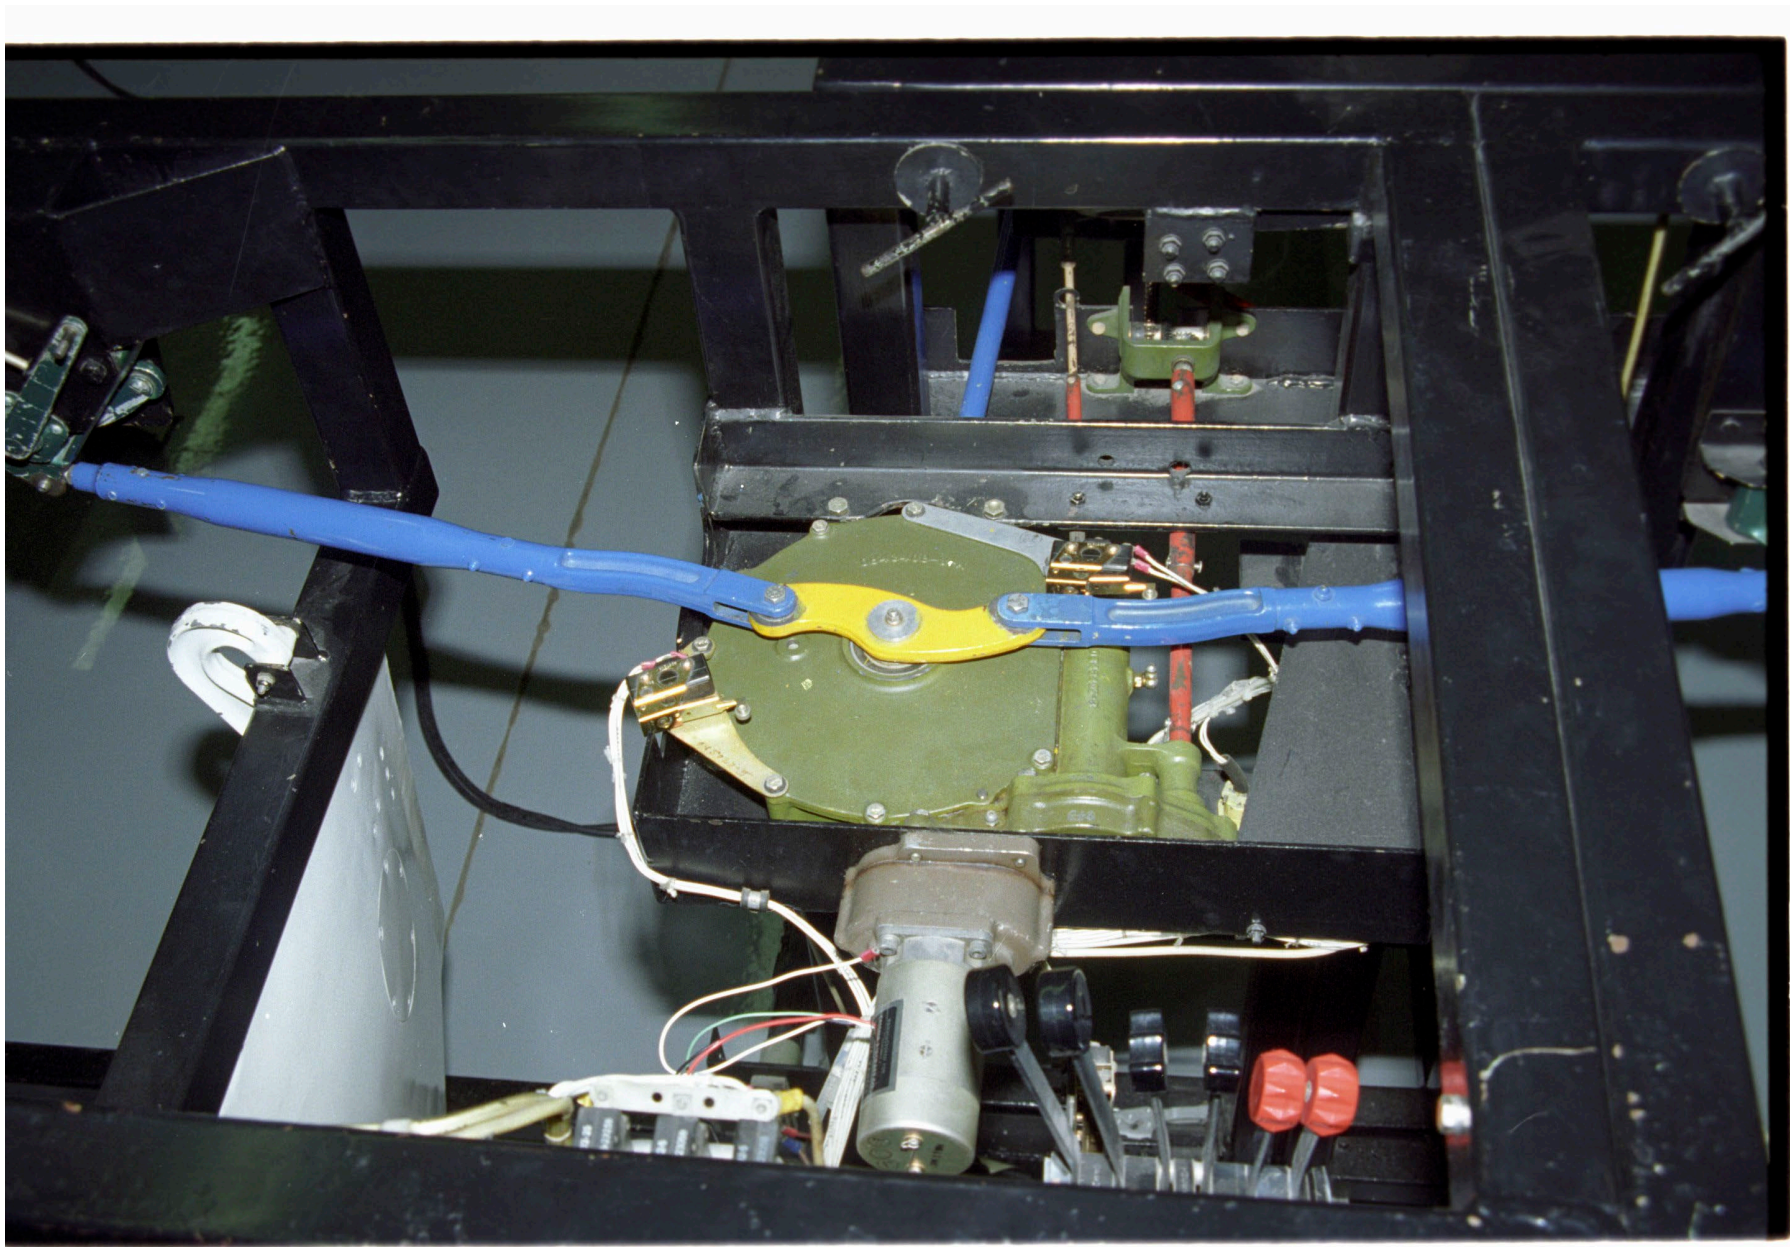
**Photo 6 – View of Exemplar Landing Gear Motor in Extended Position (Textron)**

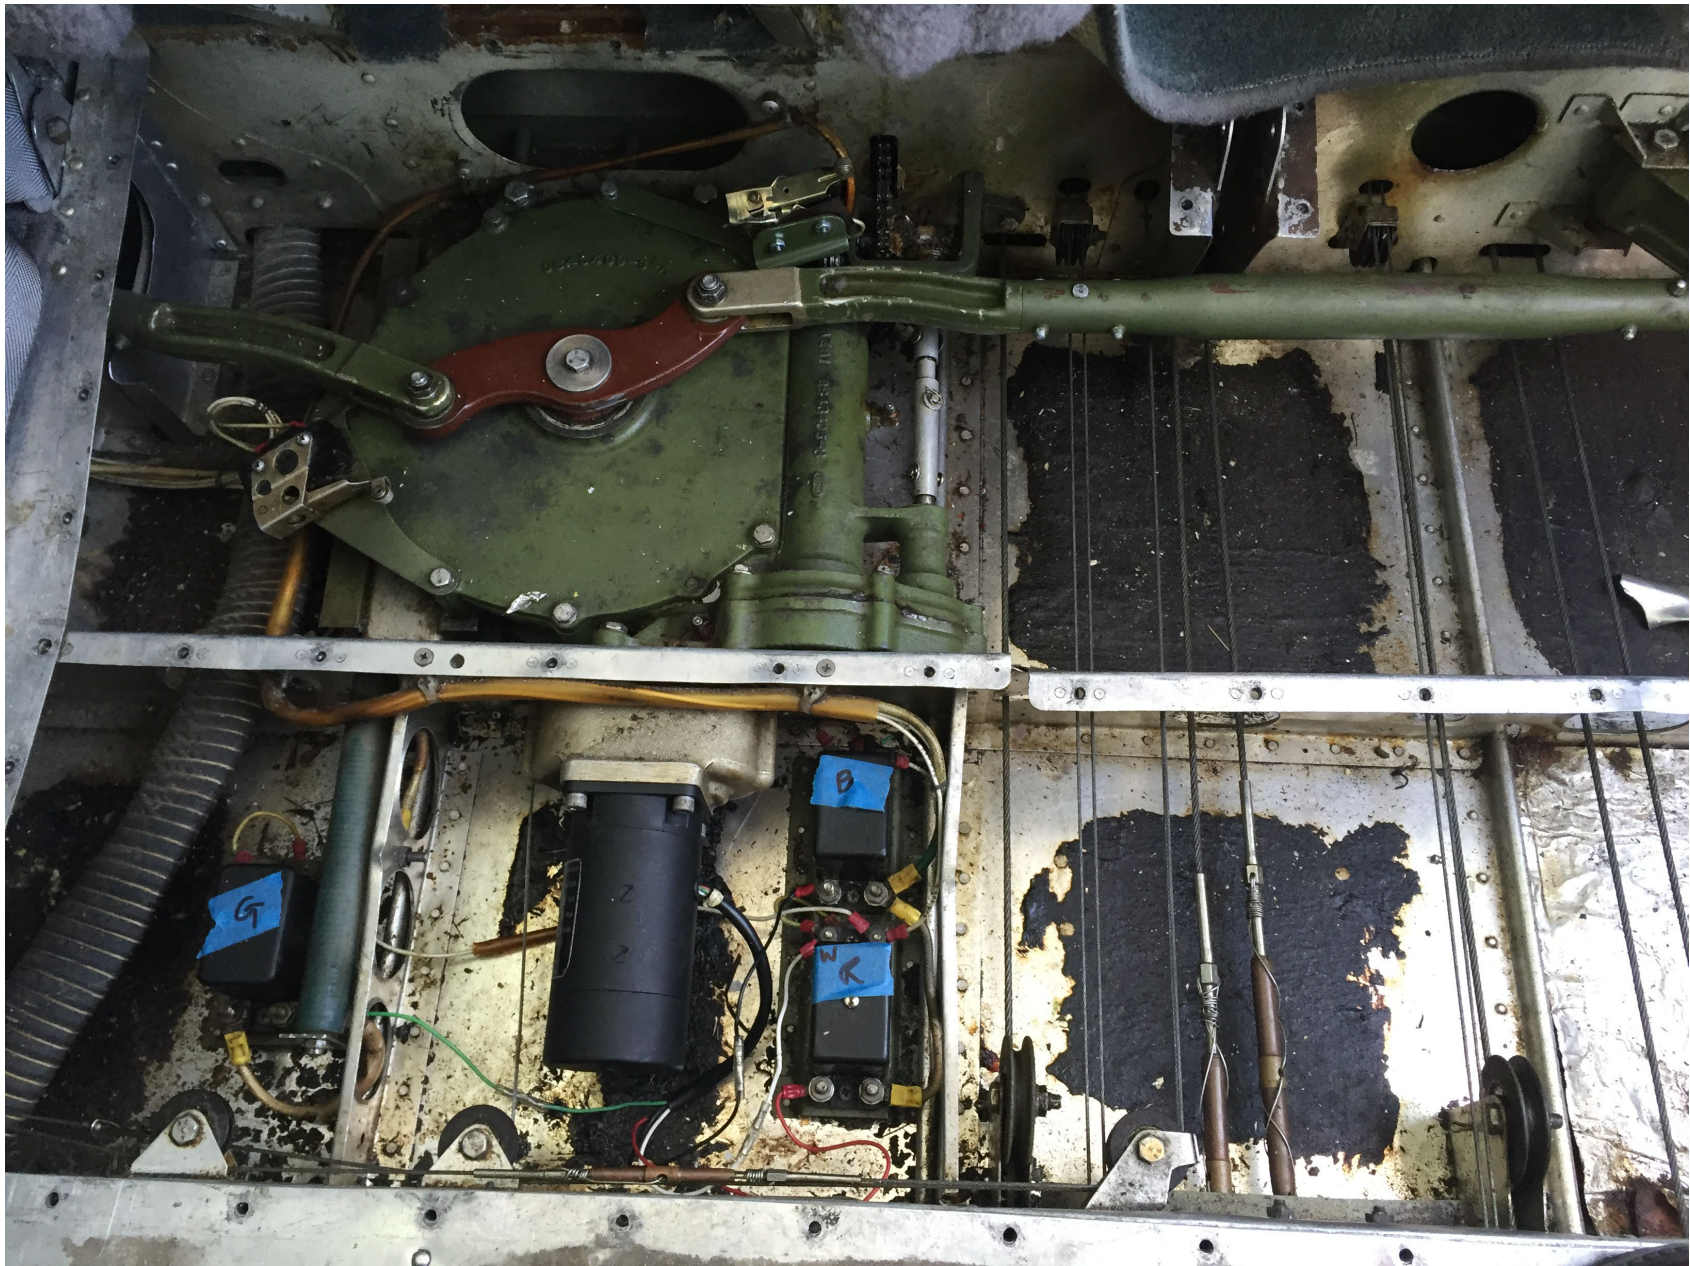
**Photo 7 – View of Landing Gear Motor and Damaged Switch from ERA16LA271 (FAA)**
