RE: 709-FY23-006

I am amending my initial statement on the cause of the accident involving N565TF that occurred on March 19, 2023. I request that this document and Piper Service Letter #1318A be included in all your reports.

# SERVICE NO. 1318A LETTER

**BRAKE LINE MODIFICATION**

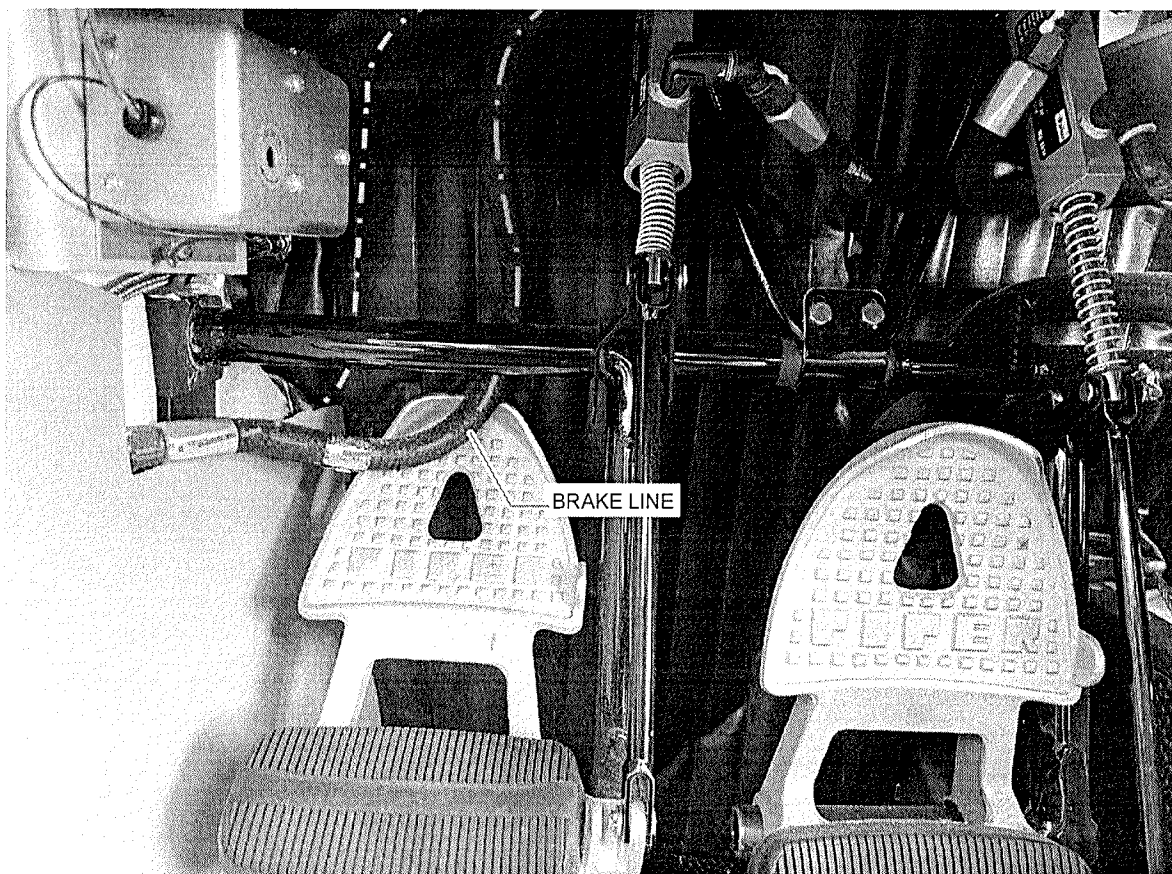
**Figure 1**  
Brake Line Location and Routing

In some of the affected airplanes, the brake line (hose) may have enough freedom to move into a position that obstructs the pilot's left pedal, restricting control of the brakes and rudder. This service letter provides instructions for correction and modification of the brake line routing to prevent pedal obstruction.

— - — INCORRECT ROUTING

- - - CORRECT ROUTING

1. Locate brake line near the left foot pedal on the pilot's side of the cockpit as shown in Figure 1. Compare the routing of the brake line and correct as required.
2. Secure the brake line to the flange on the firewall stiffener as shown in Figure 2. Slit the firewall blanket as required to install the clamp, screw, washers, and nut, to the 0.191 inch hole in the flange.
