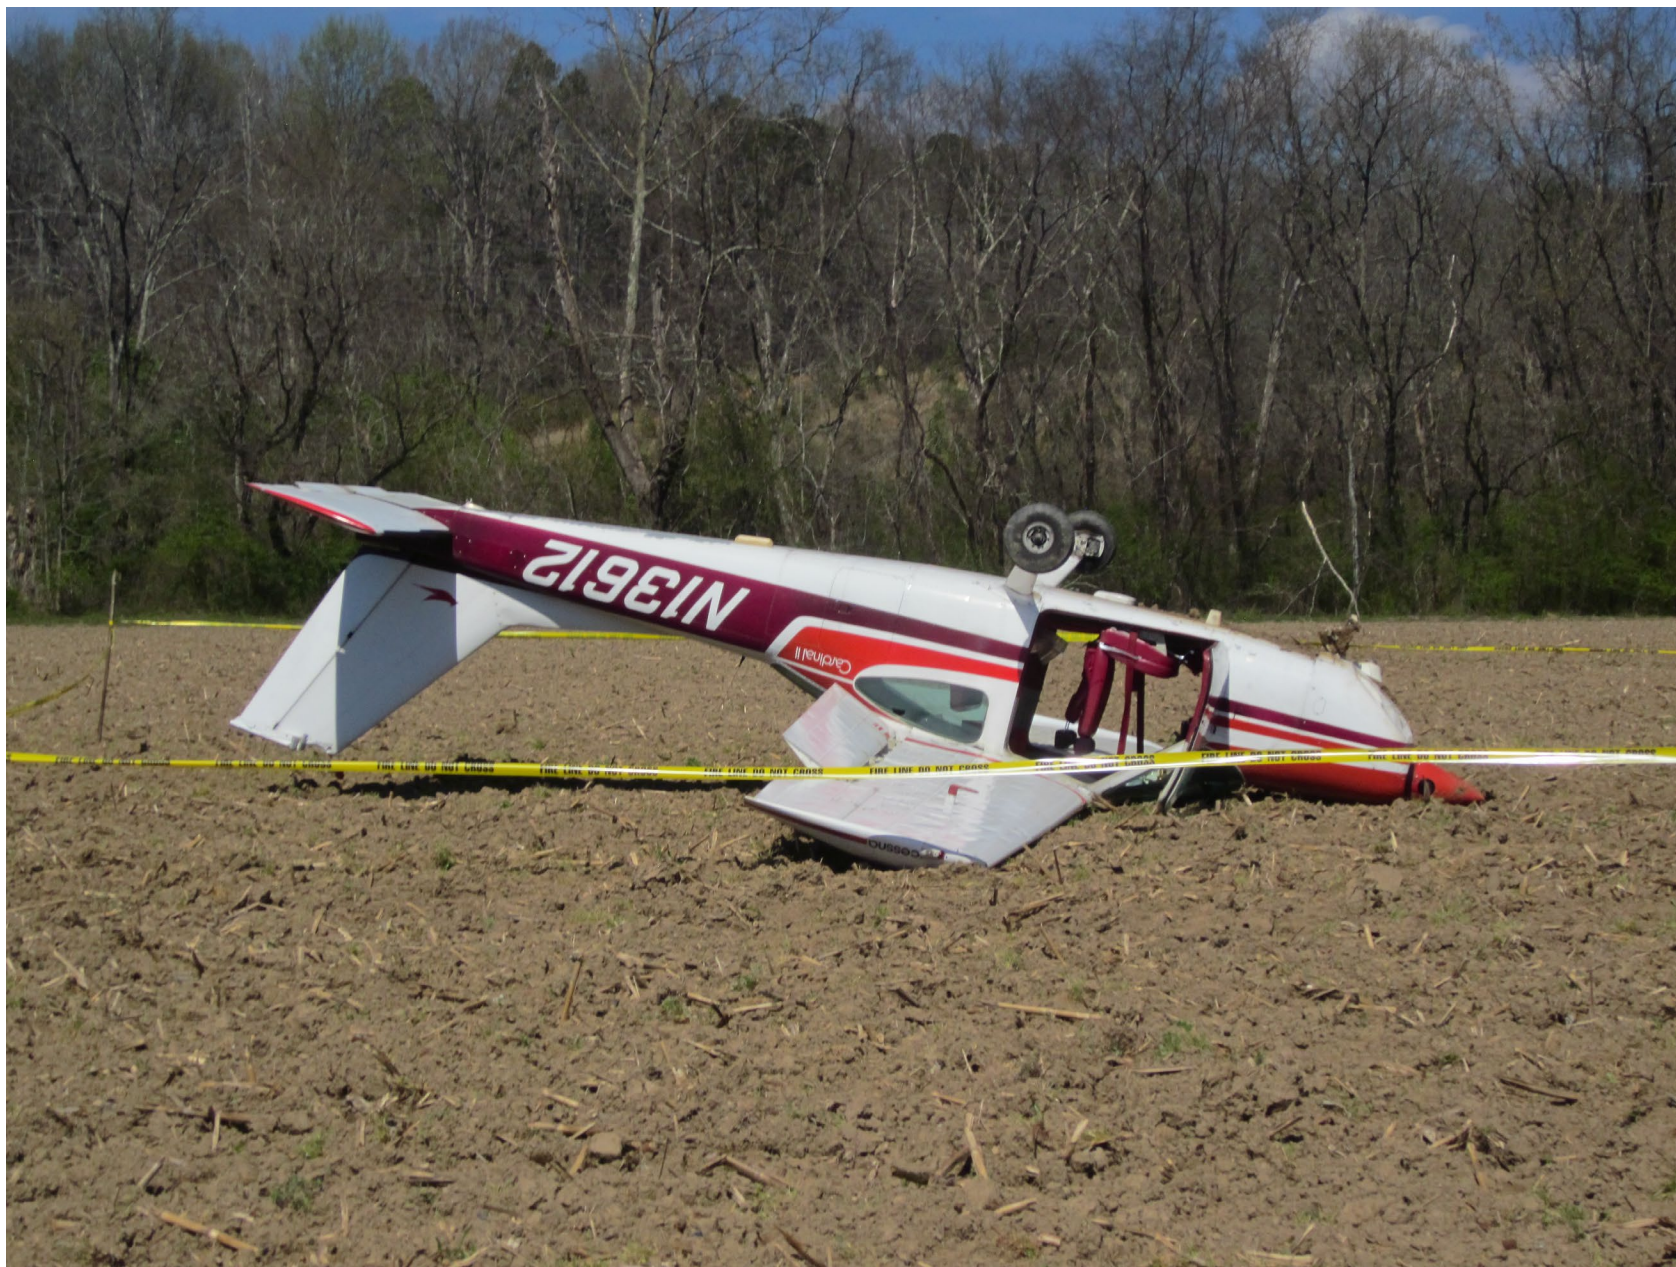
**Photo 1 – FAA Digital Photograph. View of the Left Side of the Inverted Airplane. Note the Damage to the top of the Vertical Stabilizer.**

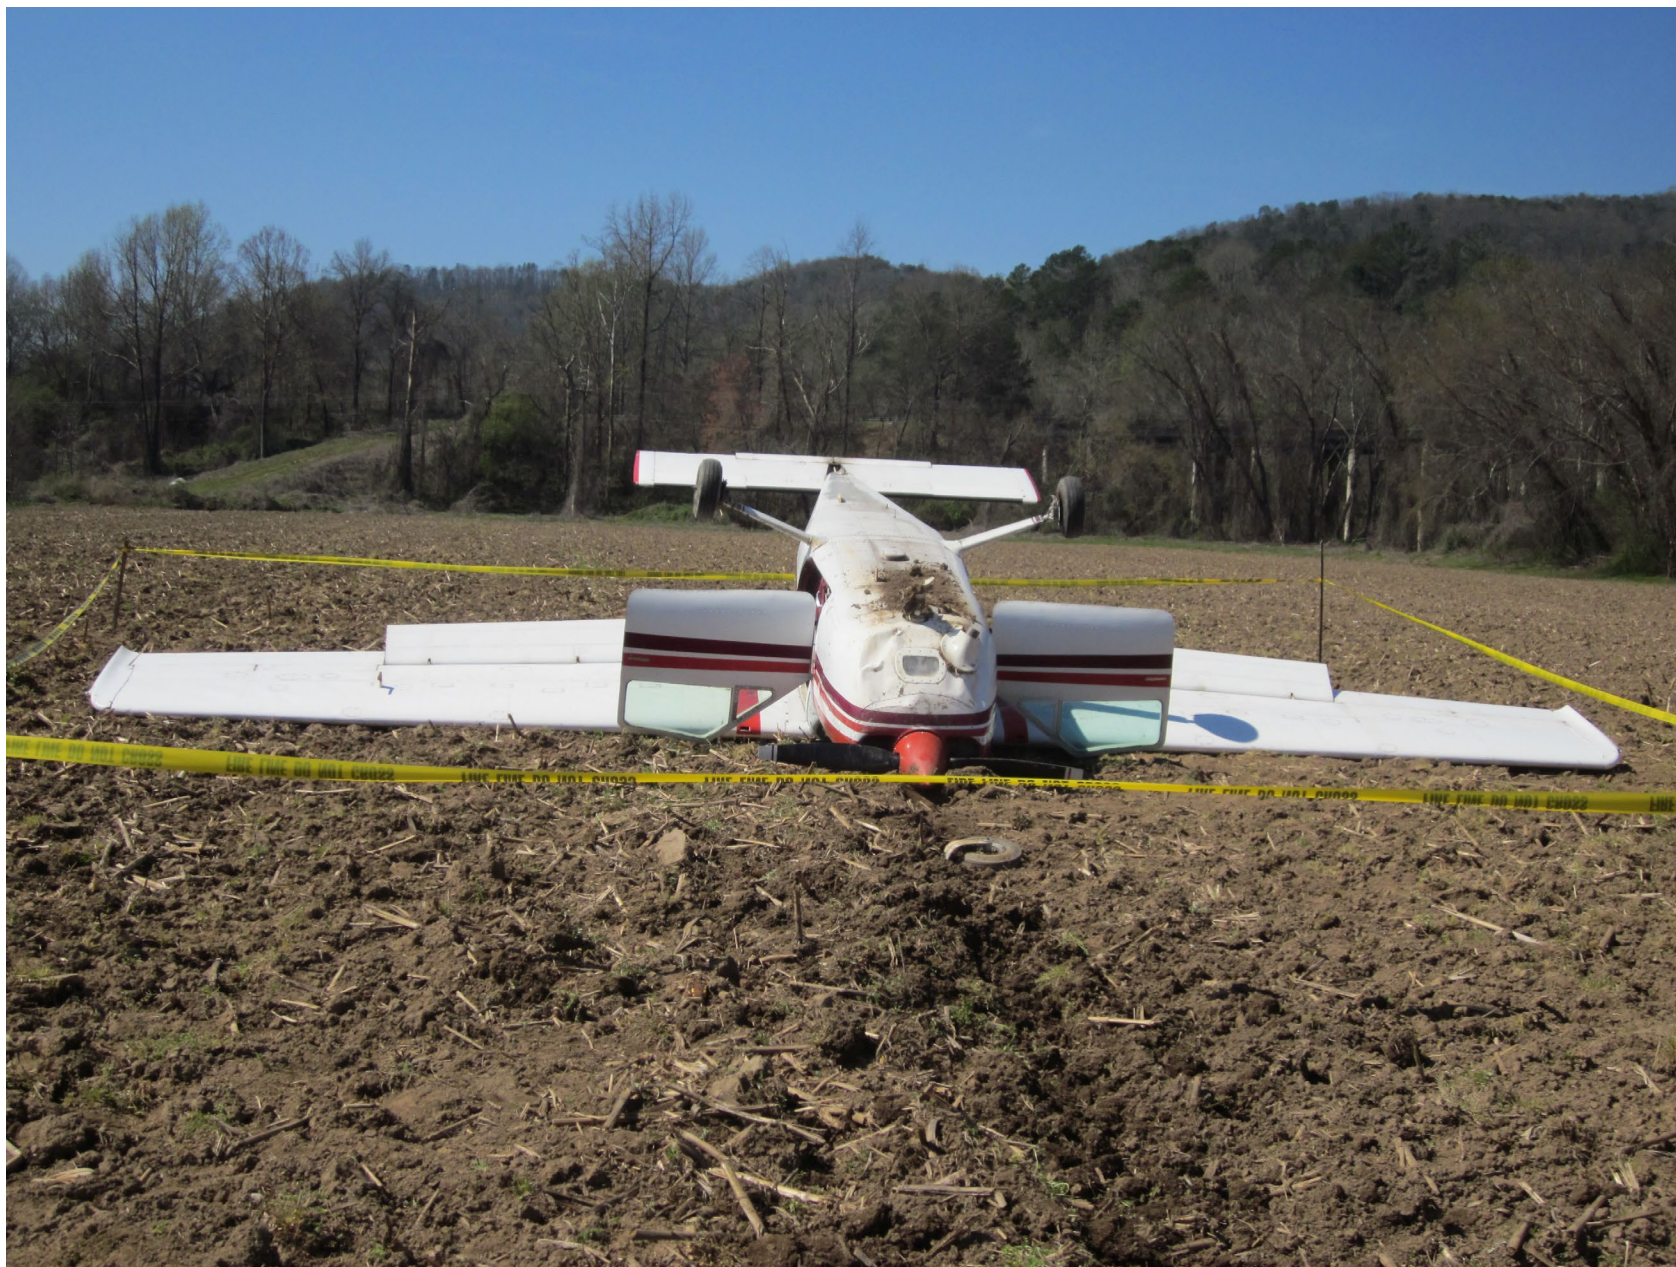
**Photo 2 - FAA Digital Photograph. Front View of the Inverted Airplane. Note the Lack of Damage to the Propeller.**

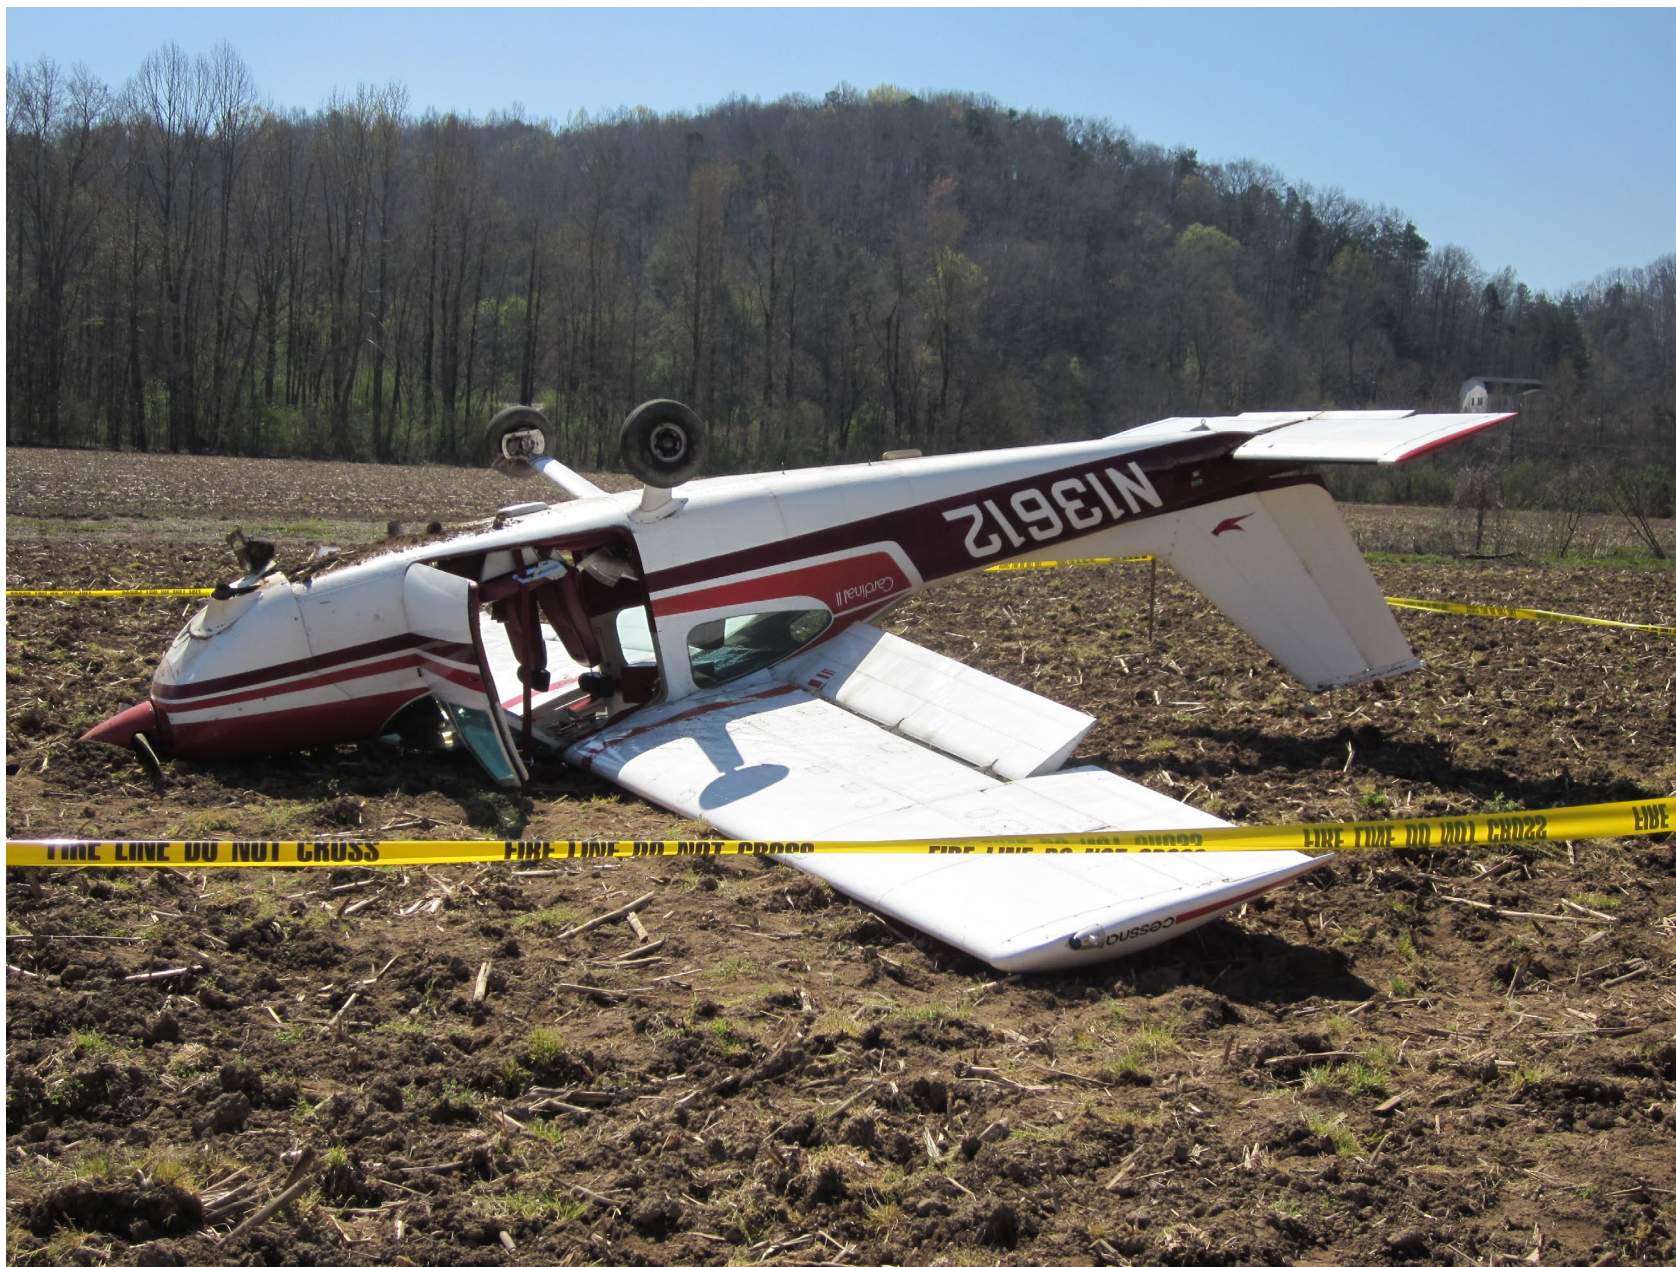
**Photo 3 - FAA Digital Photograph. View of the Right Side of the Inverted Airplane. Note the Wrinkles on the lower Right Wing Skin near the Wing Root.**

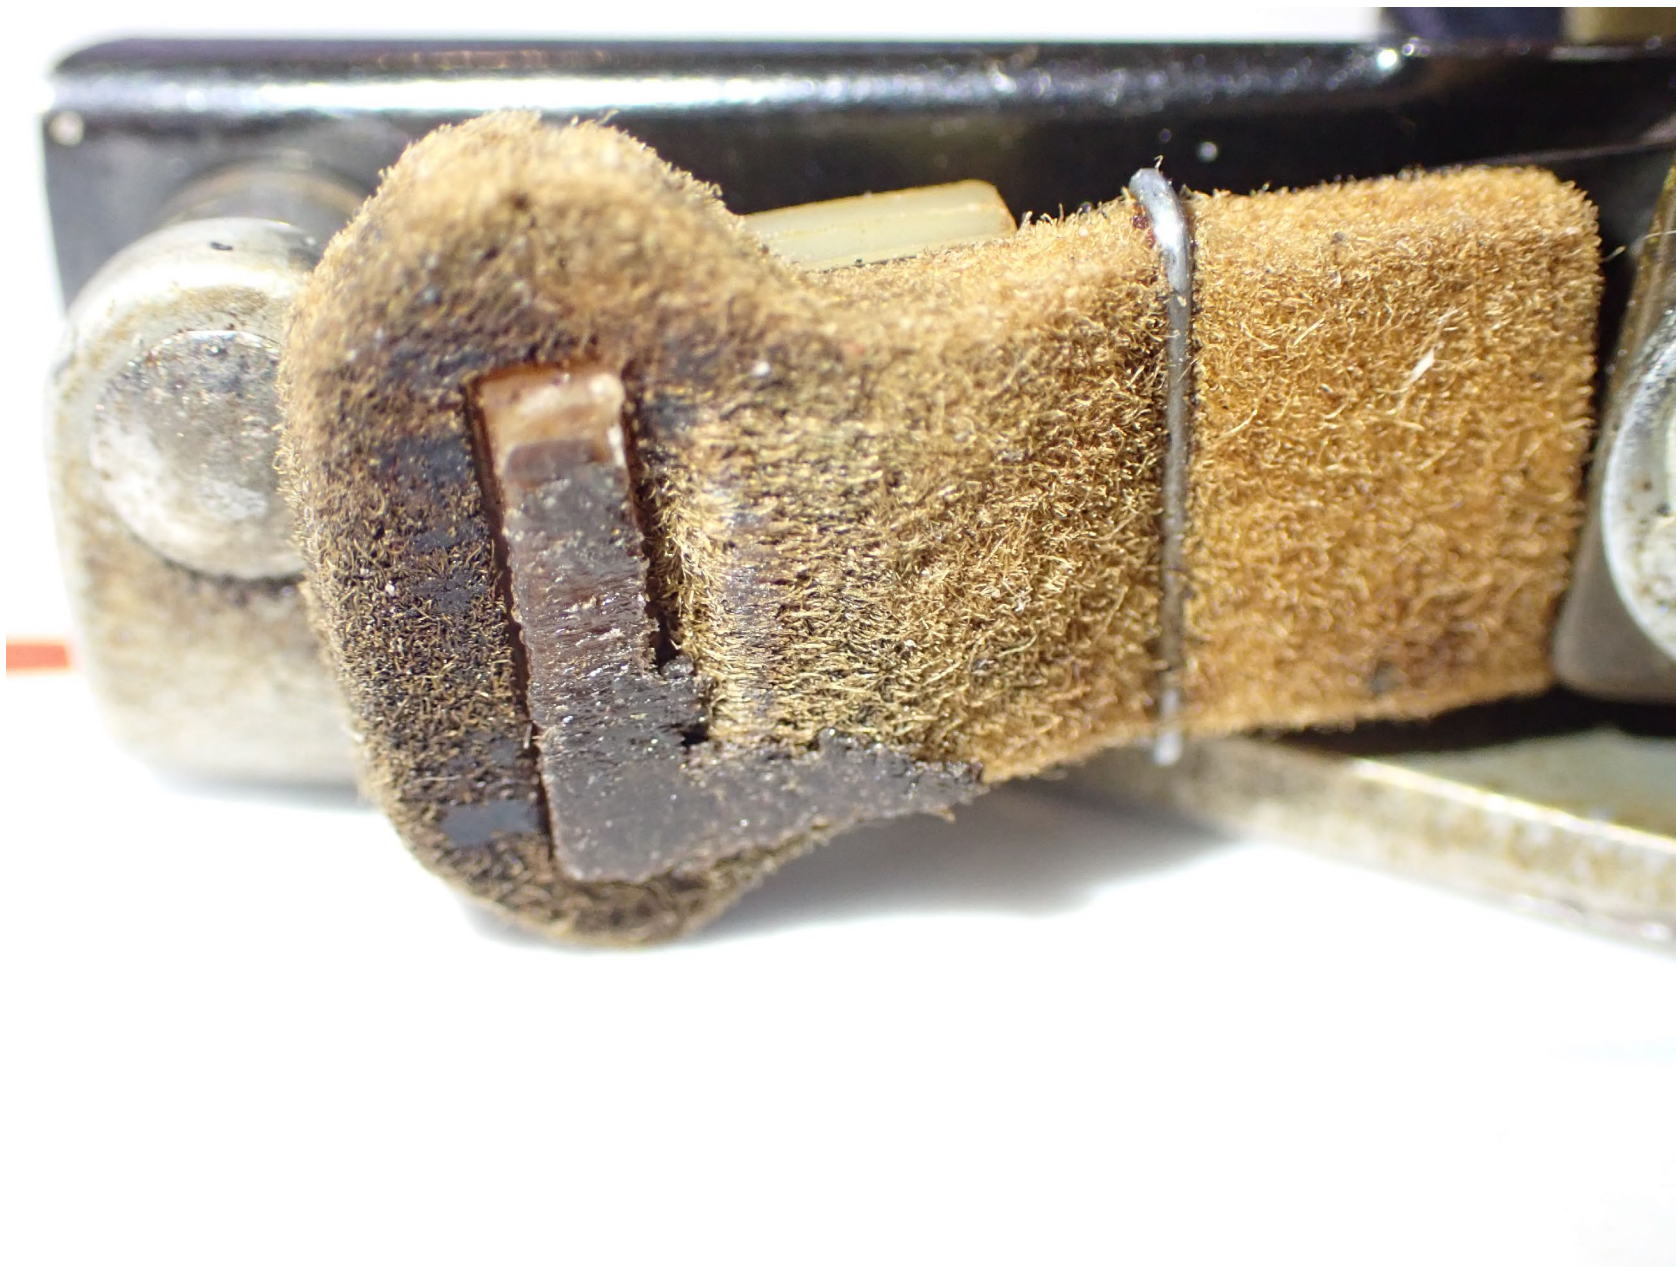
**Photo 6 – NTSB Digital Photograph. Close-Up View of the Left Cam Follower and Felt. Note the Heat Discoloration and Distortion of the Cam Follower.**

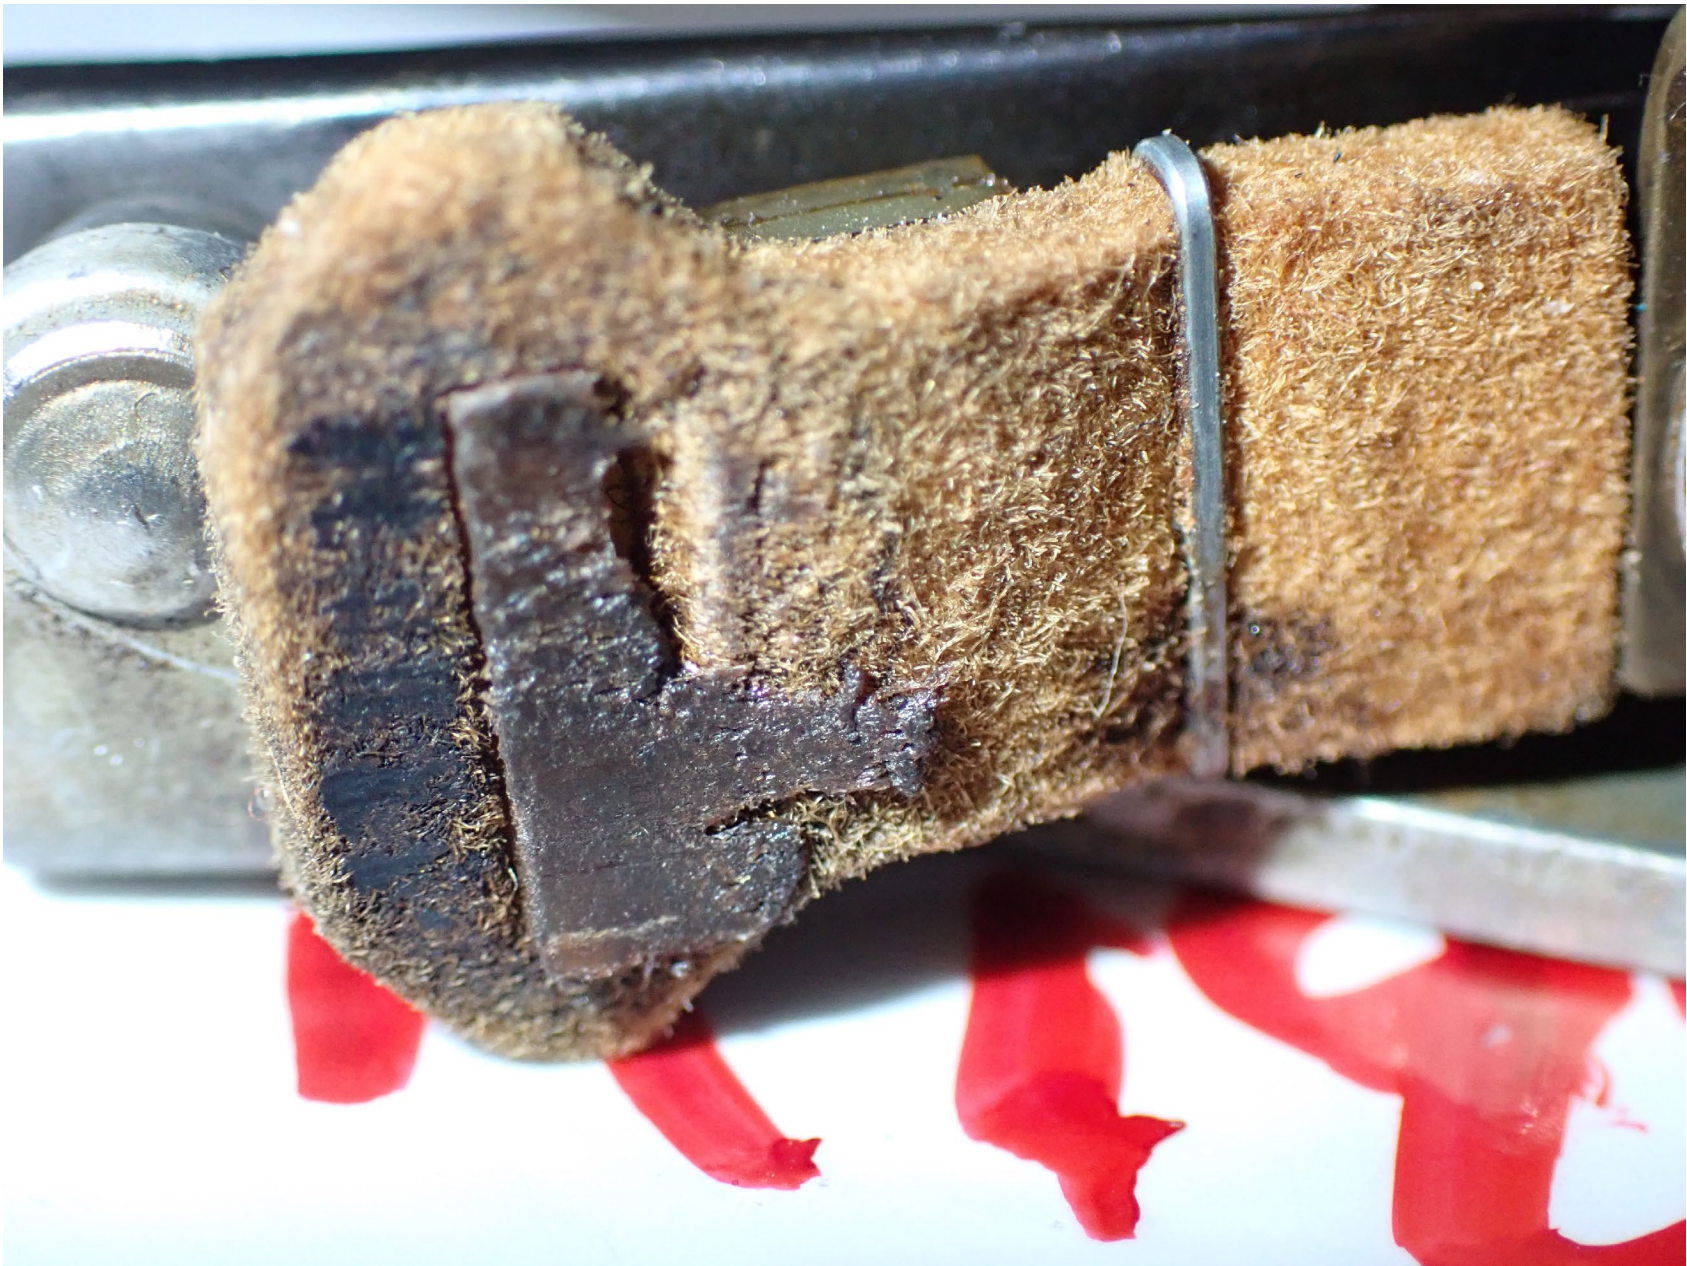
**Photo 7 - NTSB Digital Photograph. Close-Up View of the Right Cam Follower and Felt. Note the Heat Discoloration and Distortion of the Cam Follower.**
