**NTSB ERA23LA171**

N7772B Struck Parked Aircraft N920AA  
CINCINNATI MUNI/LUNKEN FLD

Photo Array

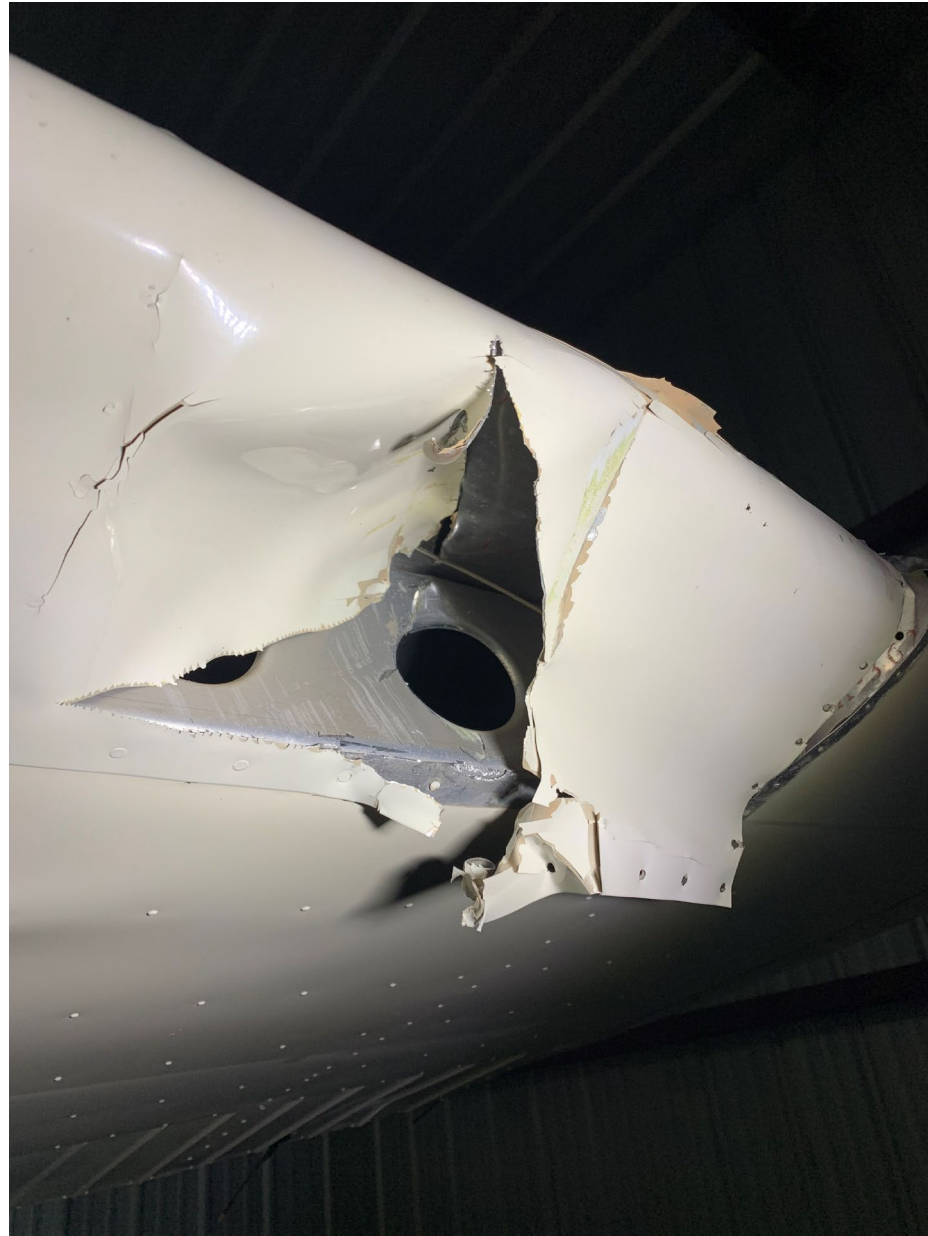
Photo 1: Left wing damage to N7772B

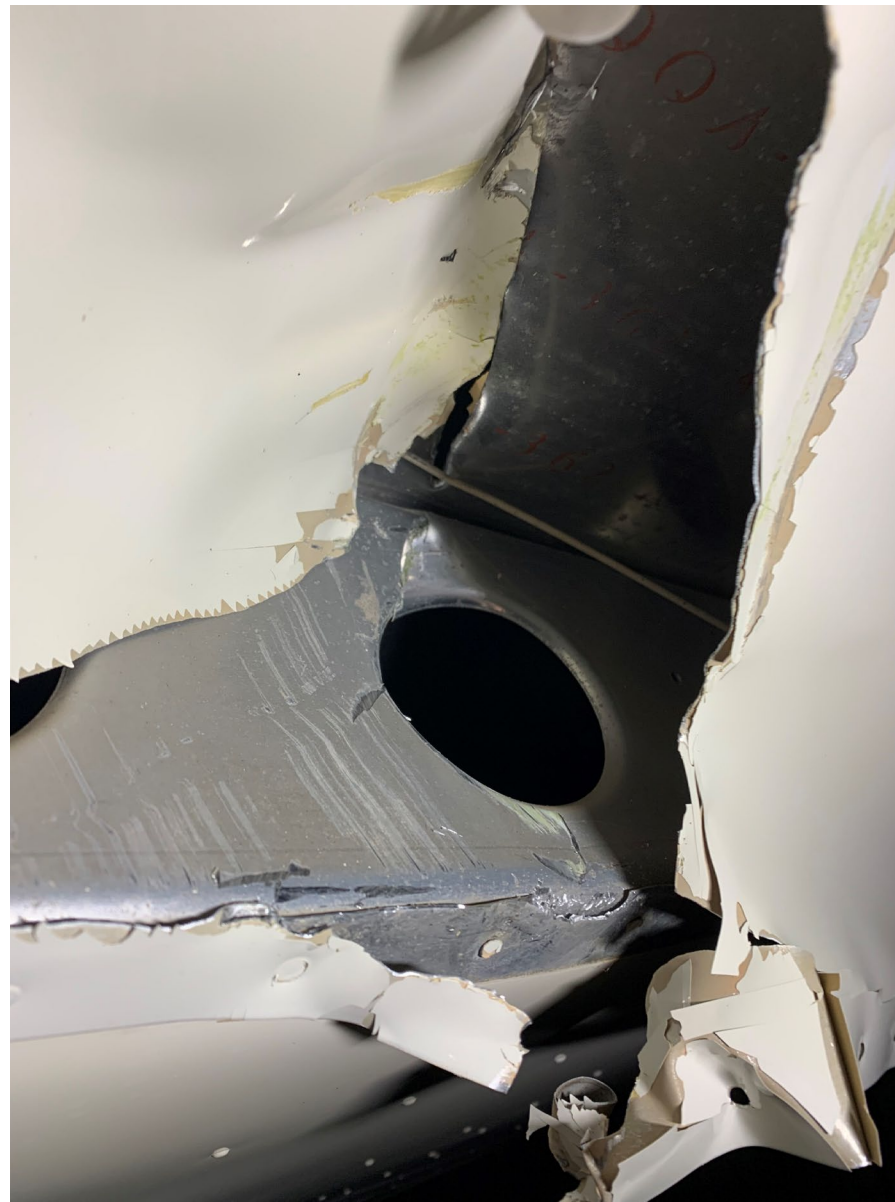
Photo 2: Close-up view of left wing damage to N7772B. Note damage required a form 337 for major repair.

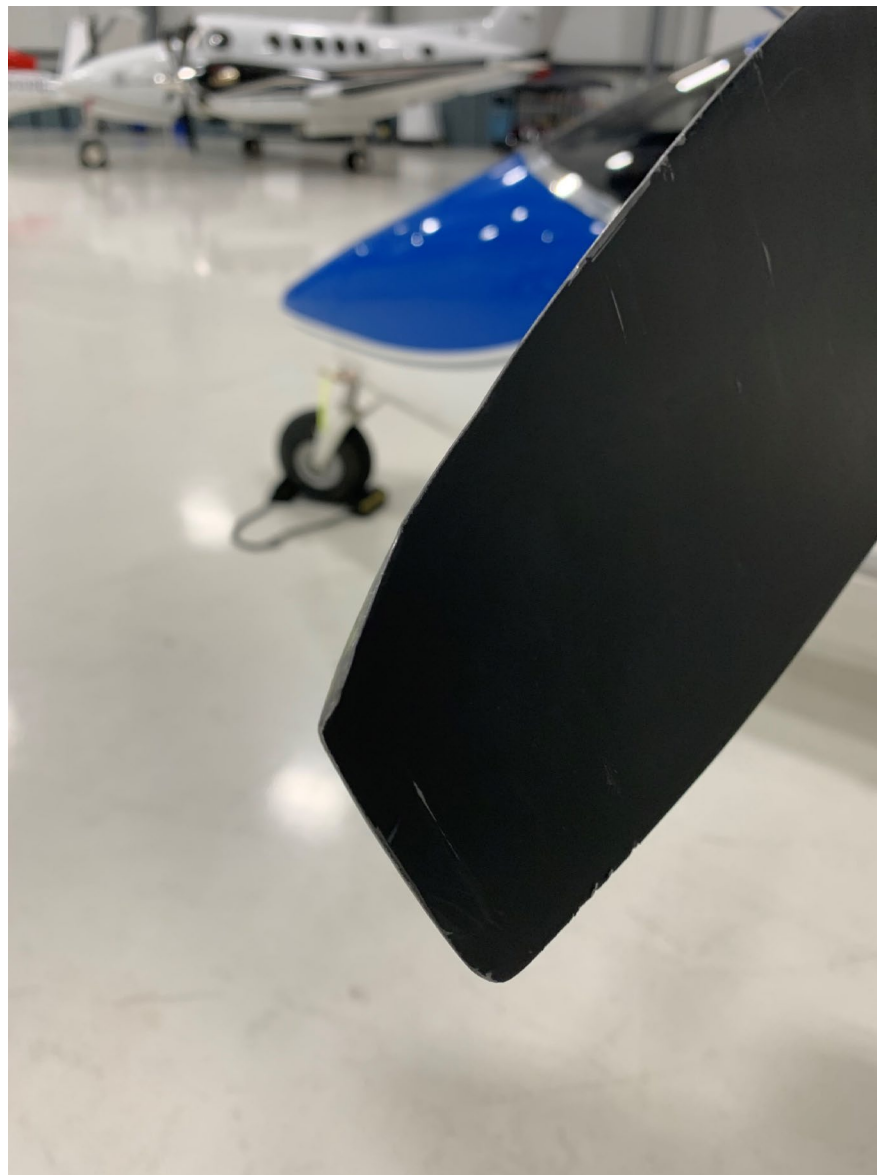
Photo 3: View of right propeller damage to N920AA

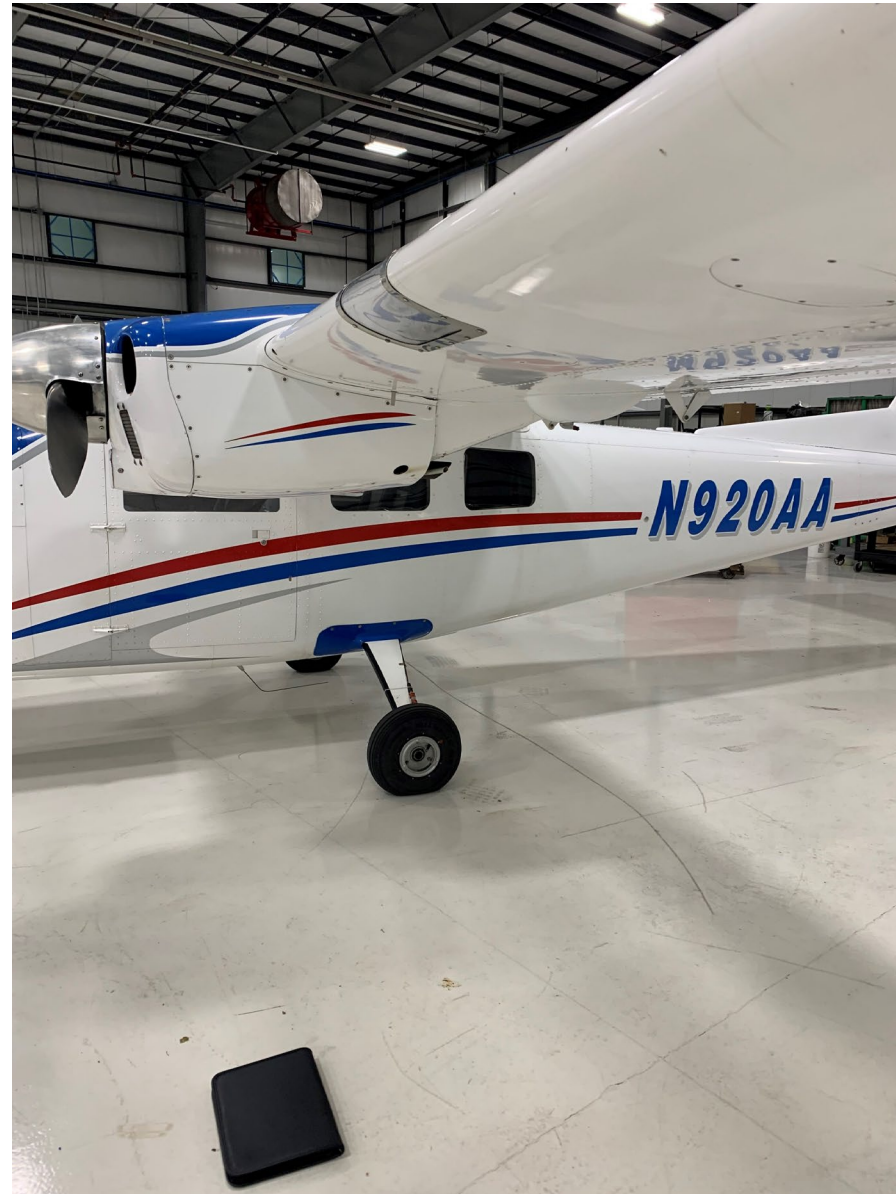
Photo 4: Left engine and profile view of N920AA
