## Airworthiness Directive

**96-12-22 CESSNA AIRCRAFT COMPANY:** Amendment 39-9665; Docket No. 93-CE-54-AD.

AD 96-12-22

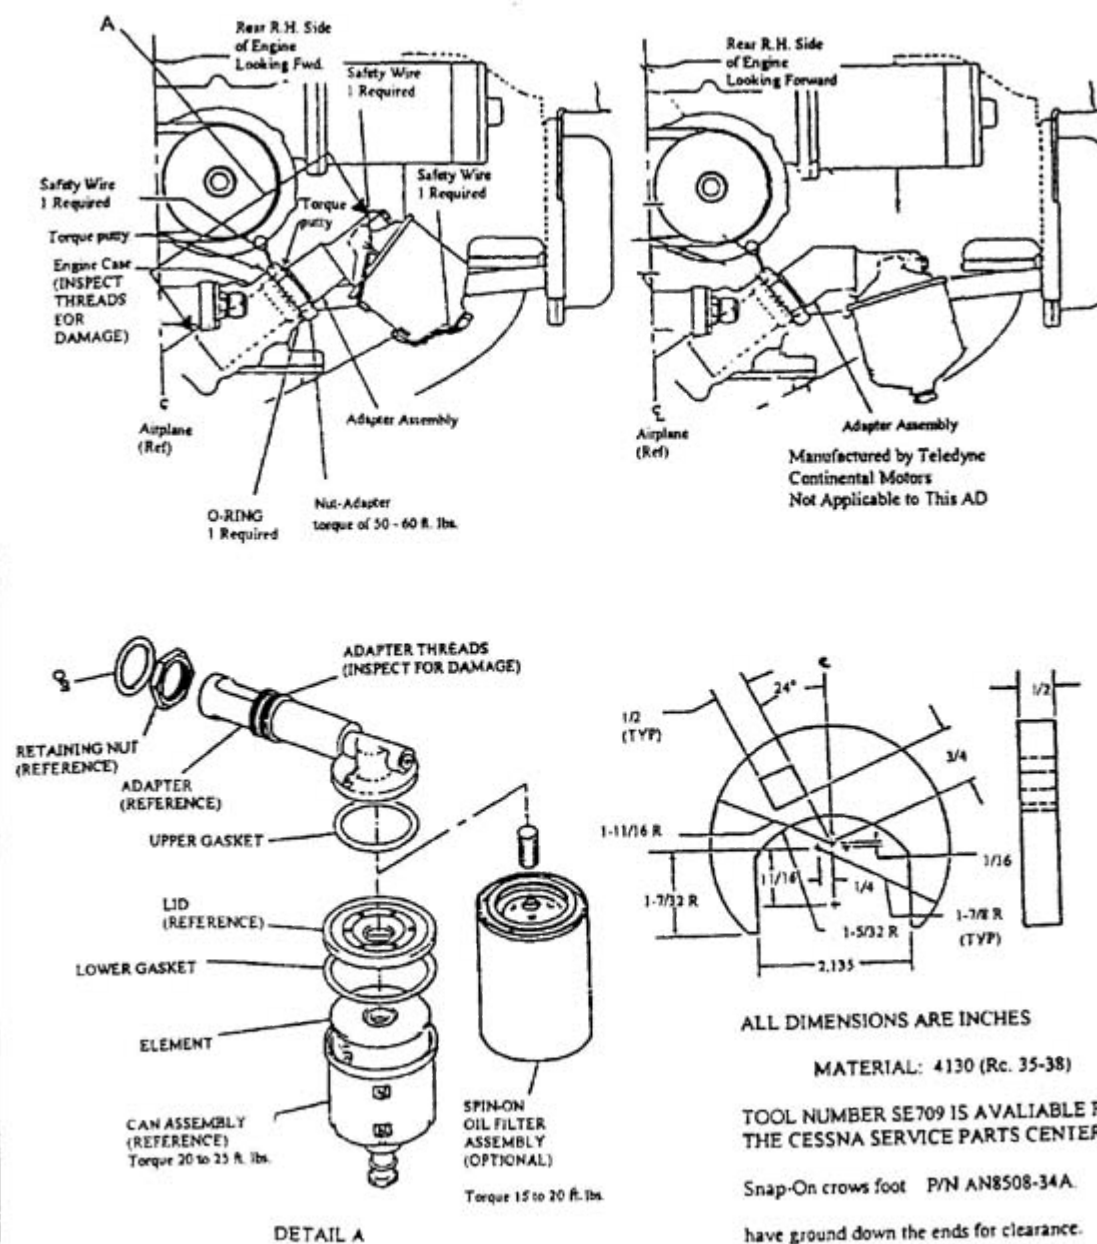
Figure 1. Oil Filter Adapter Installation

NOTE 2: This AD does not apply to engine oil filter adapter assemblies manufactured by Teledyne Continental Motors (See Figure 1 of this AD).

To prevent loss of engine oil caused by loose or separated oil filter adapters, which could result in engine stoppage while in flight and loss of control of the airplane, accomplish the following:

- (b) For airplanes with torque putty between the engine filter adapter assembly, nut, and oil pump housing, inspect the torque putty for misalignment, evidence of oil leakage, or cracks.

- (4) Apply torque putty between the engine filter adapter assembly, nut, and oil pump housing as specified in Figure 1 of this AD.
  - (5) Reassemble the engine oil filter assembly.
