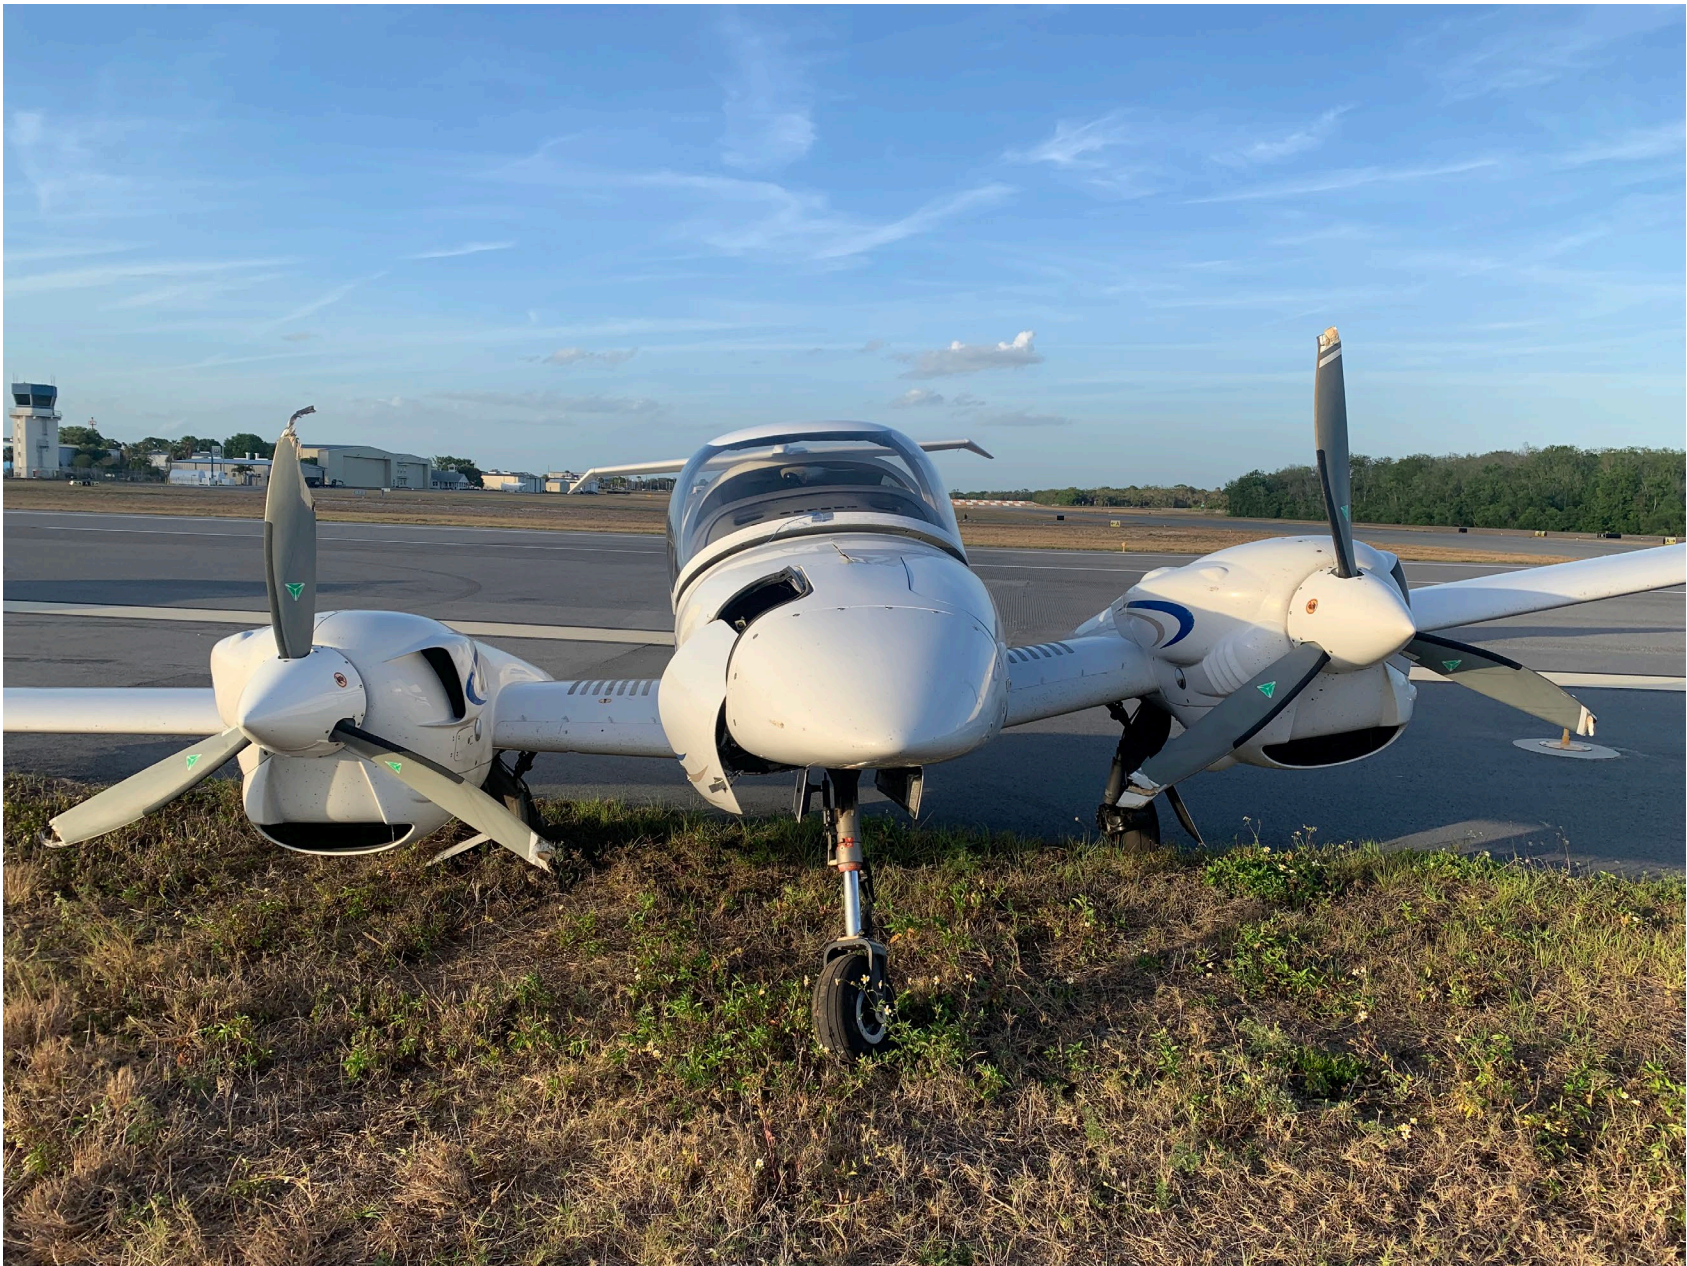
**Photo 1 – Embry-Riddle Digital Photograph. Frontal View of the Airplane. Note the Partially Collapsed Right Main Landing Gear.**

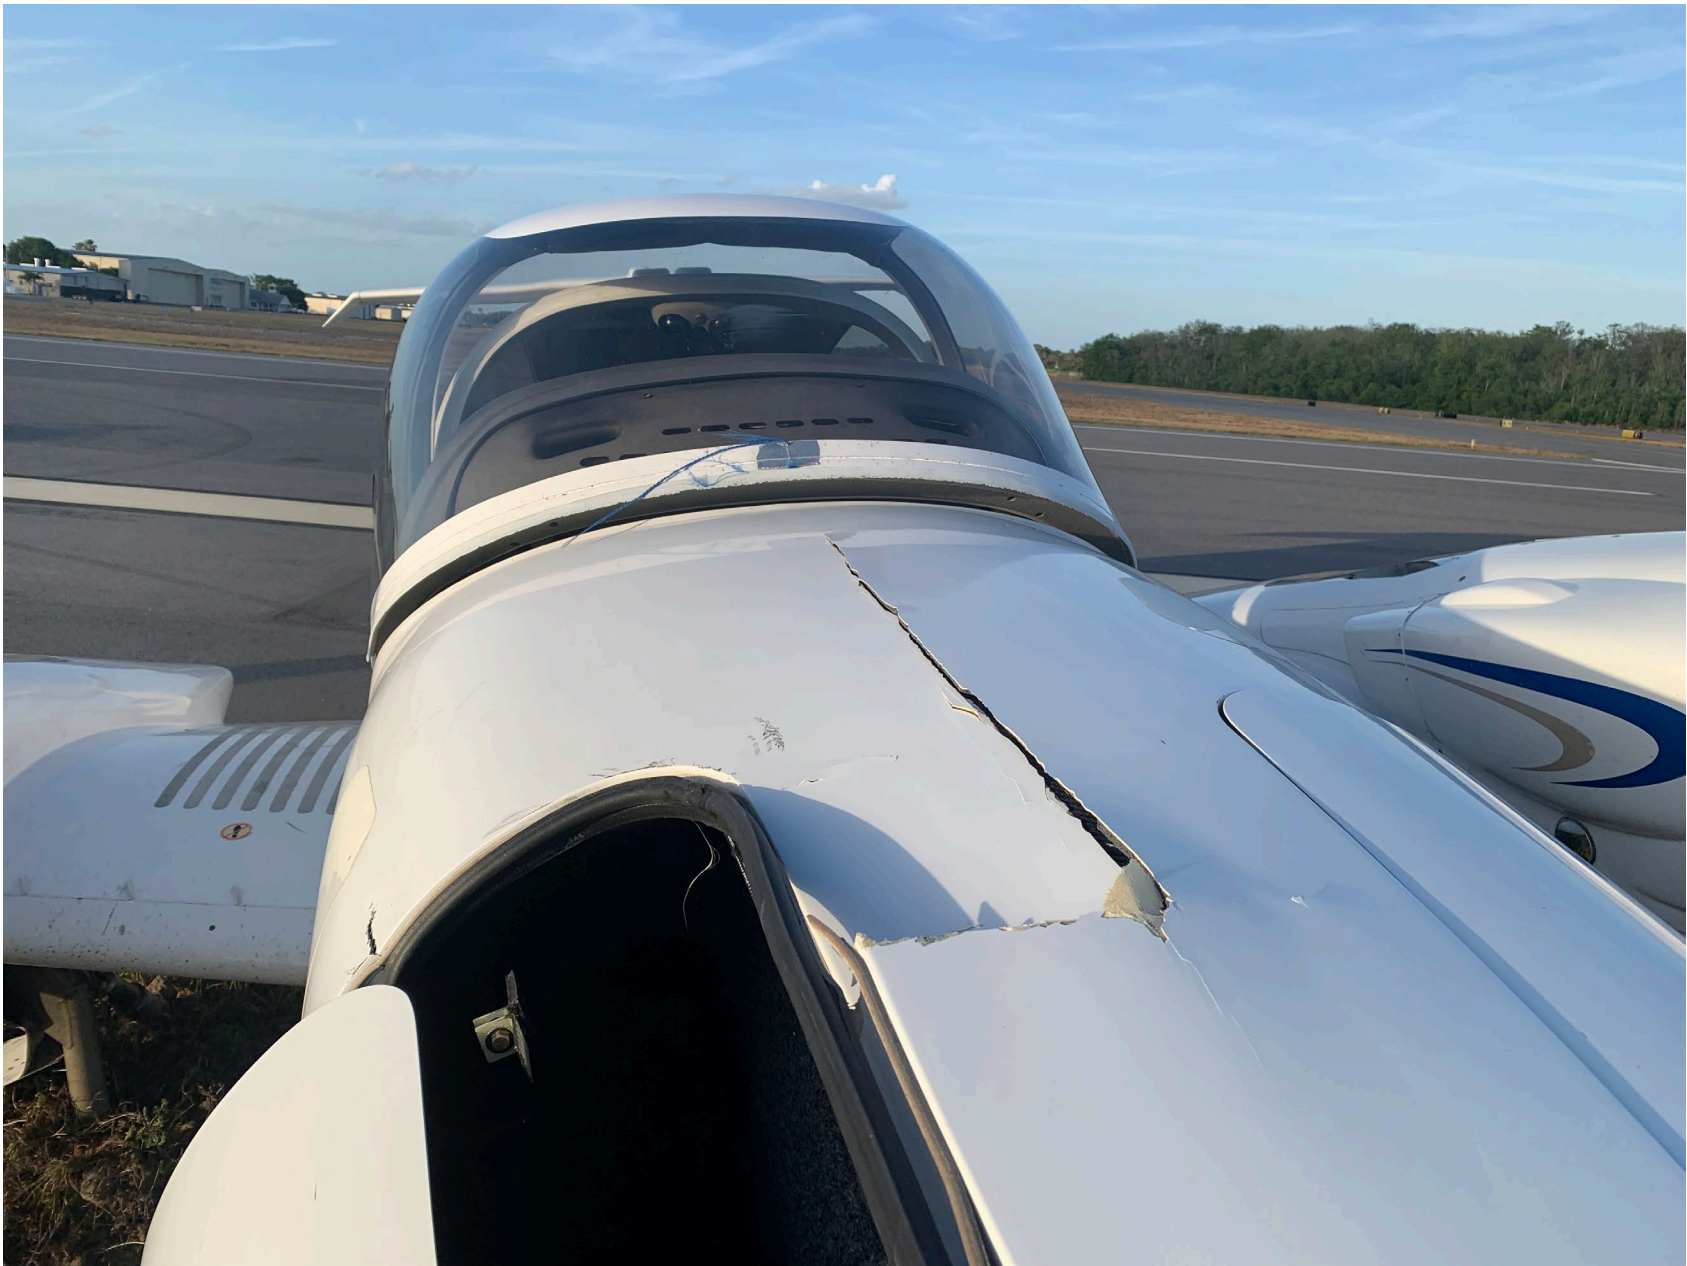
**Photo 2 - Embry-Riddle Digital Photograph. Frontal View of the Airplane. Note the Split on the Top Center Portion of the Carbon Fiber Reinforced Polymer Molded Construction Fuselage From Just Forward of the Windshield to About ½ Way Along Nose Section Baggage Compartment Door.**
