**NATIONAL TRANSPORTATION SAFETY BOARD**

**Photo Array**

**ERA23LA178**

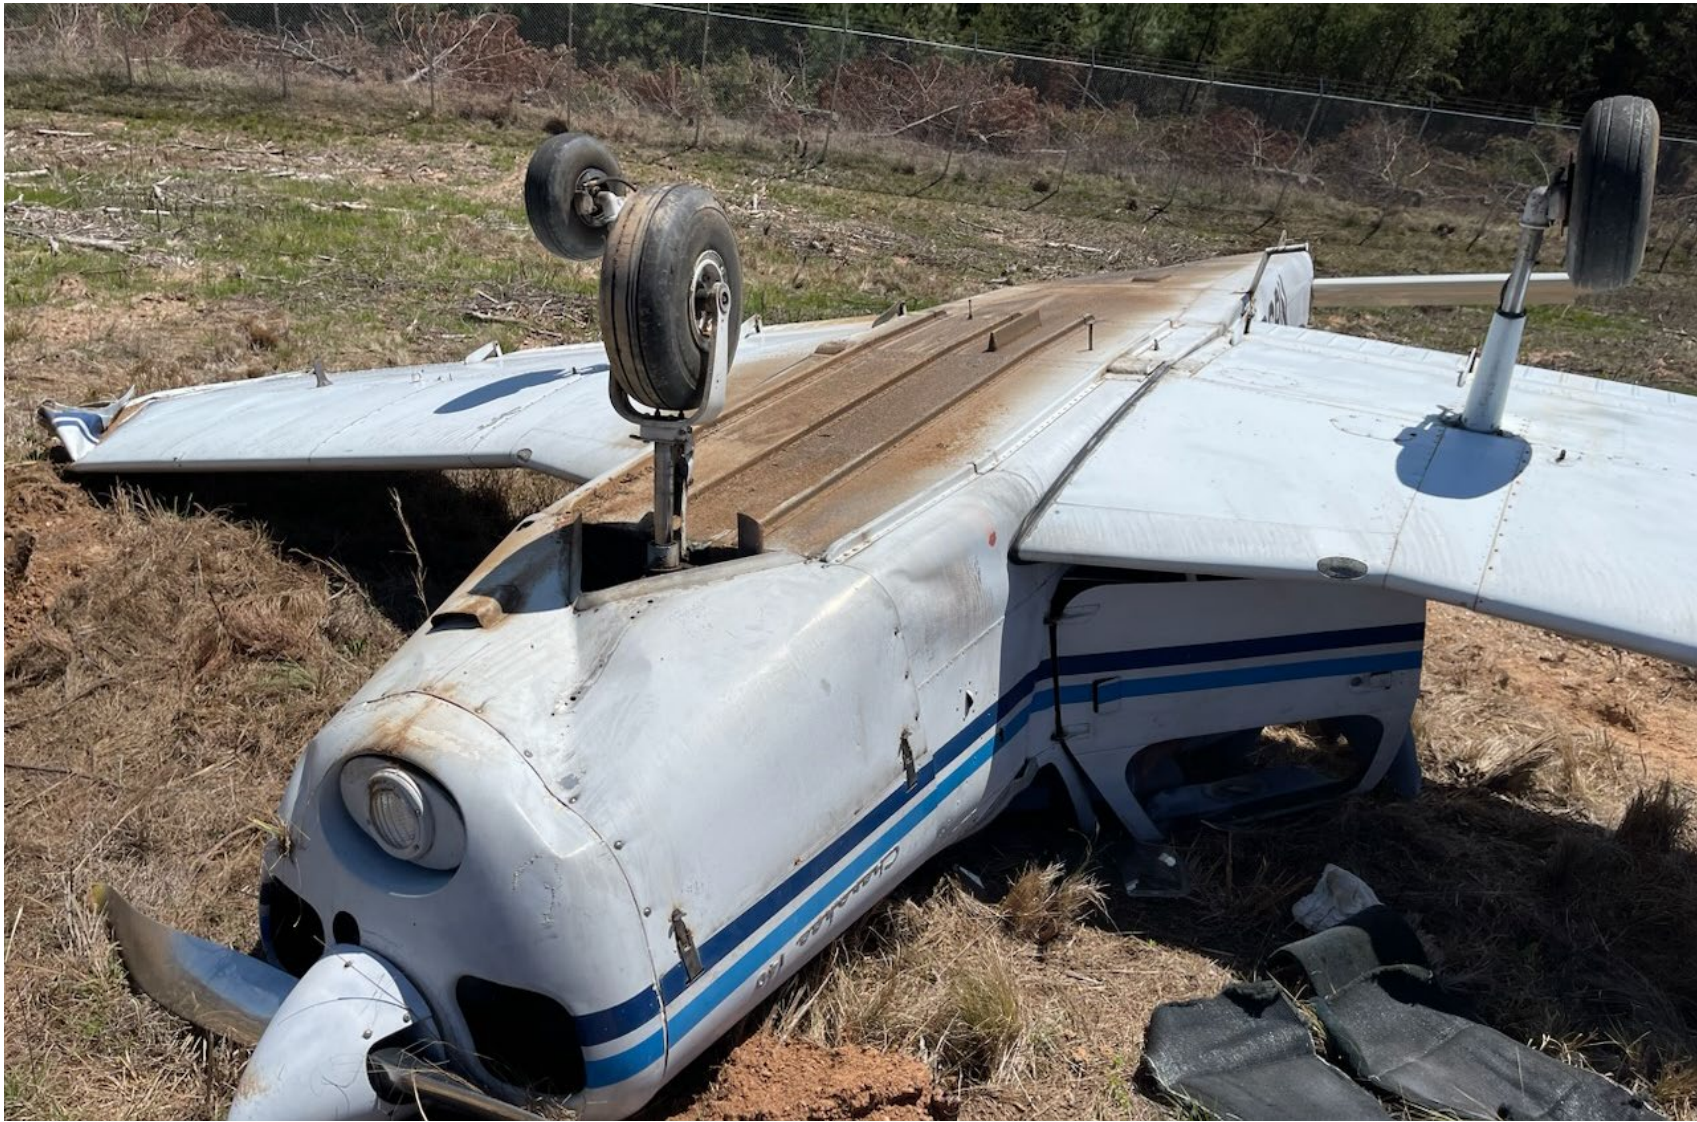
**Photo 1 – View of Accident Airplane, Inverted, from Front Right (Courtesy of FAA)**

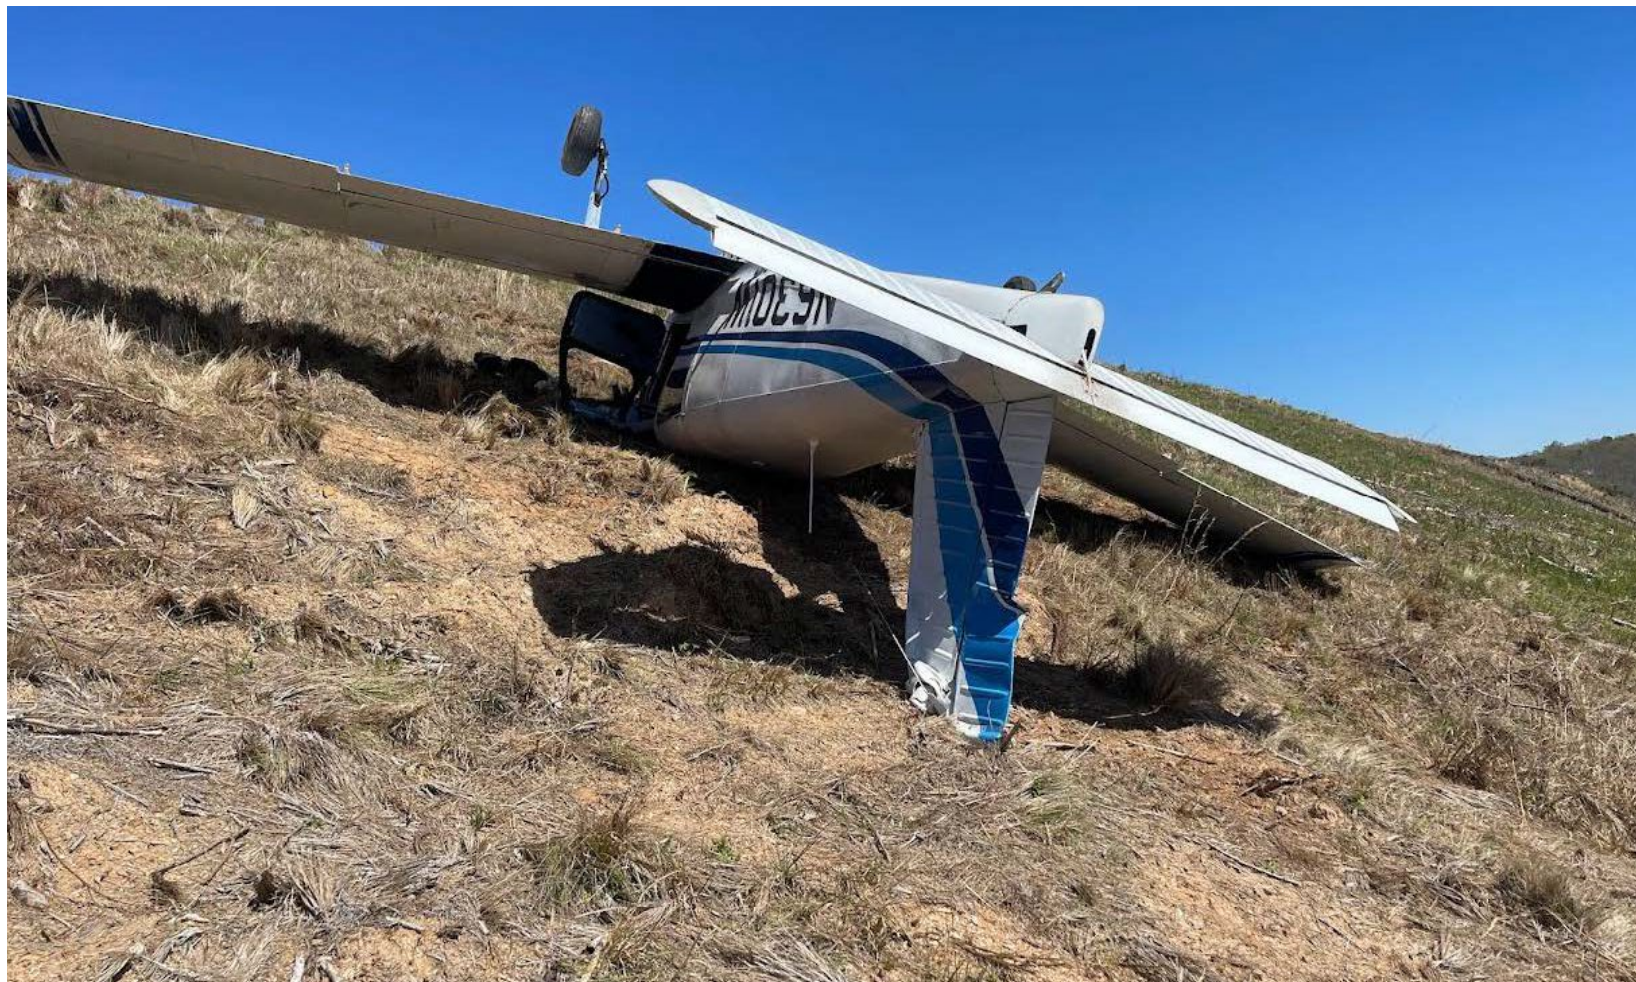
**Photo 2 – View of Accident Airplane, Inverted, from Rear Right - Note Damage to Rudder (Courtesy of FAA)**

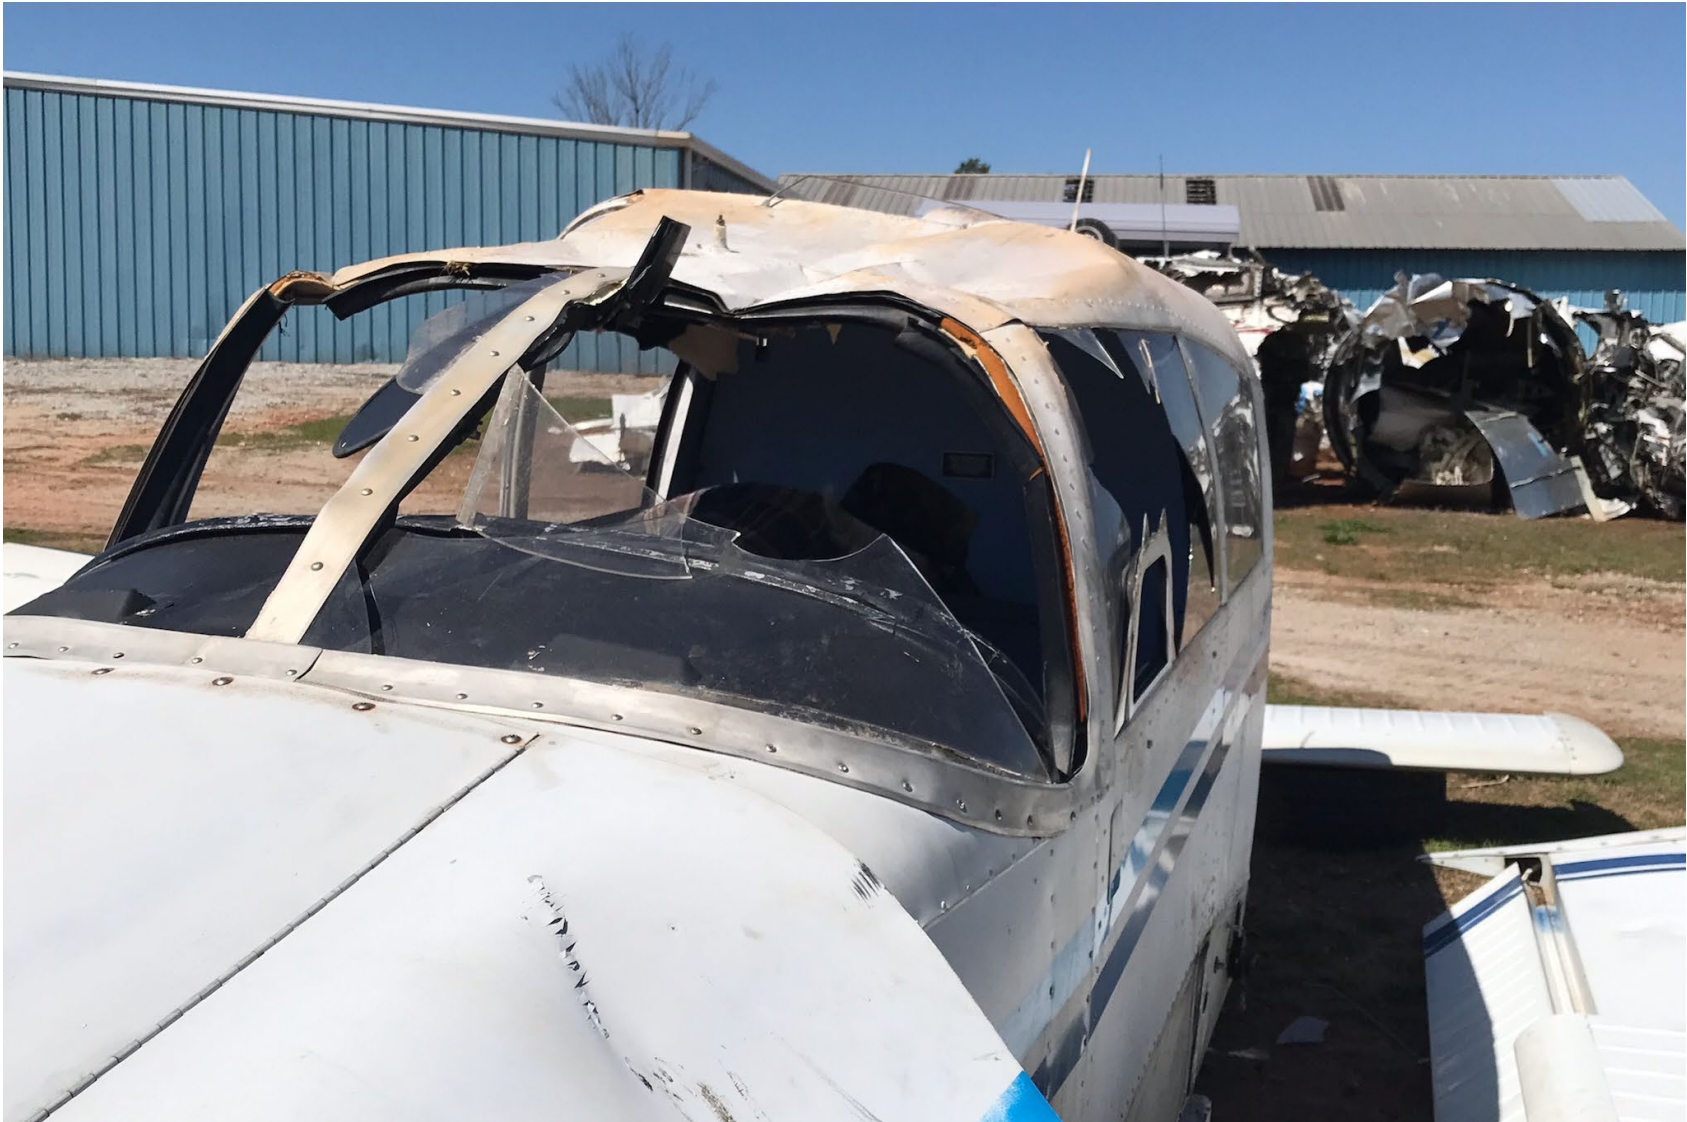
**Photo 3 – View of Fuselage – Note Crush Damage (Courtesy of FAA)**
