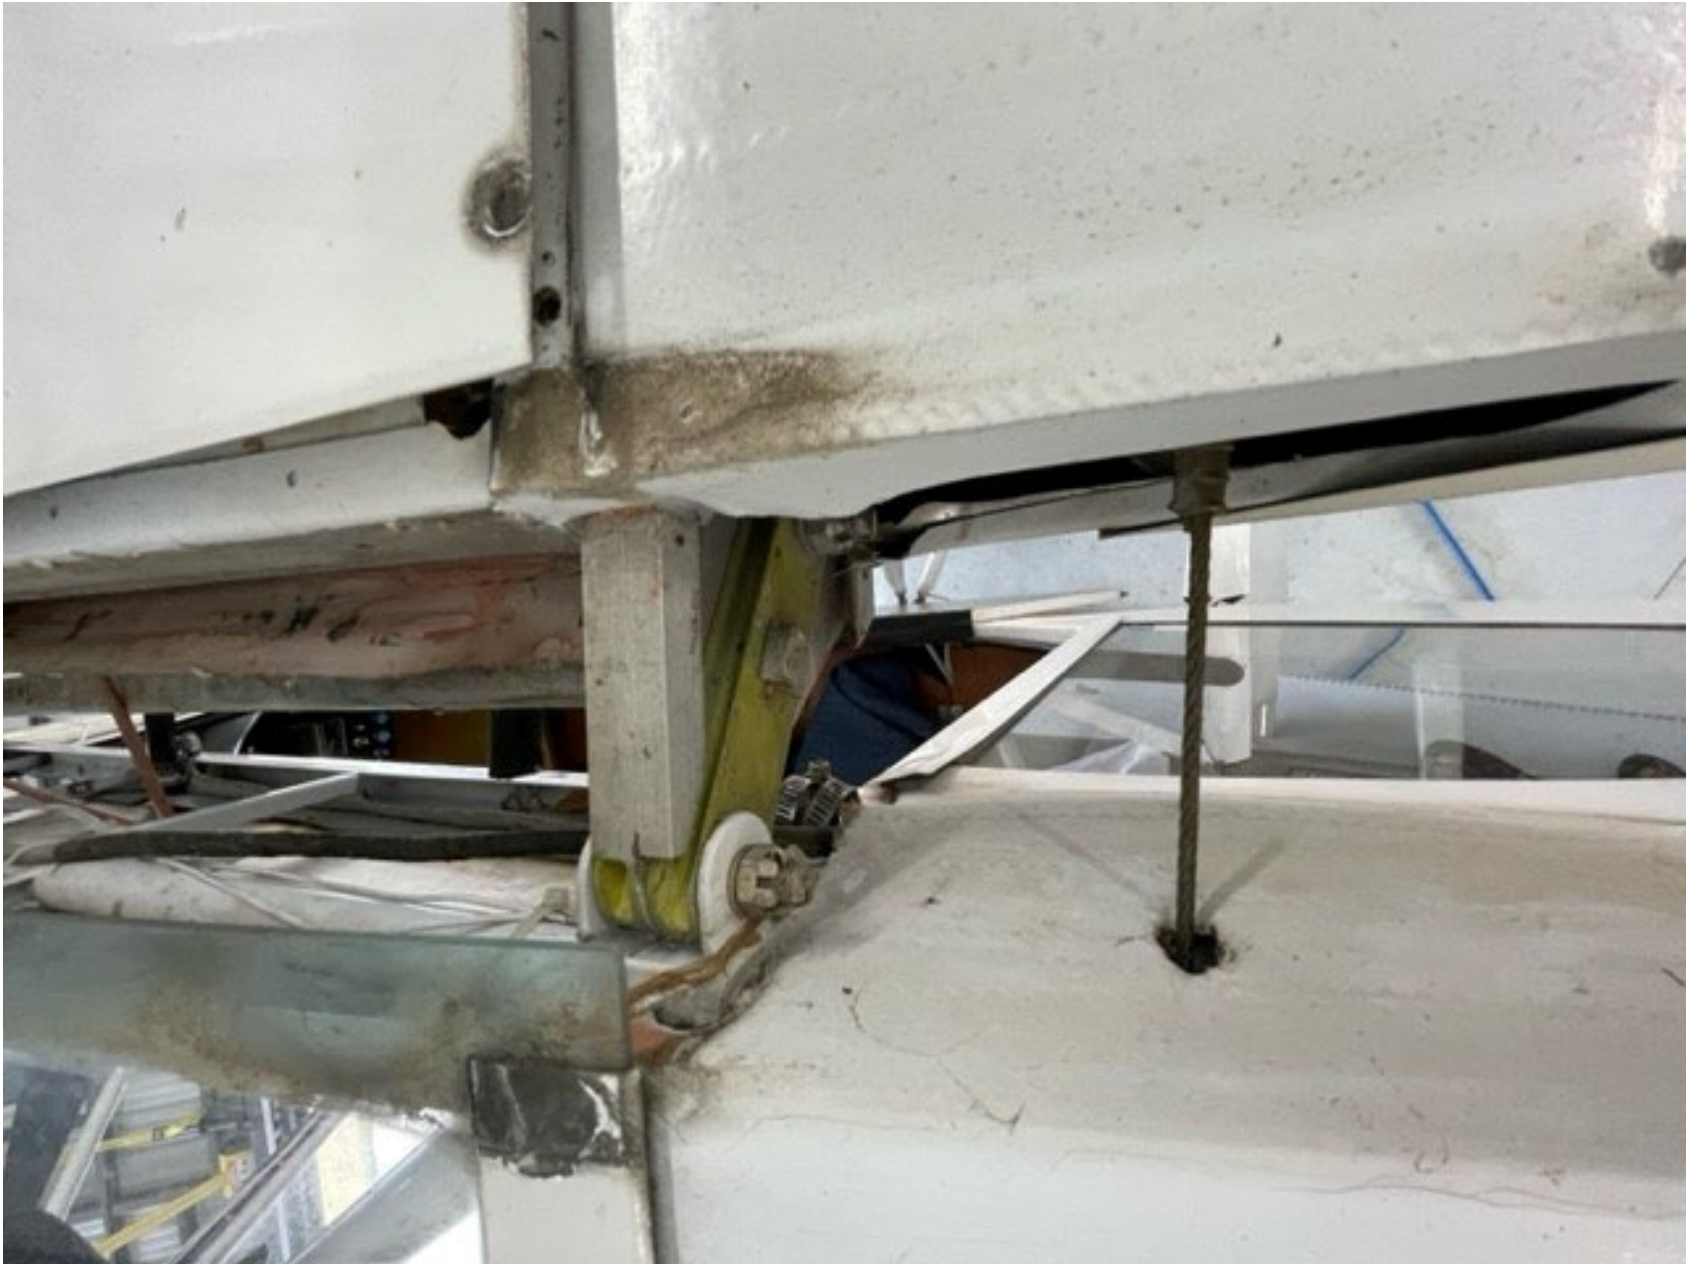
**Photo 1 – View of bent wing spar (FAA Photo)**

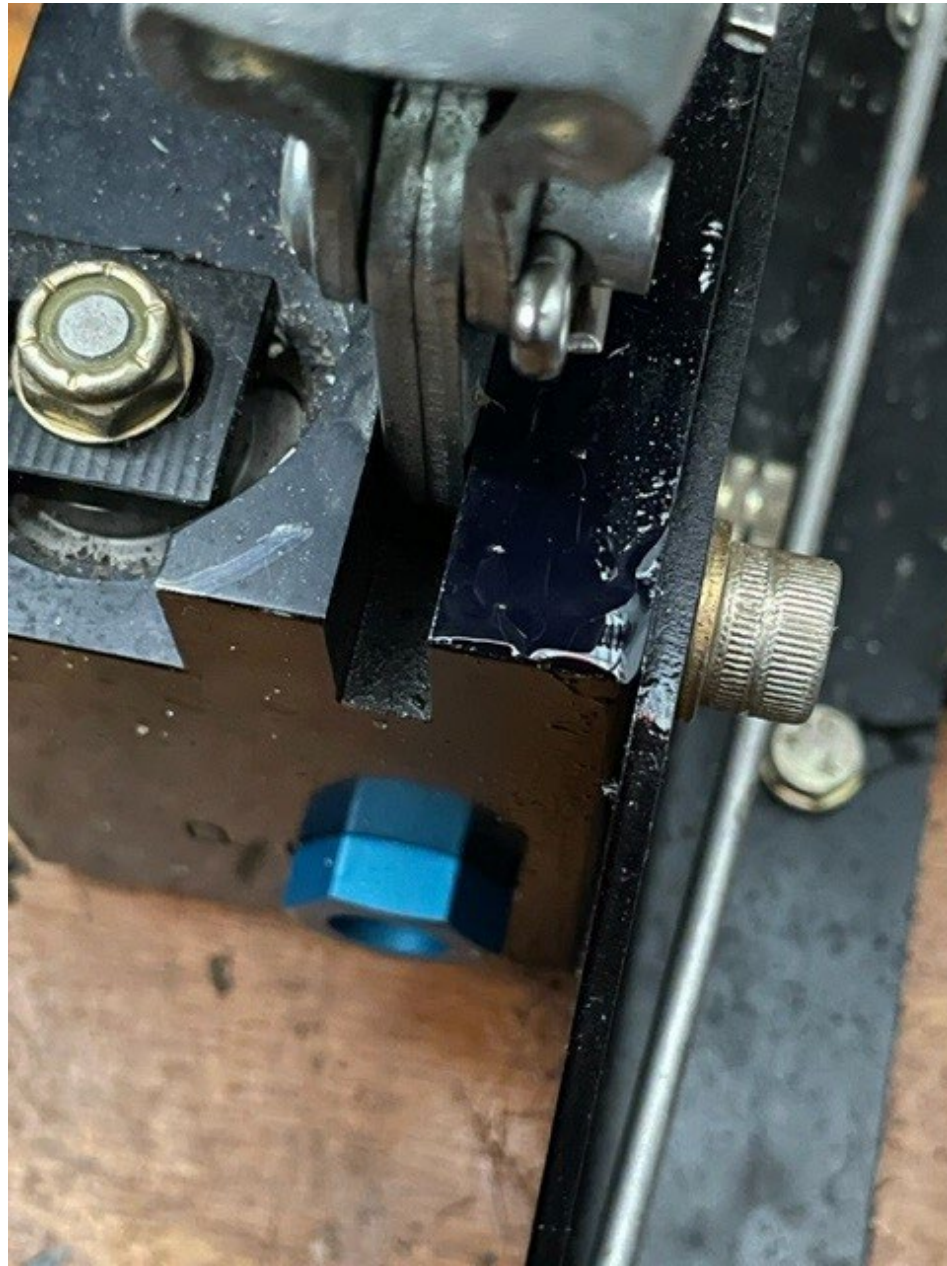
**Photo 2 – View of hand pump showing minor leakage (FAA Photo)**
