# National Transportation Safety Board

ERA23LA195

## **WRECKAGE AND ENGINE EXAMINATION**

Location: Fallston, MD  
Date: April 13, 2023  
Time: 1515 EDT  
1915 UTC  
Airplane: N412RS; RV-14A

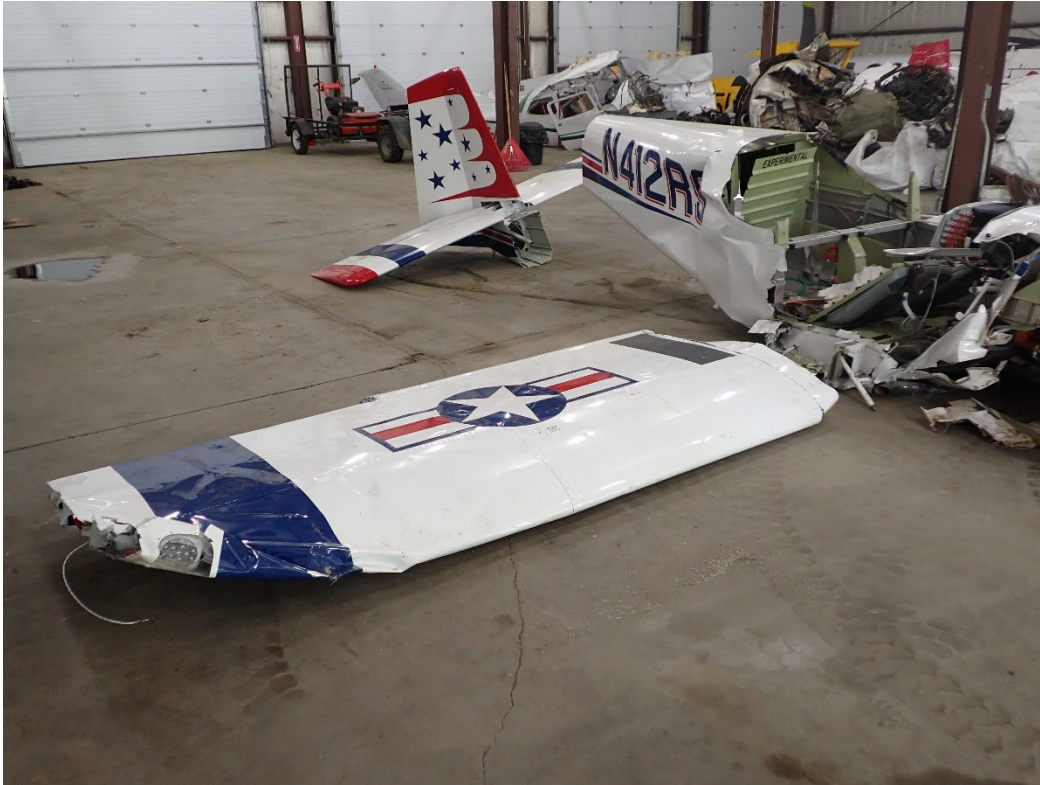
The airplane as it sat at the recovery facility was in four main pieces consisting of the fuselage, empennage and both wings. There was no evidence of a fire.

**Photo 1: The airplane laid out at the recovery facility.**

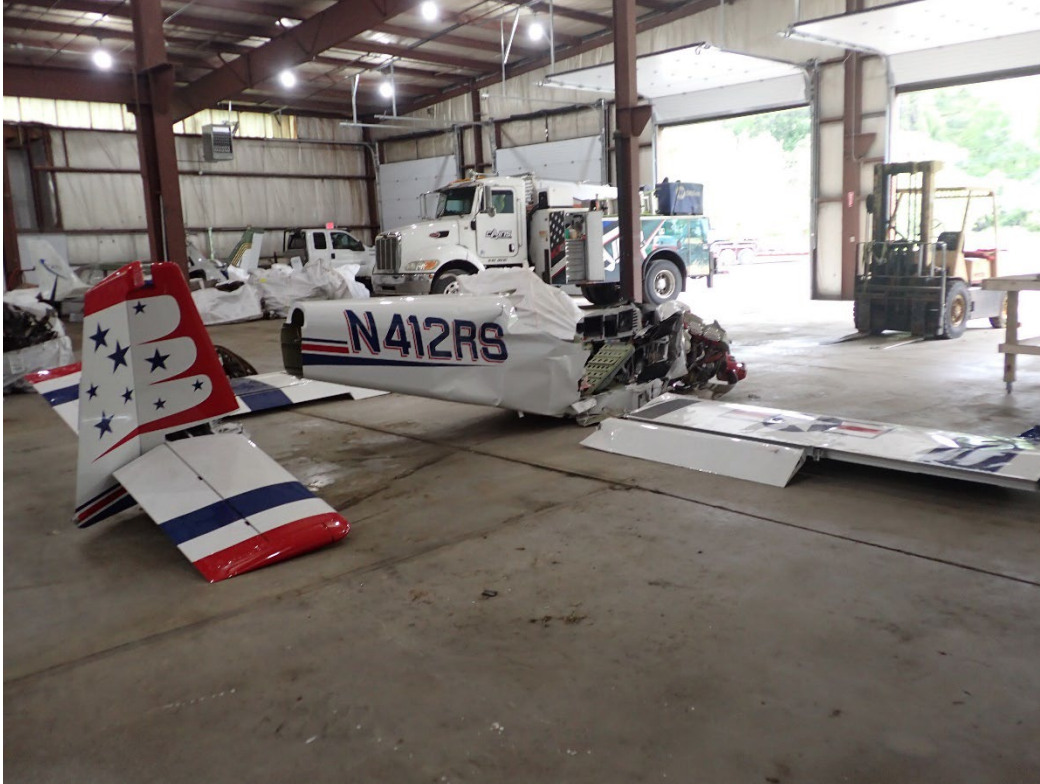
**Photo 2: The airplane laid out at the recovery facility.**

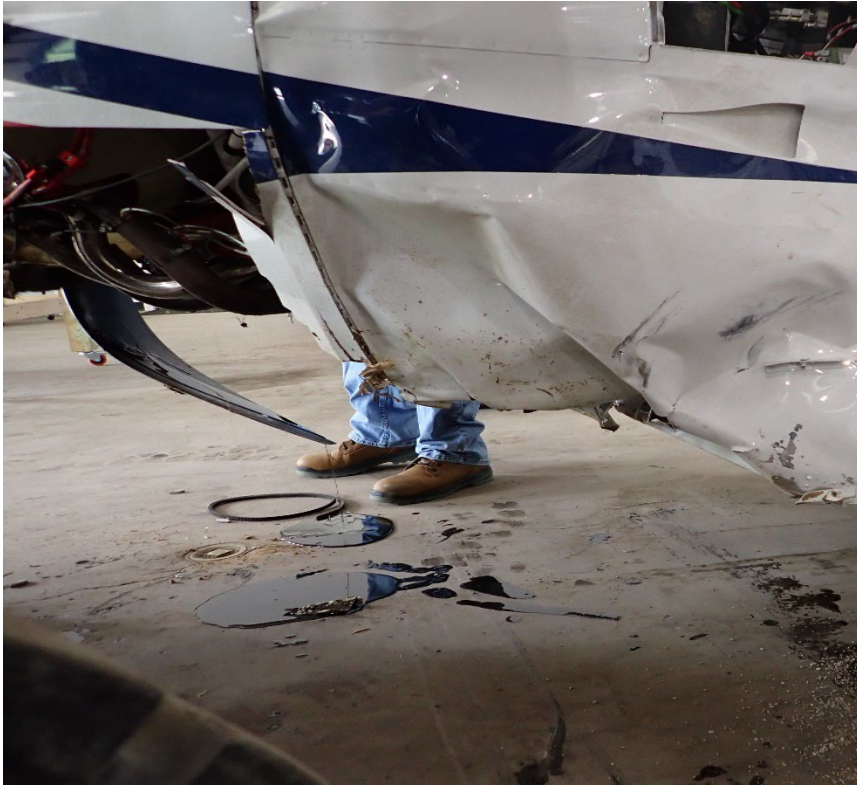
The fuselage remained intact with the canopy cut for recovery. The bottom of the fuselage, beneath the instrument panel, was crushed upwards and aft into the footwell of the cockpit. There was buckling on the left side of the fuselage at the bulkhead aft of the wing root. The right side of the fuselage was impact crushed inwards and buckled. The right side of the fuselage from the canopy rail to the floorboard was cut and separated from the back of the left seat forward to the firewall.

**Photo 3: View of the forward fuselage crushed up and aft.**

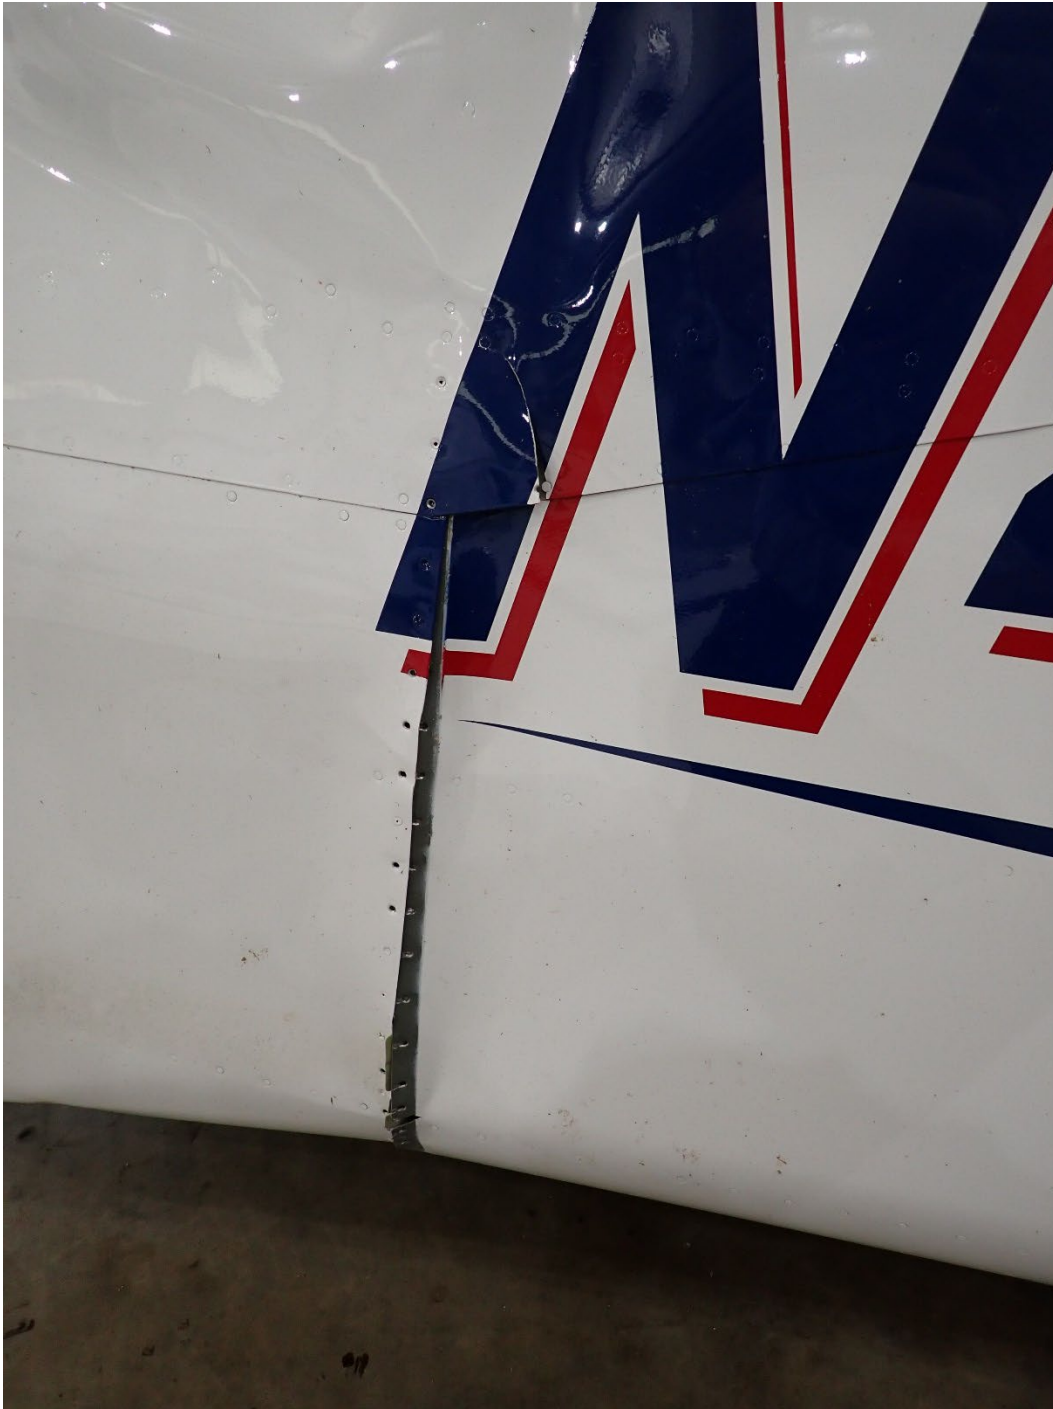
**Photo 4: Buckling of the left side of the fuselage.**

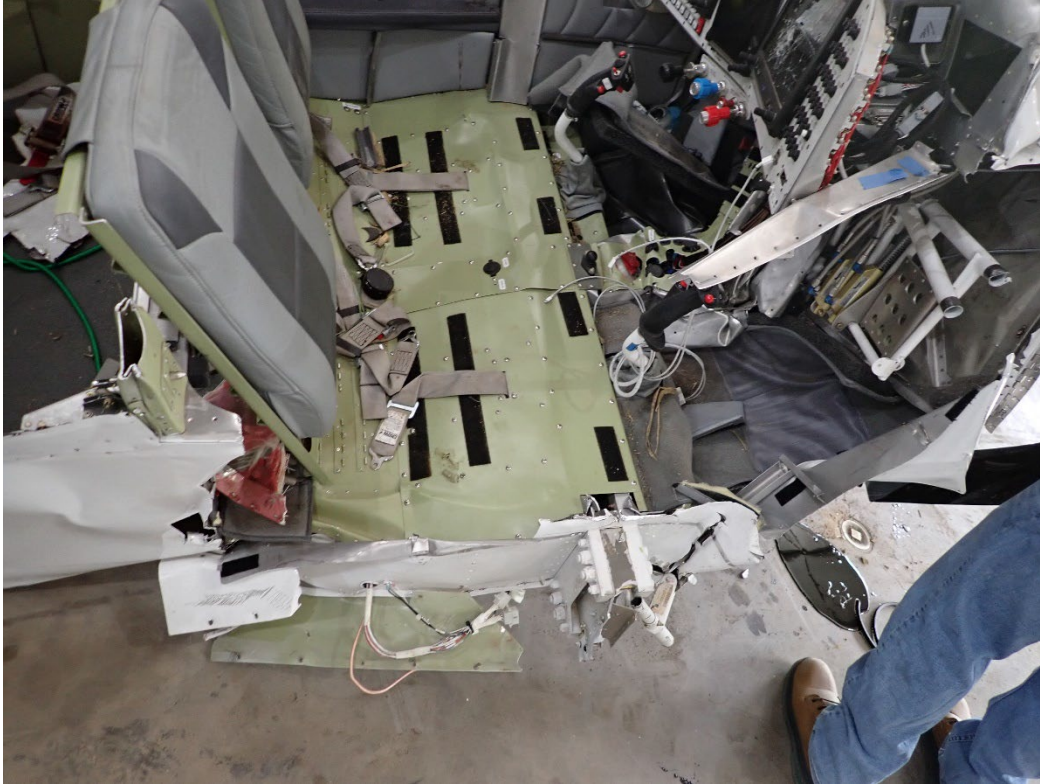
**Photo 5: View of the right side of the fuselage.**

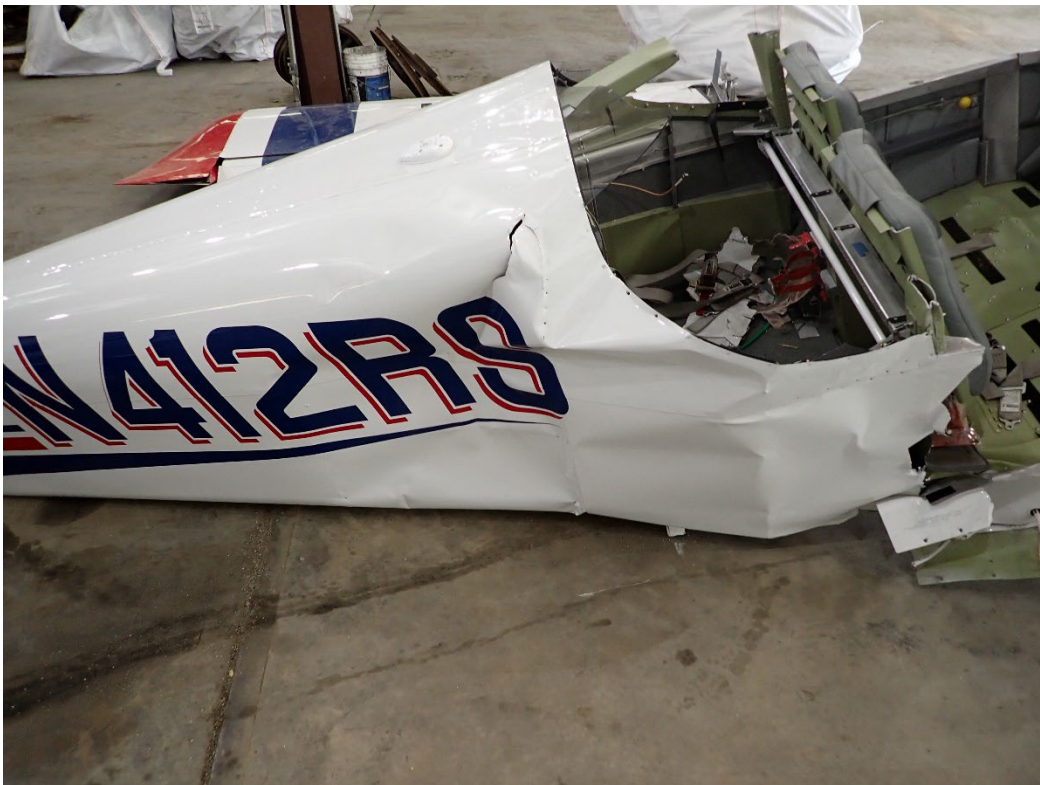
**Photo 6: View of the right side of the fuselage.**

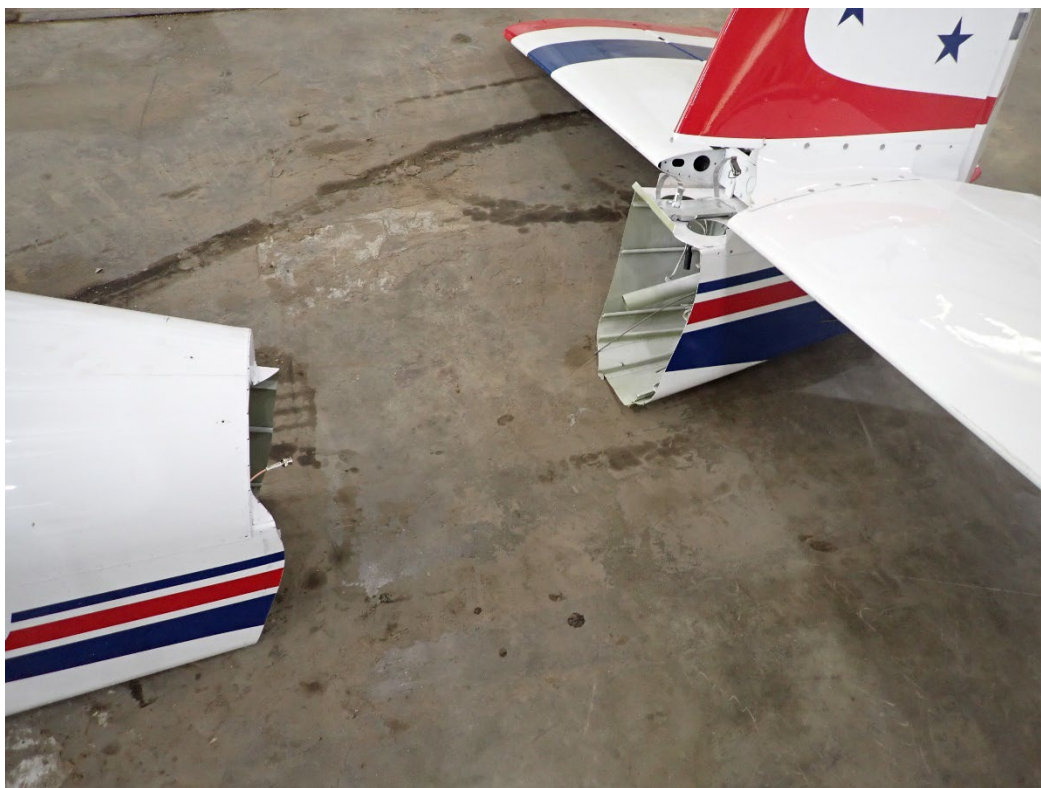
The empennage was cut away from the fuselage to facilitate recovery. Continuity of the elevator was confirmed from the flight control in the cockpit to the flight control surface through one cut made for recovery. Continuity of the rudder was confirmed from the cockpit flight control to the flight control surface through one cut made to facilitate recovery. The left horizontal stabilizer remained attached to the empennage and the left elevator remained attached to the left horizontal stabilizer at all attachment points. The left elevator counterweight remained in place. The trim tab remained attached to the left elevator at all attach points and was in line with the elevator. The left elevator trailing edge tip was deformed slightly down. The right horizontal stabilizer remained attached to the empennage. The right elevator remained attached to the right horizontal stabilizer at all attachment points and the counterweight remained in place. The vertical stabilizer exhibited slight leading-edge abrasion. The rudder remained attached to the vertical stabilizer at all attachment points. The ELT was removed from the empennage and its bracket was still in place with no damage.

**Photo 7: View of the empennage, cut for recovery.**

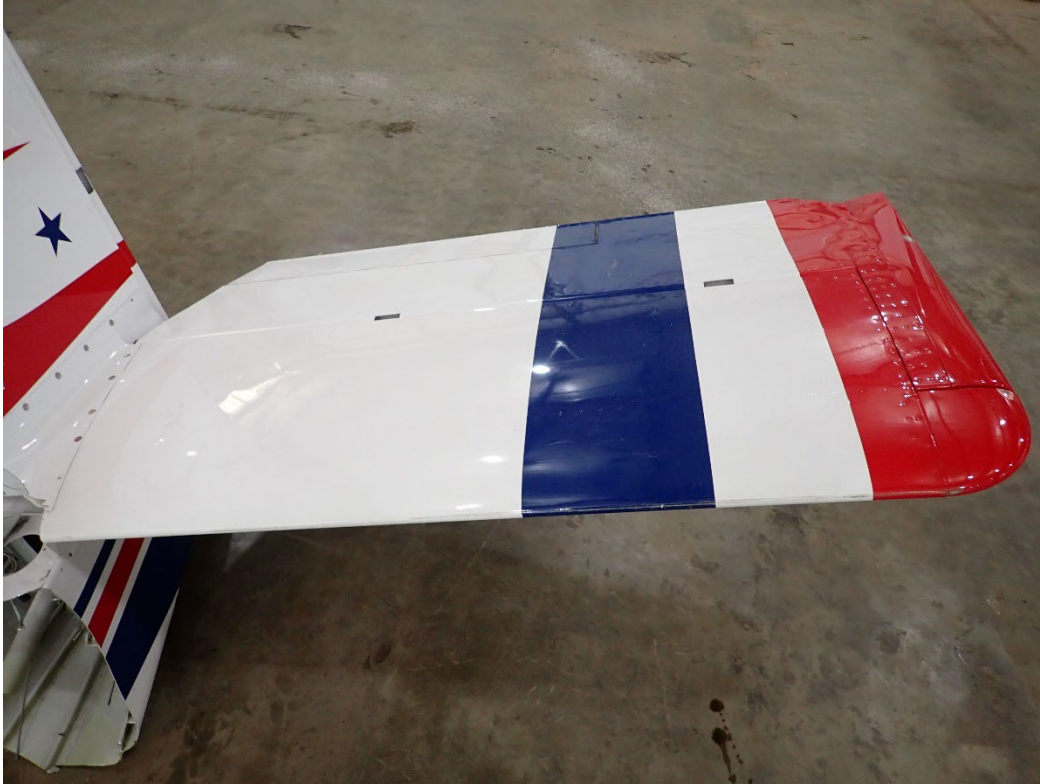
**Photo 8: View of the right horizontal stabilizer, elevator, and trim tab.**

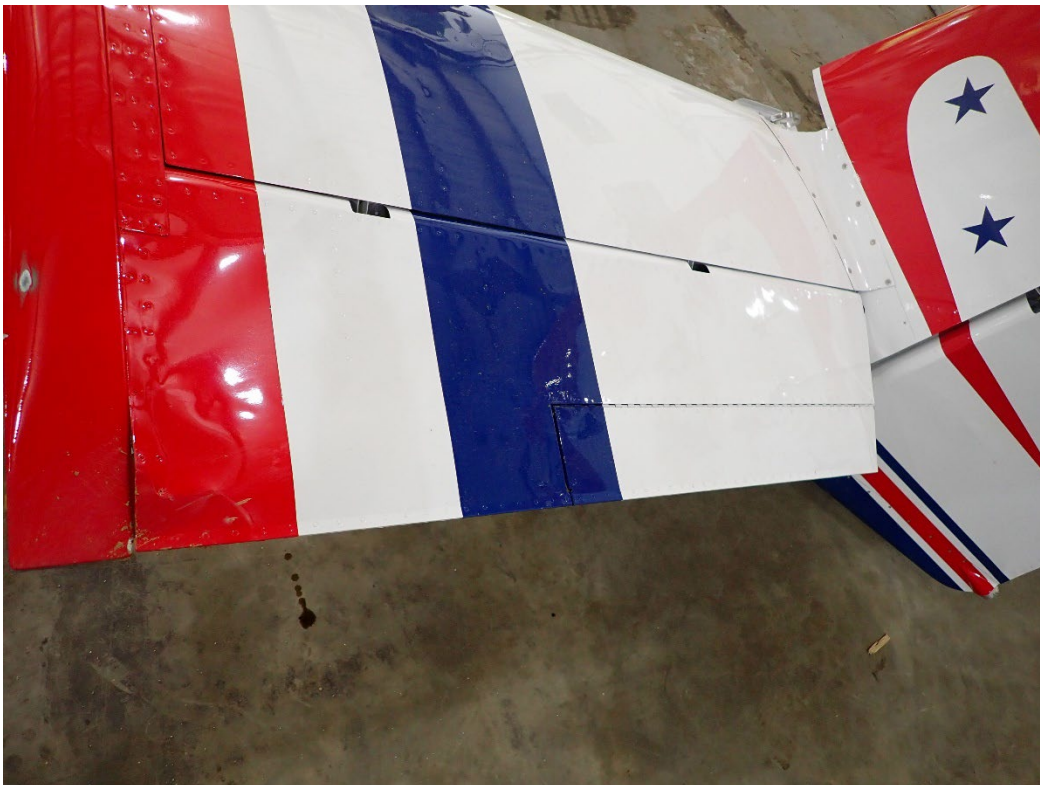
**Photo 9: View of the right elevator and trim tab.**

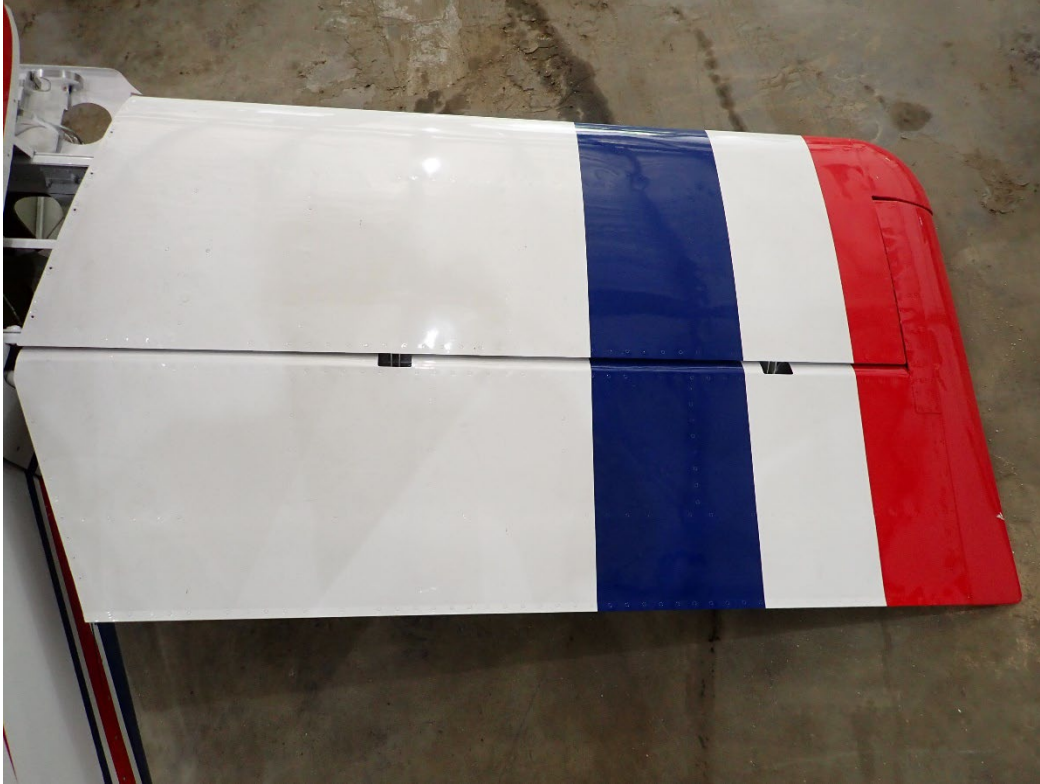
**Photo 10: View of the left horizontal stabilizer and elevator.**

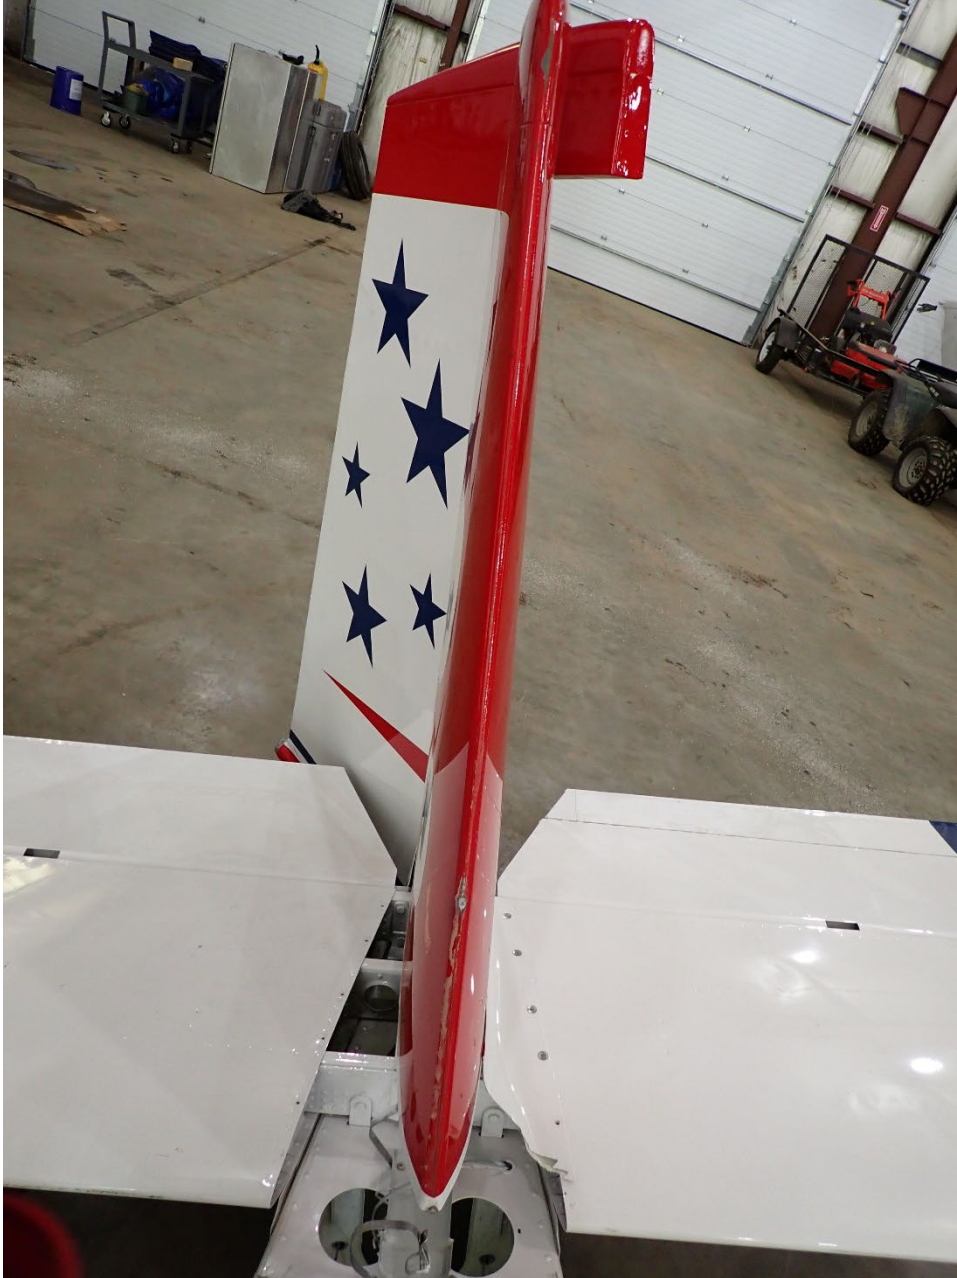
**Photo 11: View of the leading edge of the vertical stabilizer.**

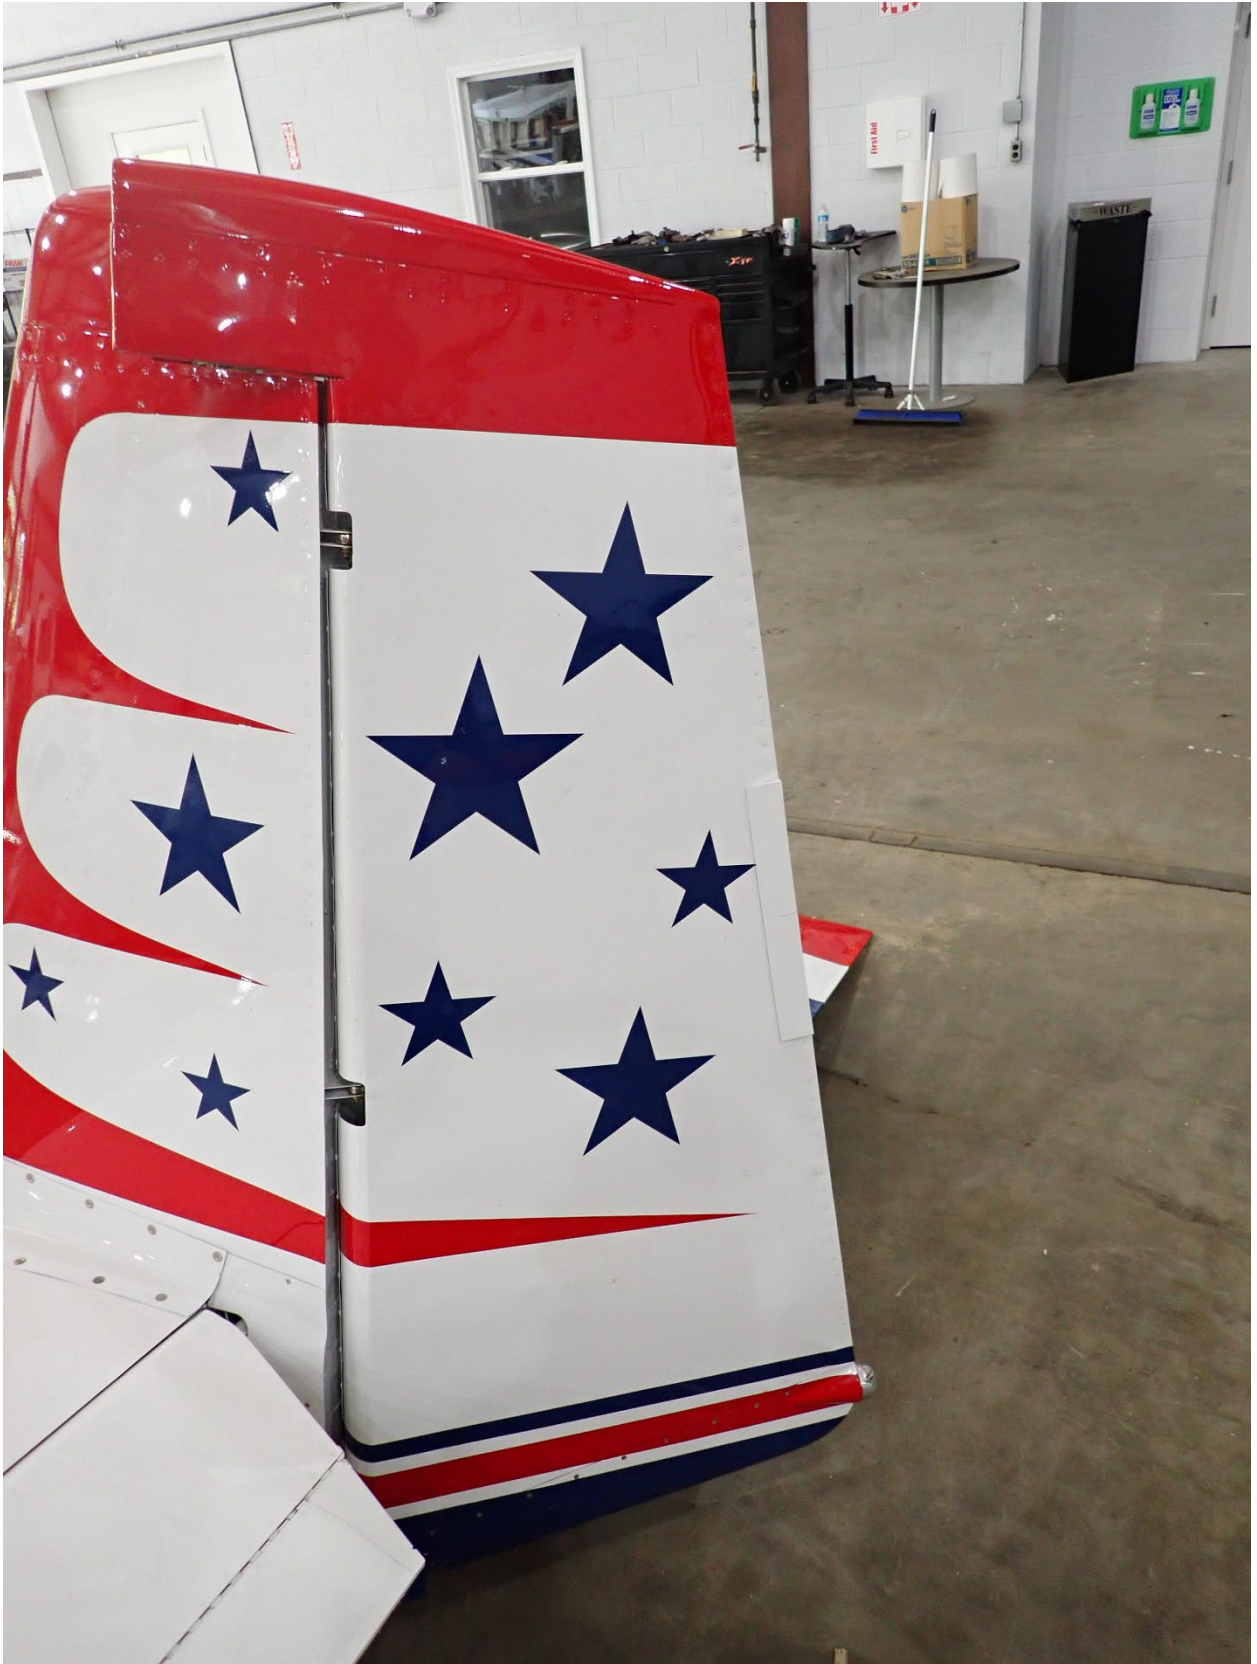
**Photo 12: View of the rudder.**

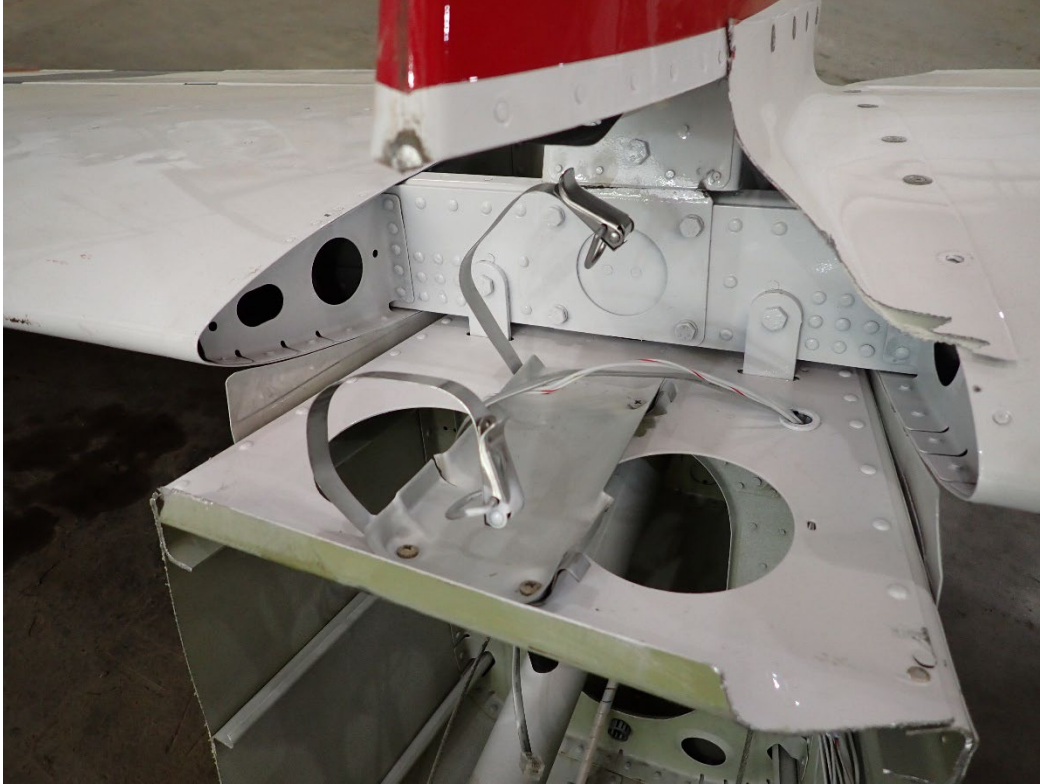
**Photo 13: View of the ELT cradle.**

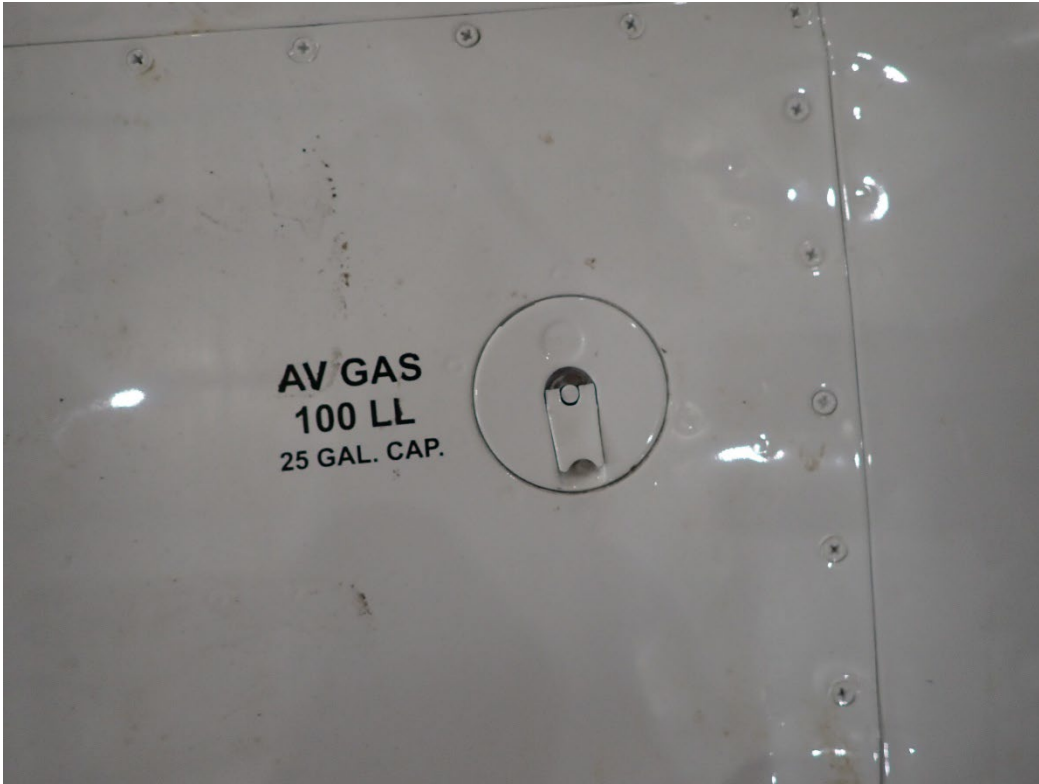
**Photo 14: Left fuel cap seated in place.**

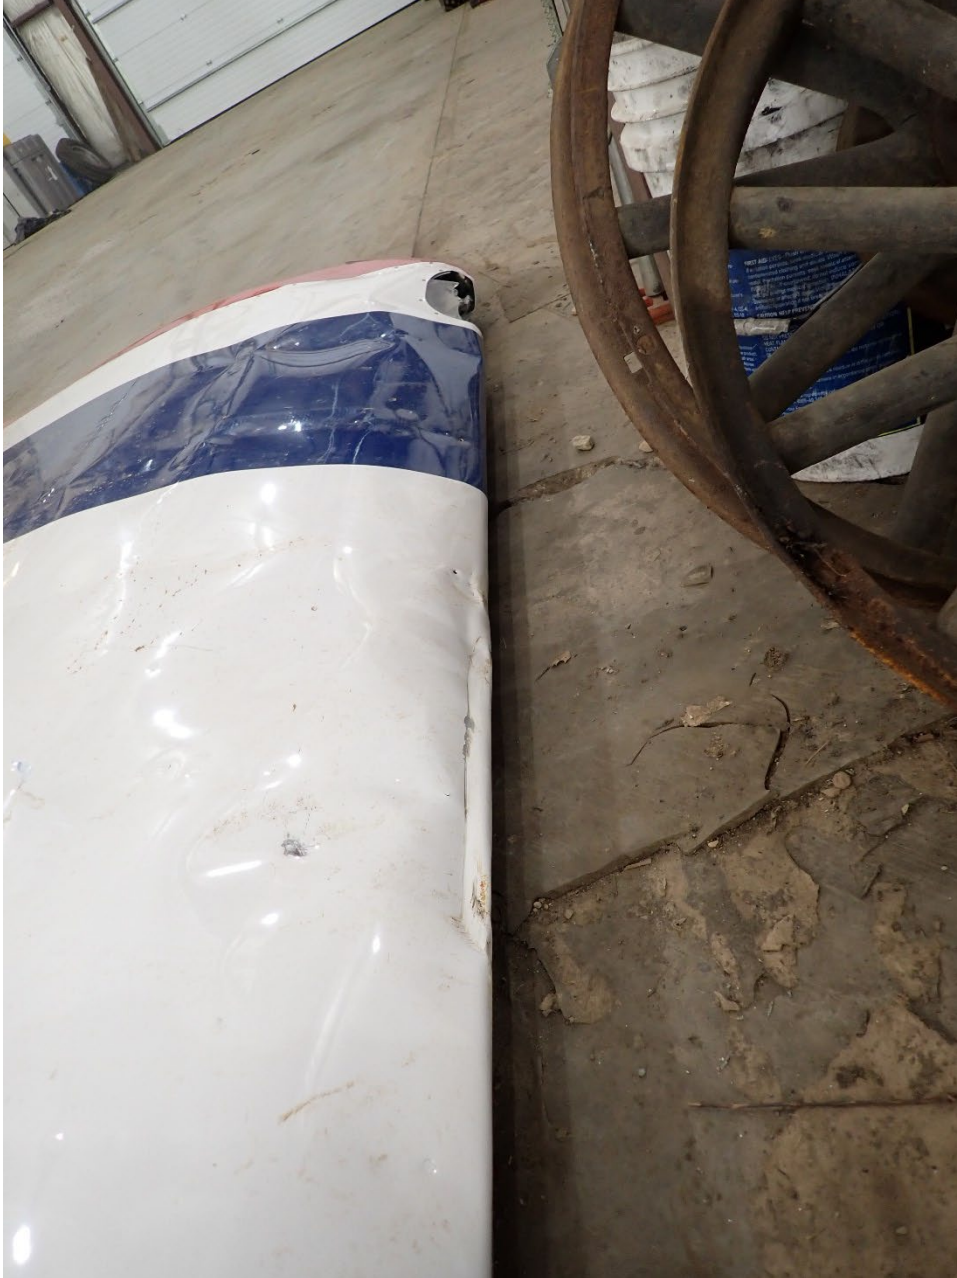
**Photo 15: View of the left-wing leading-edge damage.**

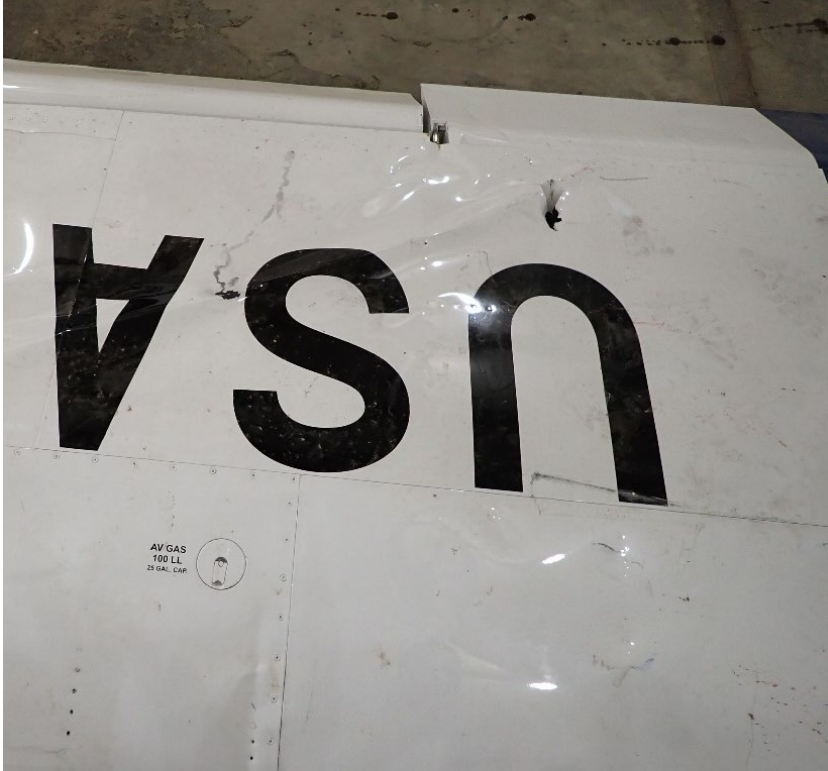
**Photo 16: View of the buckling on the top of the left wing.**

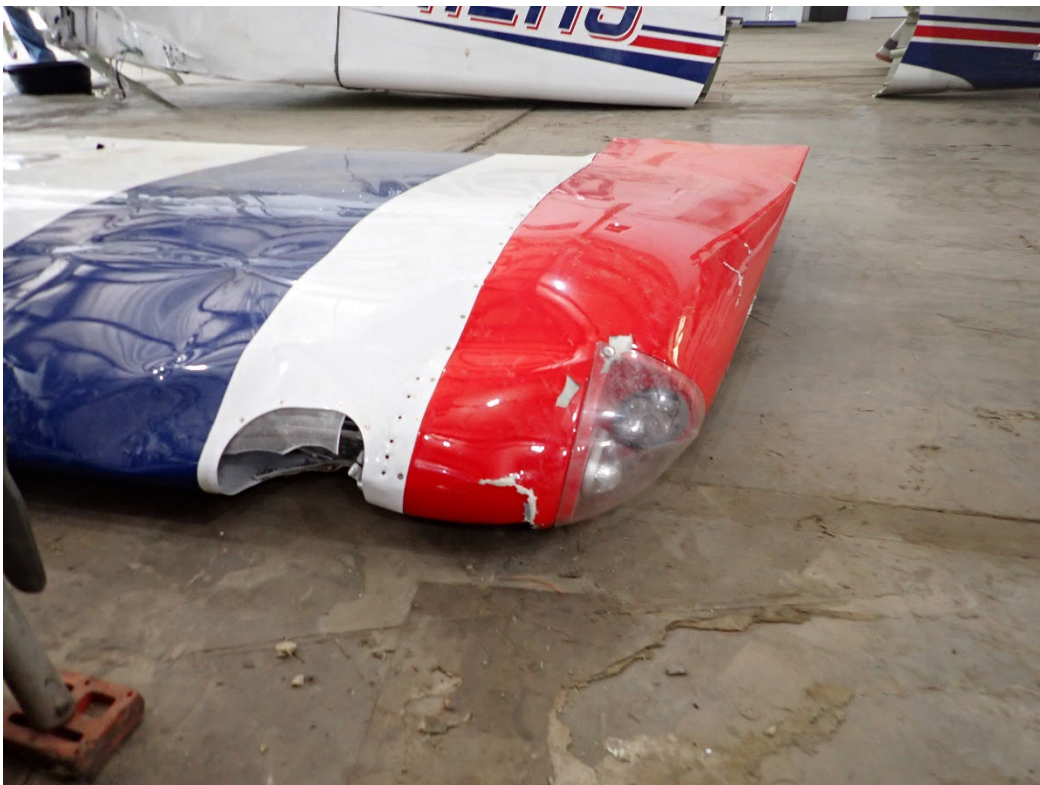
**Photo 17: View of the left wing tip damage.**

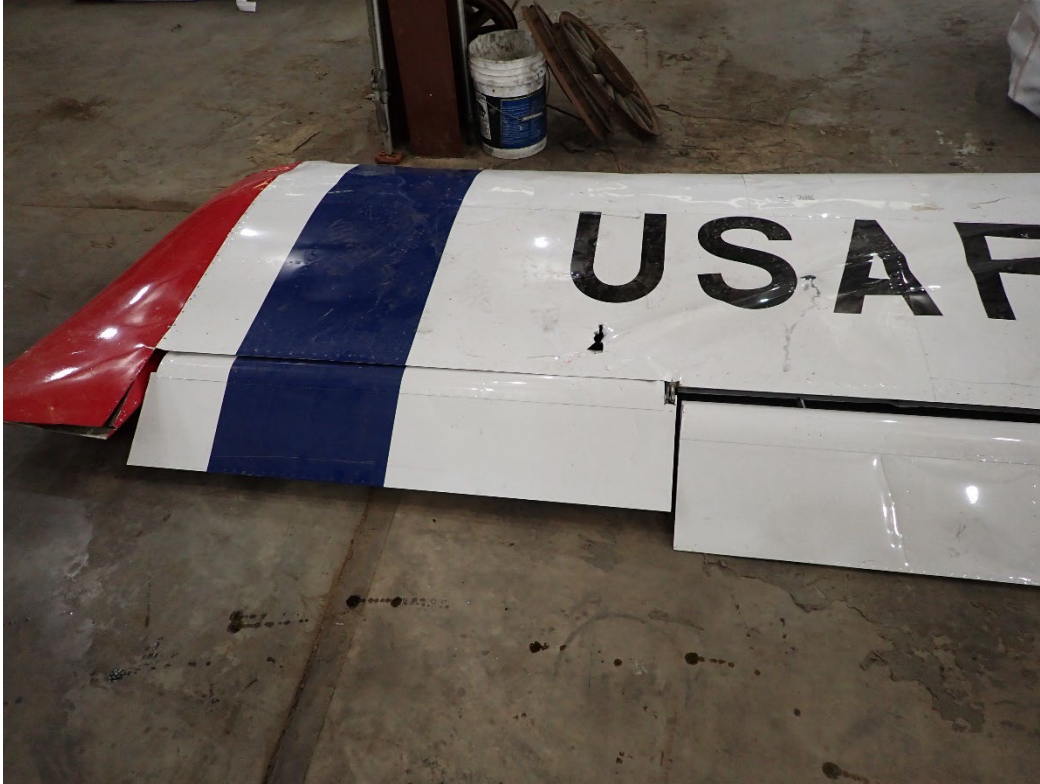
**Photo 18: View of the left aileron.**

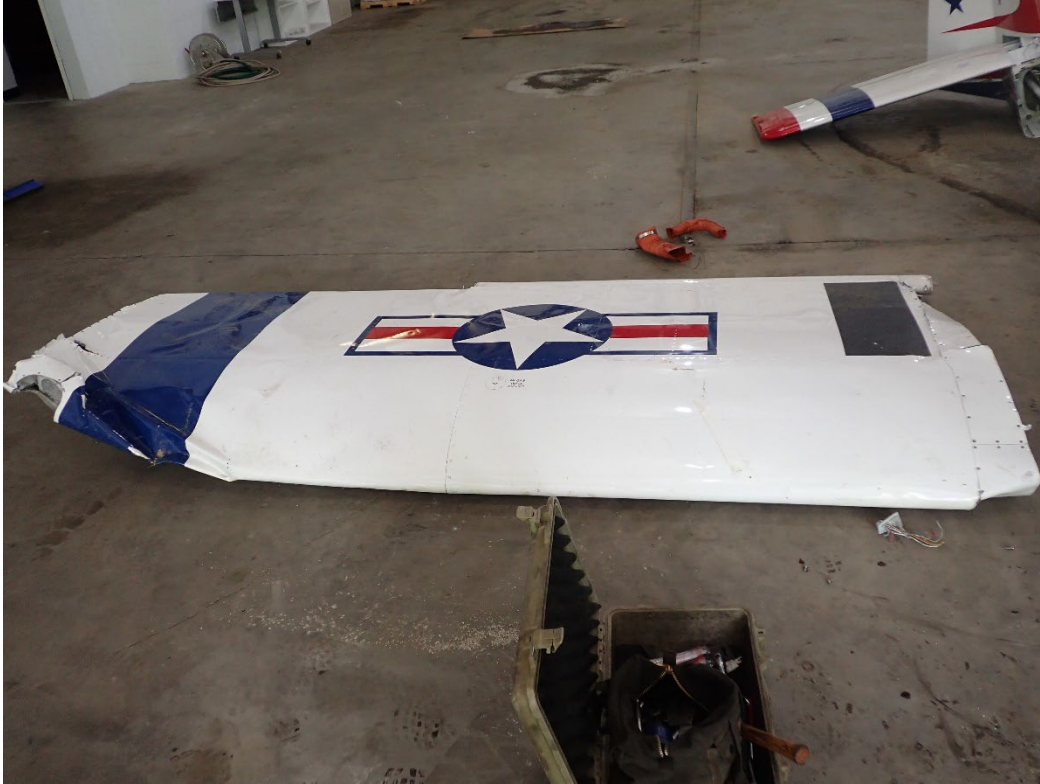
The right wing was impact separated from the airplane and the fracture at the wing spar exhibited overload failure. The leading edge exhibited denting throughout its length. The outboard leading edge was crushed up and aft and the wing tip was impact separated. The aileron was impact separated from the wing. Continuity was confirmed from the cockpit flight control to the control surface through multiple overload fractures. The flap remained attached to the wing at all attachment points and moved freely by hand. The right fuel cap was seated in place and was opened by hand. The right fuel tank was punctured and the smell of 100LL aviation fuel was noted when the fuel cap was removed.

**Photo 19: Overview of the right wing as found at the recovery facility.**

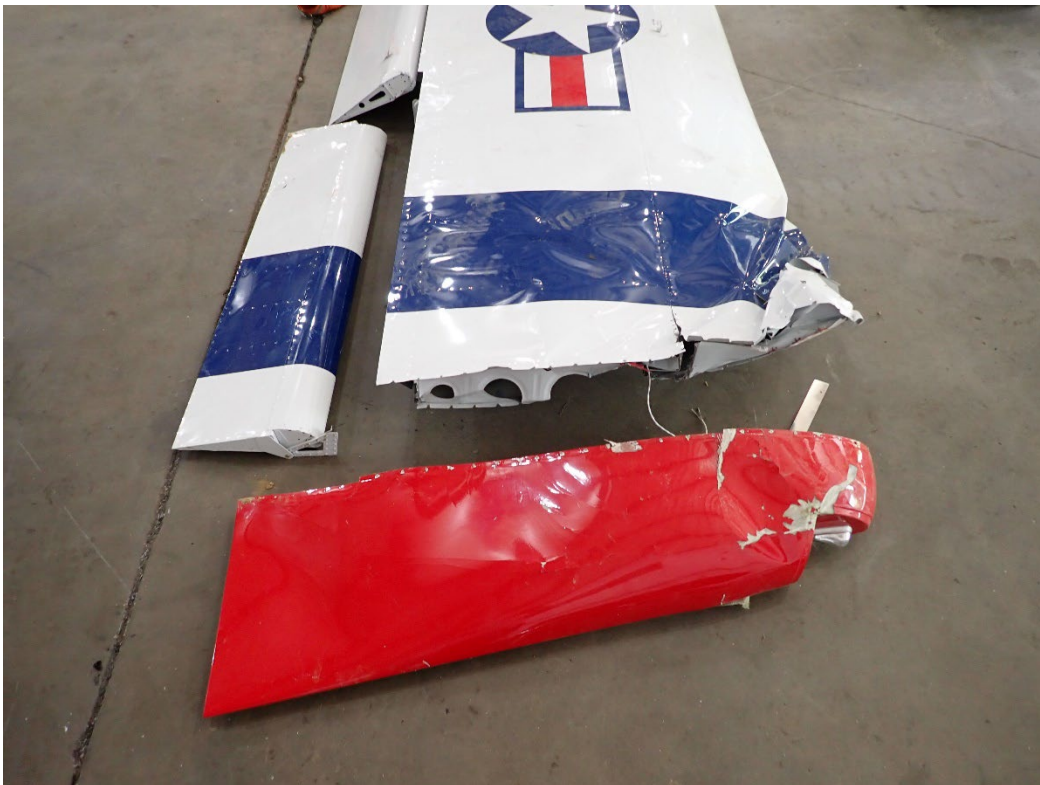
**Photo 20: Overview of the right wing with aileron and wingtip laid out.**

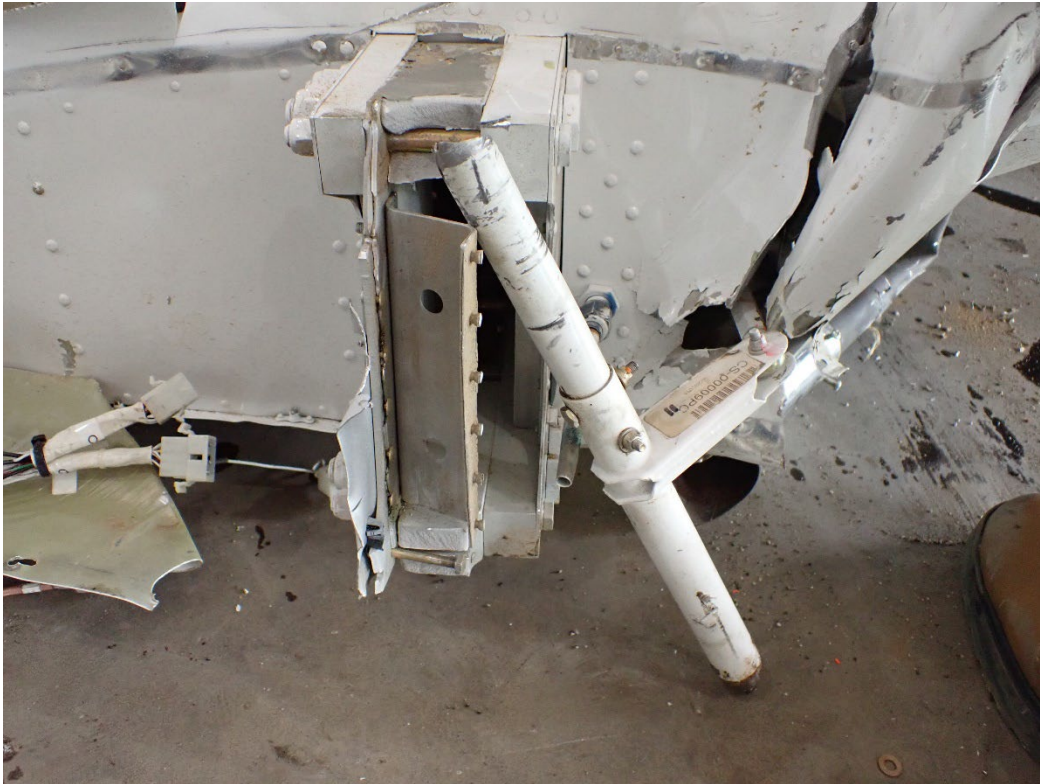
**Photo 21: View of the right wing spar that remained attached to the fuselage.**

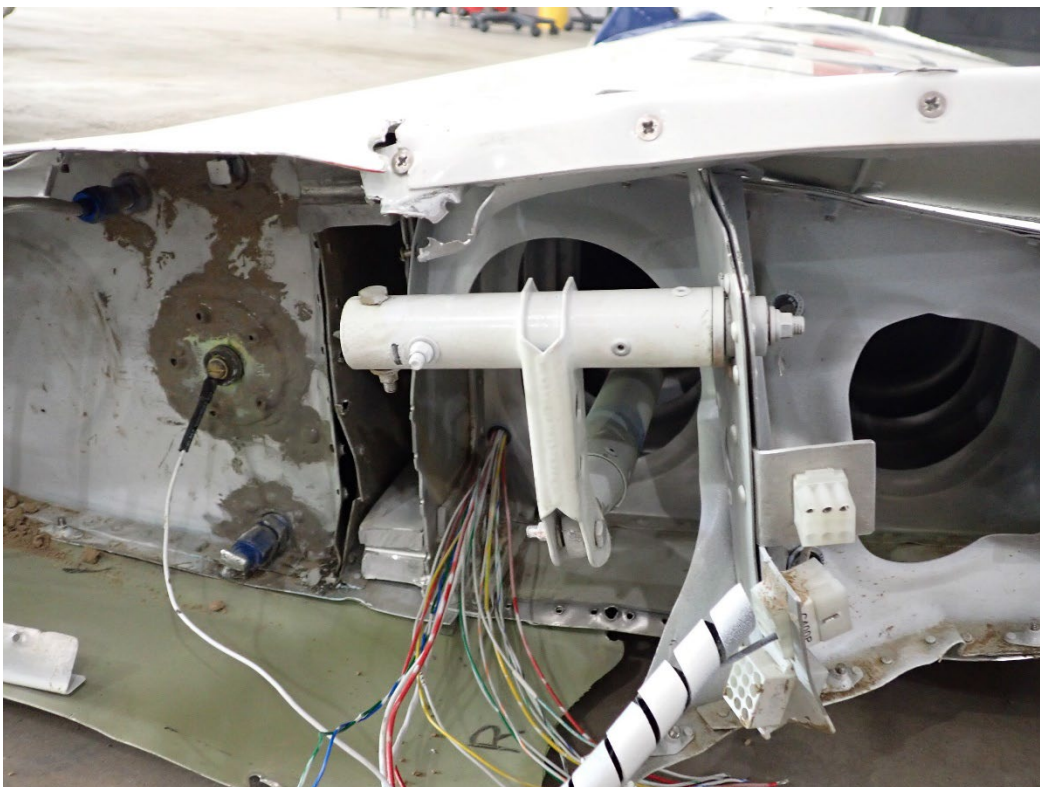
**Photo 22: View of the right wing root.**

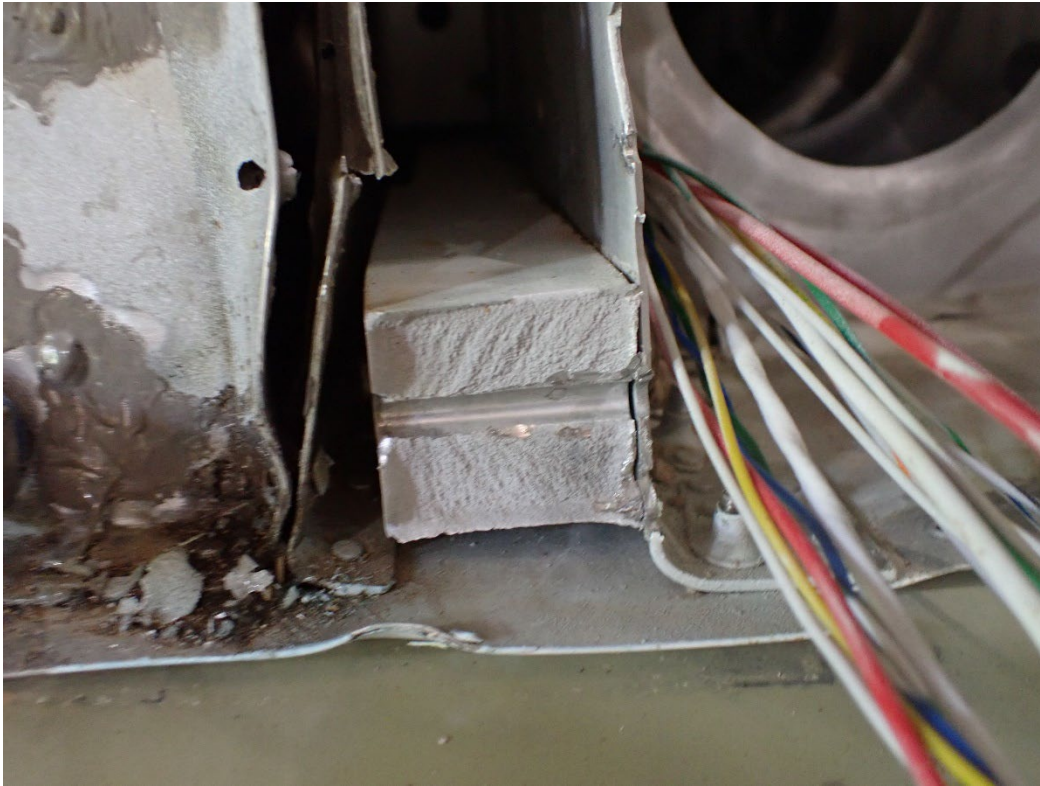
**Photo 23: Right wing lower spar fracture.**

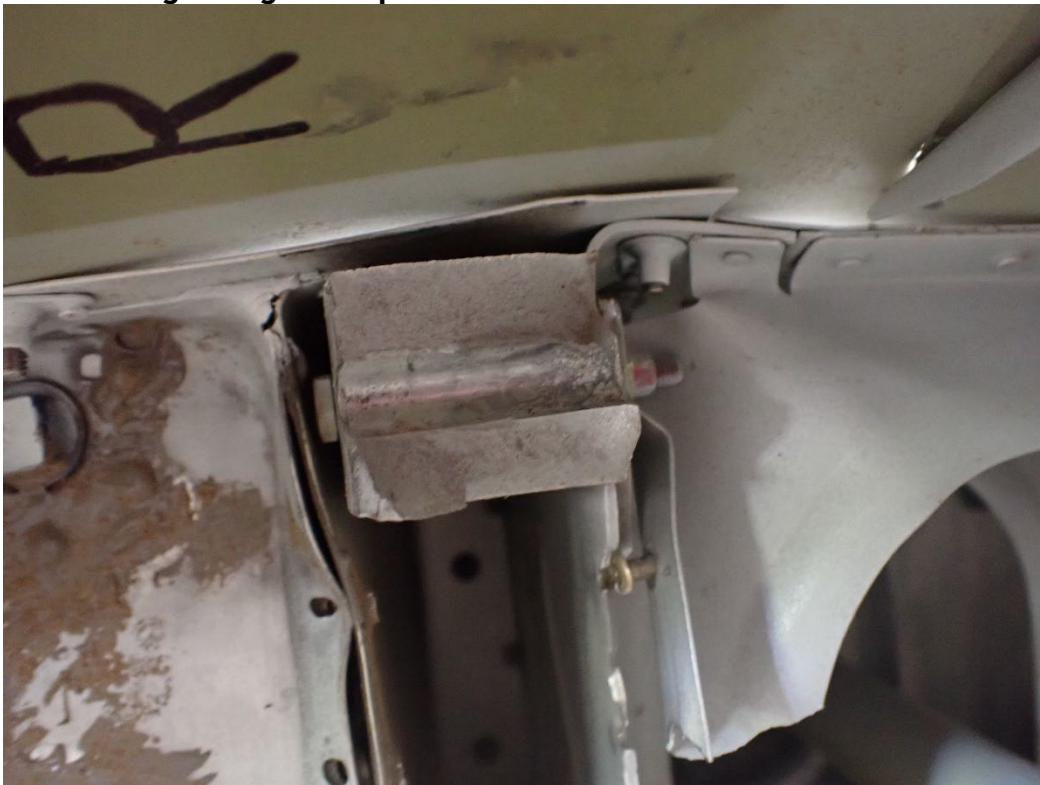
**Photo 24: Right wing upper spar fracture.**
