# National Transportation Safety Board

ERA23LA195

## **WRECKAGE AND ENGINE EXAMINATION**

Location: Fallston, MD  
Date: April 13, 2023  
Time: 1515 EDT  
1915 UTC  
Airplane: N412RS; RV-14A

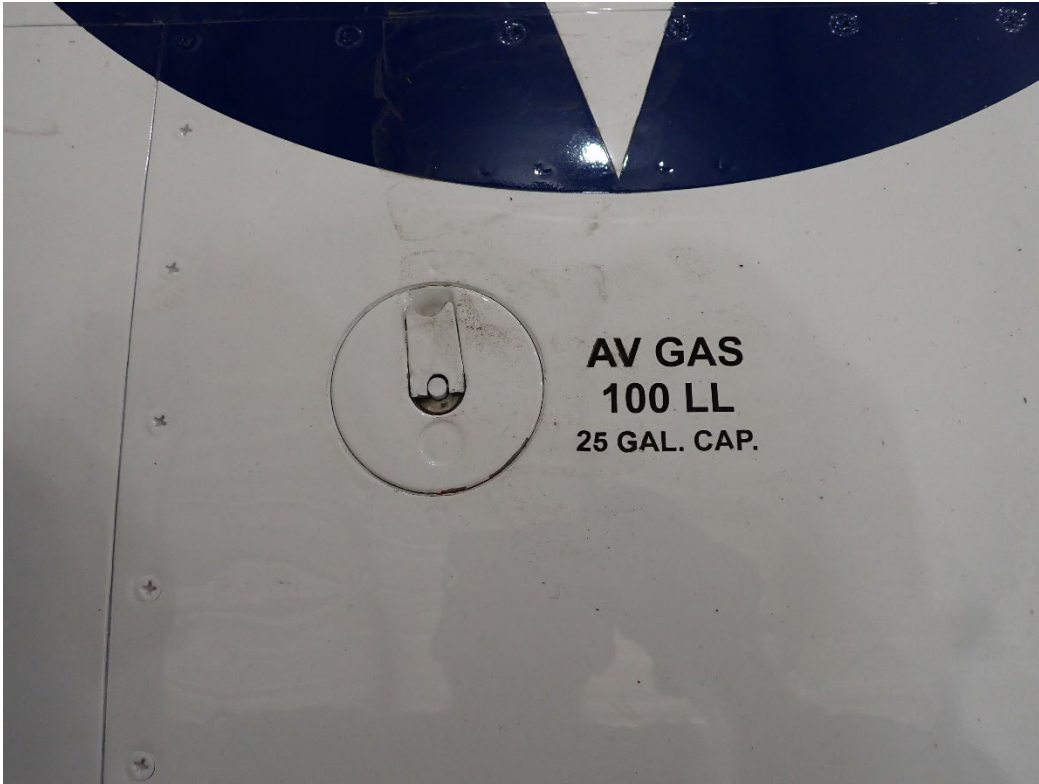
**Photo 25: Right wing fuel cap seated.**

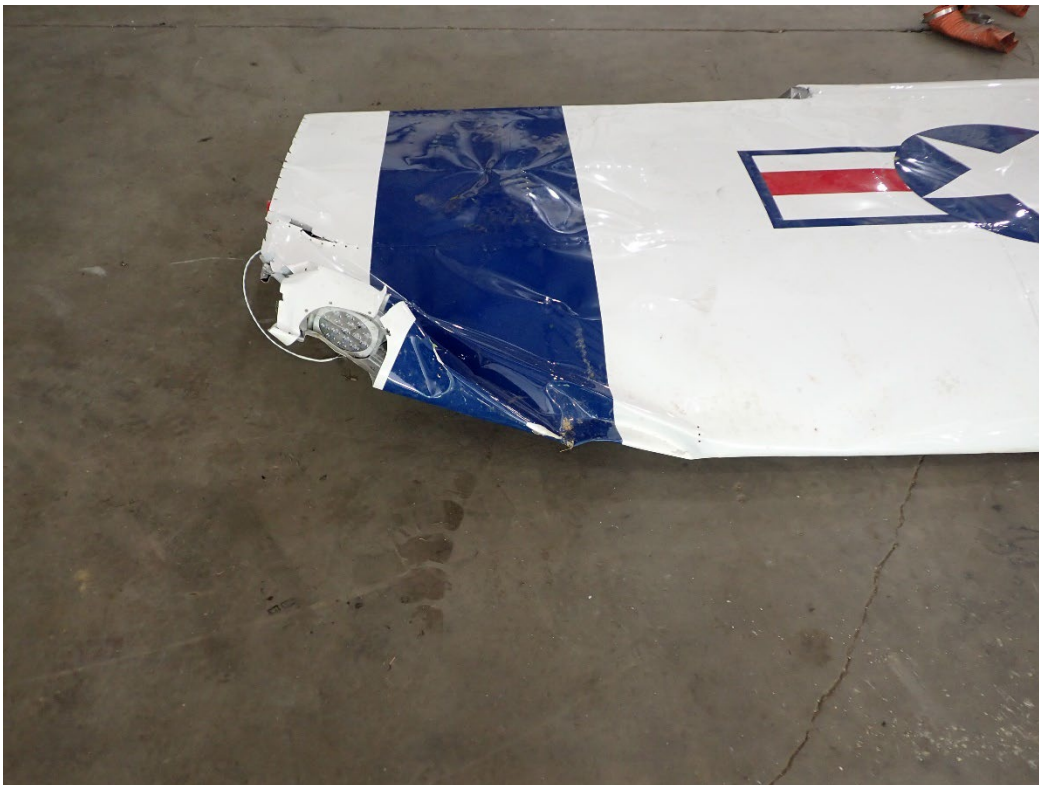
**Photo 26: Damage to the right wing outboard leading edge.**

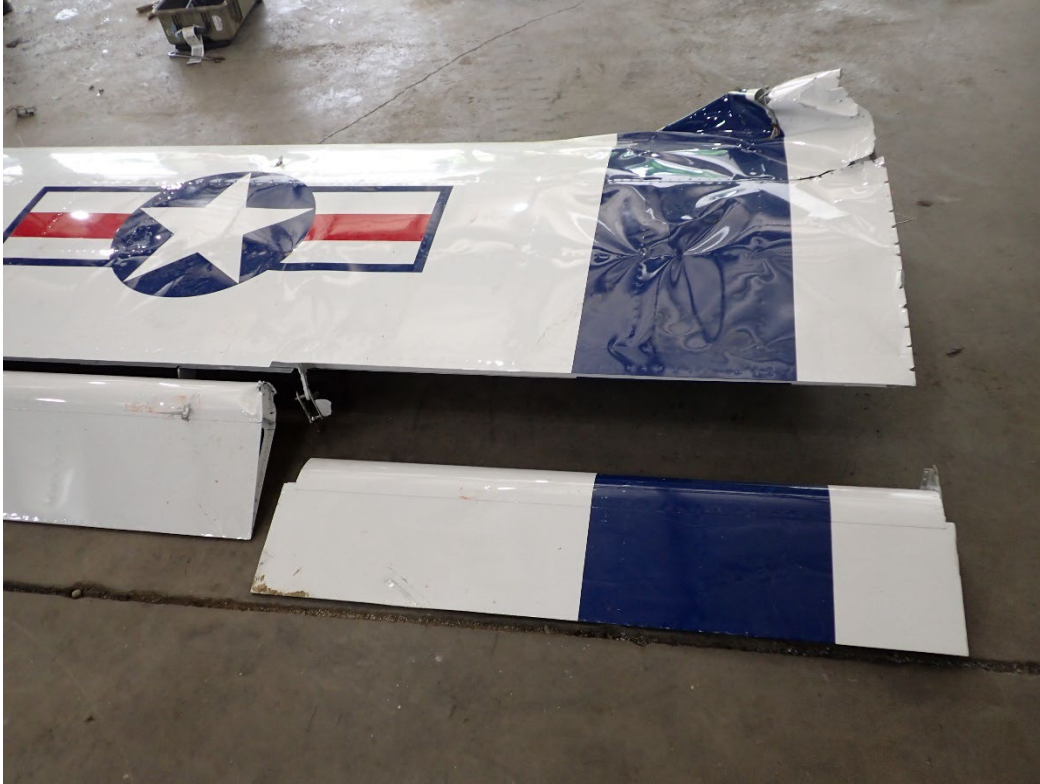
**Photo 27: View of the right aileron laid out with the right wing.**

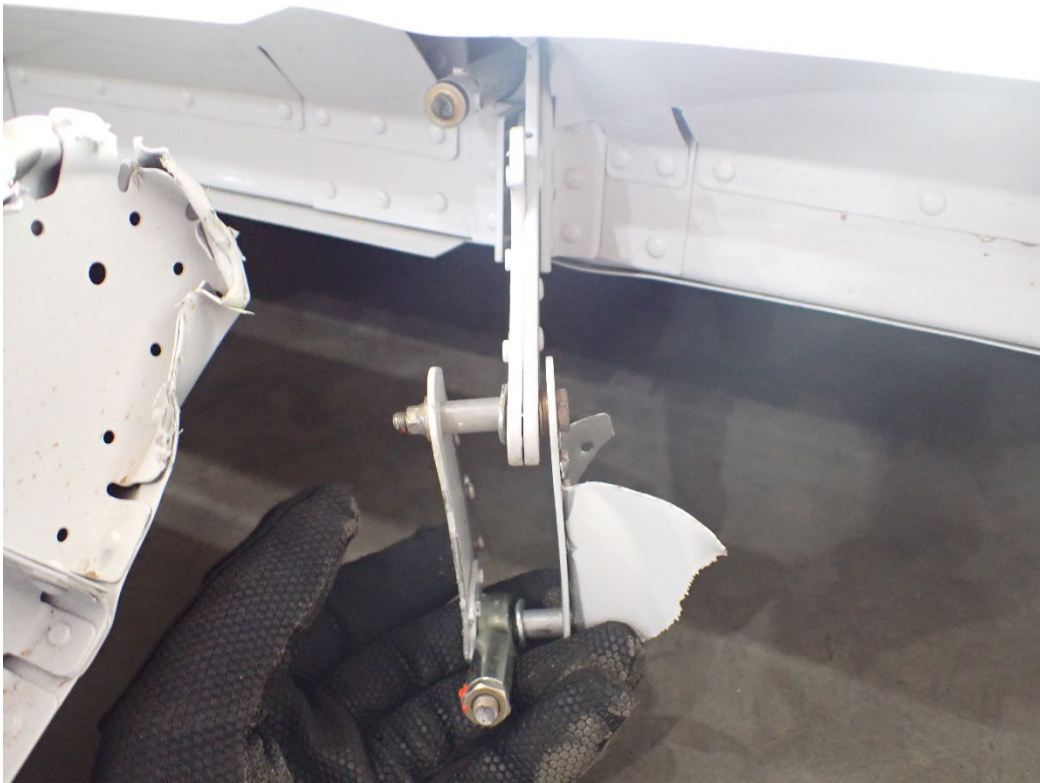
**Photo 28: View of impact fractured right aileron pushrod head.**

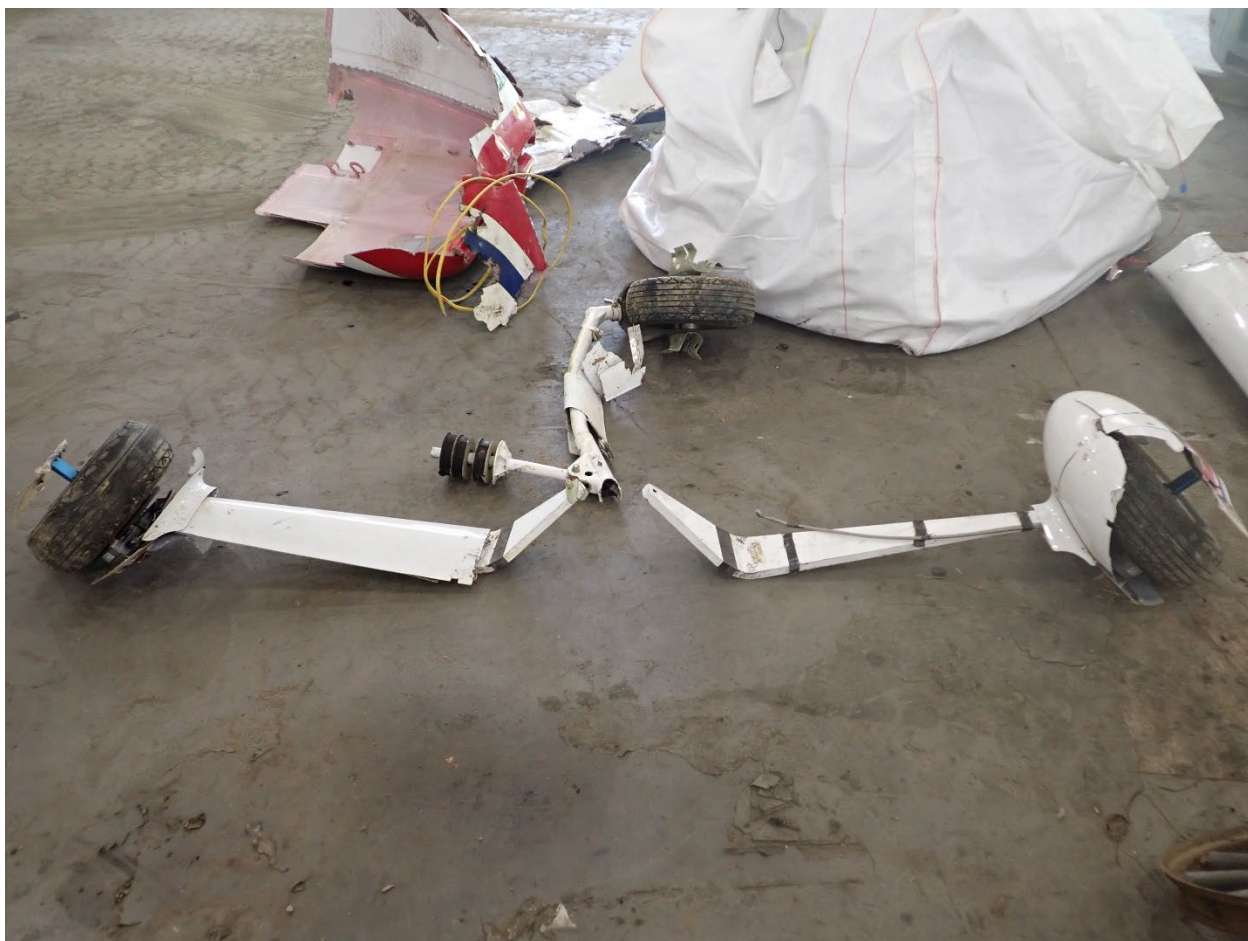
The nose and main landing gear were separated from the airplane at the recovery facility. The nose landing gear was impact separated from its attachment point. The right main landing gear was impact separated from its attachment point. The left main landing gear was impact separated from its attachment point with the attachment bolt remaining in place.

**Photo 29: View of the landing gear laid out.**

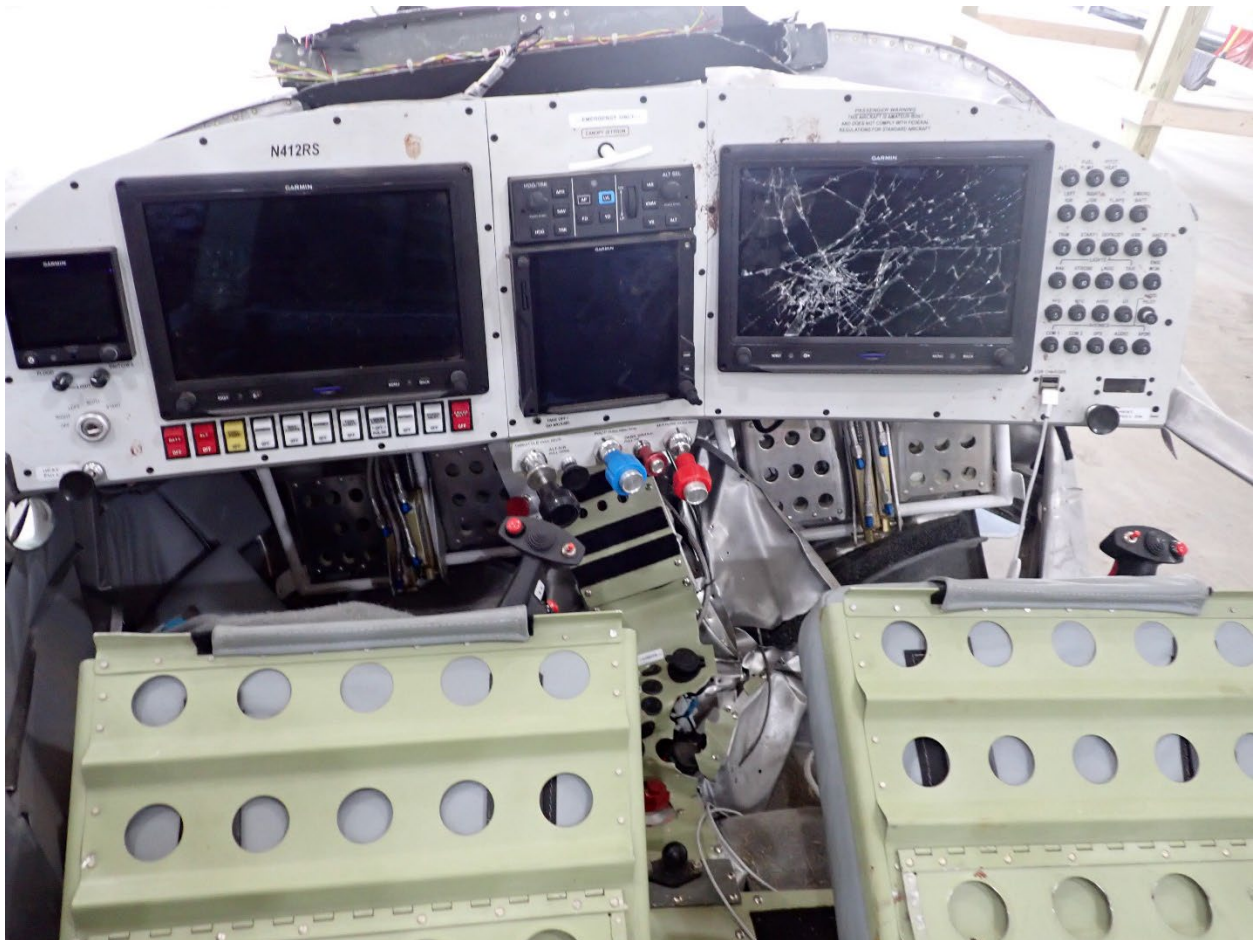
The cockpit was intact and contained no conventional instrumentation. The throttle and mixture knobs were slightly less than full forward and the propeller control was full forward. The cabin heat knob was pulled out slightly. The circuit breakers were examined with only the autopilot breaker having been tripped. The following switches in the cockpit were noted:

**Photo 30: View of the cockpit as found at the recovery facility.**

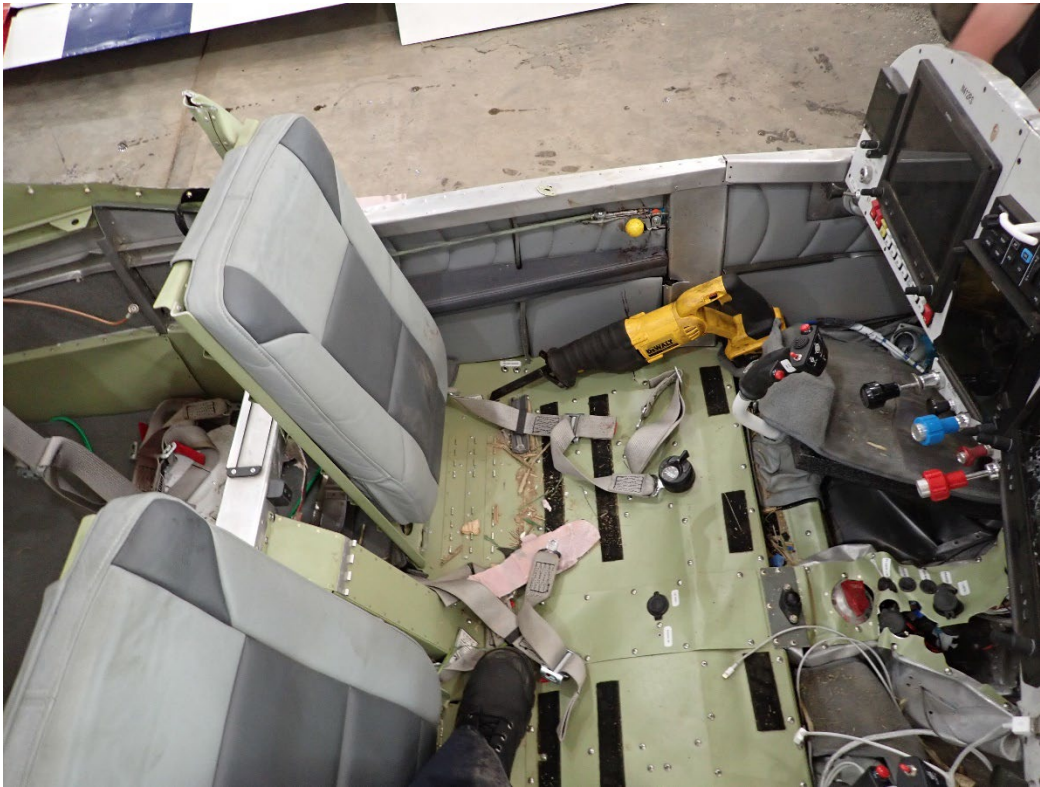
**Photo 31: View of the cockpit seats.**

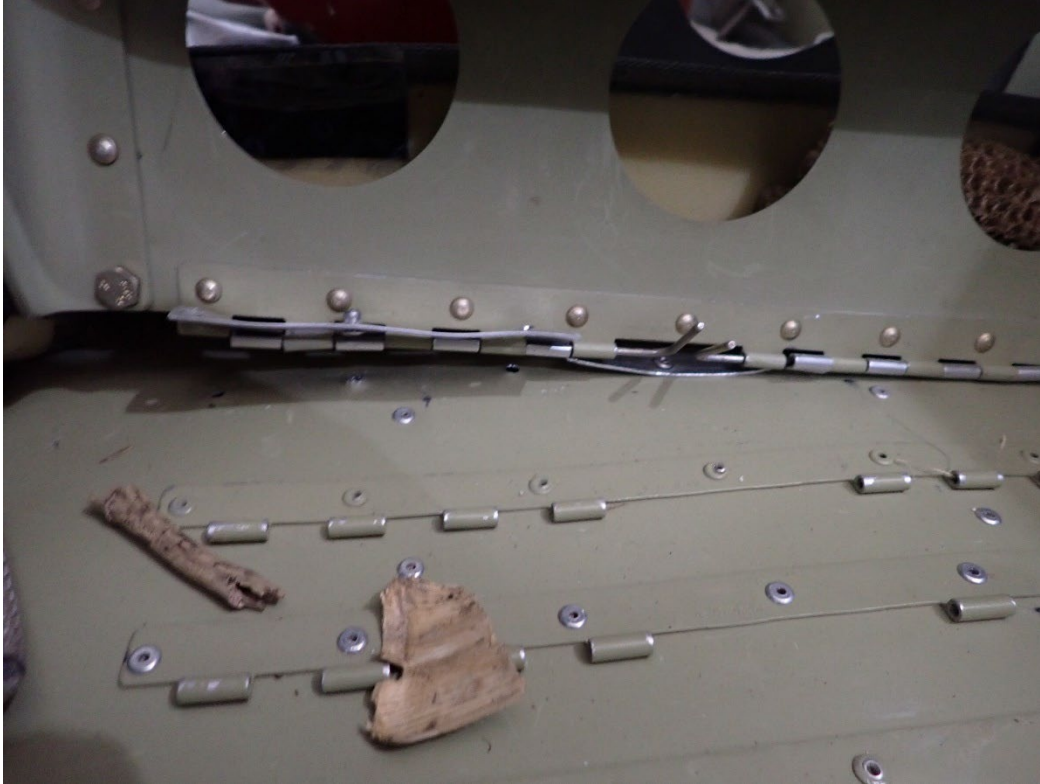
The left seat back remained attached by one of the 2 hinges with the other hinge having the rivets pulled from the airframe. The left seat was equipped with a five point harness which operated normally. The harness remained attached at all attachment points. The right seat back remained attached at

**Photo 32: View of the left seat back hinges.**

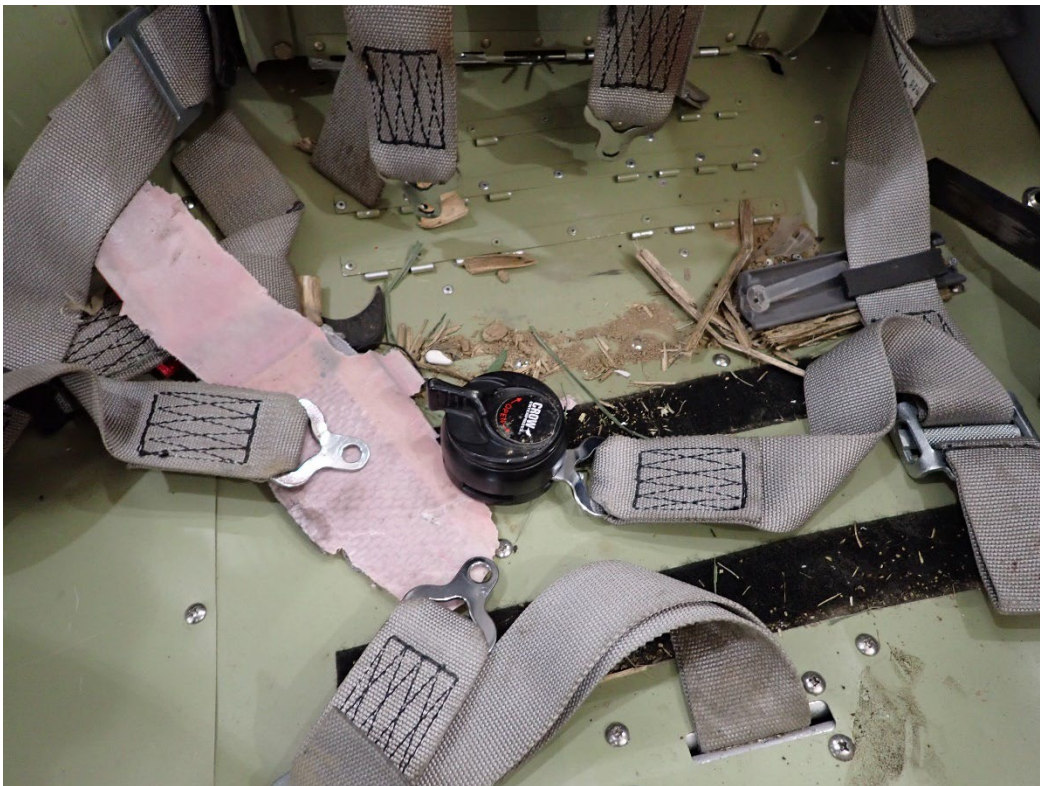
**Photo 33: View of the left seat harness.**

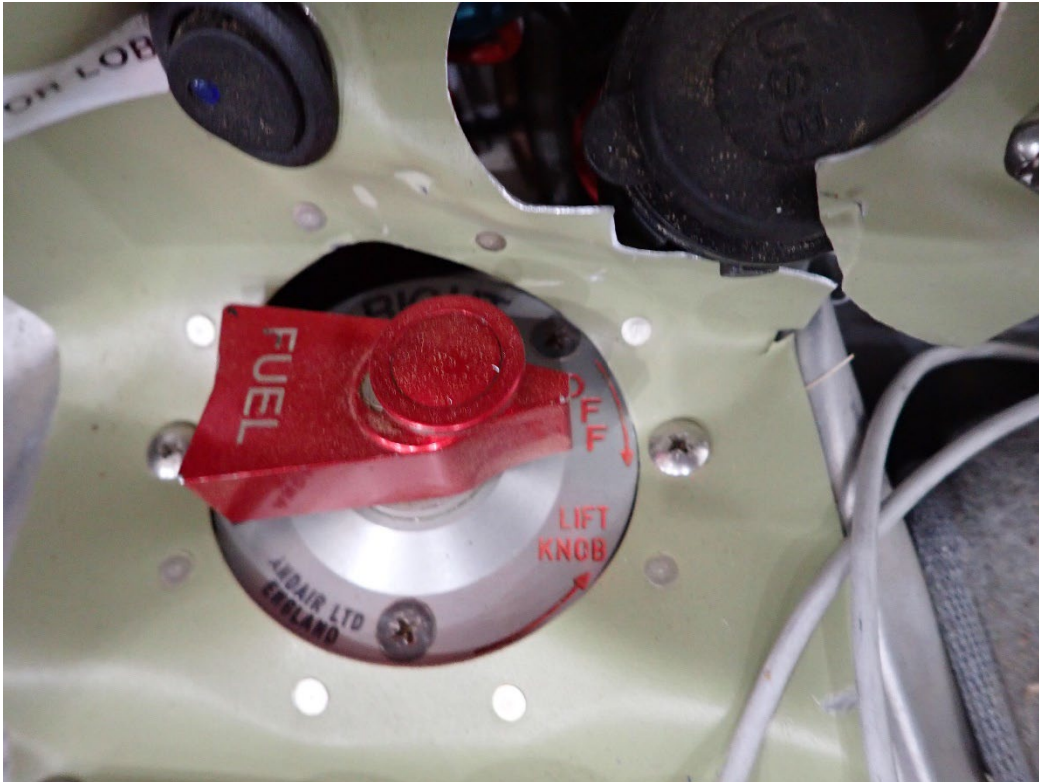
**Photo 34: Fuel selector as found.**

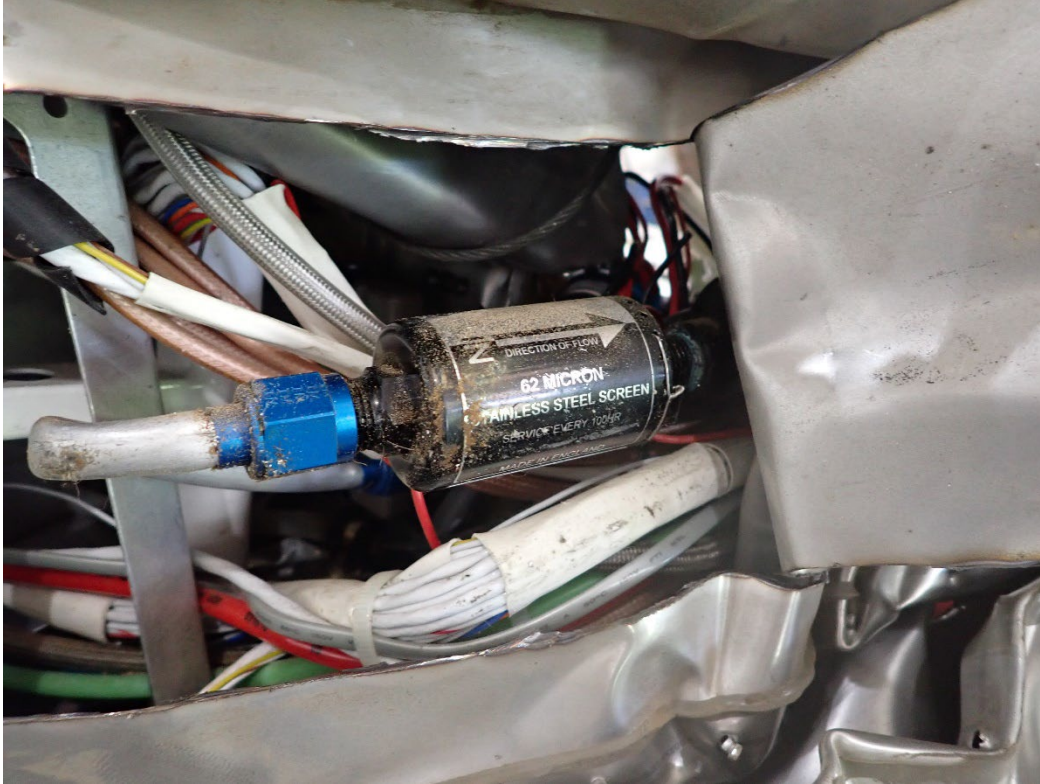
Both wing fuel tanks were punctured. The fuel selector was in the off position. An inline fuel filter was found downstream of the fuel selector but prior to the electric fuel pump. The inline fuel filter was removed and contained debris both in the cup and on the filter pleats. The inline fuel filter contained fuel that appeared to be 100LL aviation fuel, the fuel was tested with water finding paste and no water was noted.

**Photo 35: View of the inline fuel filter.**

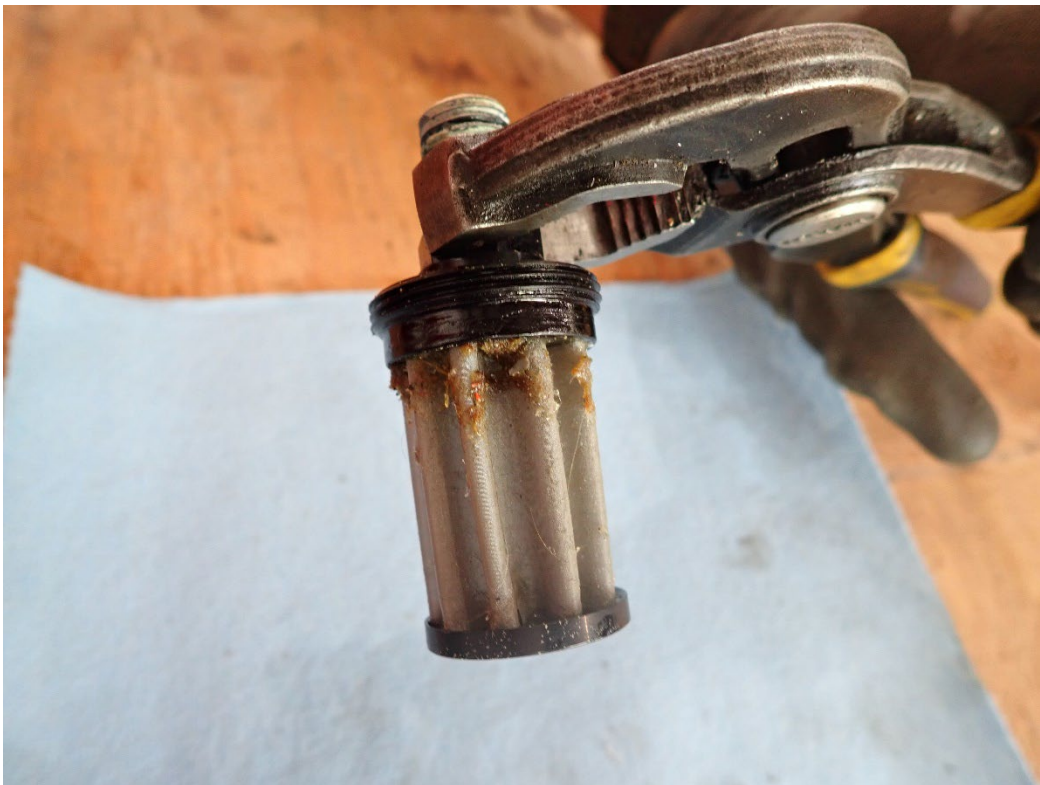
**Photo 36: View of debris found in the inline fuel filter.**

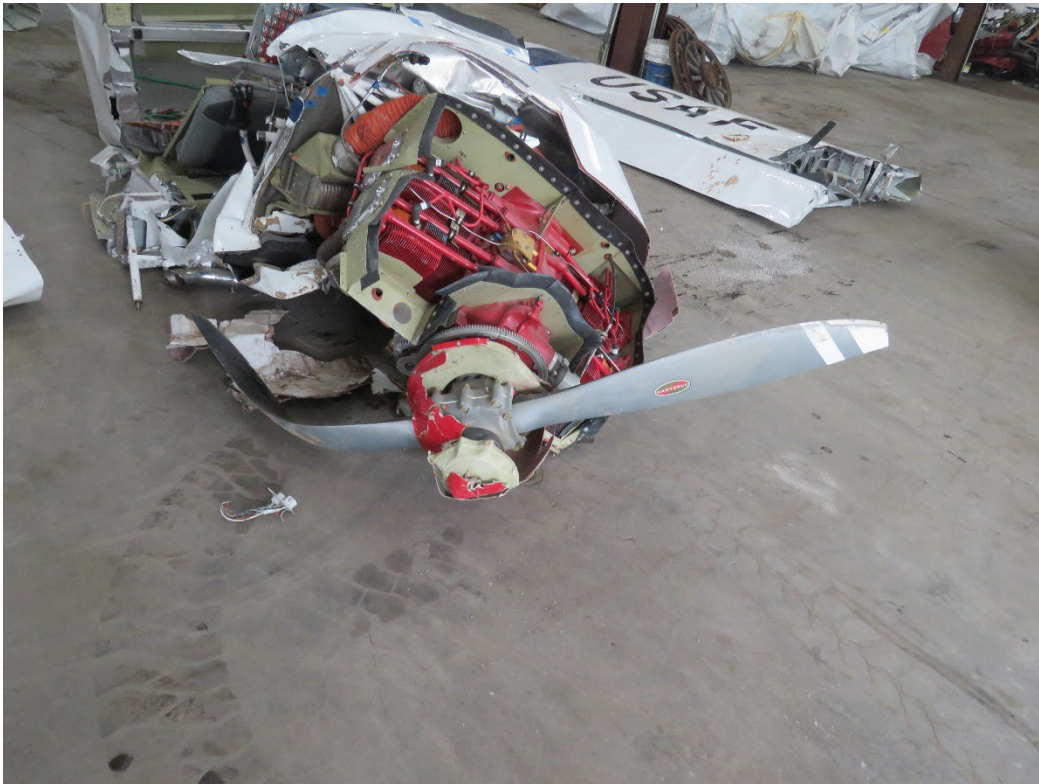
**Photo 37: The engine as found at the recovery facility. (Lycoming Photo)**

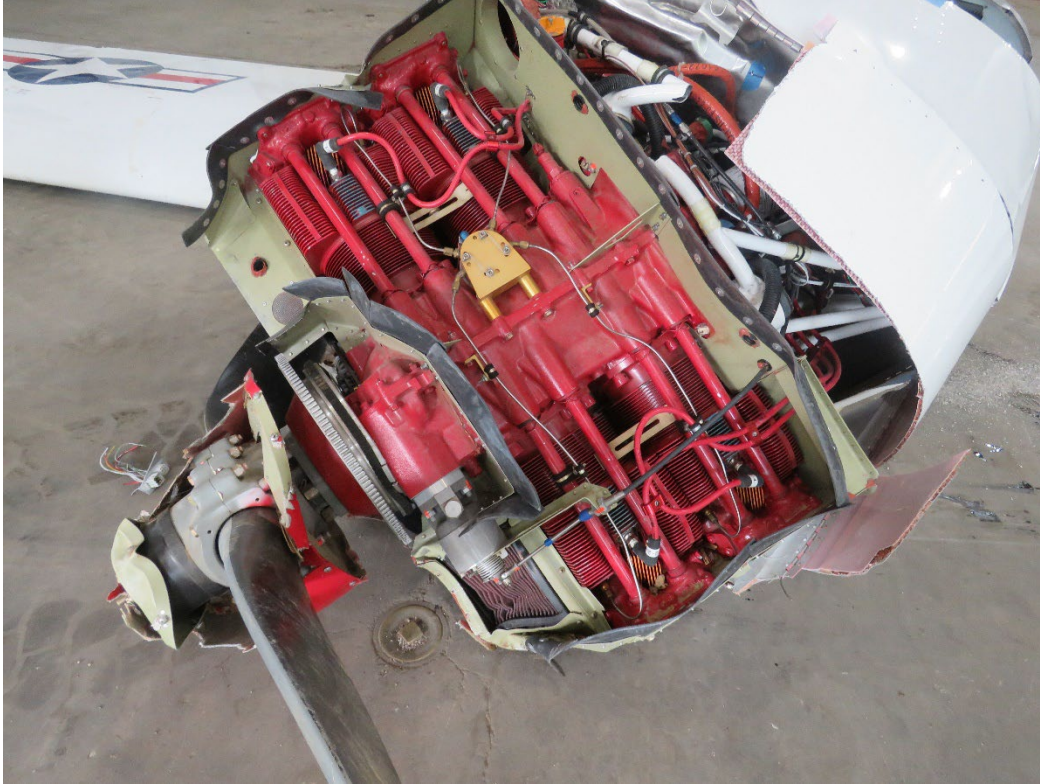
**Photo 38: The engine as found at the recovery facility. (Lycoming Photo)**

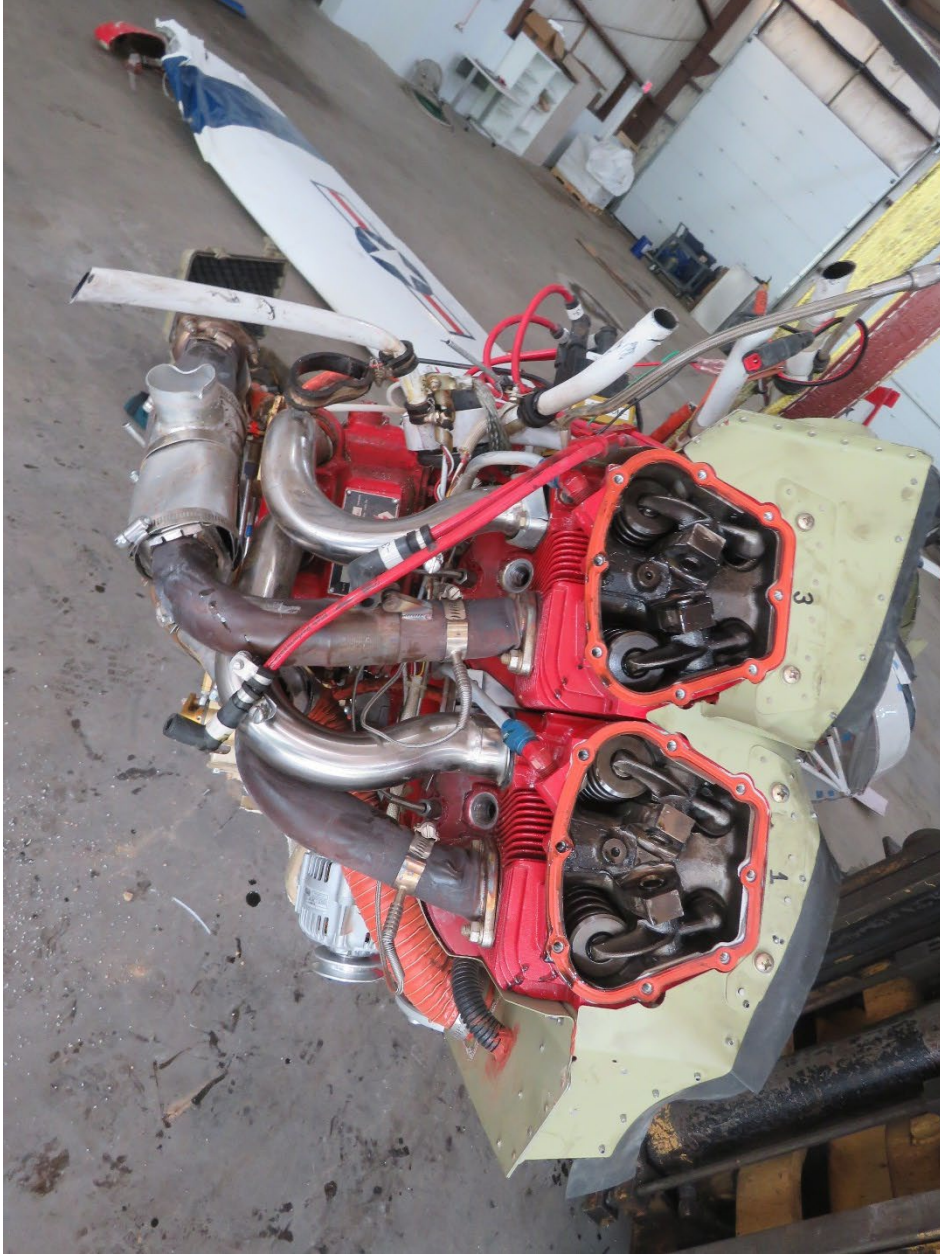
**Photo 39: Engine suspended for examination with rocker covers removed. (Lycoming Photo)**

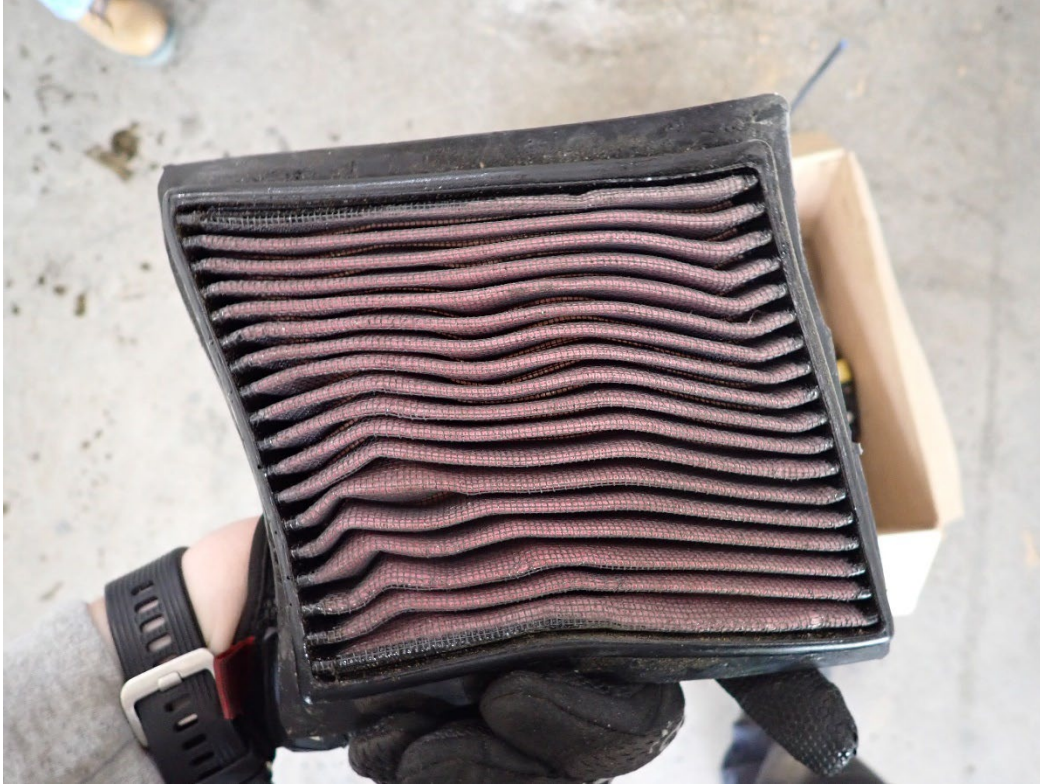
**Photo 40: View of the air intake filter.**

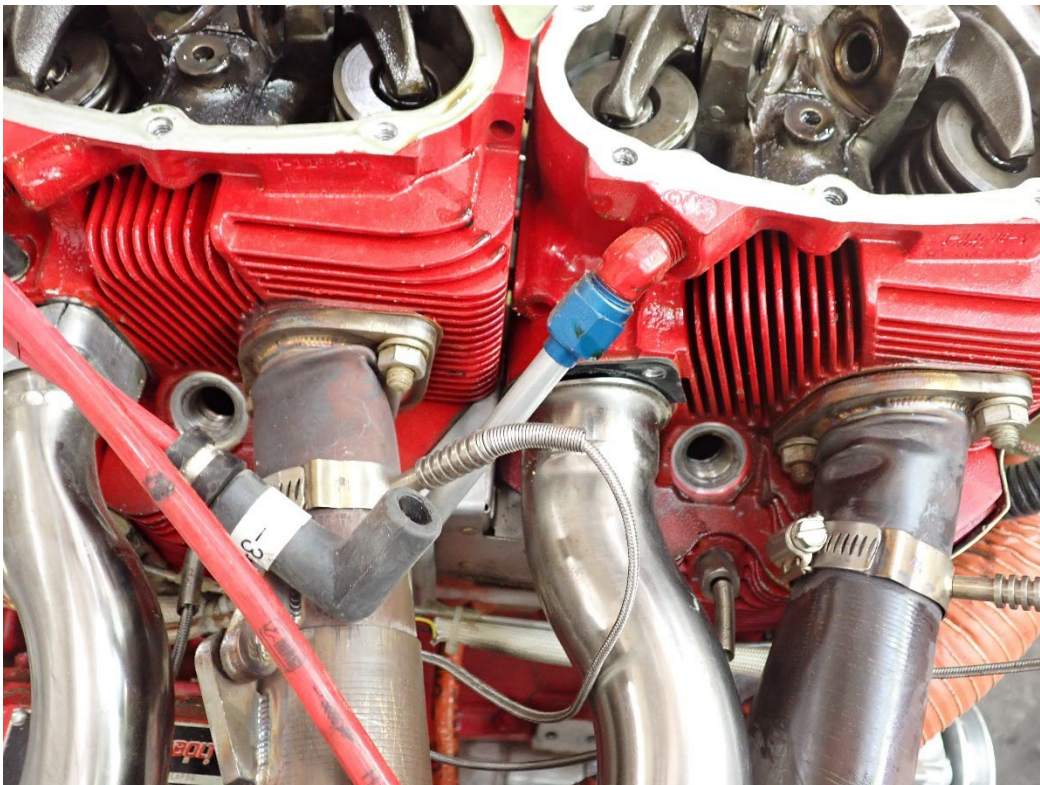
The induction air filter remained secure in the engine baffling and was removed with minimal debris noted. The intake and exhaust pipes exhibited impact damage. The airplane was equipped with exhaust gas temperature sensors. All intake and exhaust valves operated normally when the engine was rotated by hand.

**Photo 41: View of impact damage to the intake and exhaust pipes.**

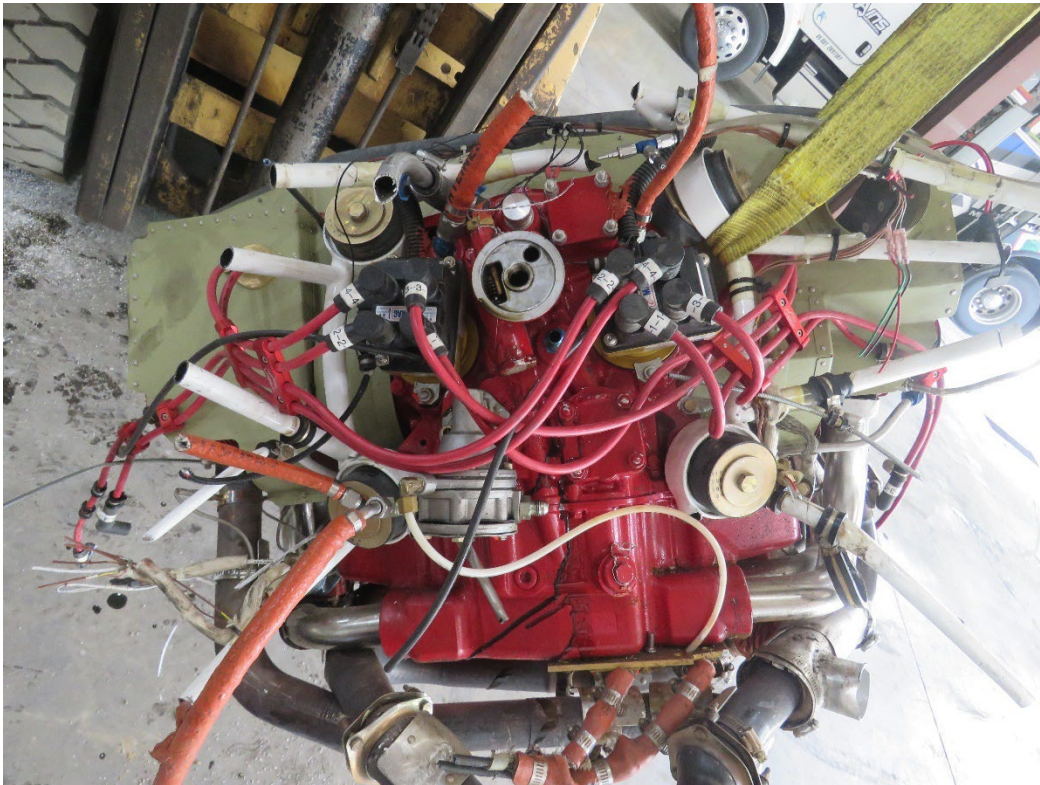
The engine was equipped with two electronic magnetos which remained attached to the engine at all attachment points and were undamaged. The timing of both magnetos was checked and was between 2° and 4° after top dead center which is within the range noted in the E-mag Electronic Ignition installation and operating guide (LC114.28).

**Photo 42: View of the engine accessory case with magnetos attached. (Lycoming Photo)**

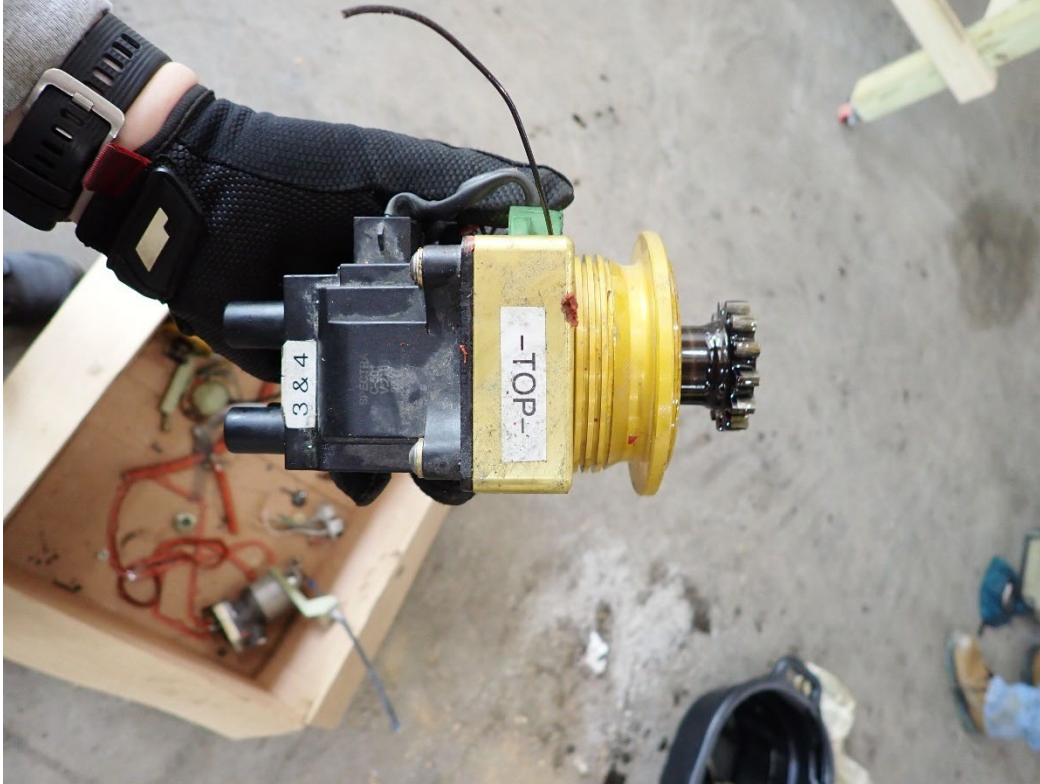
**Photo 43: View of the magneto which powered the top sparkplugs.**

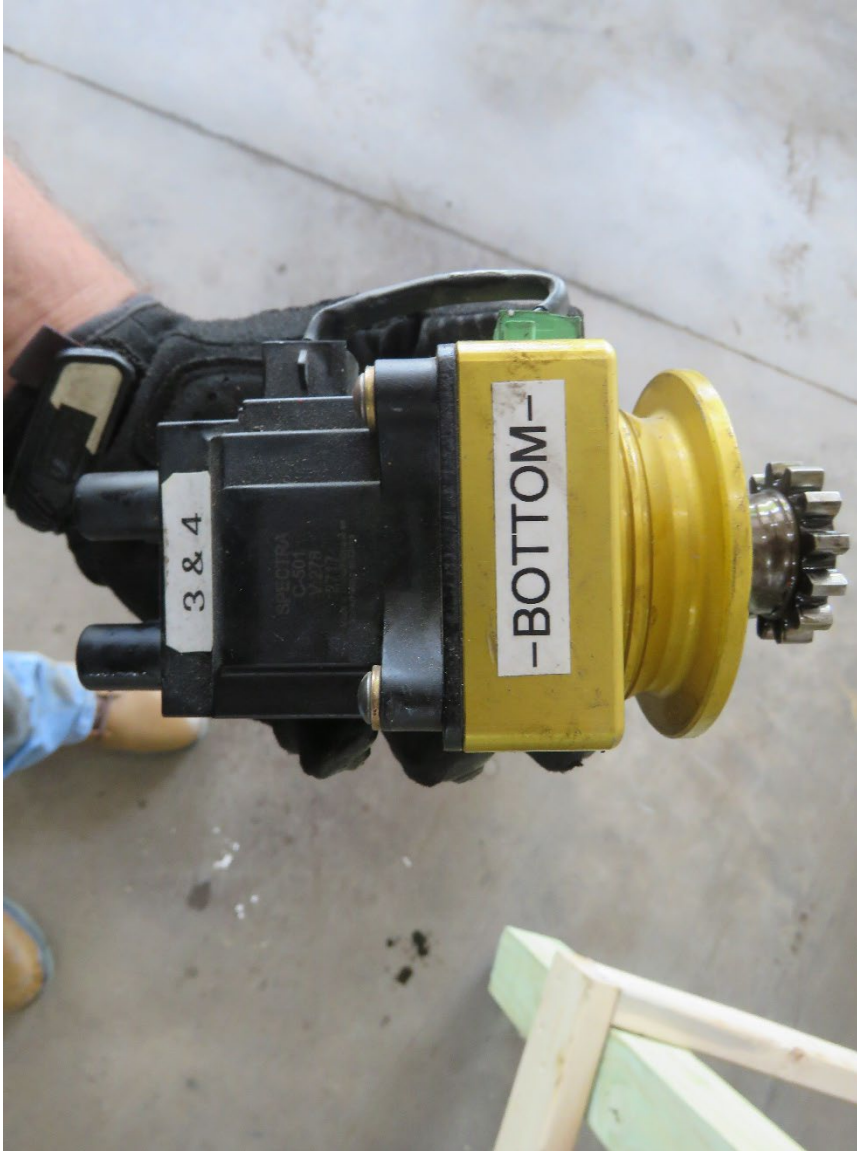
**Photo 44: View of the magneto that powered the bottom sparkplugs. (Lycoming Photo)**

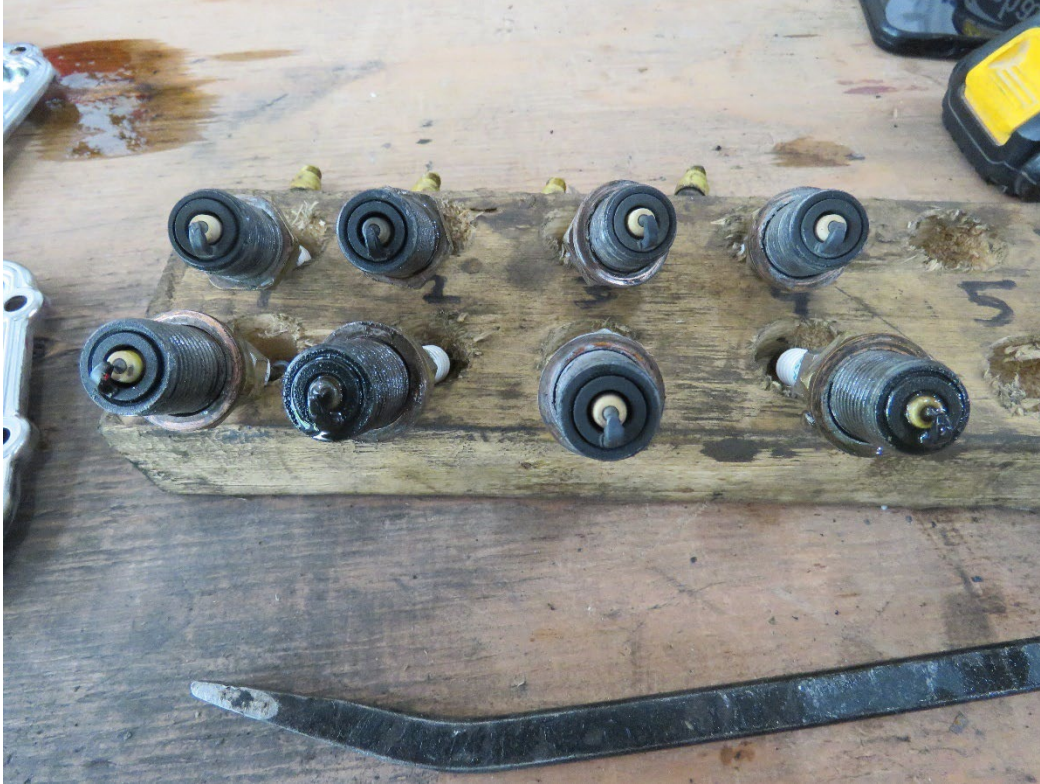
The starter motor remained attached to the engine at all attachment points and was undamaged. The starter flywheel was impact damaged and fractured and was removed to facilitate rotation of the engine. The ignition harness was undamaged and was not tested. The sparkplugs for the top and bottom were an automotive style sparkplug which were removed and examined. The Nos. 2 and 4 bottom sparkplugs were oil soaked due to the engine position after recovery, all other showed normal wear.

**Photo 45: Overview of all sparkplugs. (Lycoming Photo)**

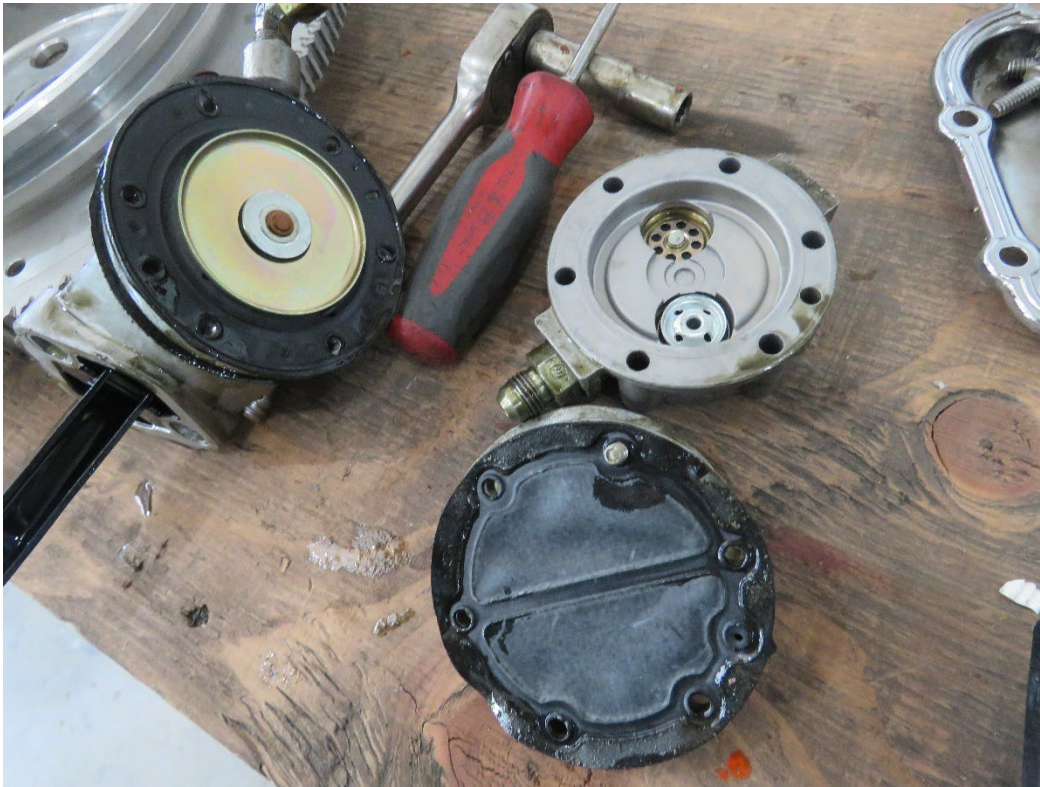
The engine driven diaphragm fuel pump was secured to the accessory housing of the engine and was undamaged. The unit was removed for further investigation and the diaphragms were undamaged.

**Photo 46: Engine driven fuel pump disassembled for examination. (Lycoming Photo)**

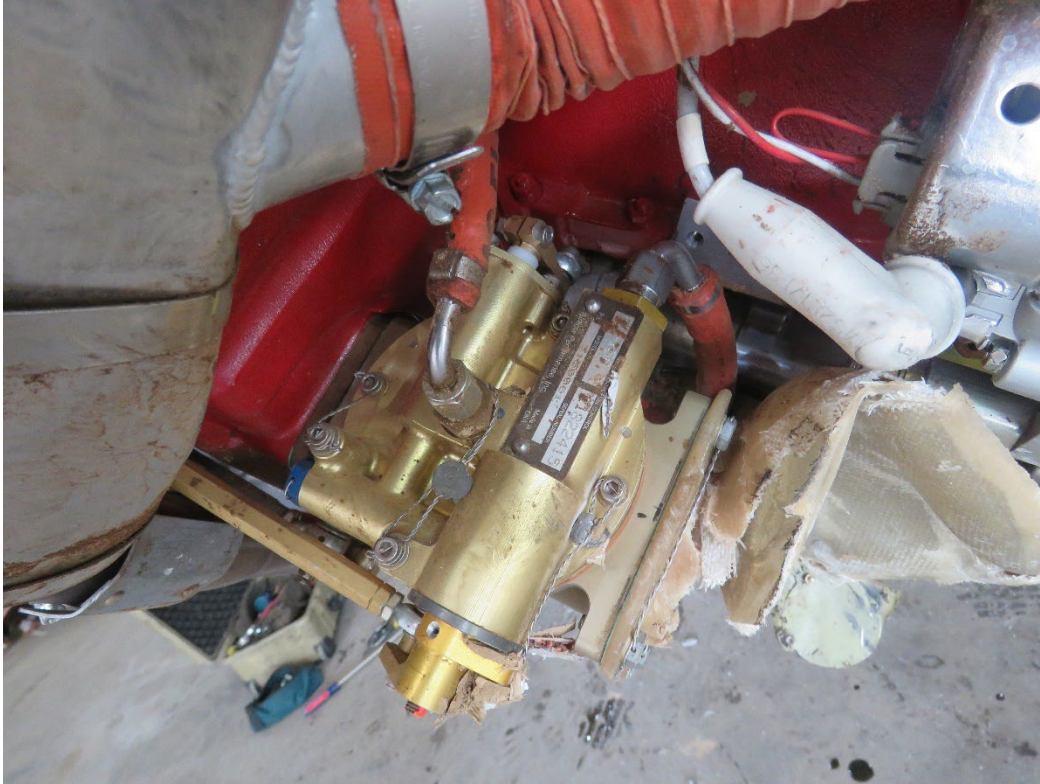
**Photo 47: Fuel injector unit attached to the engine. (Lycoming Photo)**

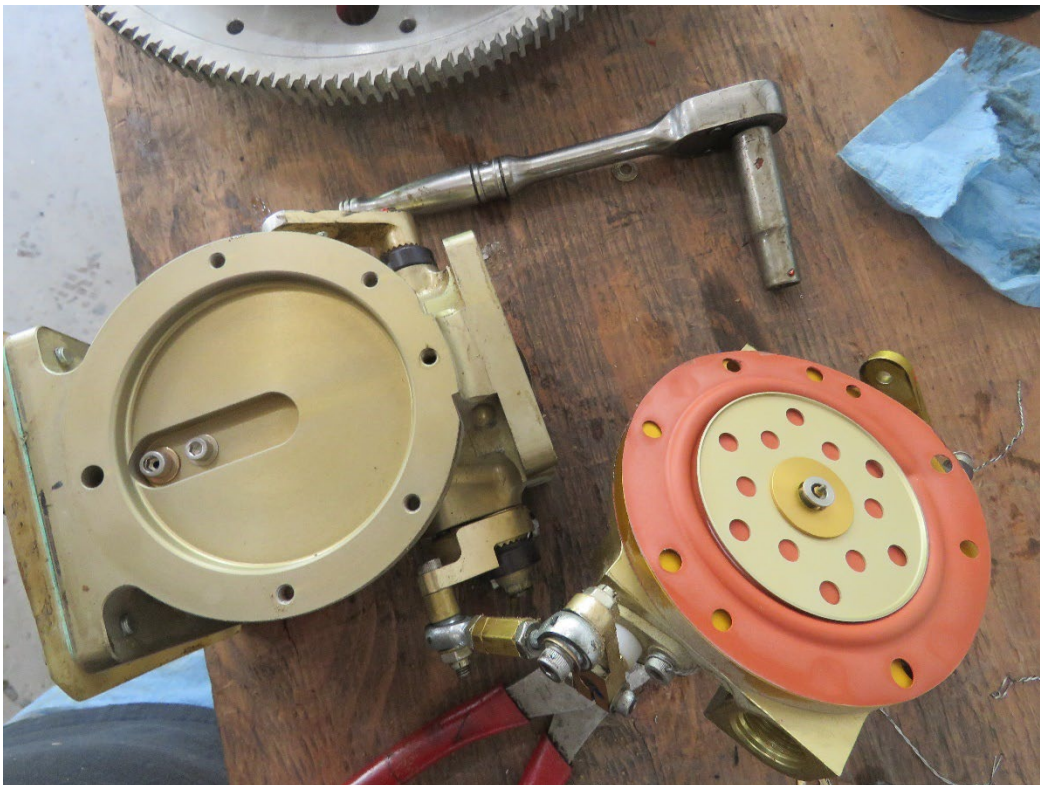
The fuel injector unit remained attached to the bottom of the engine. Organic matter was pushed into the inlet side of the unit from the impact sequence. The throttle and mixture control cables were attached, and continuity of the cables was confirmed to the cockpit controls. The unit was removed for further investigation. The fuel inlet screen had minor contamination. The diaphragms of the injector were intact and undamaged.

**Photo 48: Fuel injector unit disassembled for examination. (Lycoming Photo)**

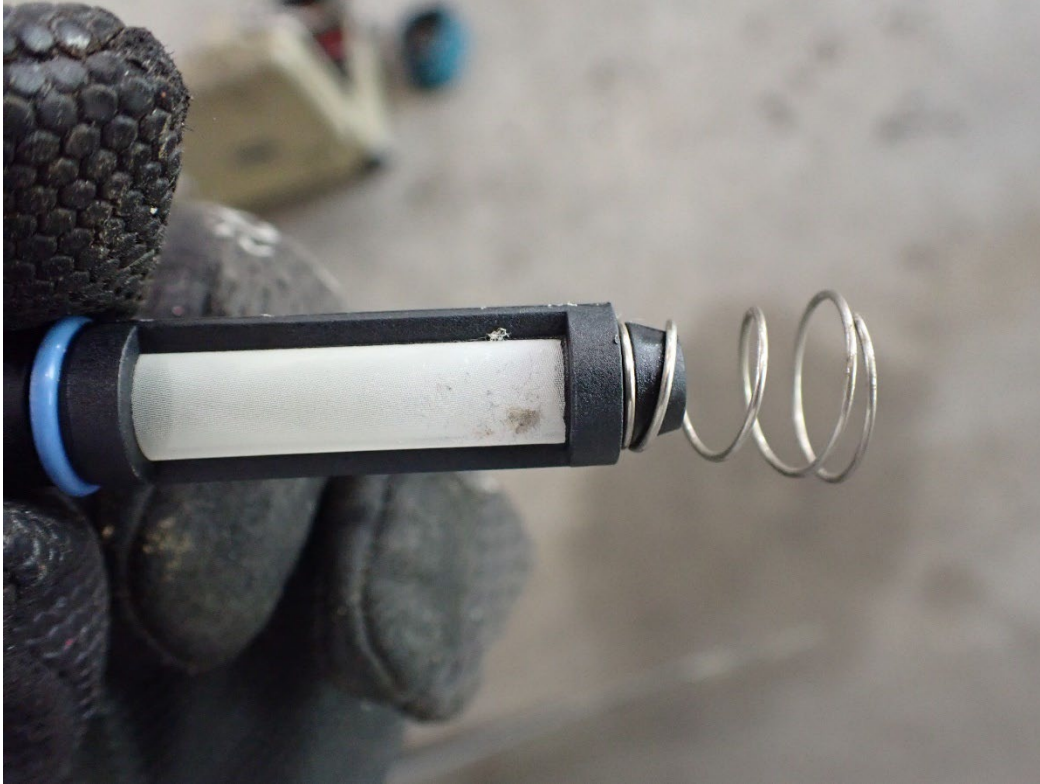
**Photo 49: Fuel inlet screen with minor contamination.**
