# National Transportation Safety Board

ERA23LA195

## **WRECKAGE AND ENGINE EXAMINATION**

Location: Fallston, MD  
Date: April 13, 2023  
Time: 1515 EDT  
1915 UTC  
Airplane: N412RS; RV-14A

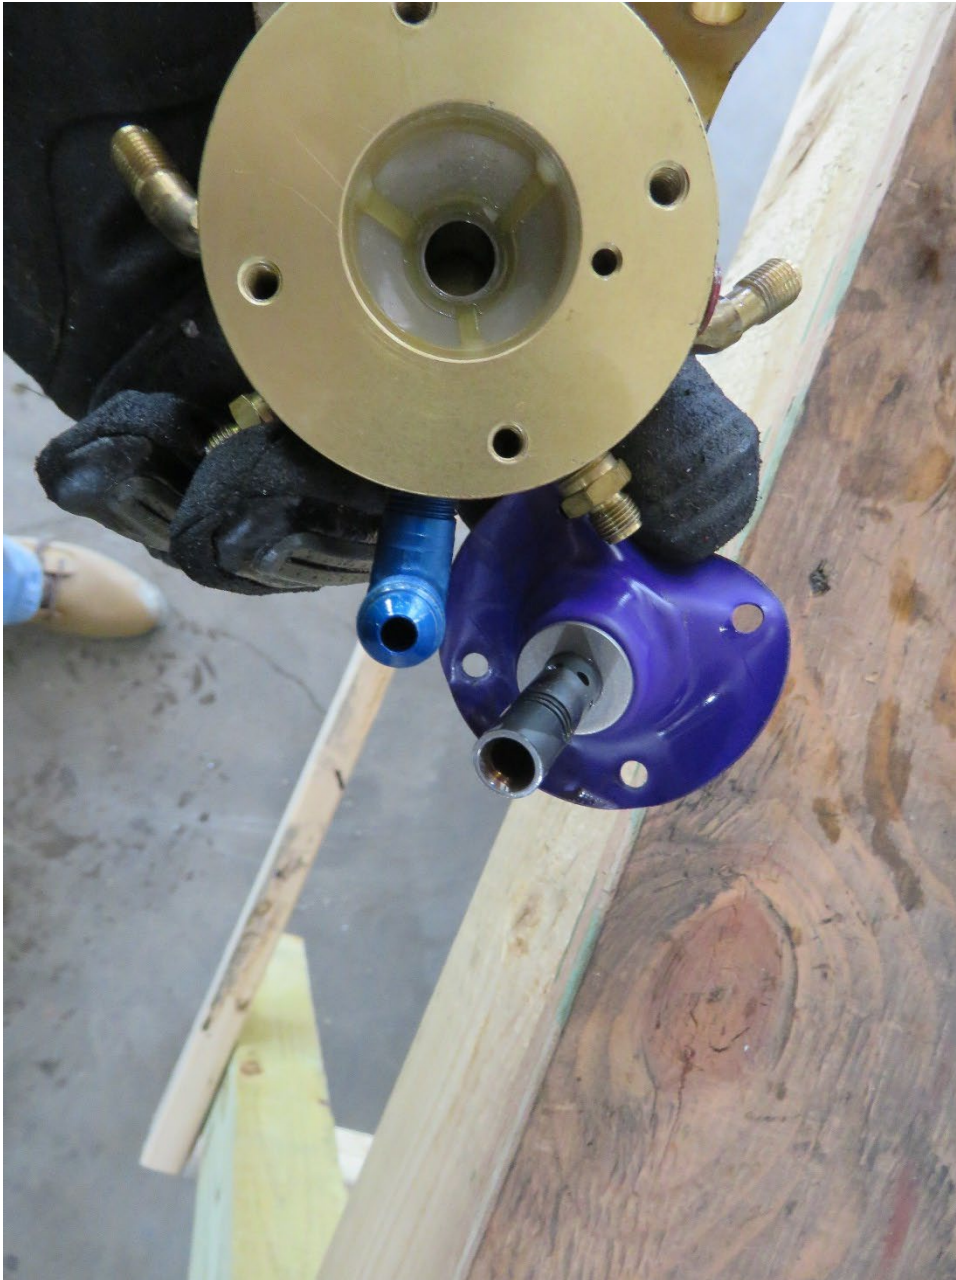
The fuel flow divider remained installed on the top of the engine and was undamaged. The unit was opened for further analysis. Liquid fuel was found in the unit and the diaphragm was undamaged.

**Photo 50: Fuel flow divider removed and disassembled for examination. (Lycoming Photo)**

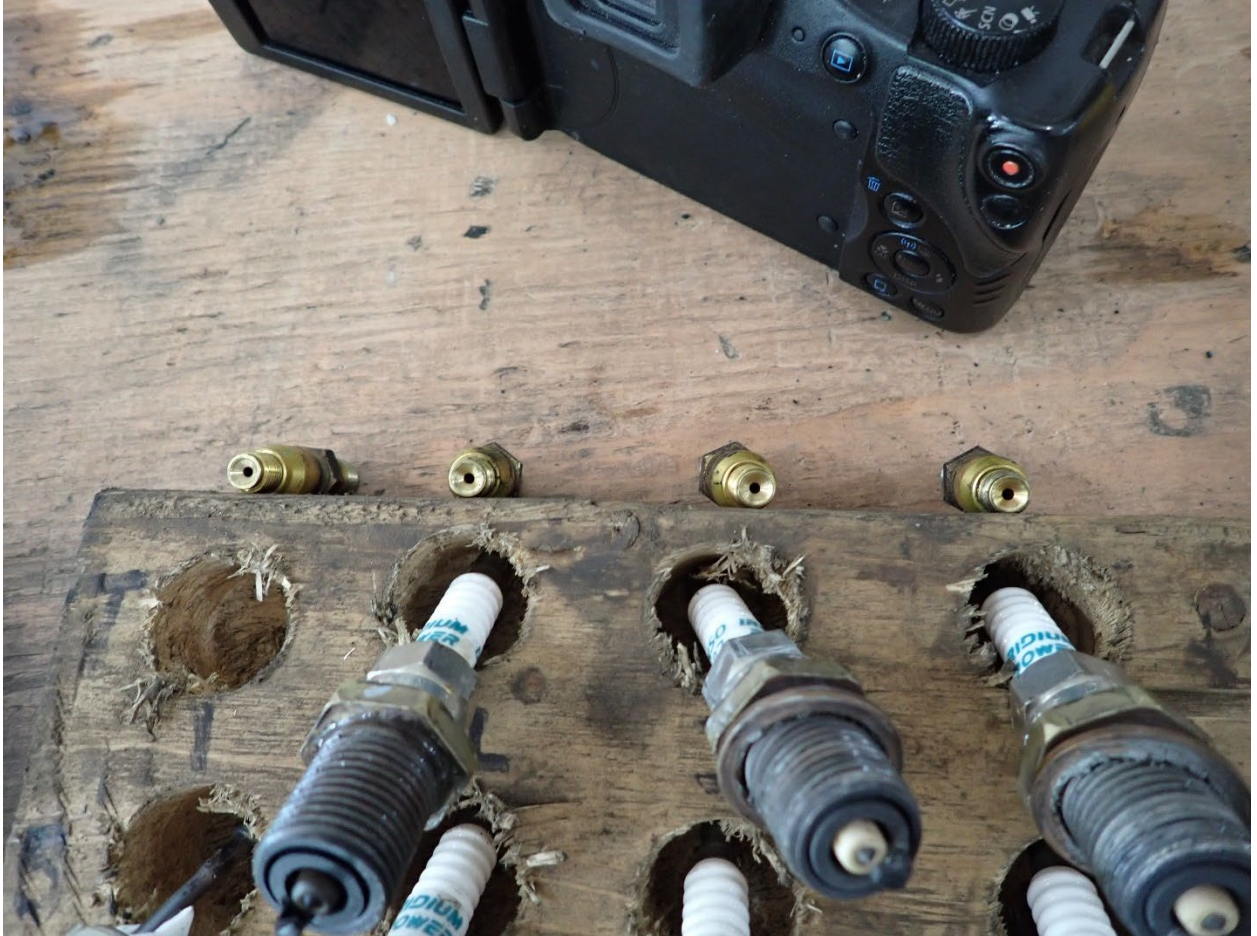
The fuel nozzles were secured into their respective cylinder heads. They were removed for further investigation and all four nozzles were unobstructed.

**Photo 51: Fuel injector nozzles removed for examination.**

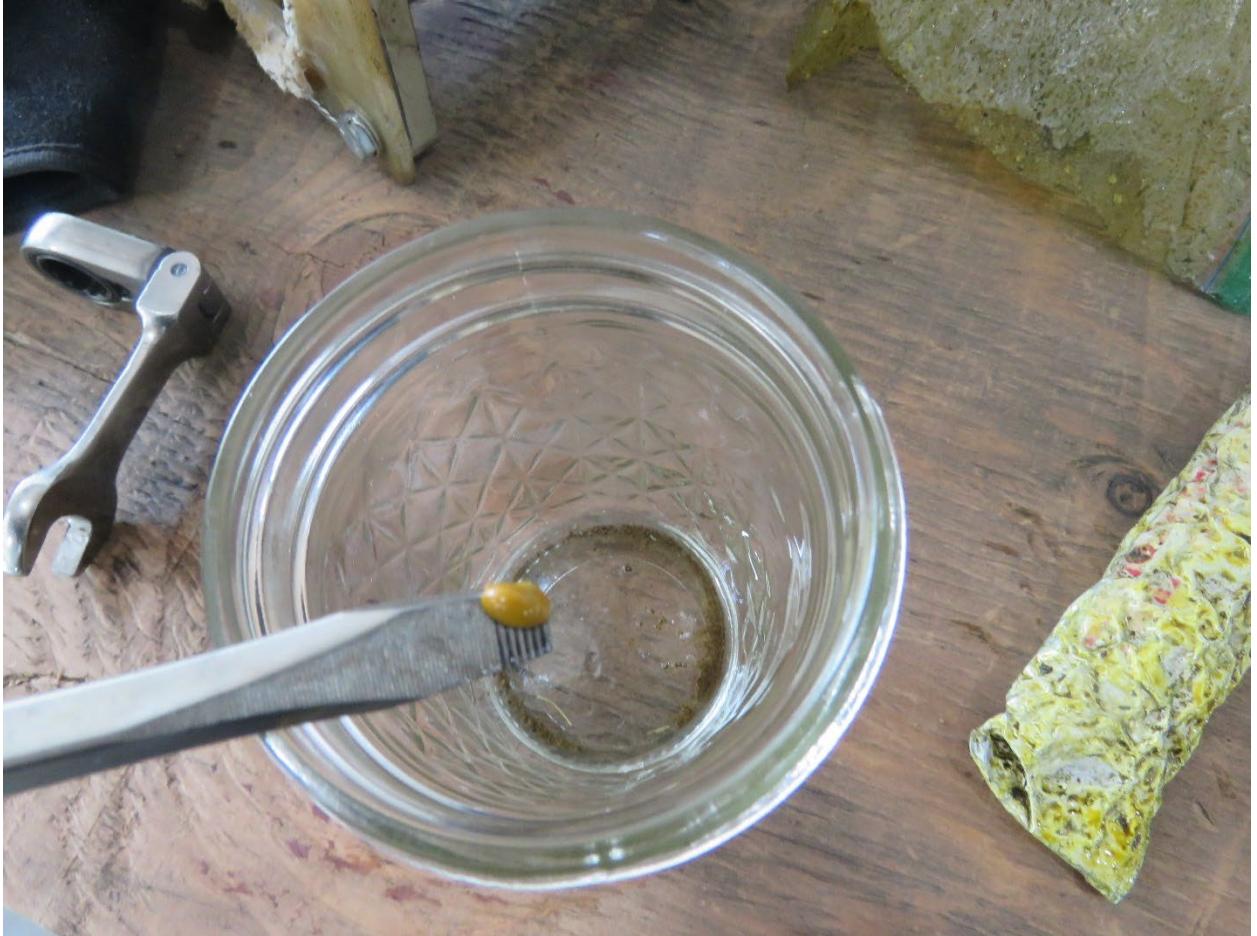
injector unit and tested with a water finding paste, no evidence of water was found.

**Photo 52: Fuel from the fuel injector unit with water test paste. (Lycoming Photo)**

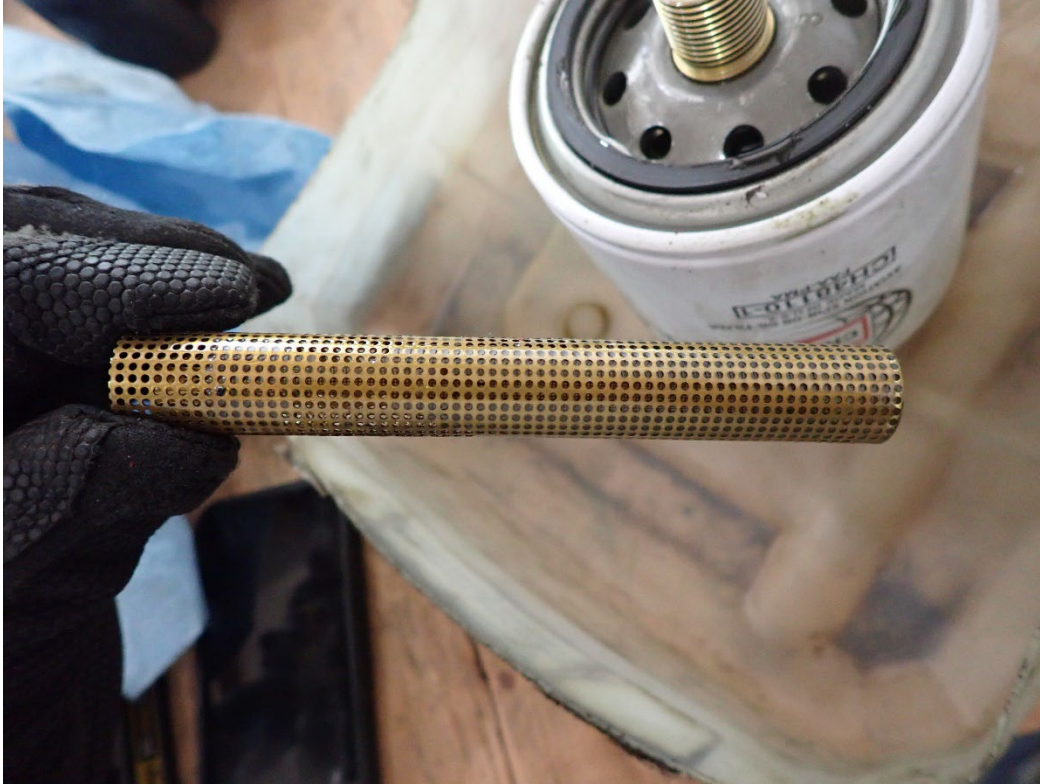
**Photo 53: Oil suction screen free of debris.**

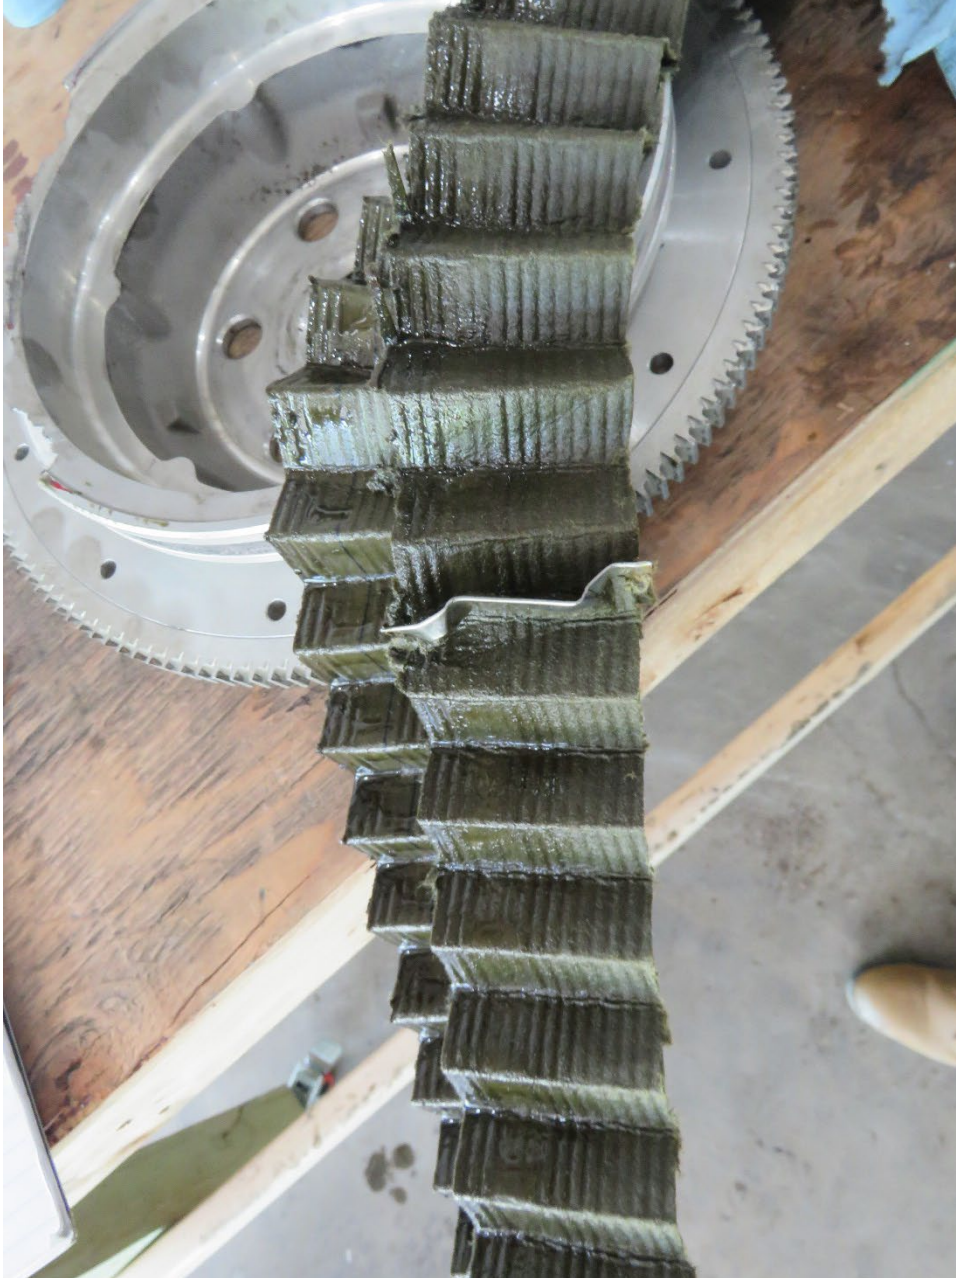
**Photo 54: Oil filter pleats free of debris. (Lycoming Photo)**

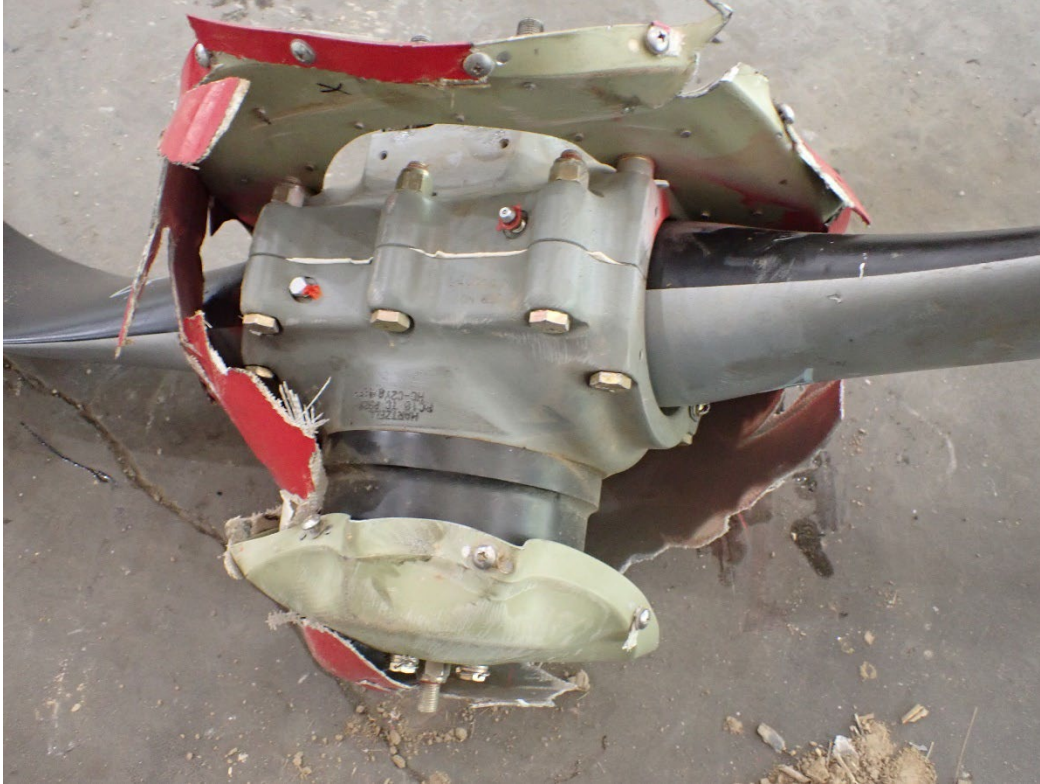
The airplane was equipped with a Hartzell controllable pitch propeller, HC-C2YR-1BFP. The spinner was impact crushed aft and fractured. The propeller remained attached to the crankshaft flange at all attachment points and was removed to facilitate examination of the engine. The propeller governor was removed from the engine and the governor gasket screen was clear of debris, the governor pumped oil when operated by hand.

**Photo 55: Propeller spinner and hub.**

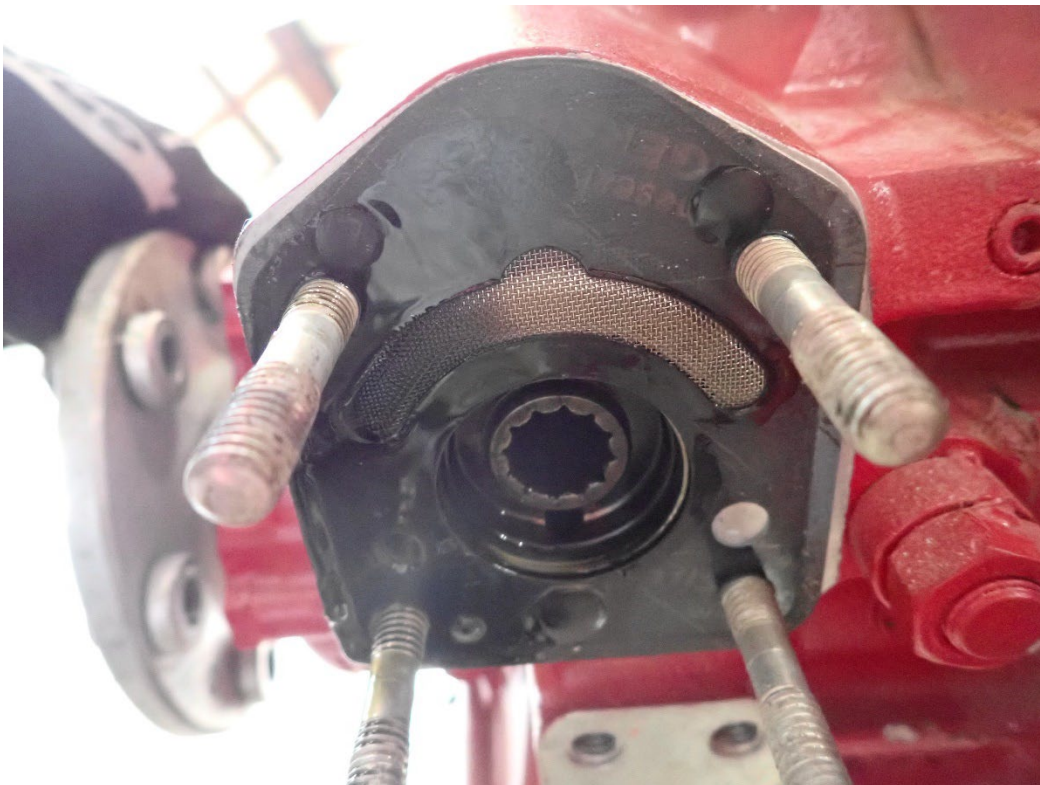
**Photo 56: Propeller governor gasket screen free of debris.**

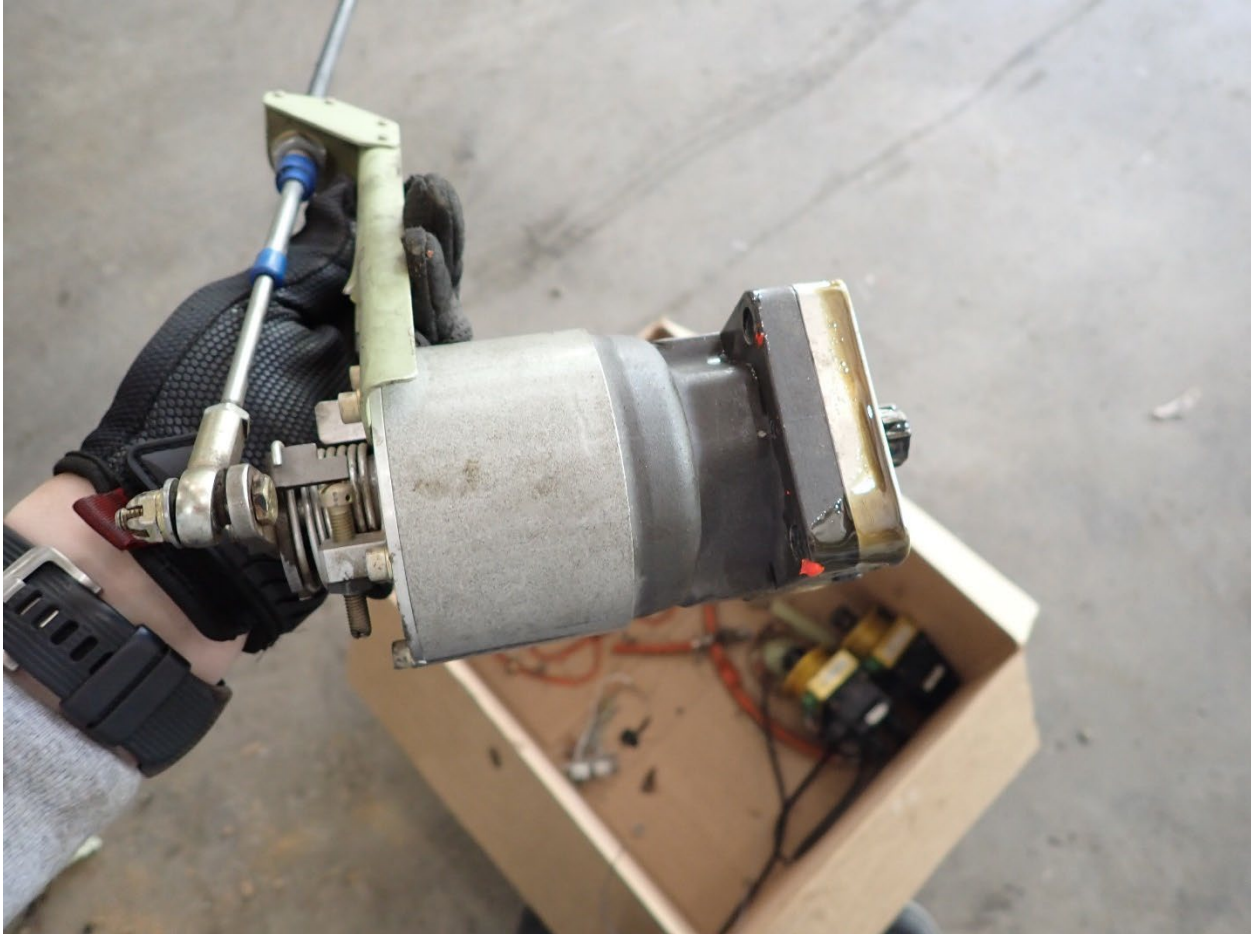
**Photo 57: Propeller governor removed for examination.**

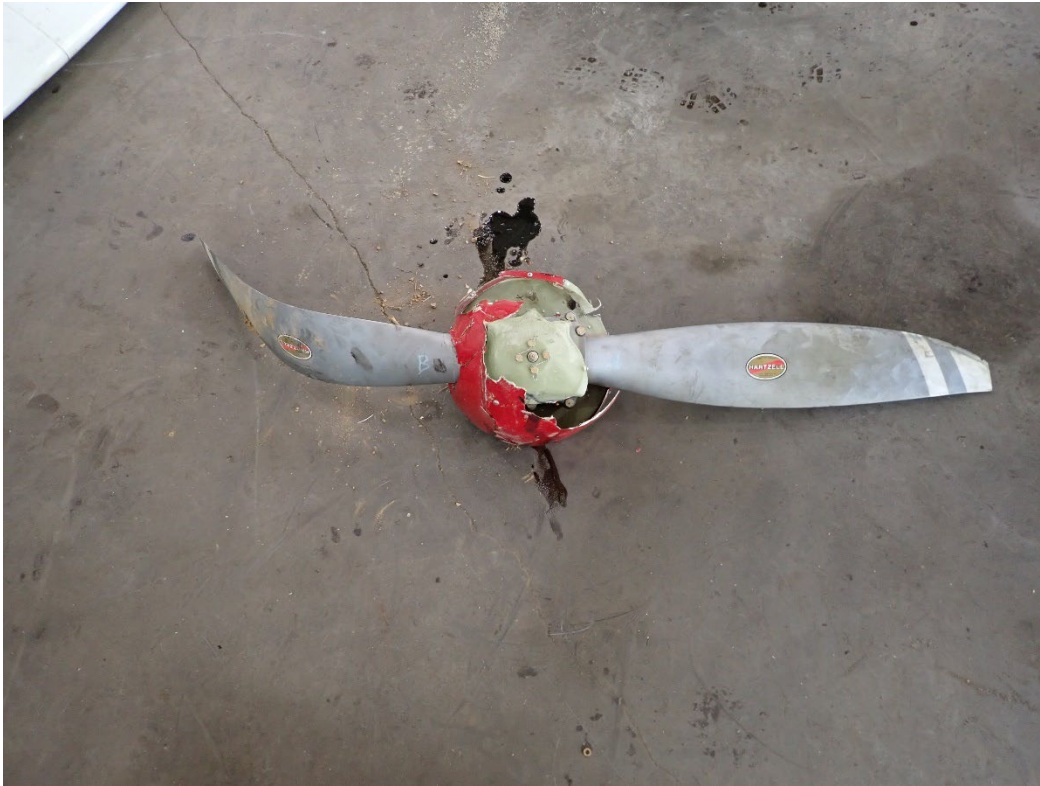
**Photo 58: Overview of the propeller.**

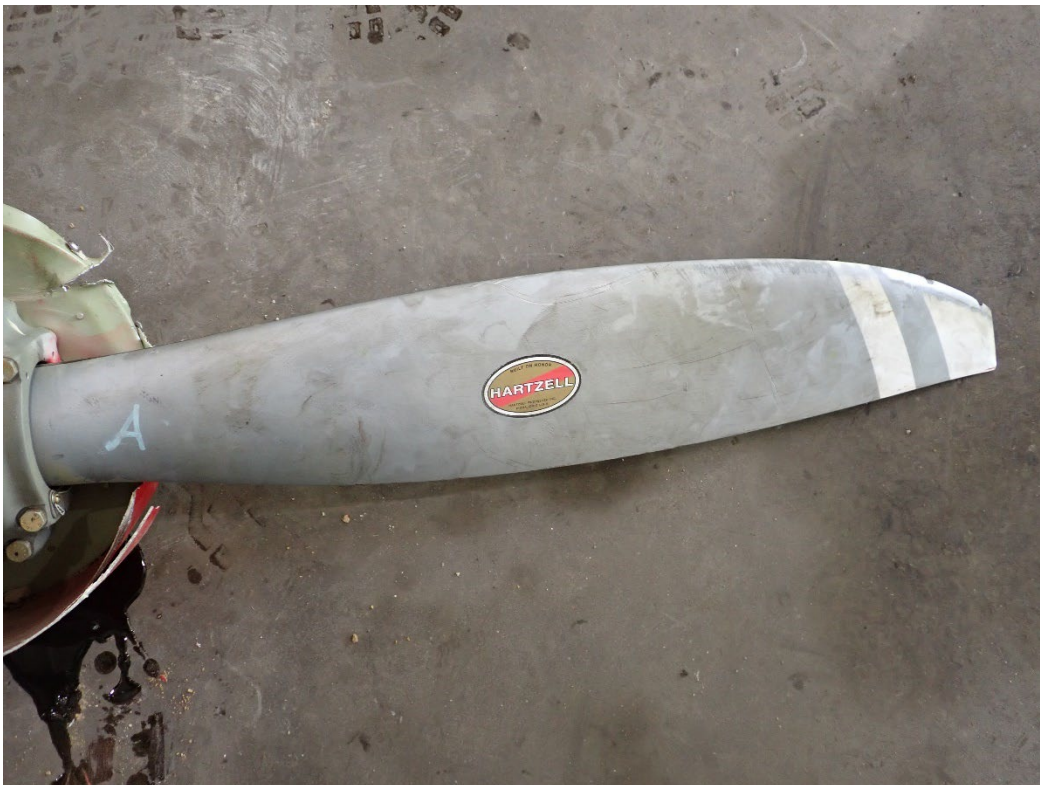
**Photo 59: Overview of blade A.**

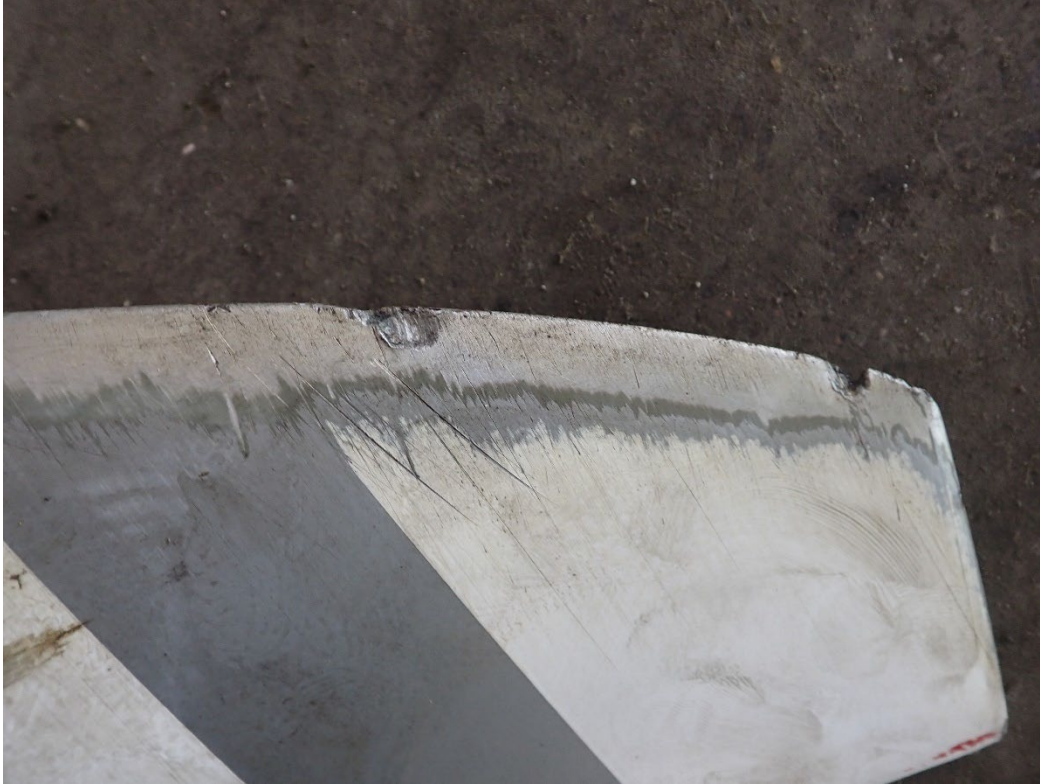
The blades of the propeller were marked arbitrarily with an A and B for identification throughout the examination and will be referred to as such. Blade A remained straight and could be rotated in the hub by hand. It exhibited leading edge gouging and polishing near the tip. Blade A also exhibited chordwise and longitudinal scratching. Blade B was able to be rotated by hand in the hub and was bent aft about 45° at the midspan. Blade B exhibited leading edge gouging and polishing. It also exhibited chordwise and longitudinal scratching.

**Photo 60: Blade A leading edge gouging, polishing and chordwise scratching.**

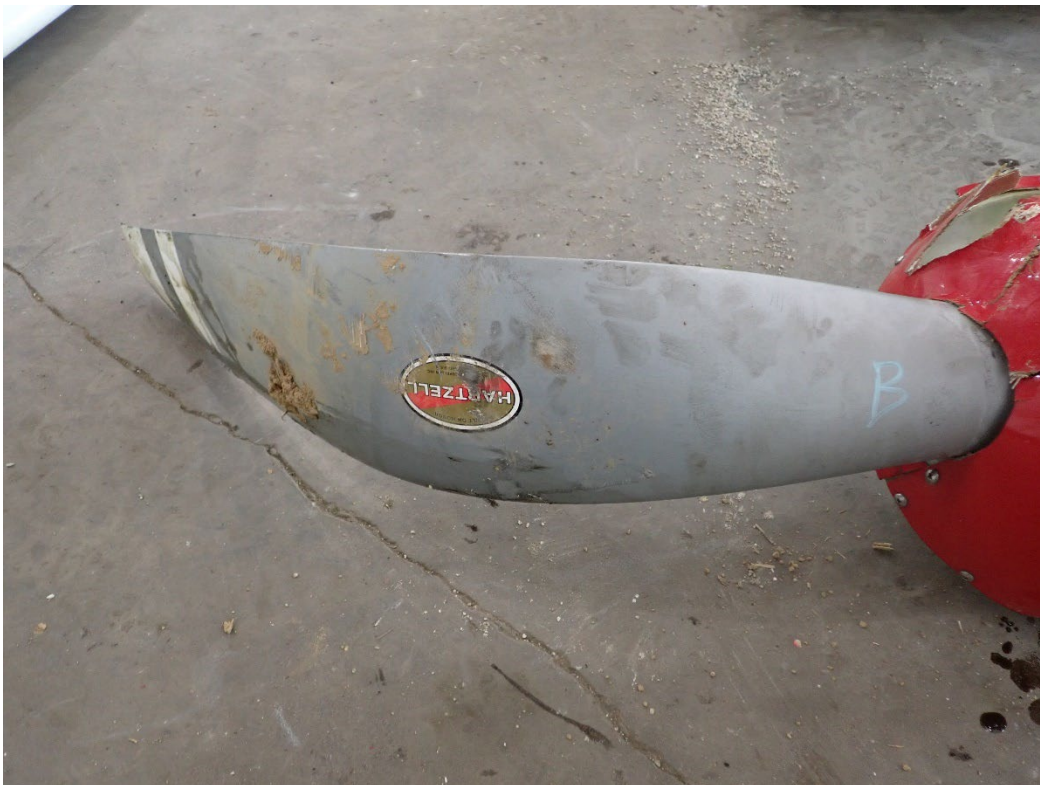
**Photo 61: Overview of blade B.**

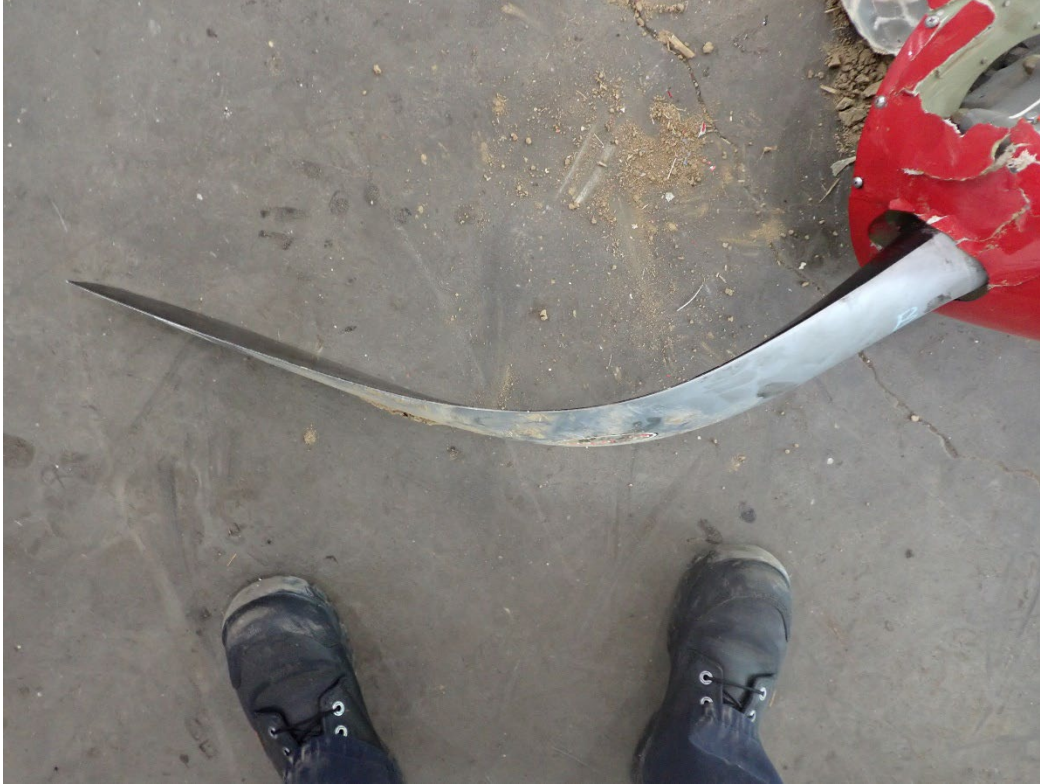
**Photo 62: View of the bend in blade B.**

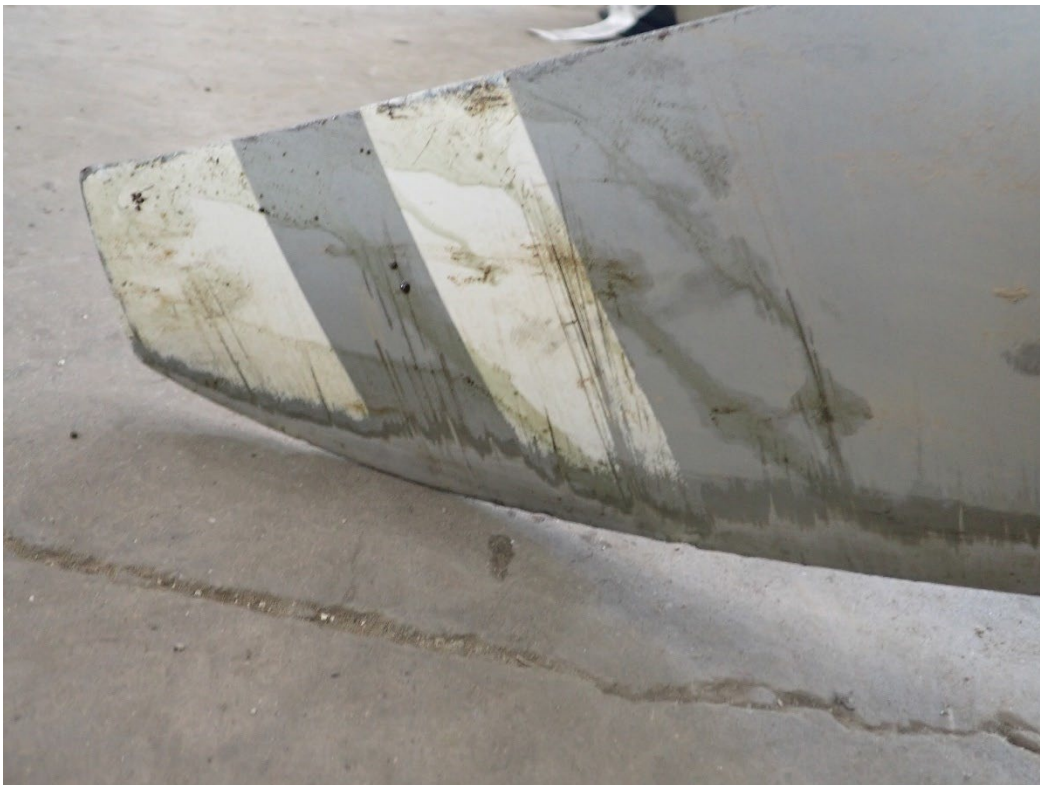
**Photo 63: Blade B leading edge polishing, gouging and chordwise scratching.**
