**NTSB ERA23LA196**

N5400S, ICP SRL Savannah S

Photo Array

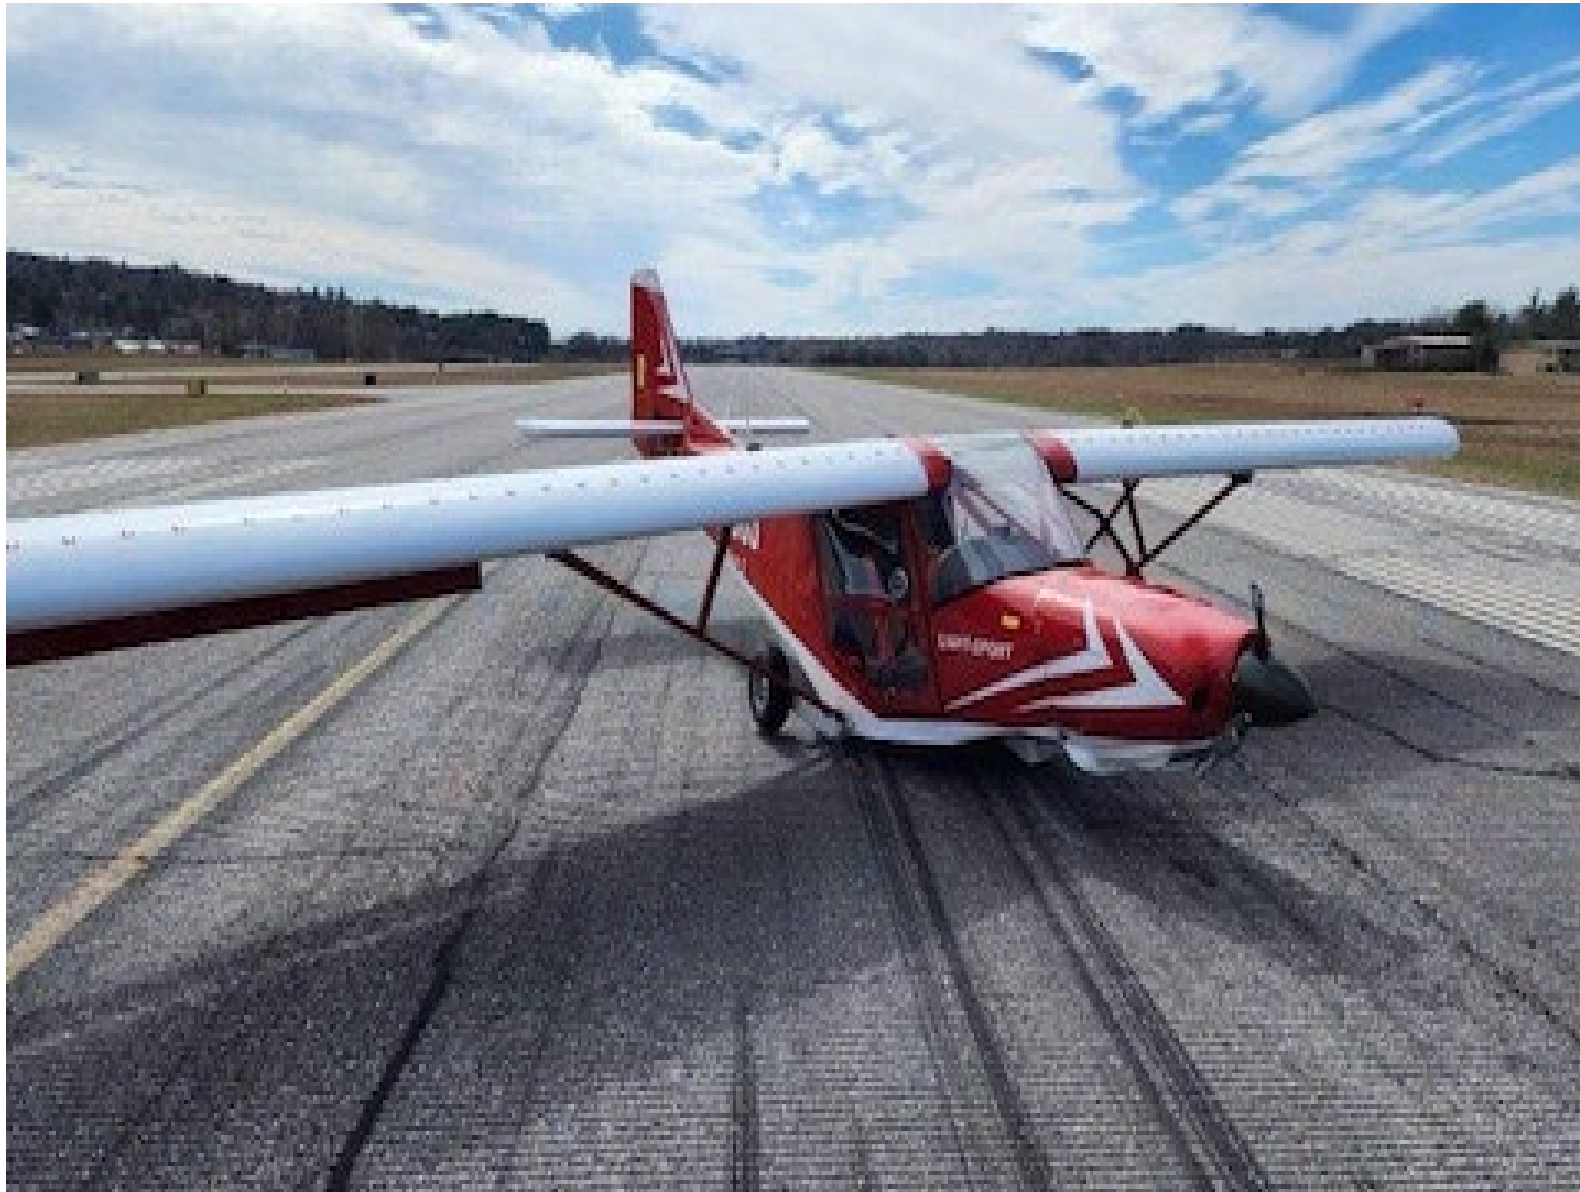
Photo 1: Overview of the airplane at the accident site (Pilot Photo)

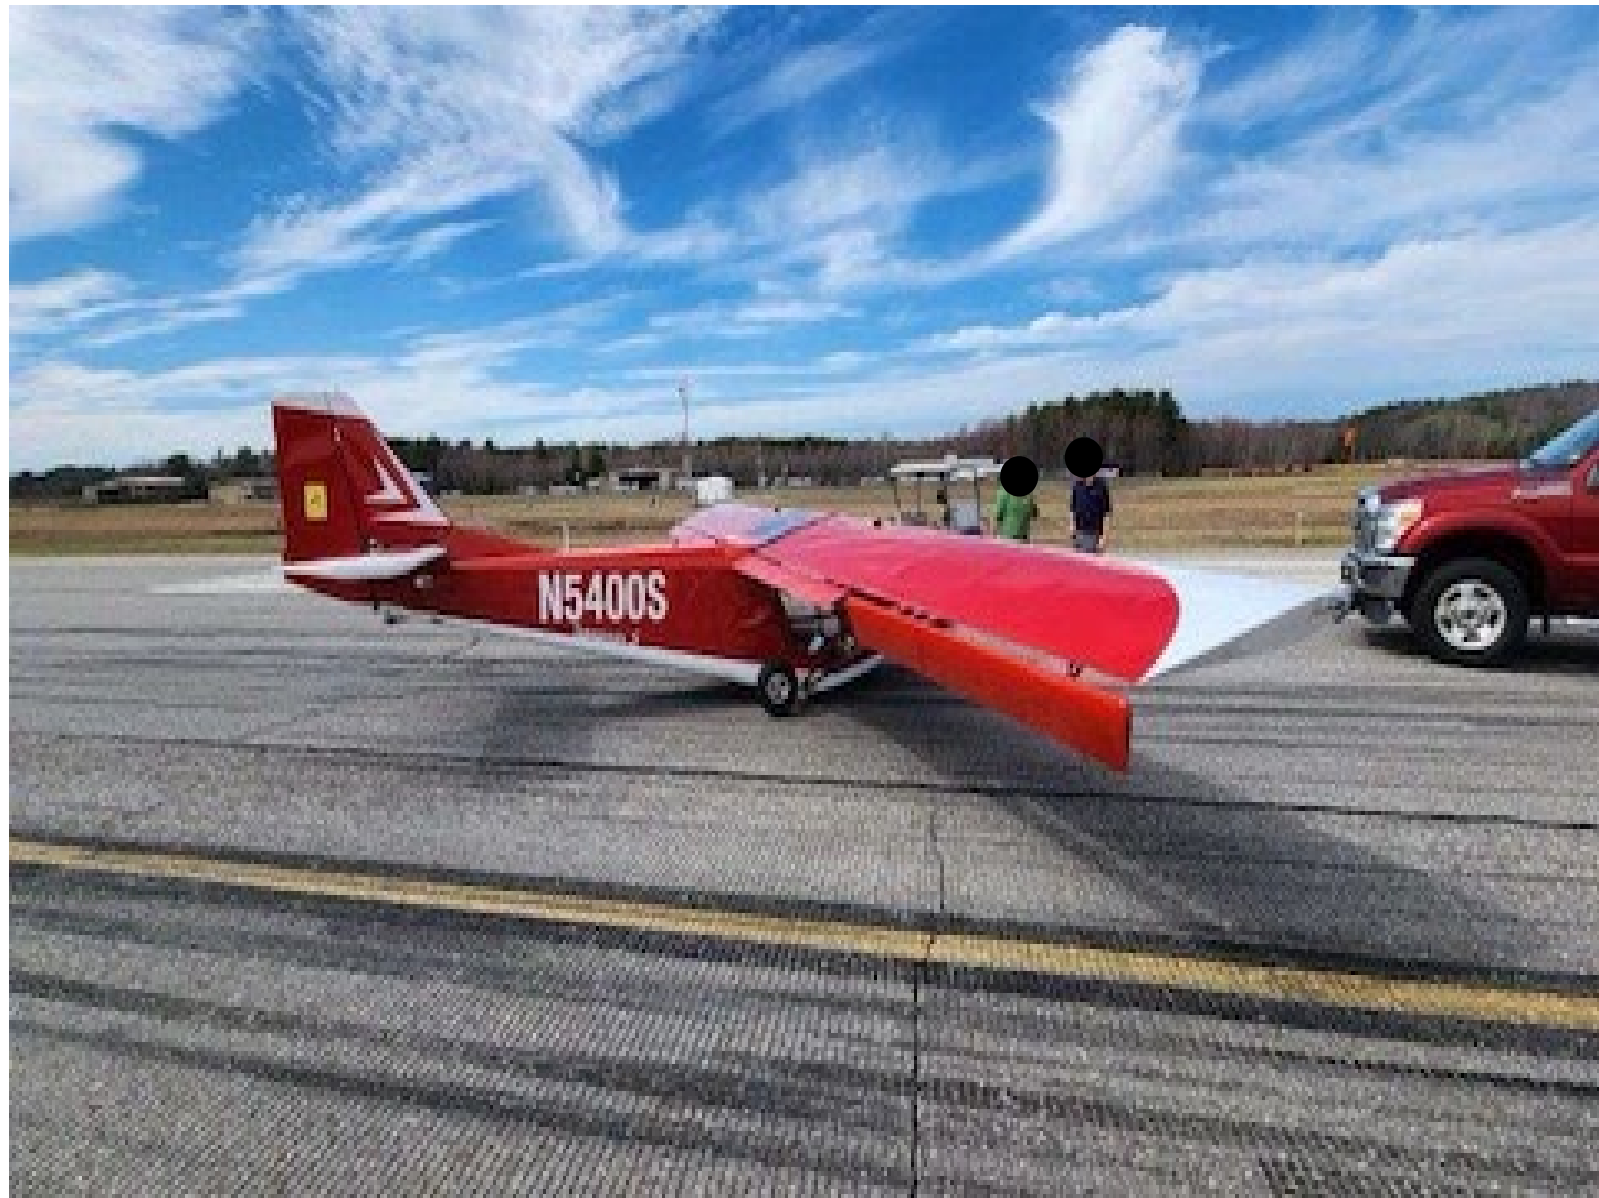
Photo 2: Overview of the right wing at the accident site (Pilot Photo)

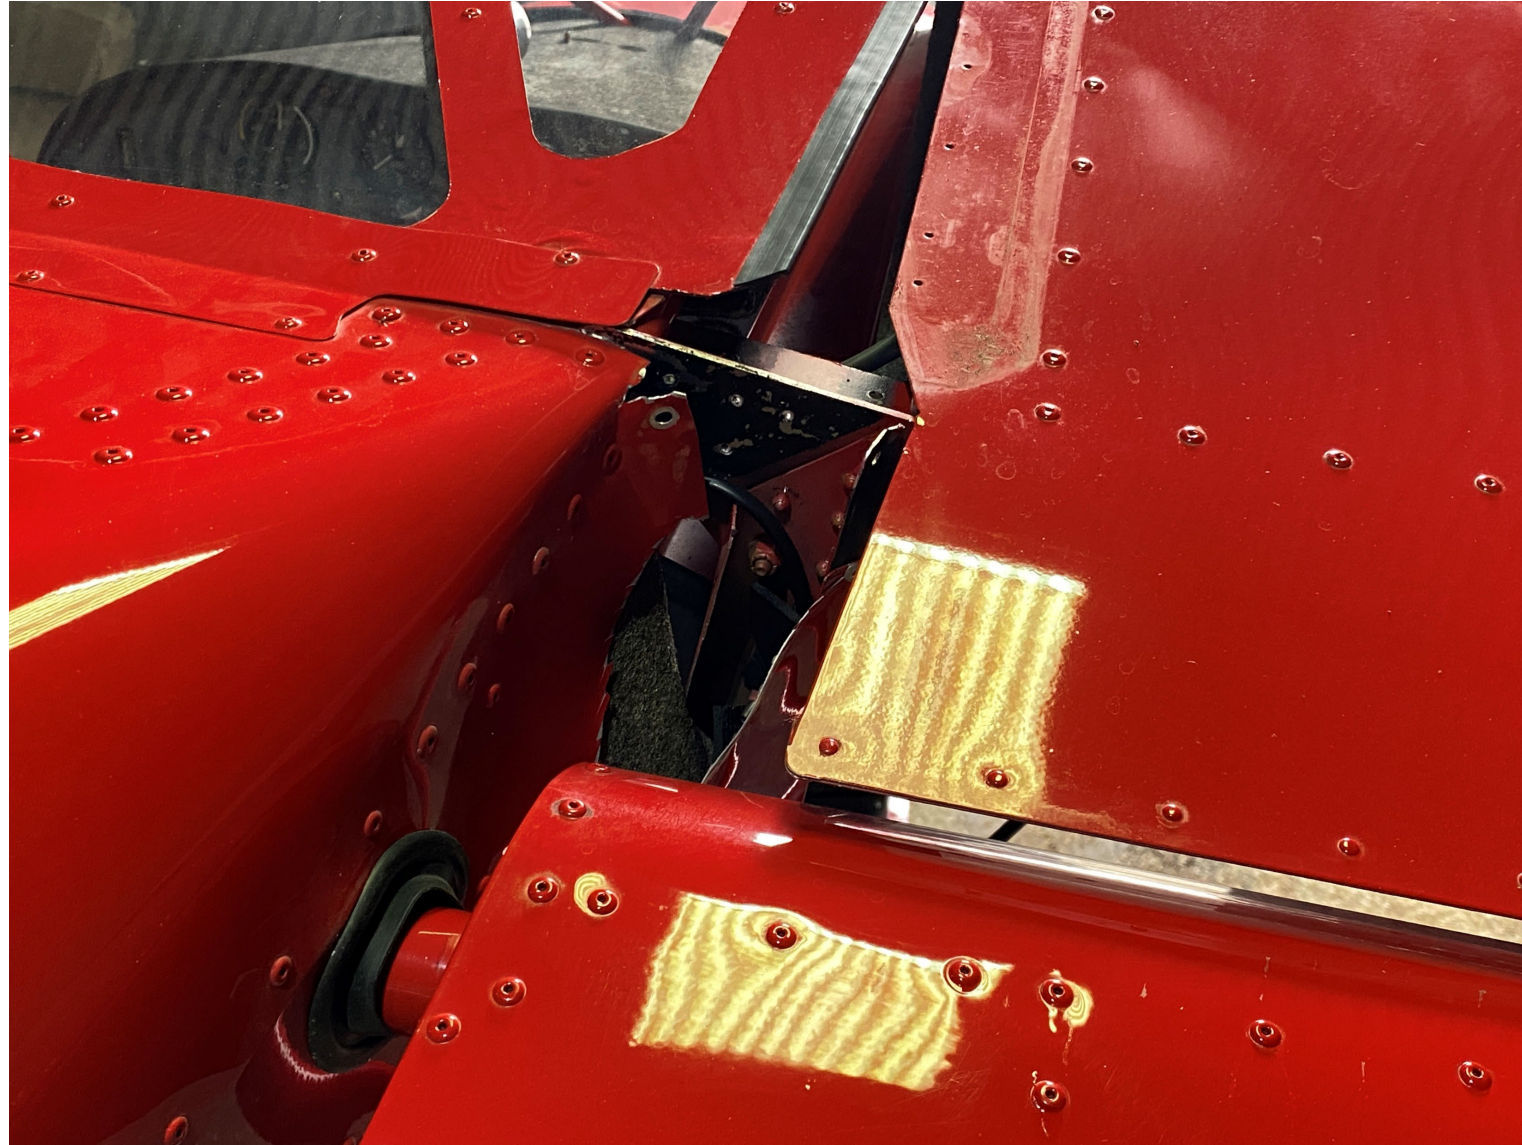
Photo 3: View of the damage to the right wing and fuselage (Photo Courtesy of FAA)

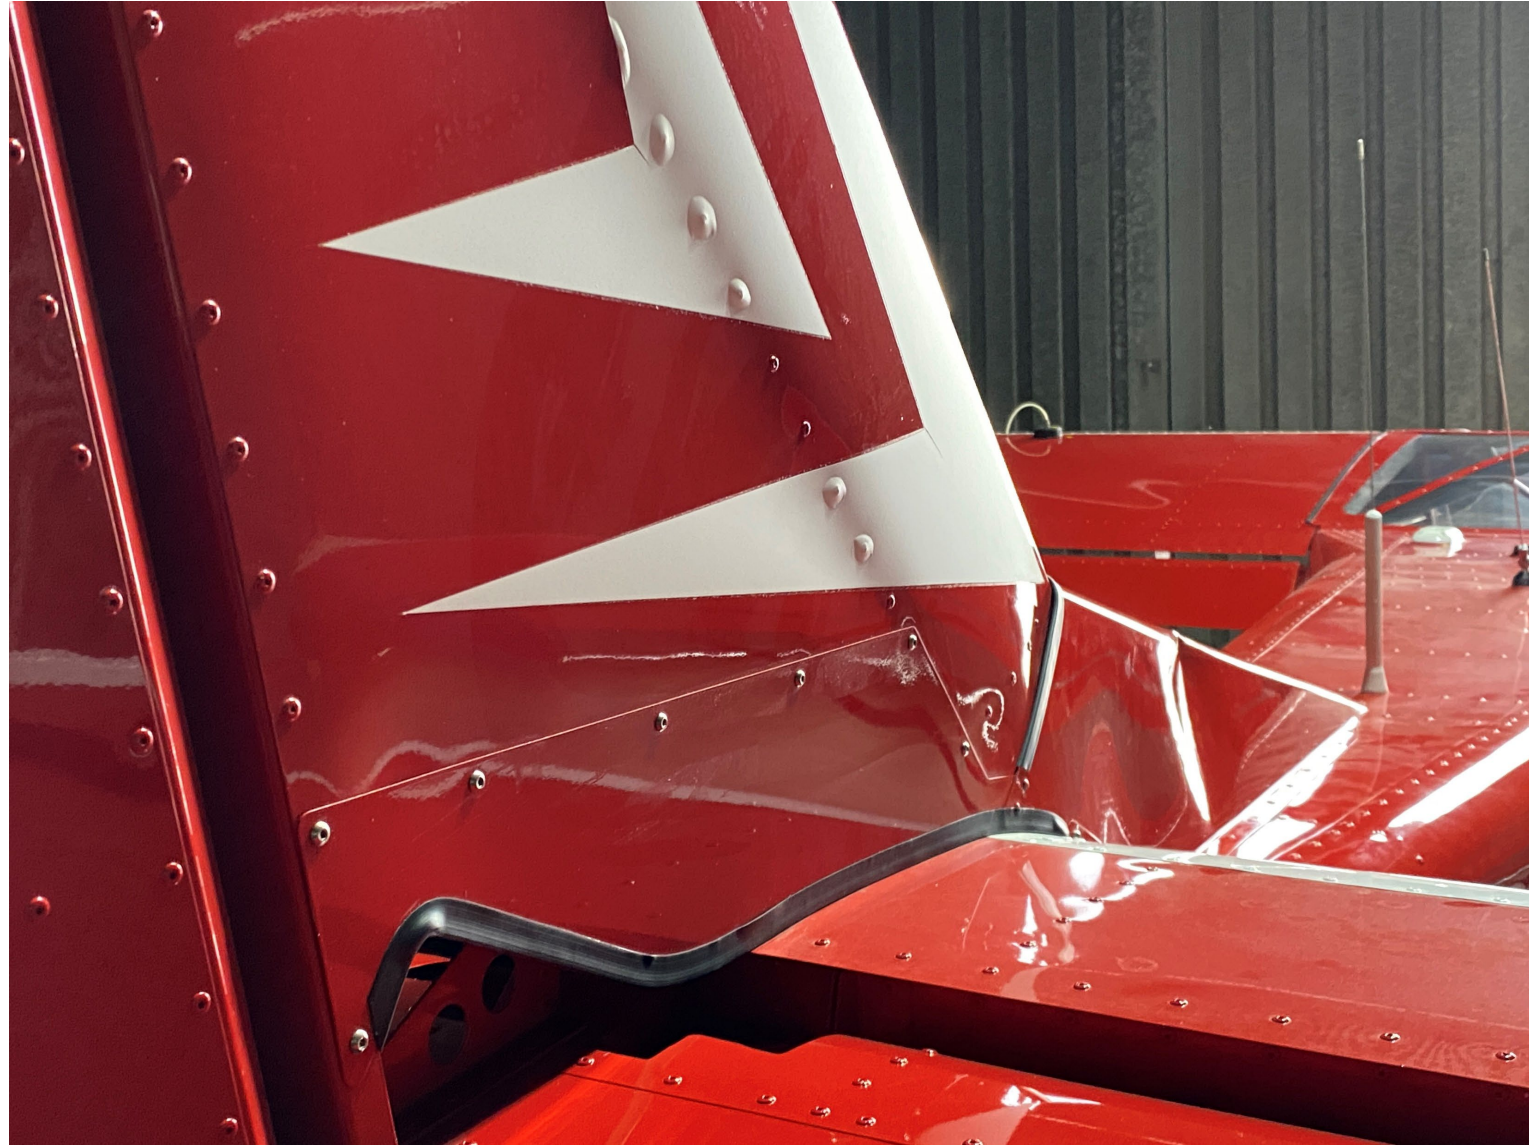
Photo 3: View of damage to the vertical stabilizer (Photo Courtesy of FAA)
