ERA23LA198

## INVESTIGATION PHOTOGRAPHS

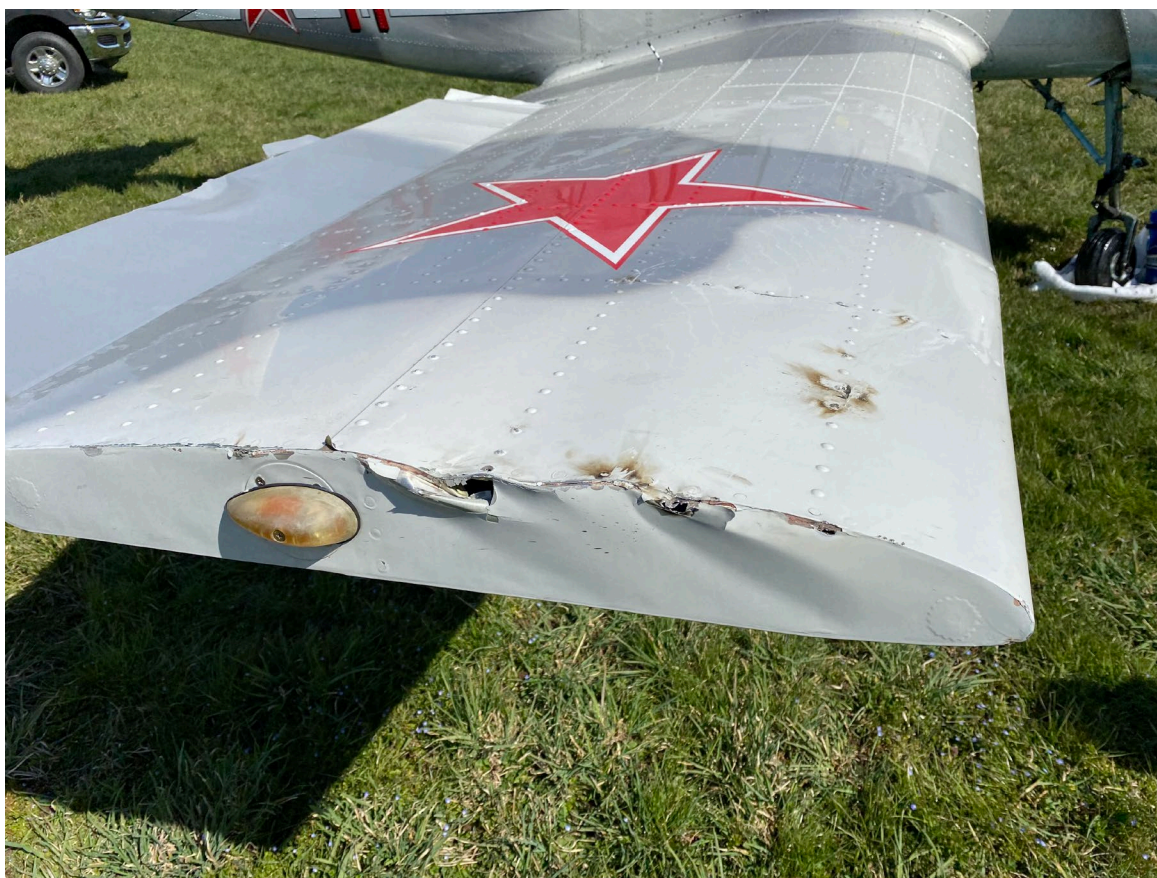
**Photograph 1 - View of damage to the right wingtip (Courtesy of FAA)**

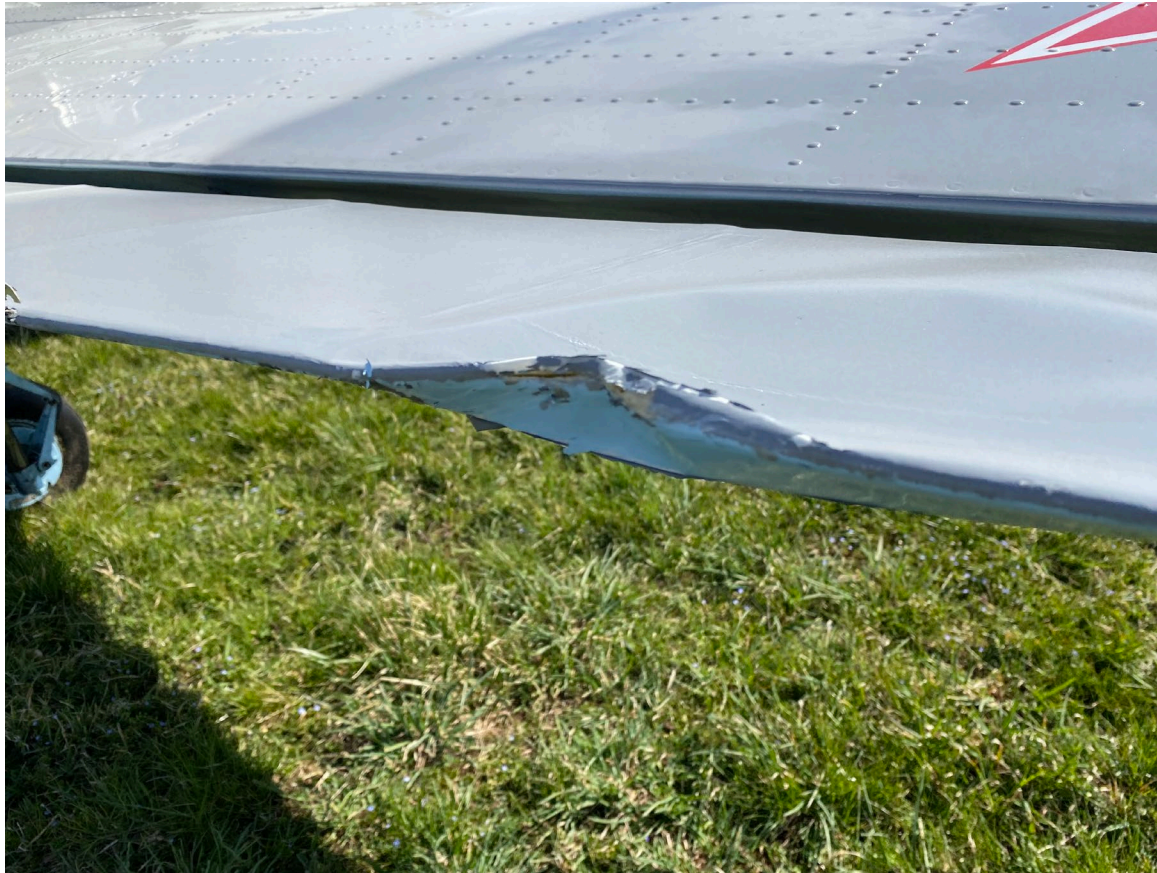
**Photograph 2 - View of aileron trailing edge damage. (Courtesy of FAA)**

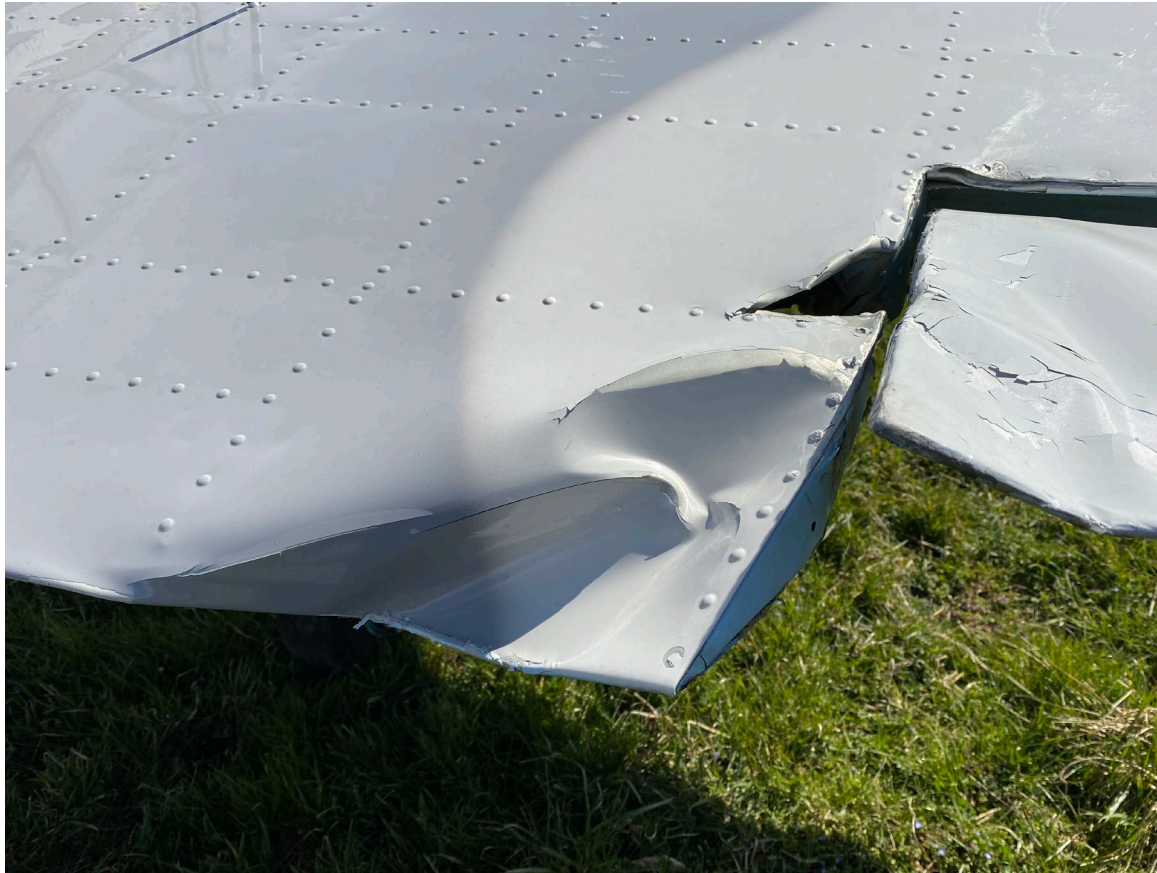
**Photograph 3 - View of right wing rib and aileron damage. (Courtesy of FAA)**
