Office of Aviation Safety  
Eastern Region

**Photo Array**

**ERA23LA199**

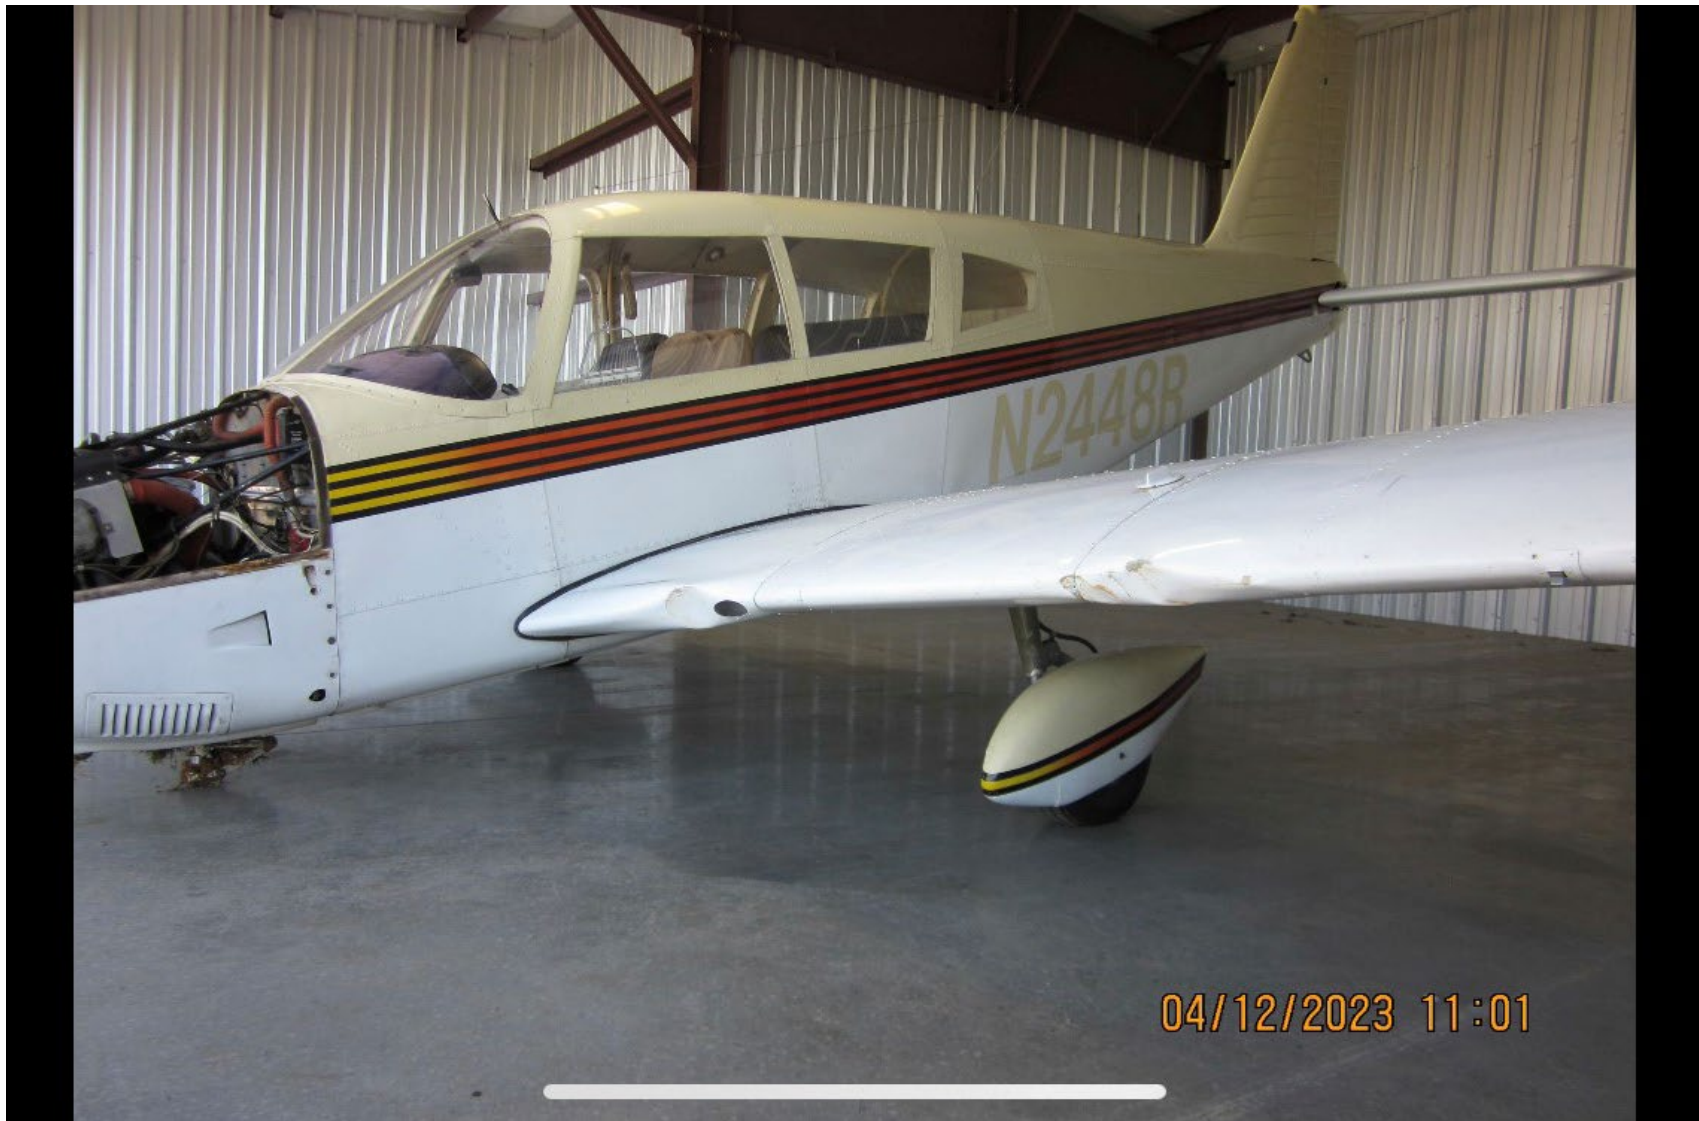
**Photo 1 – View of airplane from left wing (Photo courtesy of FAA)**

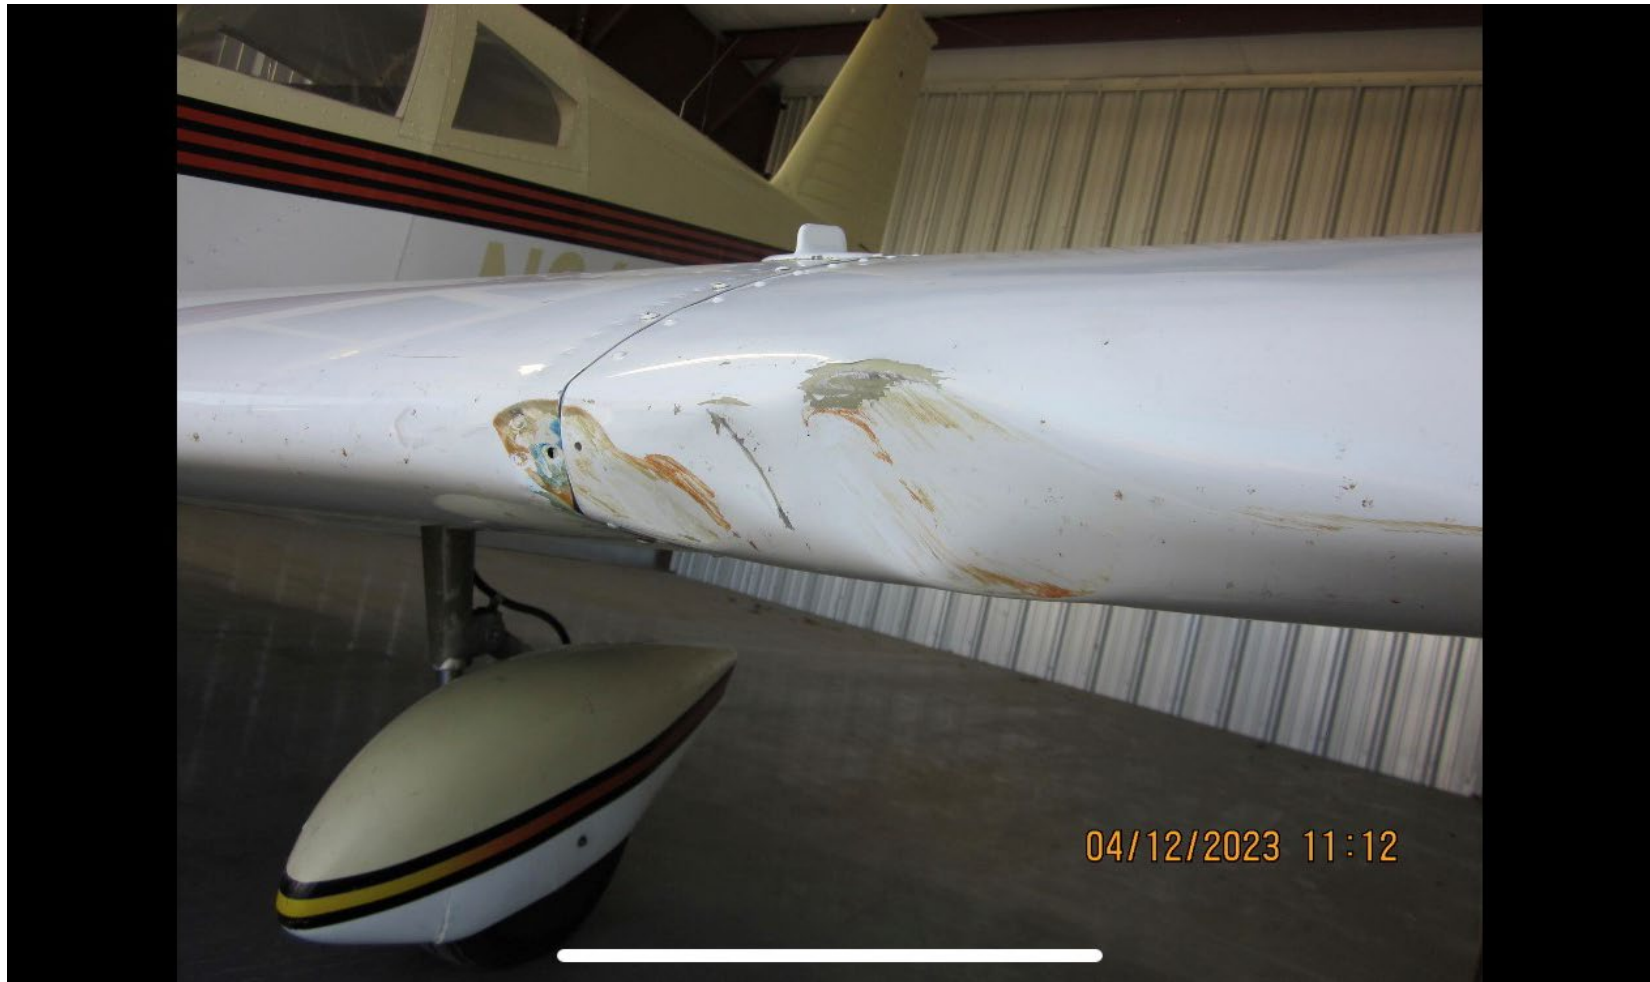
**Photo 2 – Close-up view of left wing leading edge damage (Photo courtesy of FAA)**
