ERA23LA202

## INVESTIGATION PHOTOGRAPHS

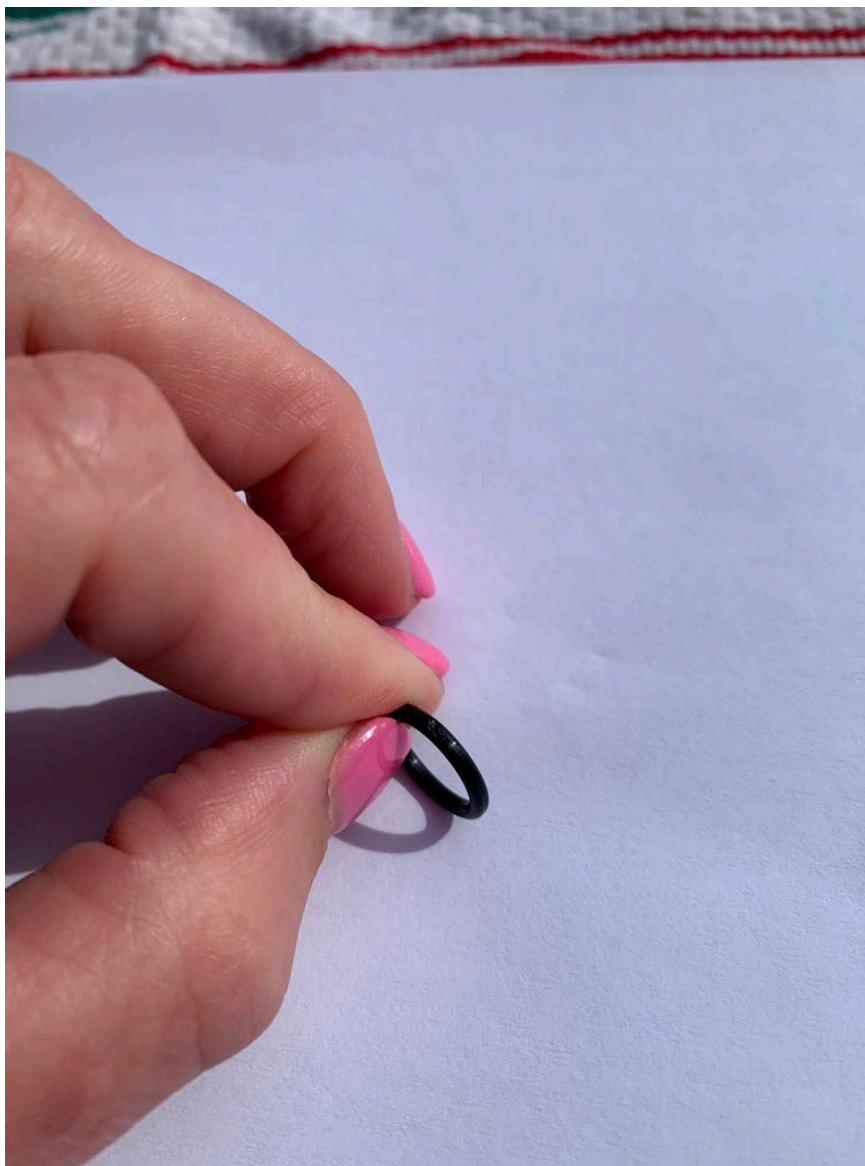
**Photograph 1 - Larger tear on check valve O-ring**

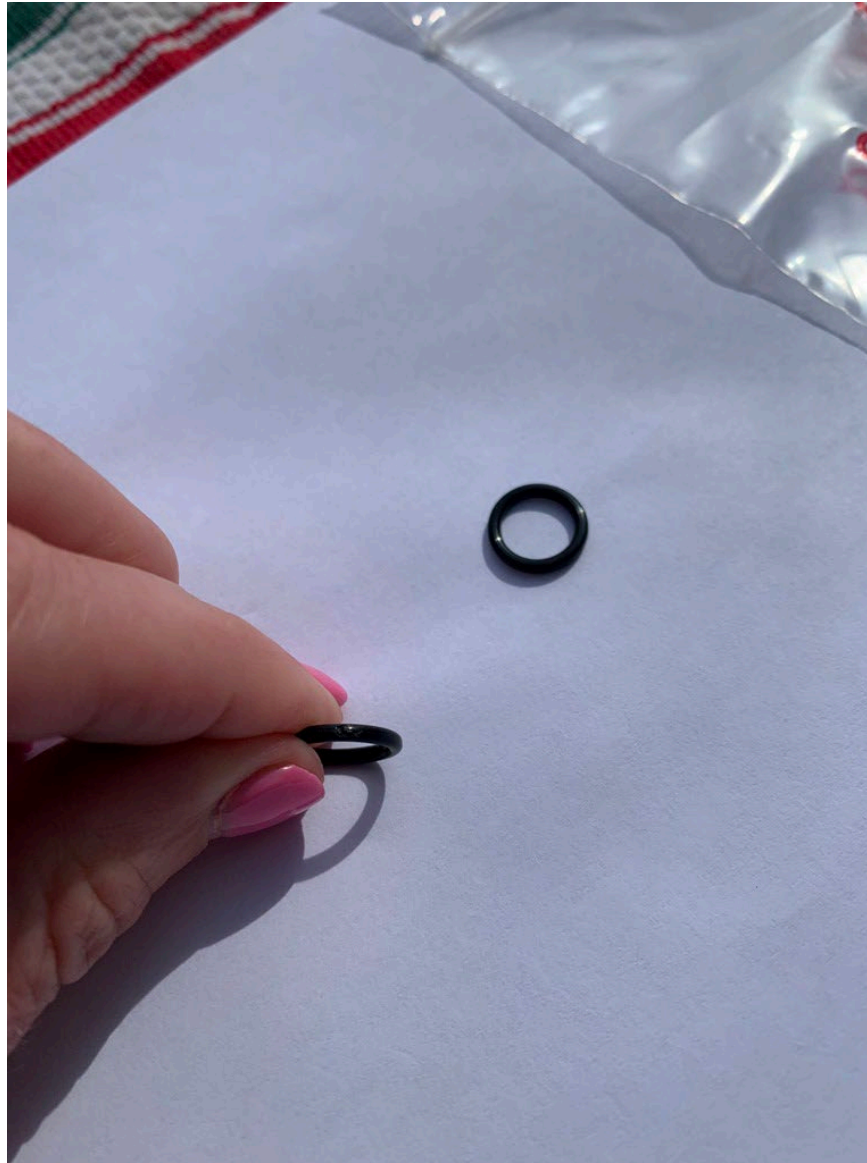
**Photograph 2 - Smaller tear on check valve O-ring**
